PROPERTY INSPECTION REPORT

Concerning: 2706 Stelter Place, Houston, TX 77007
(Address or Other Identification of Inspected Property)

By: Robert Waitschies TREC#5814 10/31/2017
(Name and License Number of Inspector) (Date)

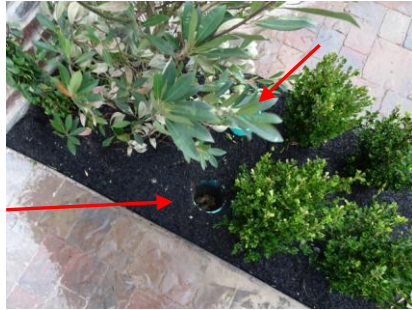
- The drain covers at the front of the home are missing.

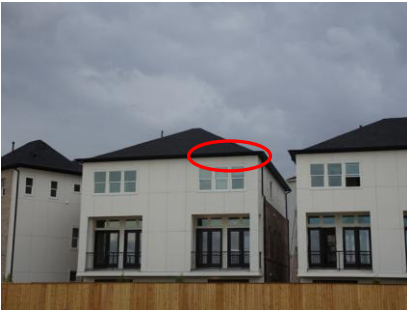
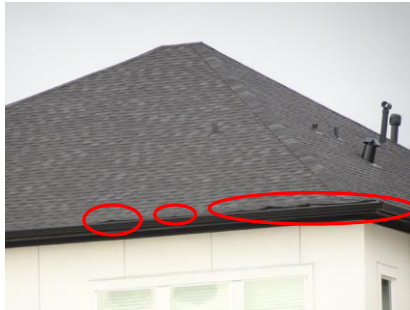
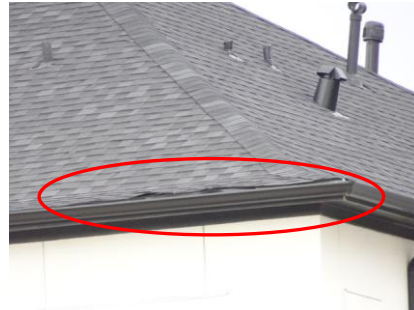
- The shingles at the lower edge of the rear slope of the roof are uneven in several locations. The nails are backing out underneath the shingles. The shingles should be resecured as necessary.

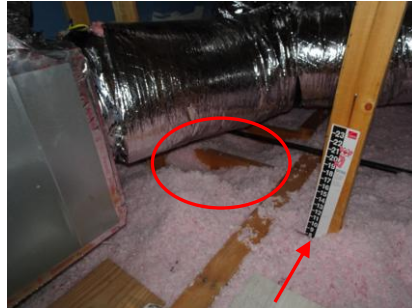
- Soffit and draft attic ventilation was observed.
- The attic insulation is low in several areas. The insulation should be improved to achieve an R-value of R-30 or R-38 (per construction specifications).

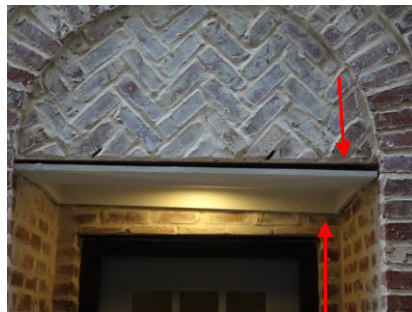
- Brick and fiber cement exterior veneer was observed.
- The ceiling trim at the front entrance of the home is poorly installed (installed crooked).

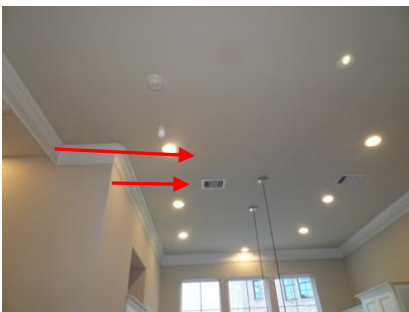
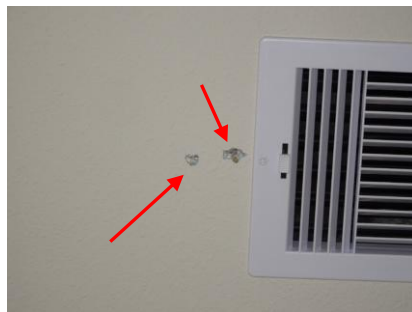
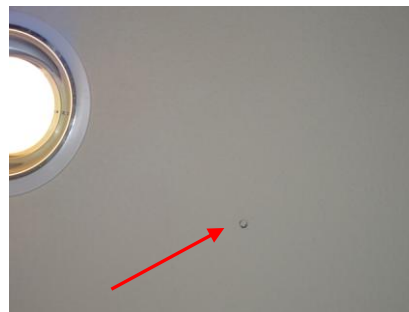
- Wood and tile flooring was observed.
- Minor damage and nail pops were observed at the kitchen ceiling.

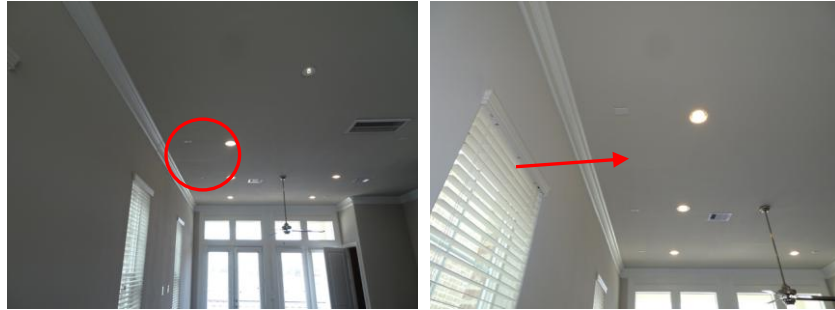
- Obvious patching was observed at the living room ceiling.

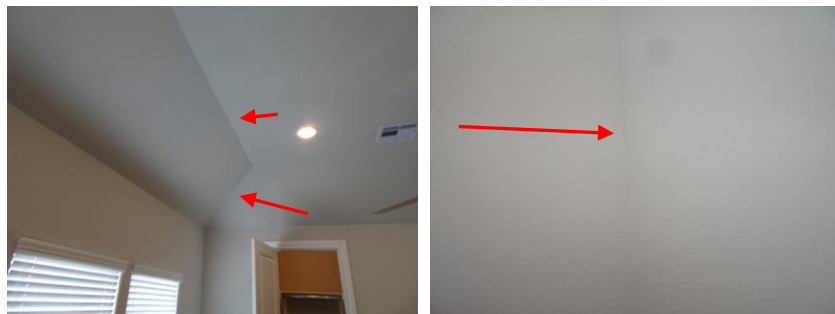
- Minor cracking was observed at the edges of the vaulted ceiling in the master bedroom.

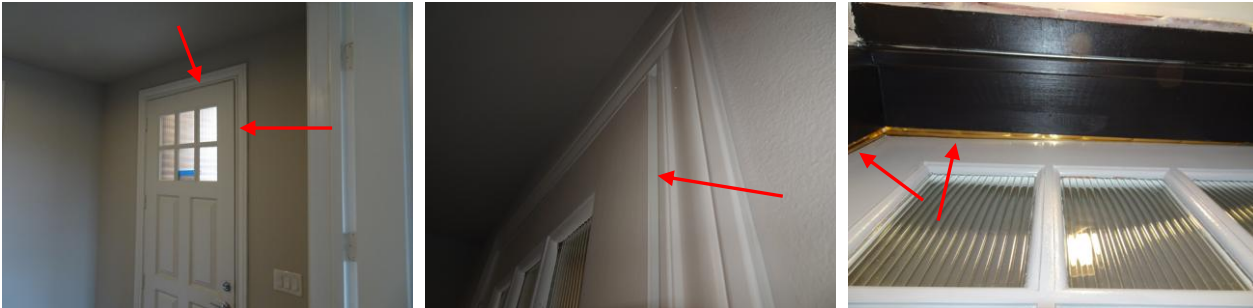
- The front door does not fully closed seal properly at the weather stripping. Repairs should be undertaken.

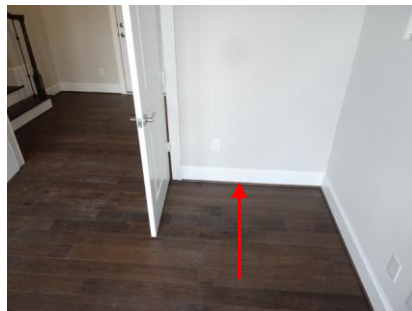
- The door bump is missing at the 1st floor guest bedroom door.

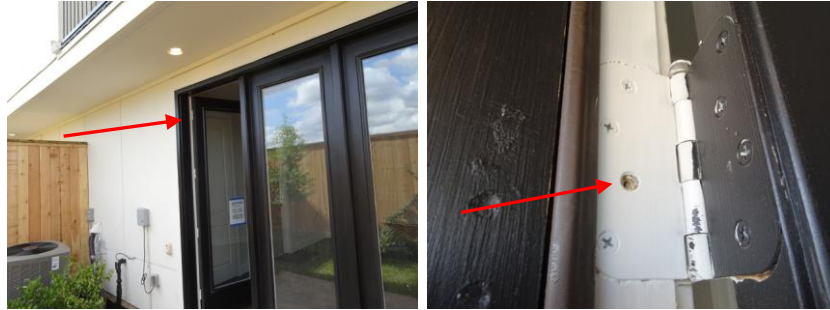
- The 1st floor guest bedroom patio door is missing a screw at the upper hinge.

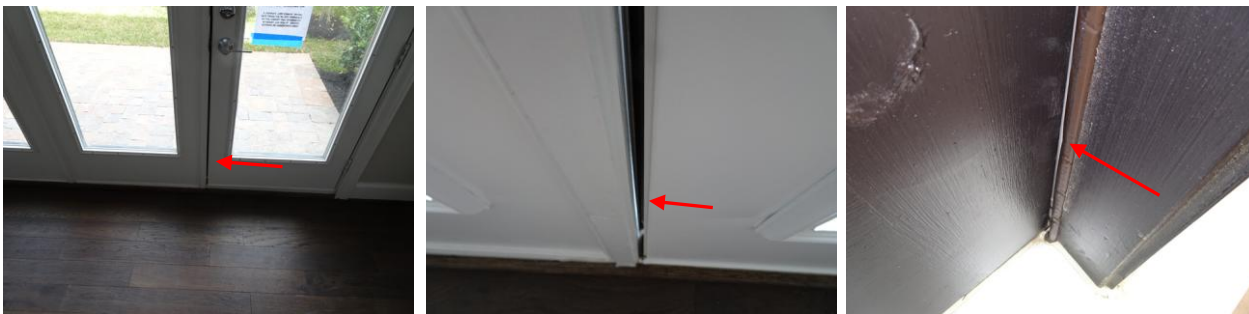
- The 1st floor guest bedroom patio door does not seal properly the weather stripping.

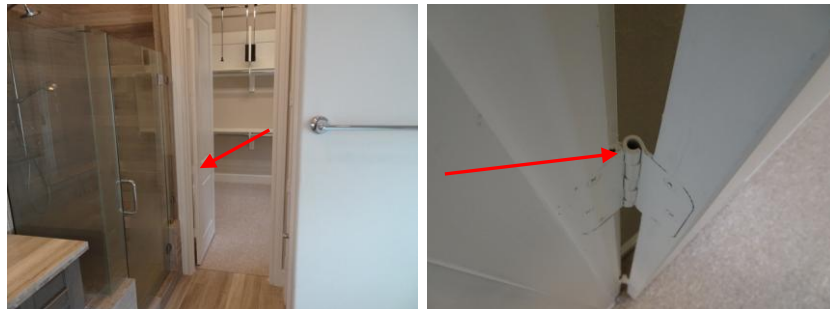
- The hinge pin is missing at the master bathroom closet door.

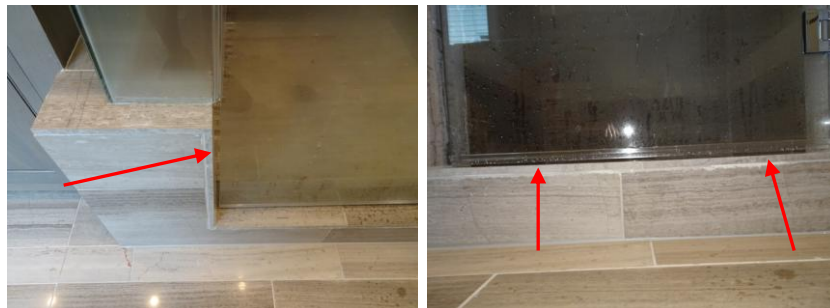
- The rubber seal is incomplete at the master bathroom shower stall door. The lower door seal is not contact the tile threshold. Repairs should be undertaken.

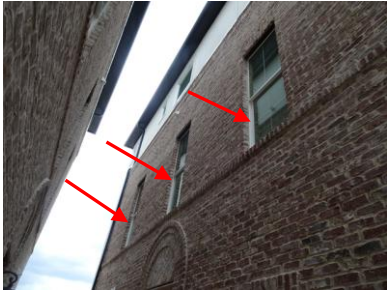
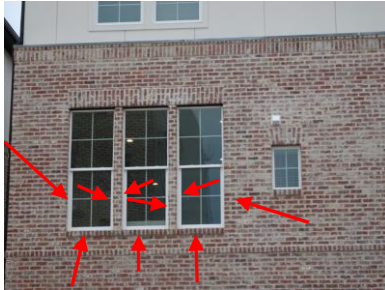
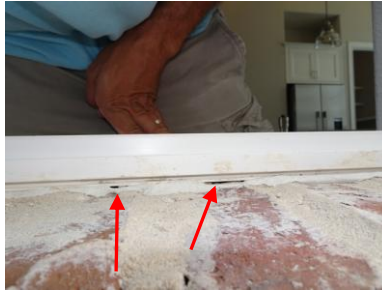
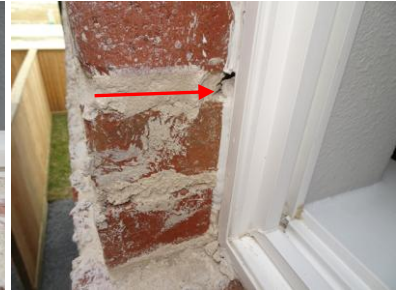
- Double pane, single hung and fixed windows
- The window screens are not installed.
- The exterior edges of the windows are poorly sealed. Caulking improvements are needed around many of the windows.

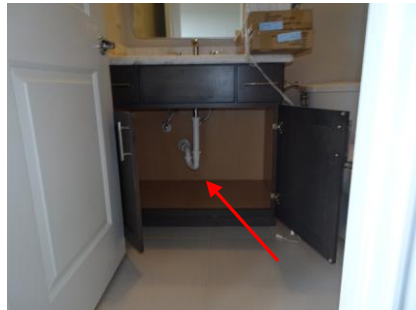
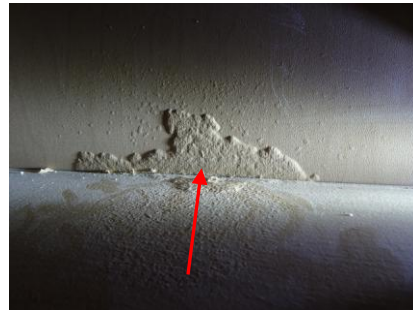
- Minor water damage was observed at the cabinet wall underneath the 1st floor guest bathroom sink. This area was dry at time of inspection.

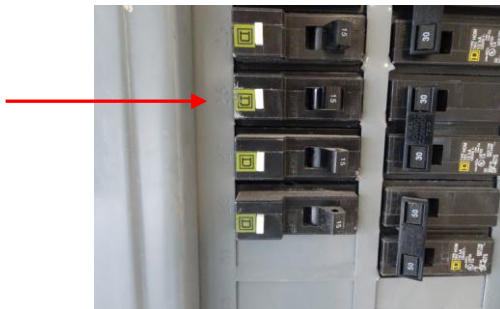
- Square D Brand, 150amp electrical service panel located in the garage.
- The breakers within the electrical panel are not properly labeled. The breaker in location #25 is labeled "M. Bed Lights and Plugs." This breakers serving the stairway, upper hallway and laundry room.

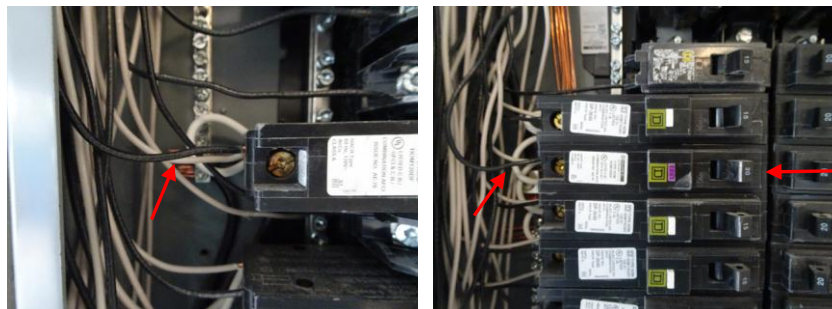
- The 20amp breakers in the electrical panel serving the garbage disposal and dishwasher are oversized (breaker #5 & #17). The wires (14AWG) routed to the breakers are only capable of handling 15amps. These breakers should be replaced with a 15 amp breakers.

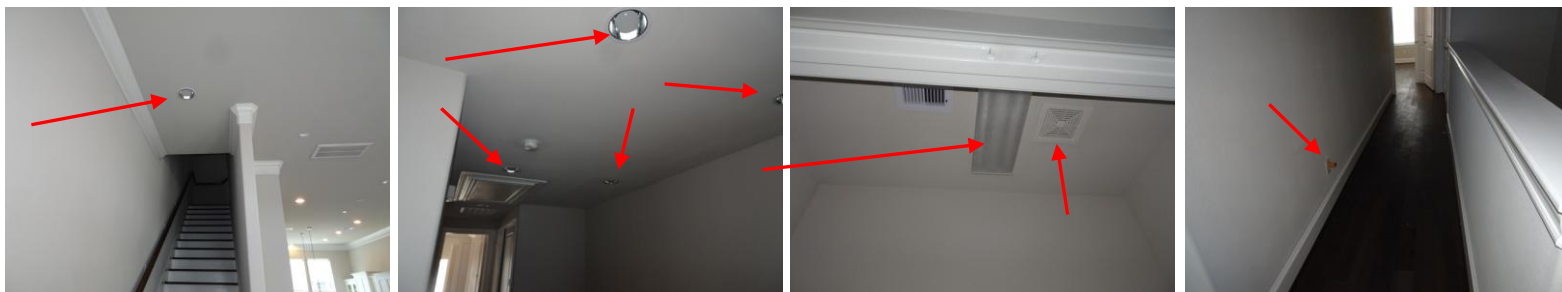
- The breaker serving the upper stairway, upper hallway and laundry room light fixtures and electrical outlets did not function properly at time of inspection. The breaker was tripped and would not reset. The electrical circuit should be investigated.

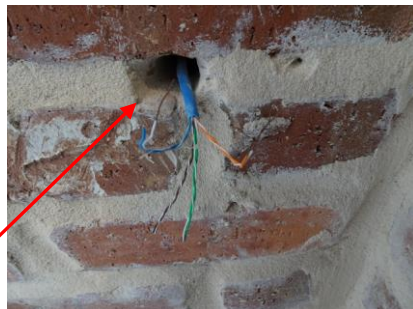
- The doorbell button is not present.

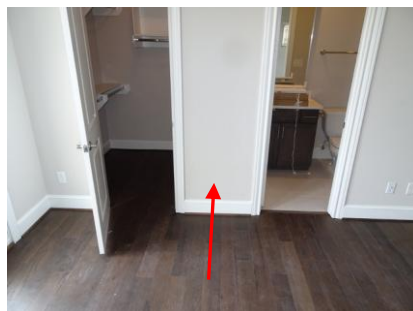
- An electrical outlet is not installed on the 1st floor bedroom wall between the closet and bathroom doors. Any section of a wall in a habitable room 24 inches or longer should have an electrical outlet installed **IRC 3801.2.2**. Repairs should be undertaken.

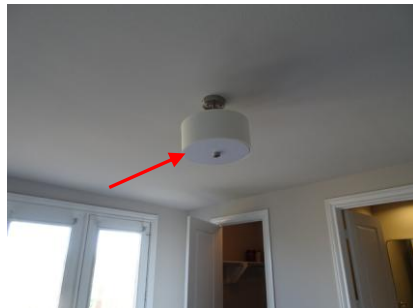
- The light fixture in the 1st floor guest bedroom did not operate at time of inspection.

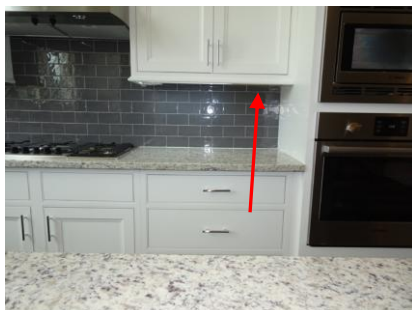
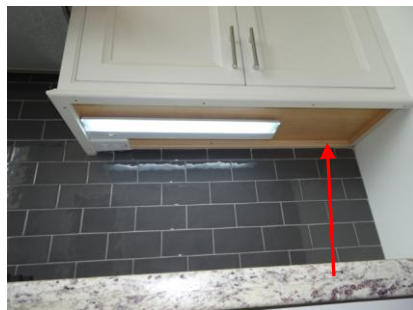
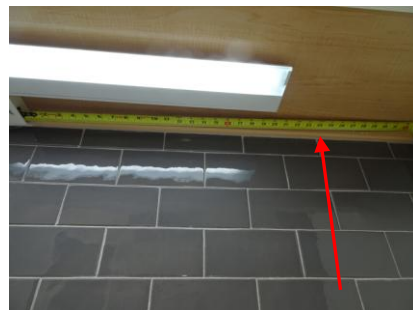
- An additional electrical outlet should be installed at the kitchen countertop space between the cooktop and other. There shall be no space along the kitchen countertop longer than 24 inches that is not served by an electrical outlet **IRC 3801.4.1**. Repairs should be undertaken.

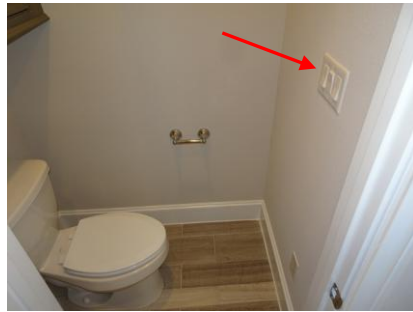
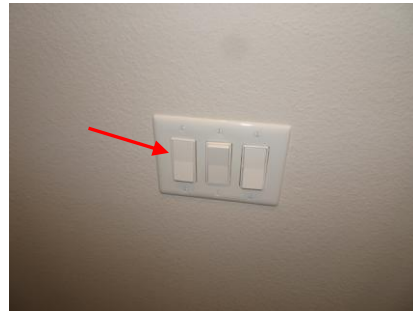
- The operation of the wall switch in the master bathroom water closet could not be determined. Further investigation is recommended.

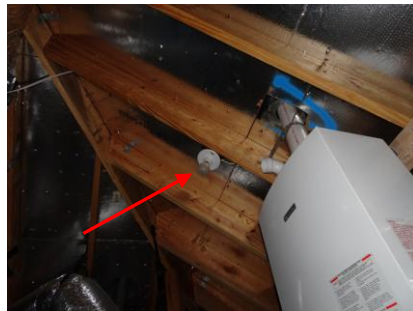
- The attic light fixture did not operate at time of inspection.

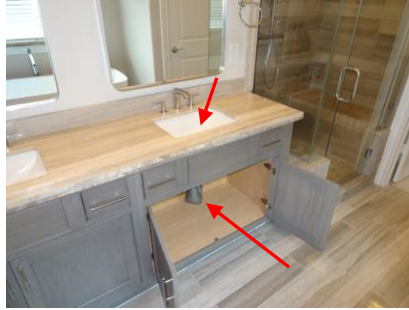
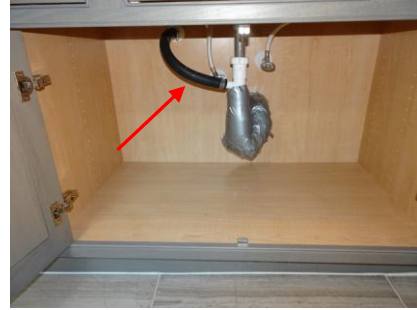
- The primary condensation drain line should be reconfigured to prevent the undesirable noise at the master bathroom right sink when the air conditioner is in operation. The drain connection underneath the sink are heavily insulated to prevent condensation from forming and dripping in the cabinet space below.

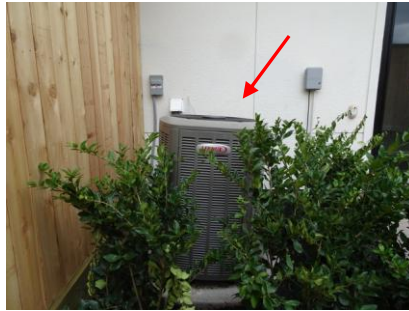
- The condensing unit at the rear of the home is not level. Repairs should be undertaken.

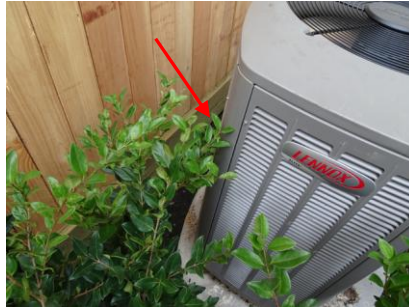
- All vegetation should be cut back away from the condensing unit at the air-conditioning system at the rear of the home.

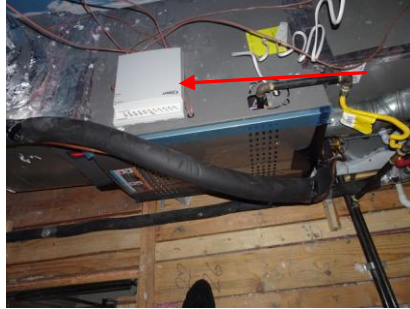
- The zone controller is not properly connected in the attic. The thermostat on the 1st floor of the home controls the 3rd floor zone. The thermostat on the 2nd floor of the home controls the 1st floor zone. The thermostat on the 3rd floor of the home controls the 2nd floor zone. Repairs should be undertaken.

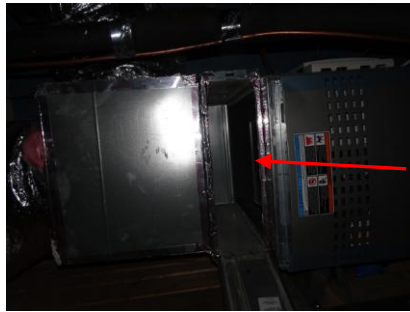
- The media air filter is not present in the attic. The heating and cooling system be cleaned and serviced.

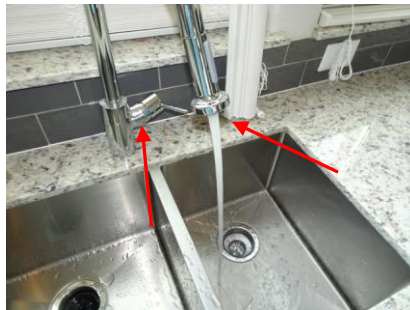
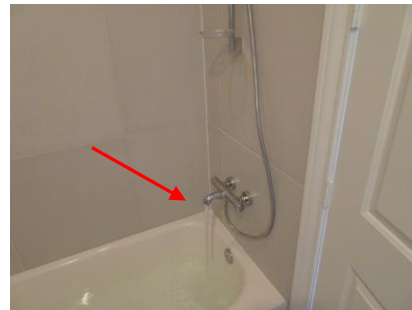
- Hot water was not present at the kitchen faucet and the upper guest bathroom tub faucet. Repairs should be undertaken.

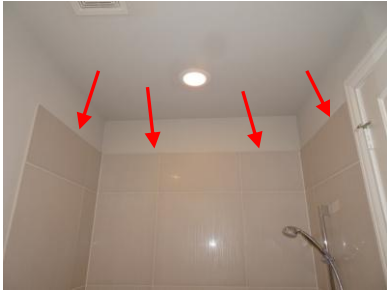
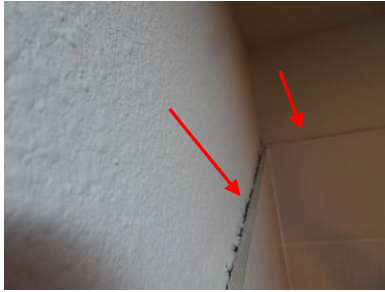
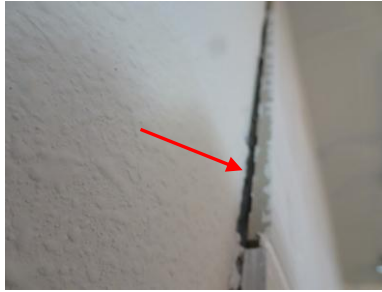
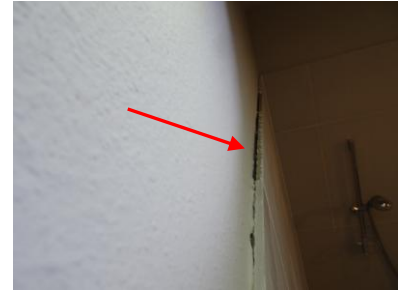
- The tops of the lower guest bathroom and upper guest bathroom tub tile surrounds are unfinished at the drywall edges.

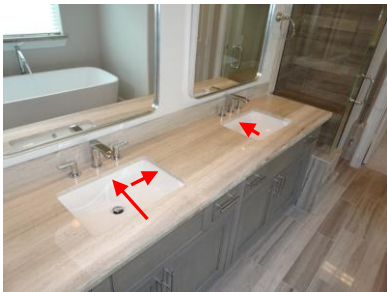
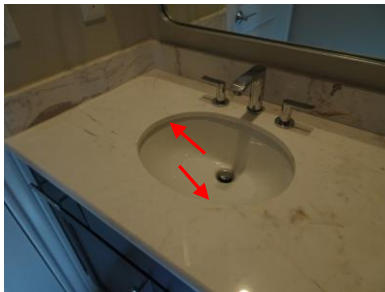
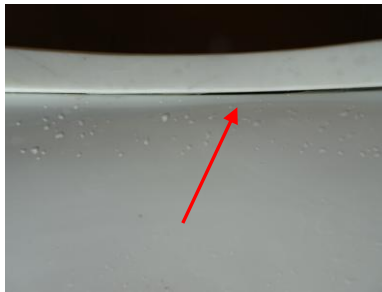
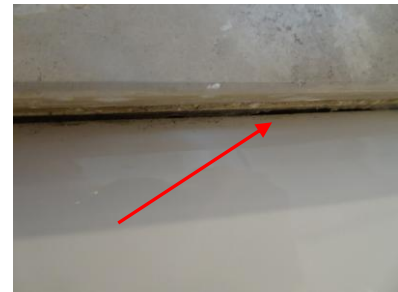
- The under mount sinks are not adequately sealed at the countertops in all bathrooms.

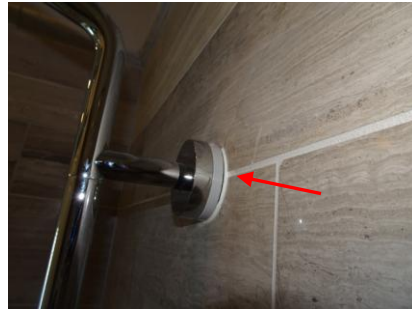
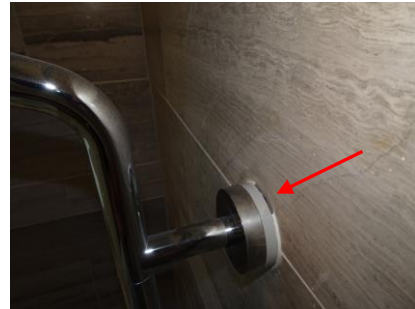
- The master bathroom shower head is loose and is poorly sealed where mounted to the wall.

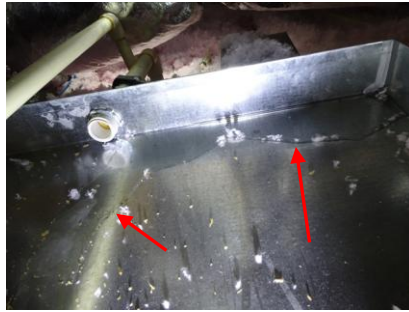
- Bosch Brand tankless water heater was observed in the attic.
- Water was observed within the water heater auxiliary drain pan in the attic. The cause for moisture should be determined and repairs should be undertaken as necessary.

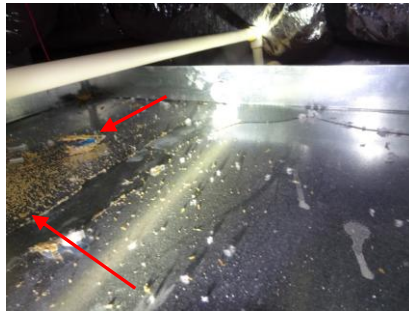
- All debris should be removed from the water heater auxiliary drain pan.

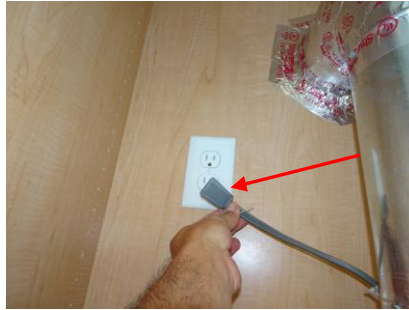
- Bosch Brand ducted unit venting to exterior
- The range vent power cord does not reach the electrical outlet installed in the cabinet above the unit. The unit could not be operated.

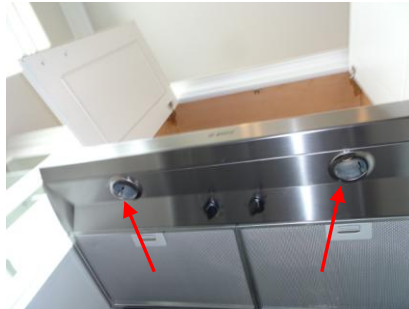
- The light bulbs are not installed at the range vent.

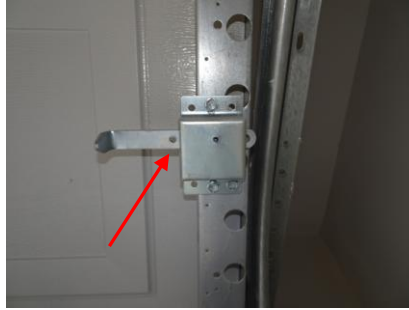
- Linear Brand
- The overhead garage door lock should be disabled when connected to an automatic garage door opener.

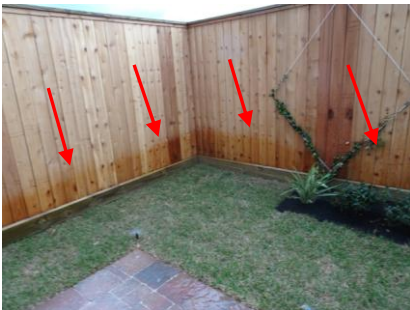
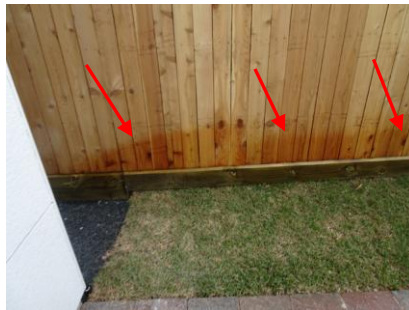
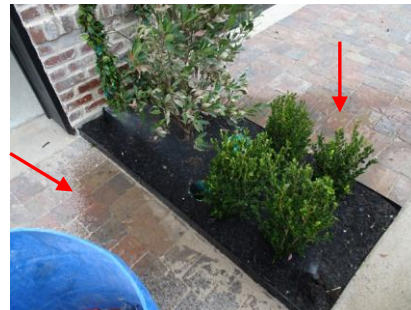
- Hunter Brand 2 zone lawn sprinkler system was operated in manual mode only.
- The water spray from the sprinkler system should be re-directed away from the structure and/or any fencing, decks, etc., to decrease the possibility of damage.

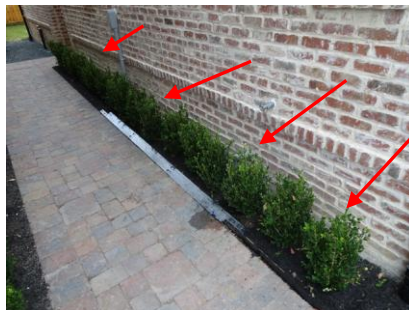
- The sprinkler system does not serve to the vegetation the left side of the home.

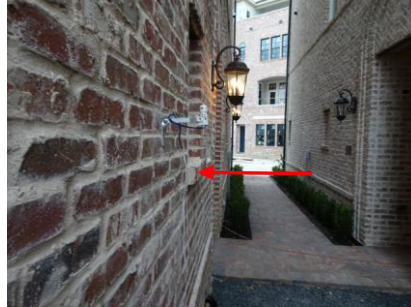
- The rain sensor is installed at the left side of the home underneath the edge of the roof. Ideally, the rain sensor should be installed at the rear fence. The rain sensor wiring is not secured and is hanging freely.
