# Island Home Inspections

## \*\*\* Residential Inspection Report \*\*\*

July 31, 2020

34 W. Dansby  
Galveston, Tx

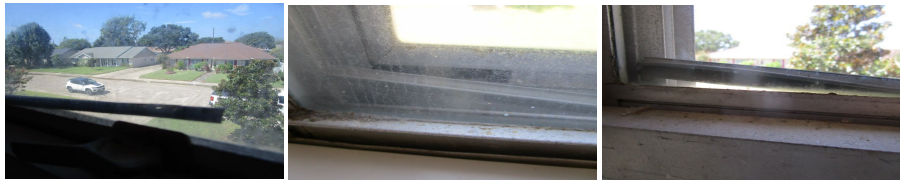
Comments: \* All screens are missing.  
 \* The kitchen window is stuck closed.  
 \* Two windows have latches missing and screws installed in the side sash to keep them closed.  
 \* Two window shutters in the upstairs south bedroom are inoperable.  
 \* Glass retaining strips are loose on several windows.
