# HIGHLAND HOME INSPECTIONS

JULY 27, 2020

# PROPERTY INSPECTION REPORT

Concerning: 3114 Fairmont Ct, Sugar Land TX 77478

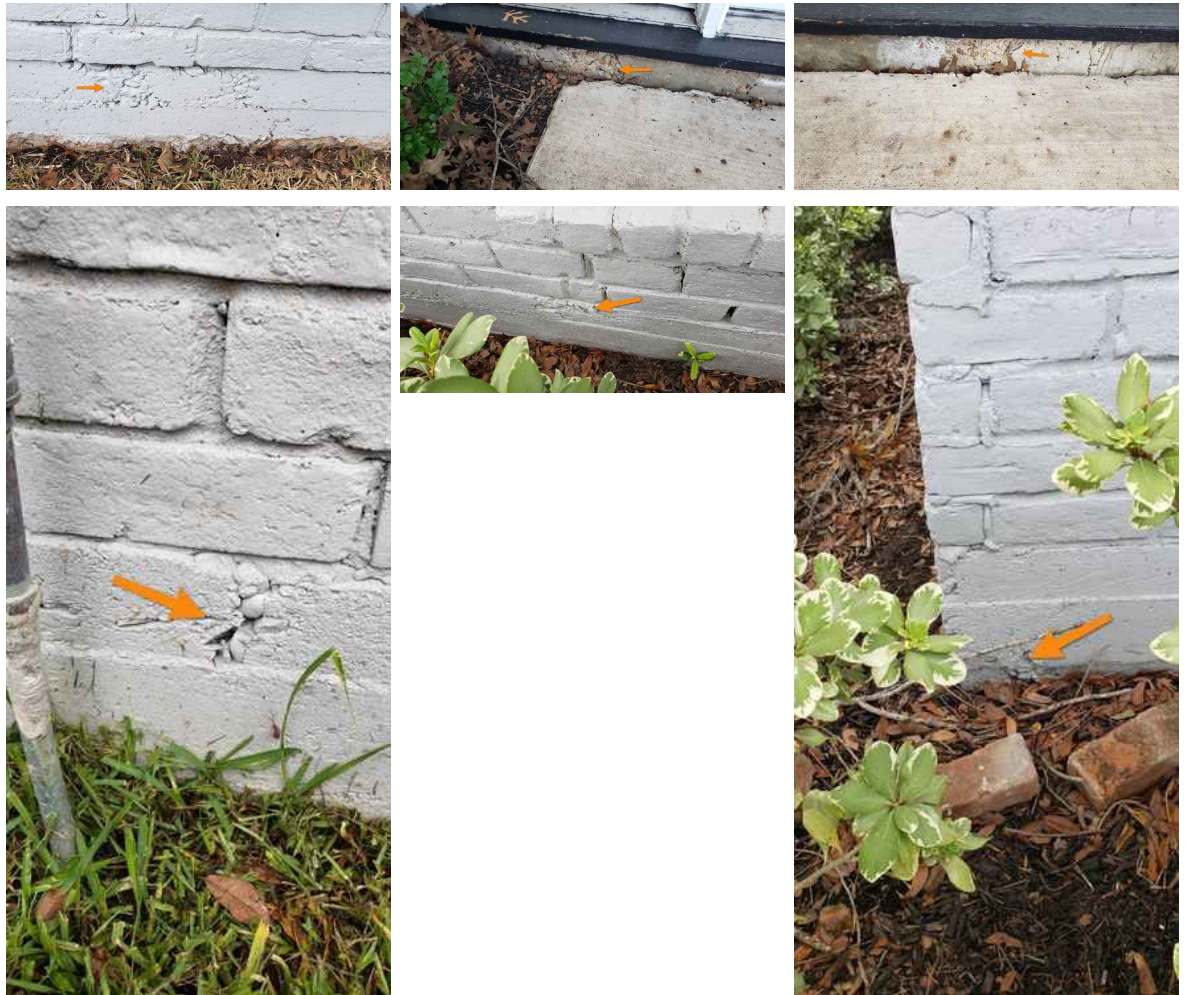
Honeycombing is caused during the pouring process when the concrete is not compacted correctly. This leads to the foundation being weaker than the designers intended. The walls of the foundation show signs of honeycombing but it is impossible to say if there were areas under the slab that have the same issue. Recommend repair by a qualified masonry contractor.

Recommendation: Contact a qualified professional.

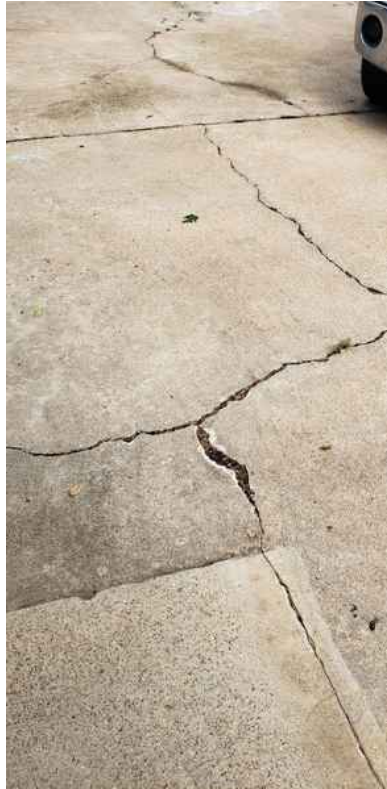
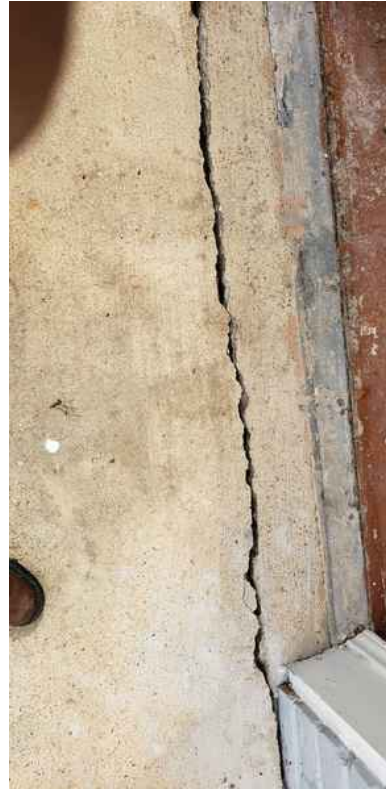
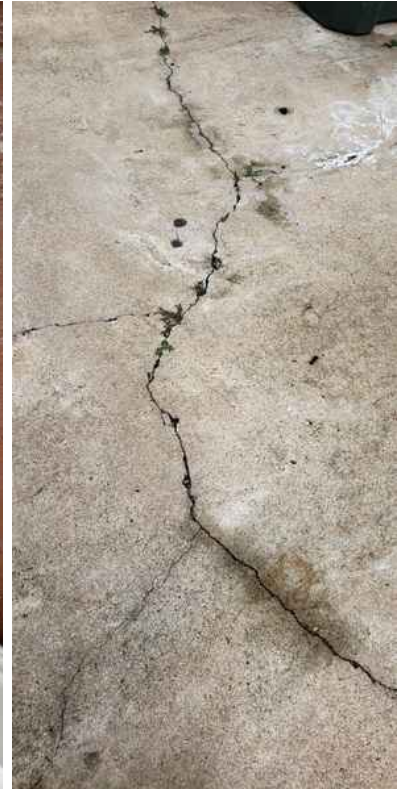
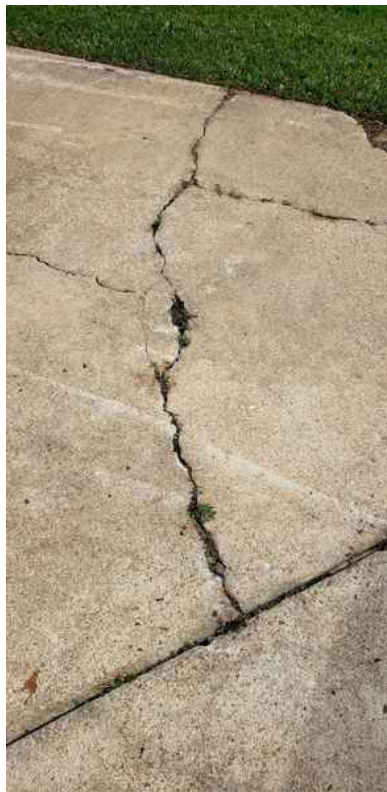
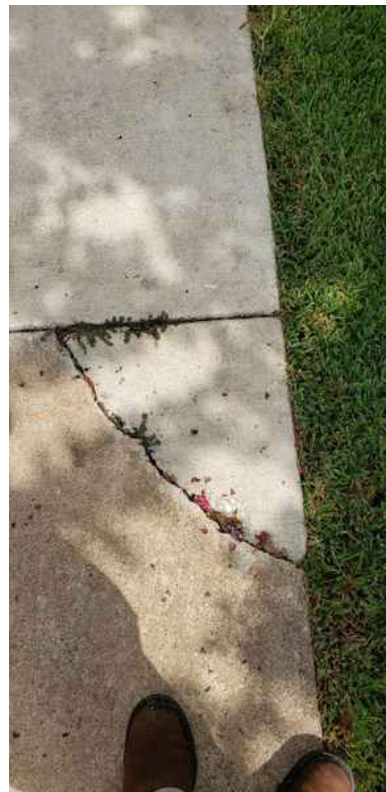
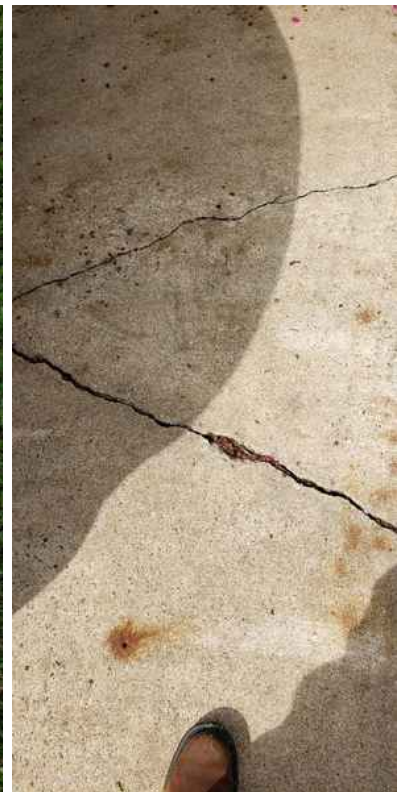
**1: Driveway significant cracks**

Significant cracks were visible in driveway at the time of the inspection. This condition appeared to be consistent with cracking caused by soil movement. If this condition was caused by inadequate compaction at the time of original construction, soil will have stabilized by now. If it was caused by expansive soil, movement and cracking may continue. Determining the soil condition would require the services of a soils (geotechnical) engineer. The Inspector recommends further evaluation and correction by a qualified contractor.

Recommendation: Contact a qualified professional.

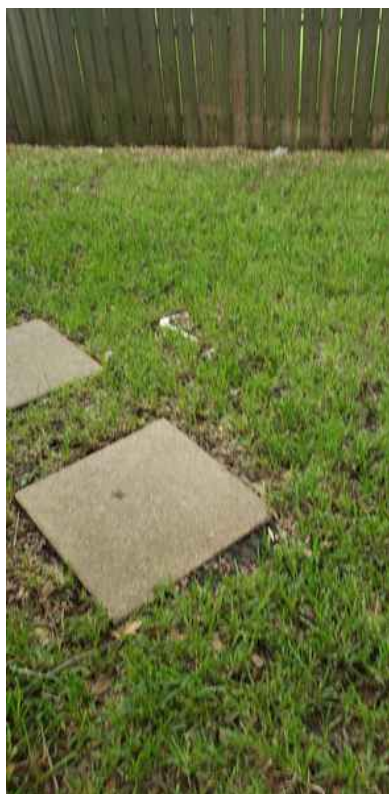
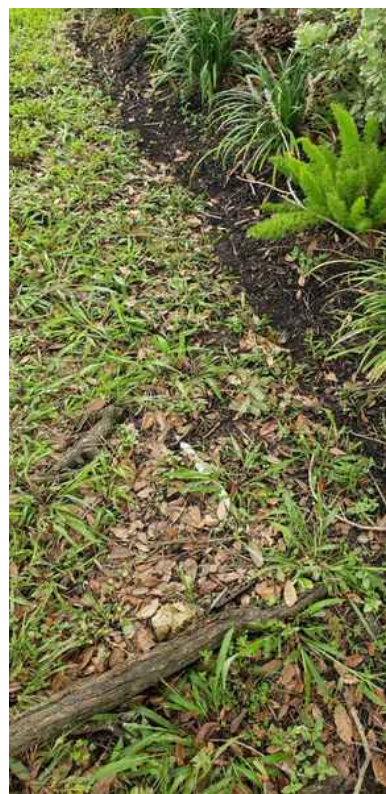
## 2: Yard grading erosion

The home had areas of significant erosion visible that will continue unless action is taken to prevent it. The Inspector recommends that before the expiration of your Inspection Objection Deadline you consult with a qualified landscape contractor to gain an idea of options and costs for correction.

Recommendation: Contact a qualified professional.

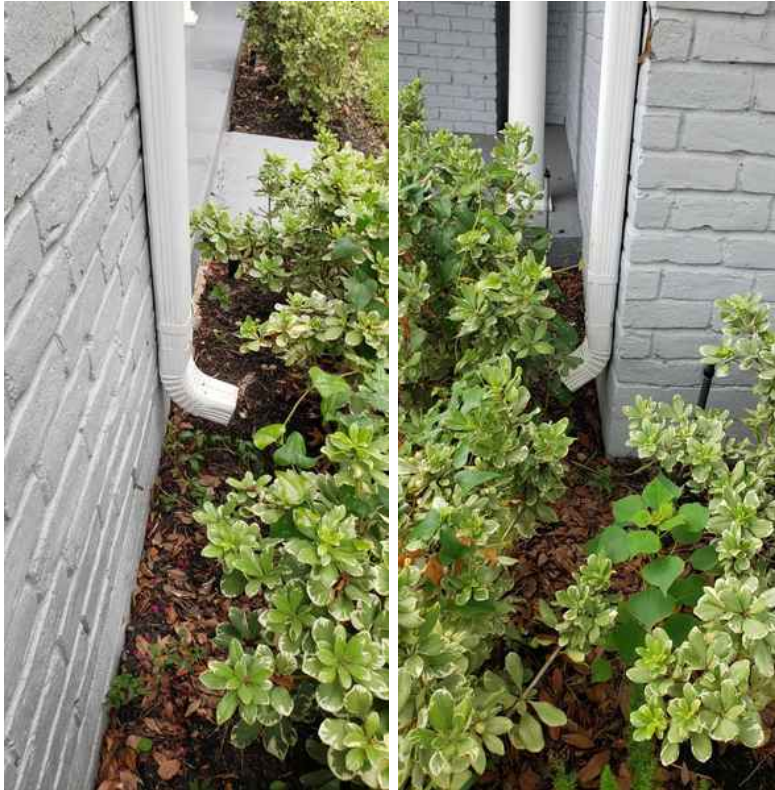
**3: Extend downspouts**

The gutter down spouts should be extended so the flow is directed away from the foundation. 5' is required in expansive soils. Excessive moisture at the foundation can cause foundation movement, in clay soils, and result in damage to the structure.

Recommendation: Contact a qualified professional.

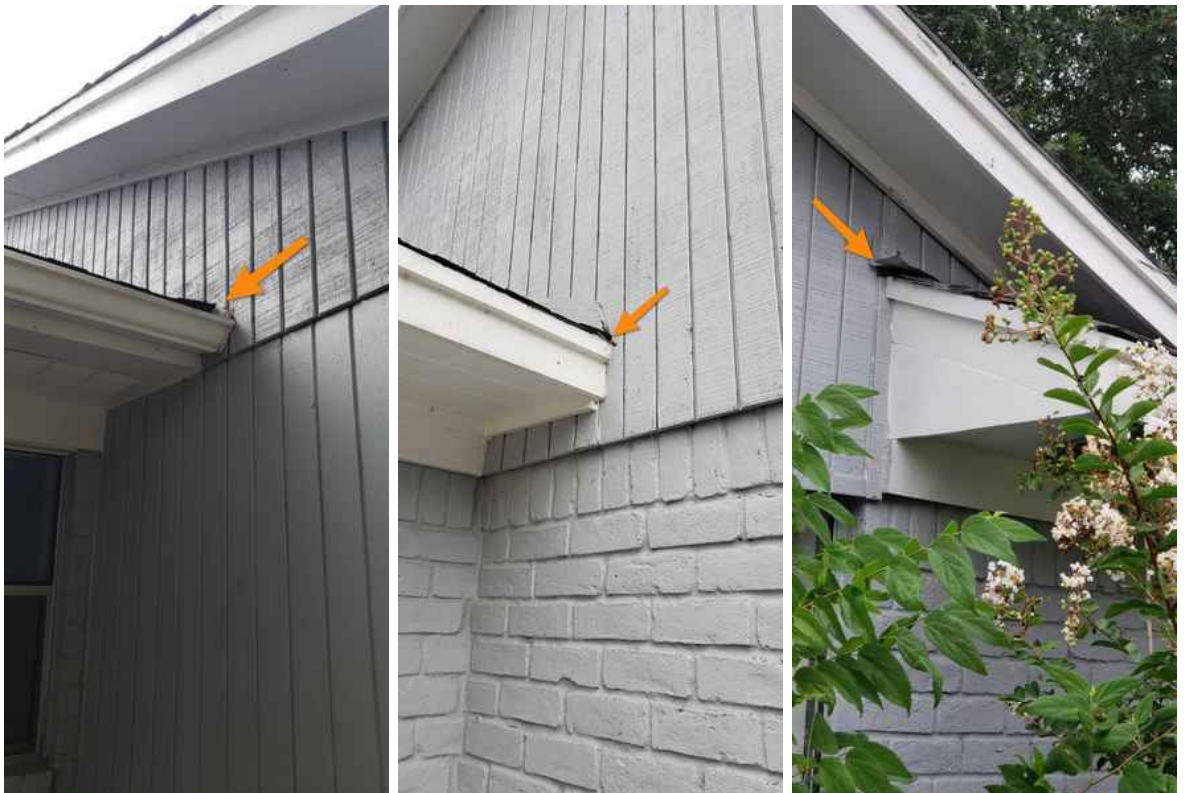
**2: Kick out flashing opinion**

Kick out flashing missing from walls, also known as diverter flashing, is a type of flashing that diverts rainwater away from the cladding and into the gutter. When installed properly, they provide excellent protection against the penetration of water into the building envelope.

Recommendation: Contact a qualified professional.

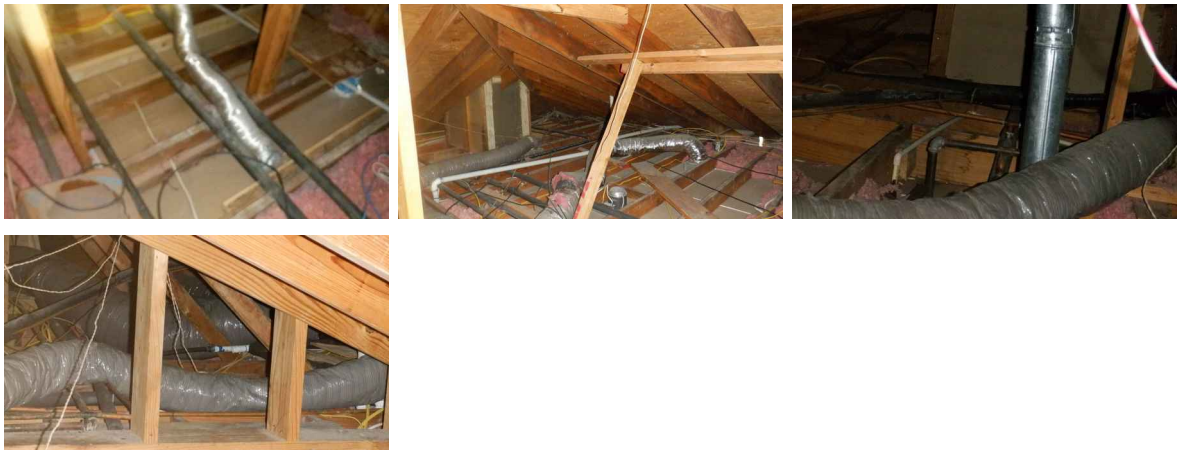
**3: Insulation missing**

Insulation is missing throughout the attic over the living areas. The absence of insulation will result in greater heat and cooling losses.

Recommendation: Contact a qualified professional.

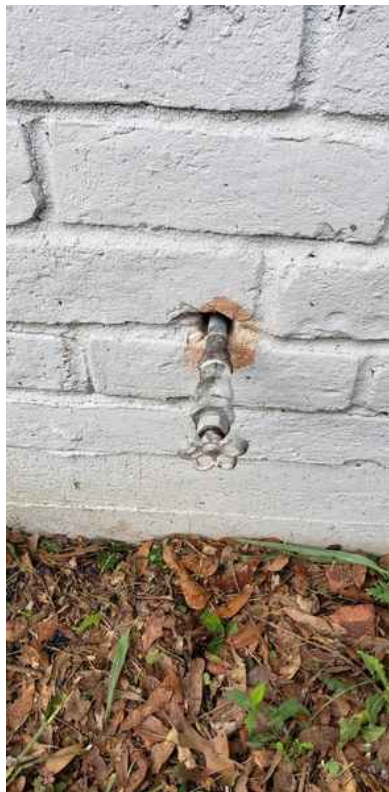
**5: Caulk & seal all gaps/cracks**

Caulk and seal all gaps, cracks, and openings. There are various areas around the house that need sealing.

Recommendation: Contact a qualified professional.

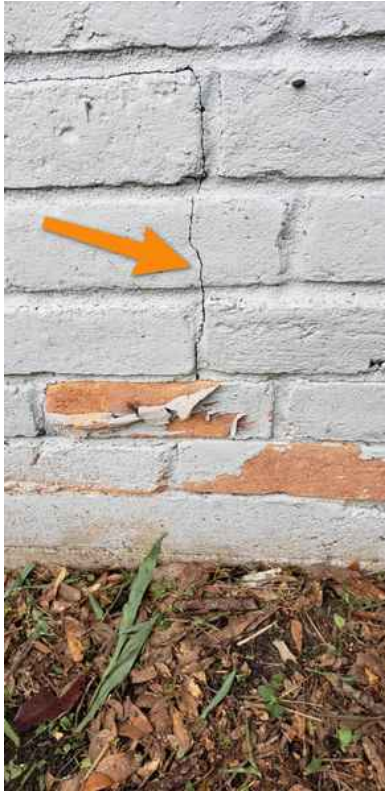
**6: Cracks - Minor**

Minor cracking was observed in wall structure. This is common in homes this age. Recommend monitoring.

Recommendation: Recommended DIY Project

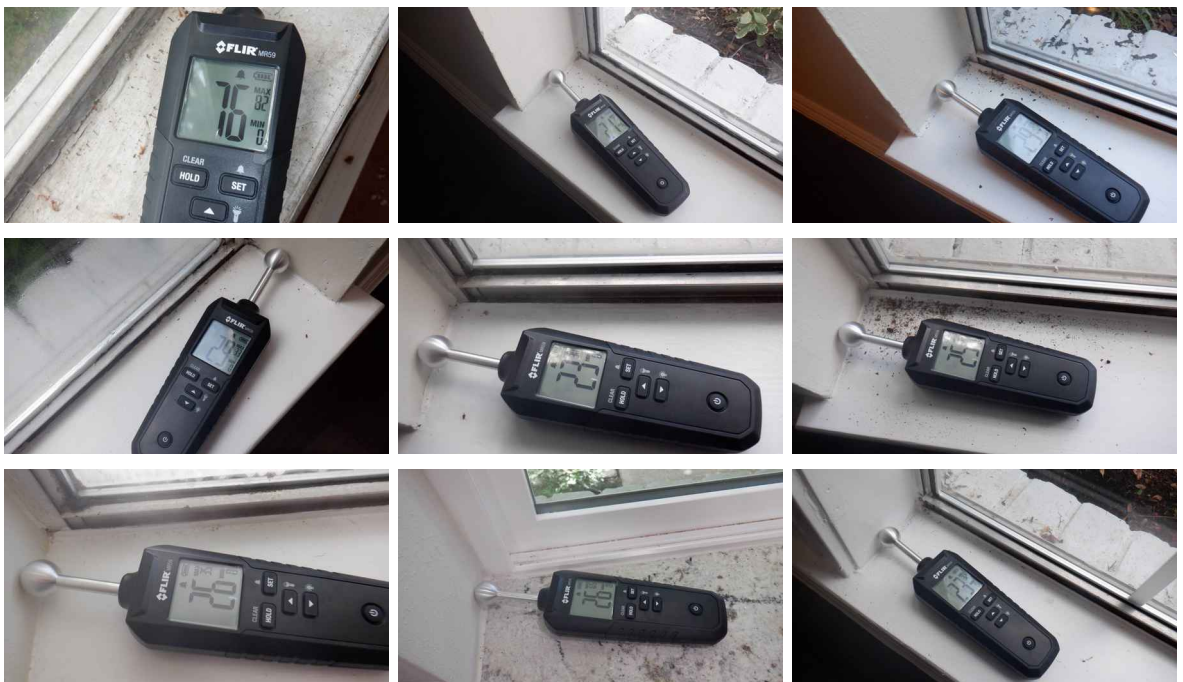
One or more windows in the home exhibited signs of water damage. This condition is typically moisture intrusion from the exterior or excessive condensation on the interior pane of the window and should be corrected to help prevent further deterioration.

Recommendation: Contact a qualified professional.

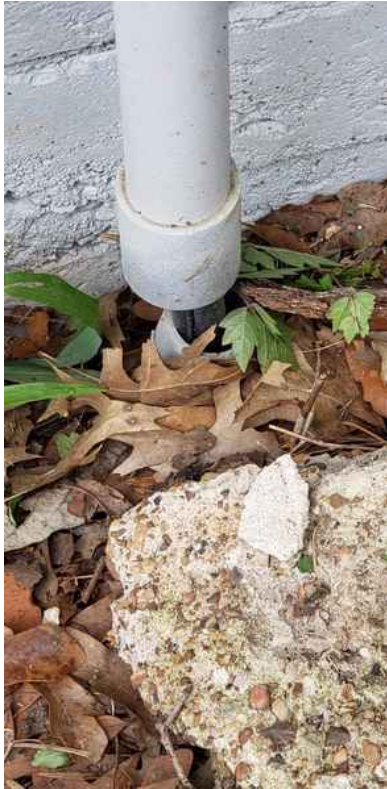
The service entrance PVC conduit is not securely attached to the meter box. This condition will provide water intrusion and presents a possible shock hazard.

Recommendation: Contact a qualified professional.

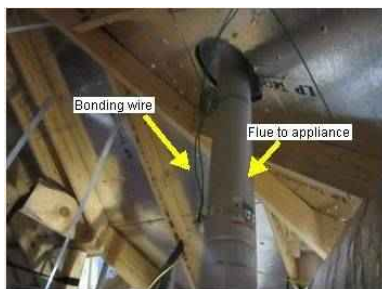
**3: Bonding appliances such as furnace(s) and water heater(s) should be bonded**

Bonding is important because it reduces the risk of lightening striking the building by eliminating the difference in electricity potential between the appliance and the ground.

Recommendation: Contact a qualified professional.
