David Grissom, P.E., PhD

28 October 2013

Ref: 8314 Argentina St.
Jersey Village, TX 77040-1305
Type investigation: Structural - Foundation
Type Construction: One-Story, Brick Veneer, Composition Roof, Detached 2-Car Garage,
Monolithic Slab-on-Grade Foundation - Waffle Design, Slab Exposure Varies from
0 inches to 6 inches, Grade Beam Depth: 17 inches.

Summary

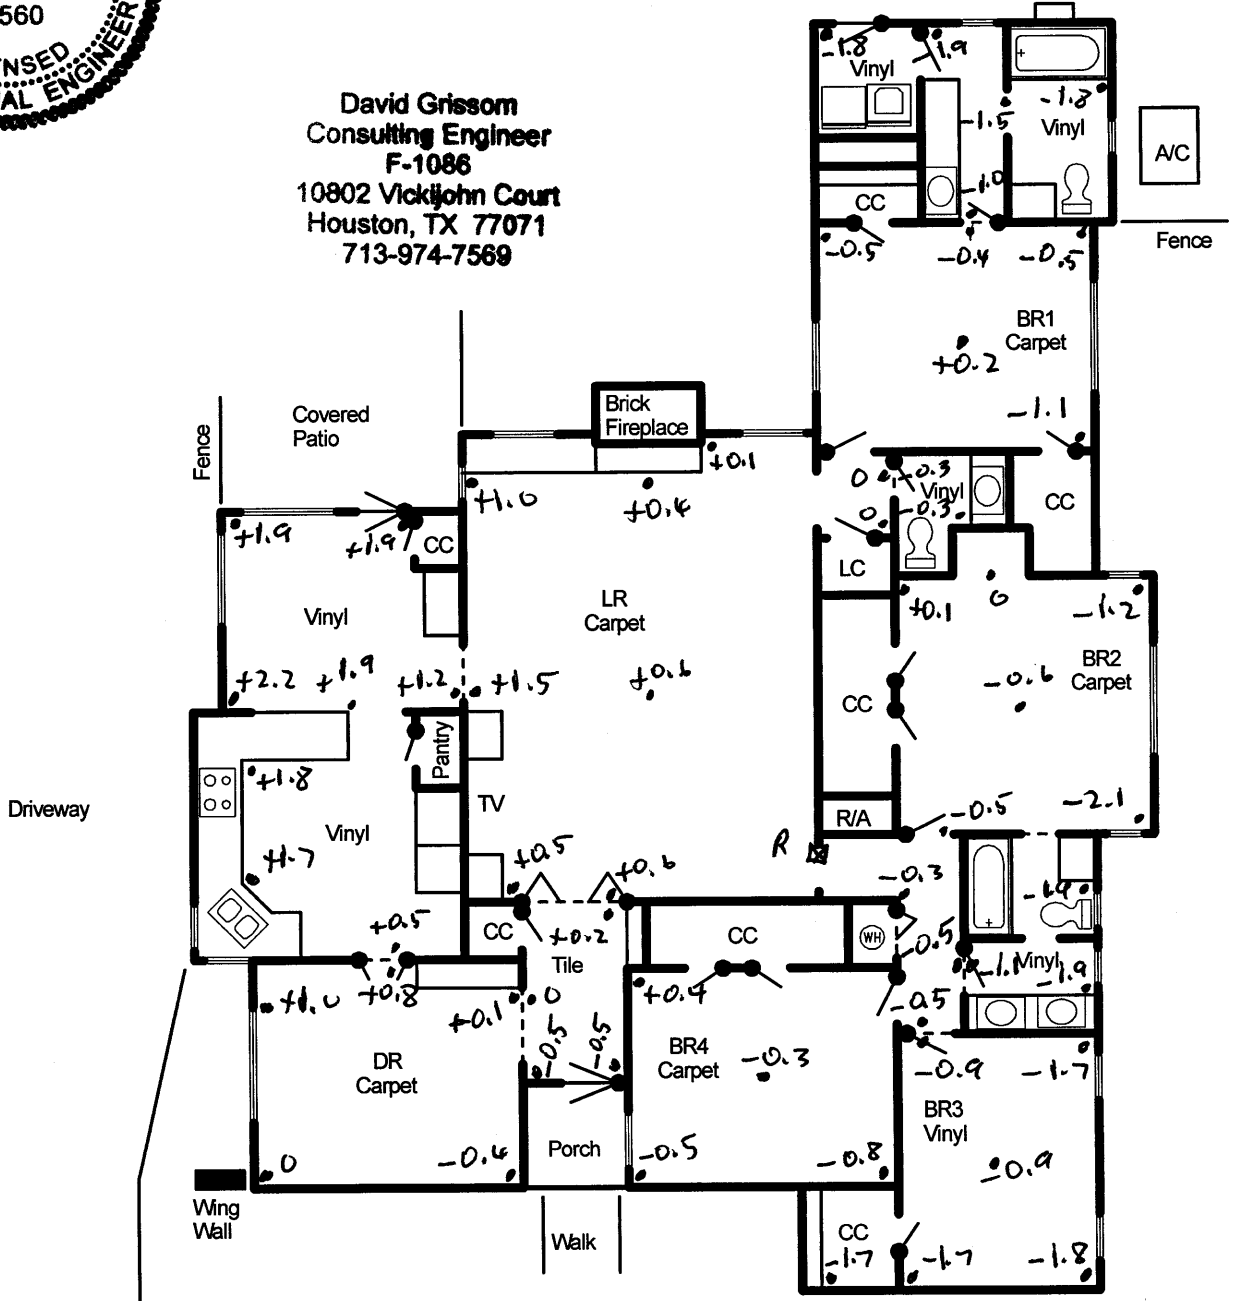
Apparent upheaval in the kitchen area is suggestive of sewer leaks under the slab. You are advised to have the sewer system tested for leaks. There are a number of companies who specialize in leak detection. What is needed is the location of the leak and not just the fact that a leak exists. A good leak detection company will trace out the paths of the sewer lines, make a drawing of the floor plan (A copy of Drawing D would be good for this.) with the sewer paths marked, and show the location of all leaks found. The accidental discharge of water under a slab foundation is sometimes an insurable loss. You should turn in a claim to the carrier of your homeowner's insurance. The insurance company sometimes pays for an investigative plumber to test the sewer

The elevation survey of Drawing A indicates foundation subsidence in the right half of the house. The signs of stress on the structure, documented on Drawing B, confirm the foundation motion suggested by the elevation survey. There may be others. The differential elevation between extremes now present in this foundation is on the order of 4.6 inches. The differential movement is not well confined to the perimeter and several interior pilings are needed as shown on Drawing C. The extent of the foundation movement is of sufficient magnitude that repair by a competent foundation company is recommended.

On the left side of the house there are no trees. There appears to be a sewer leak under the kitchen producing the apparent upheaval in the area. If no sewer leaks are found, I have no explanation for the anomalously high area in the kitchen. It could have been built that way.

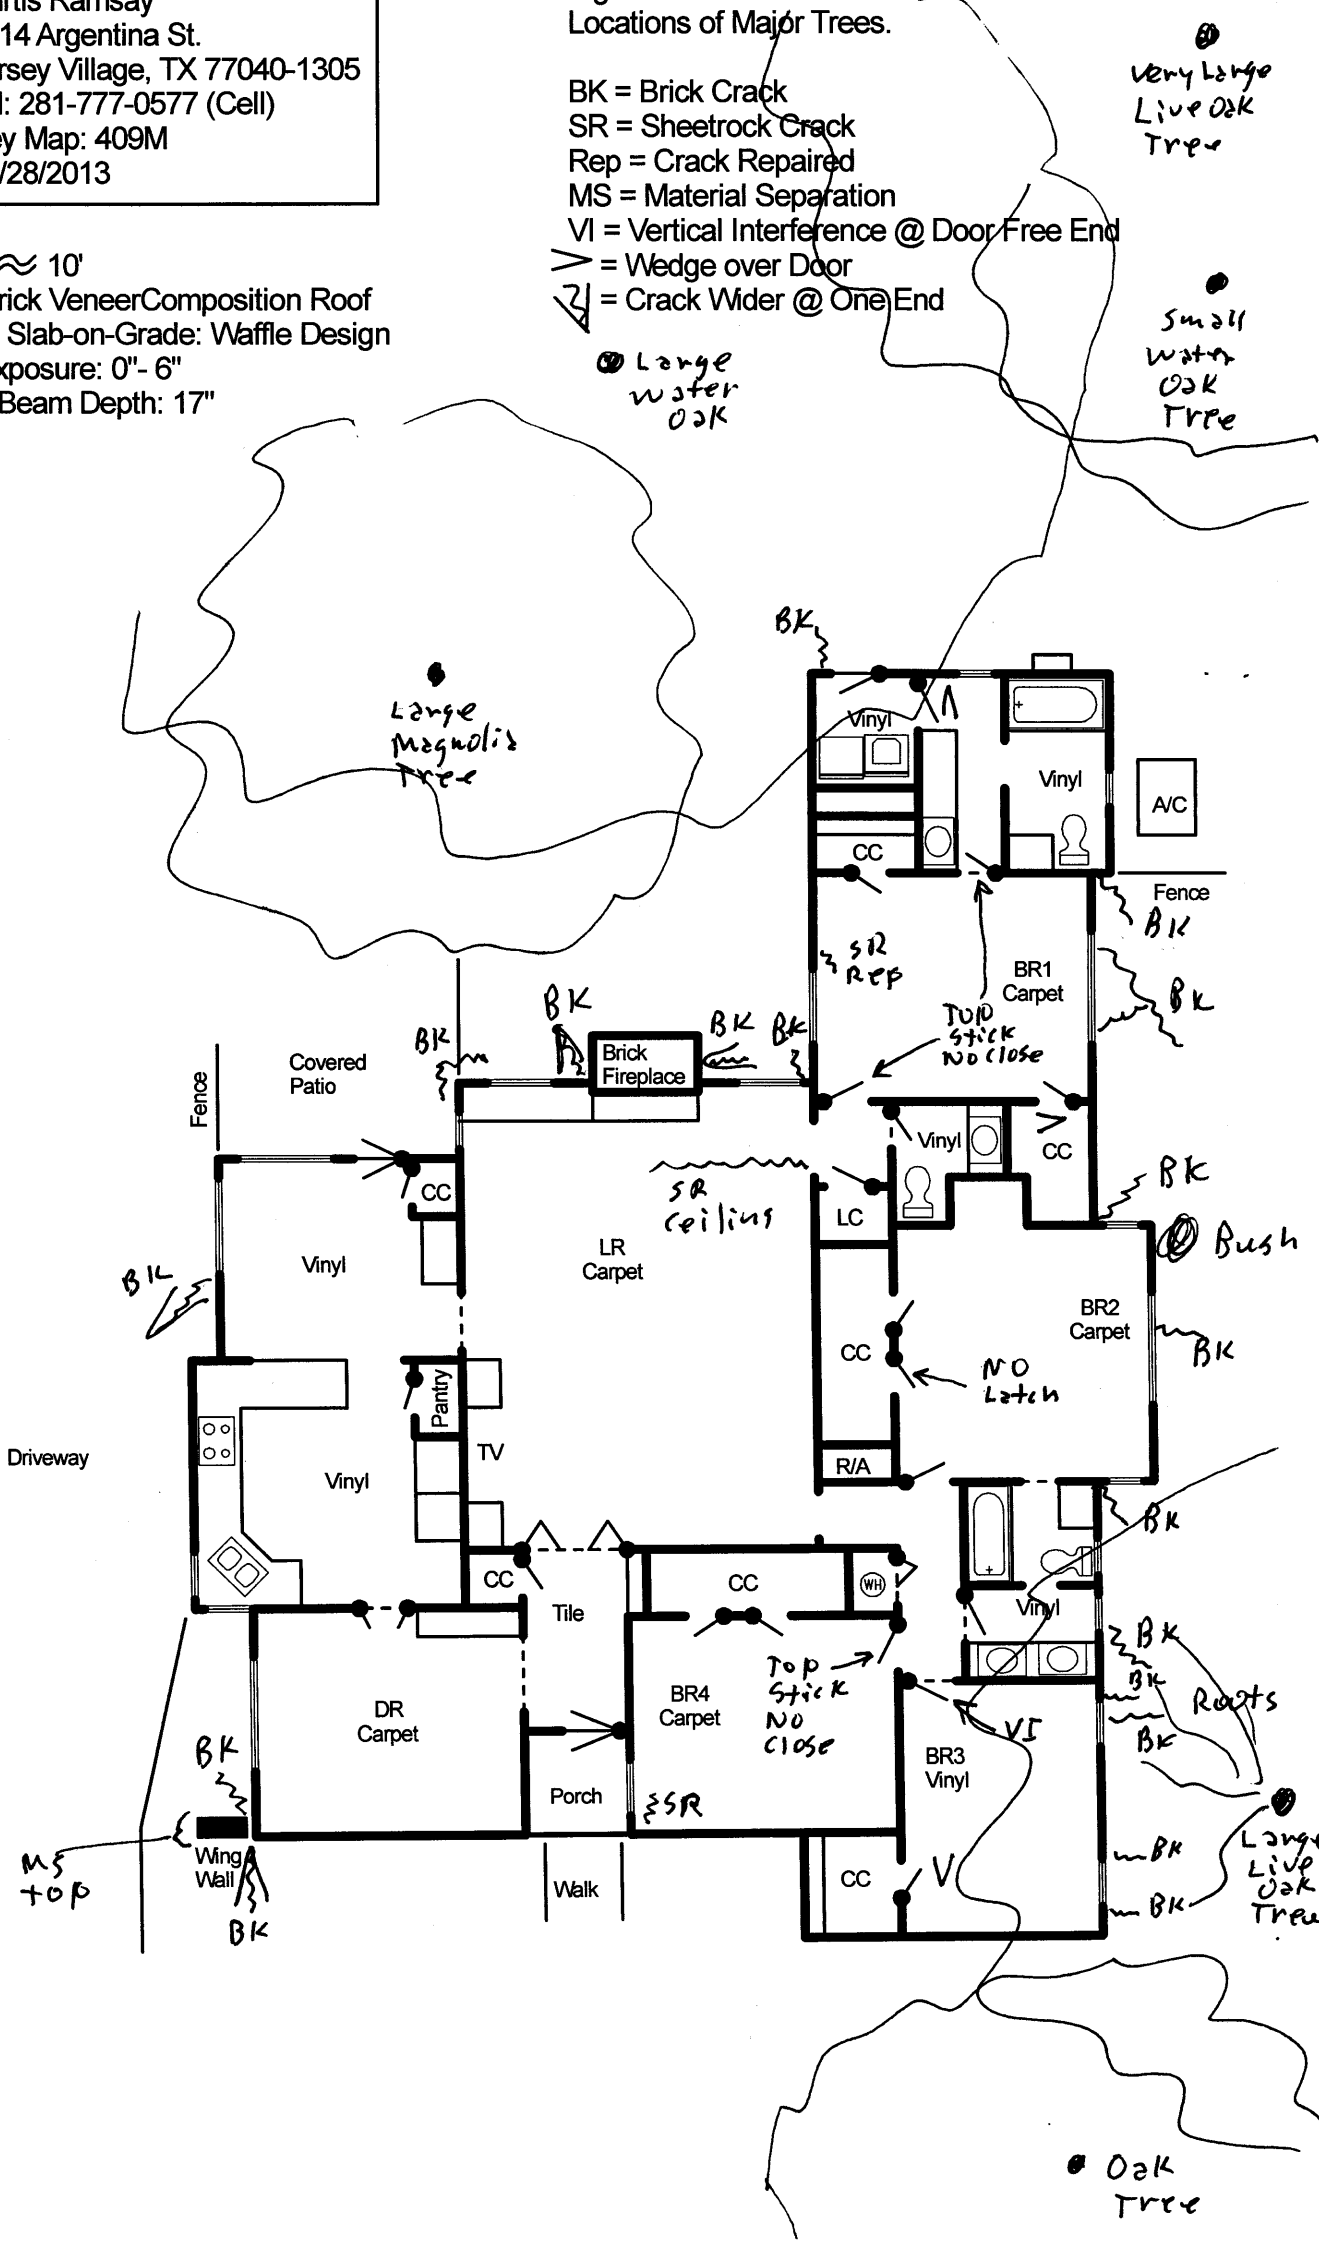
Drawing B

The cause of the foundation drop is most probably due to soil desiccation by the roots of the mature oak trees near the house. The roots of the two large oak trees near the right front corner are clearly under the foundation and probably extend as far as the livingroom. The subsidence of the master bathroom is probably caused by the large oak trees in the back yard. In the far back of the yard is a very large live oak that is most likely the culprit.

The presence of sewer leaks under the house will usually make matters worse. If the tree roots find the source of moisture, it will increase its root mass in the area to take advantage of the moisture and nutrients. Large trees can take up more water than the leak can provide, resulting in a net desiccation of the soil and concomitant shrinkage. This is the usual cause of subsidence.

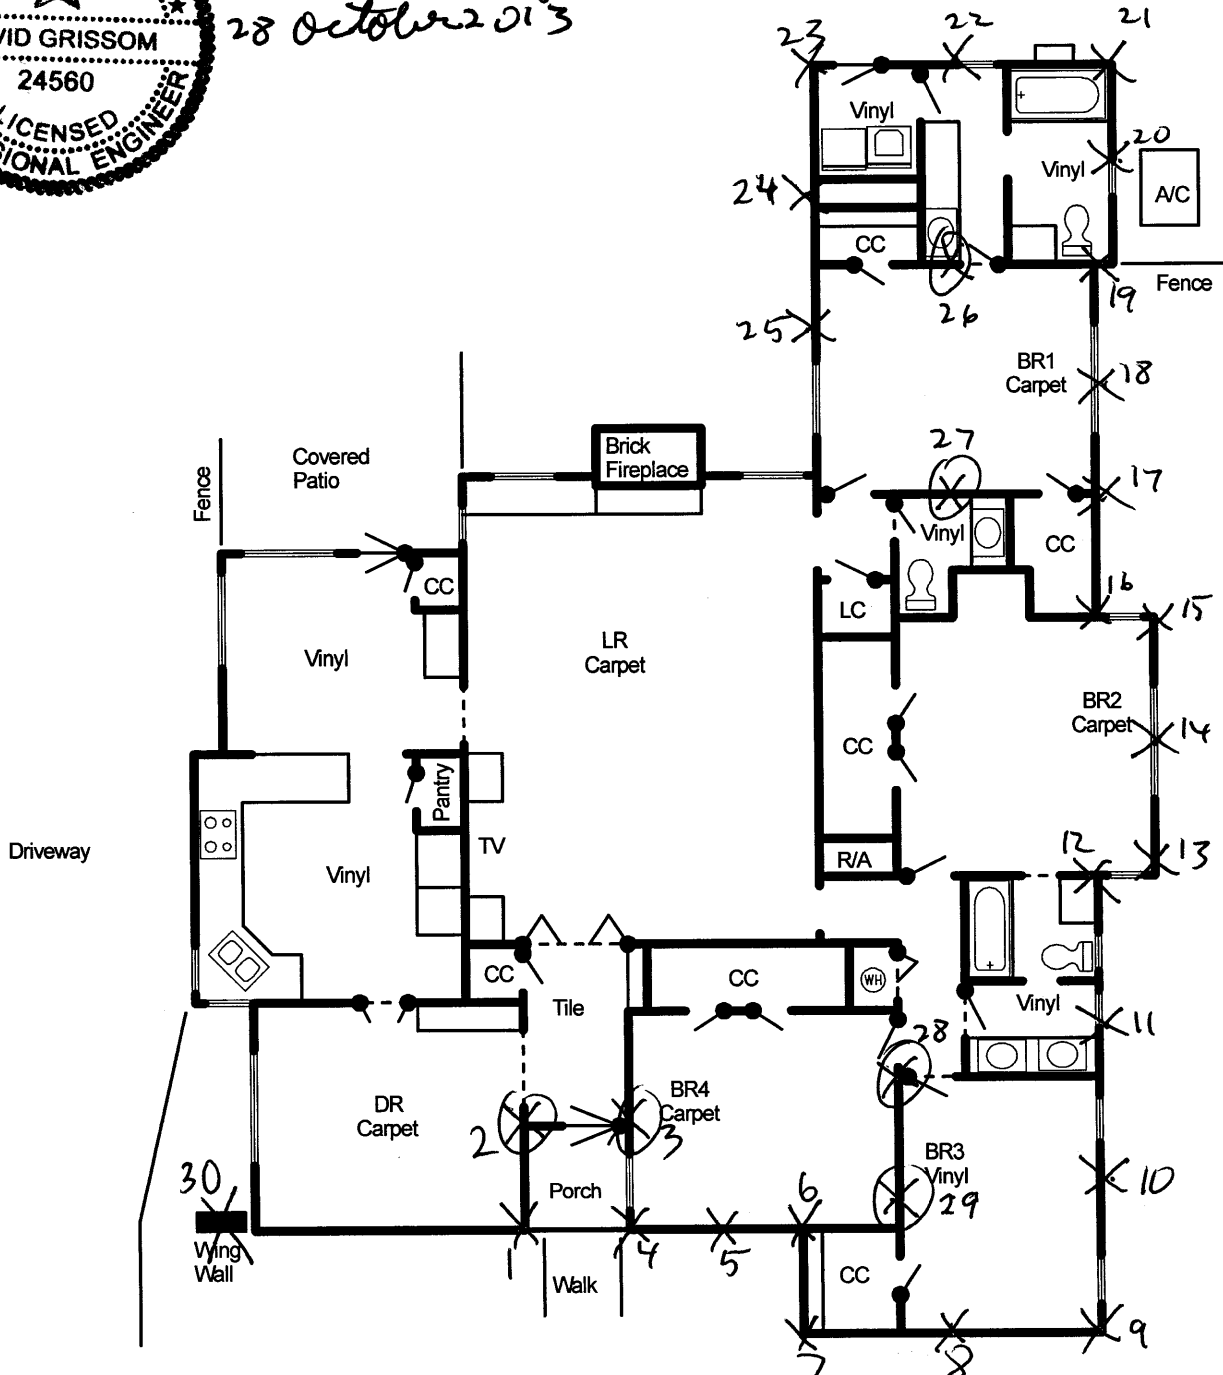
The wing wall at the left front corner is an anomaly. You have the option of installing the piling as shown on Drawing C, or completely removing the wall. It is not connected to the house. If the wall is removed, it may let the roof structure hang and droop excessively. I think the least expensive way to solve that problem is to install the piling as shown.

The plan for foundation repair shown on Drawing C will, in my opinion, stabilize the current problem areas of the foundation permanently. I recommend the use of pressed piles for the repair of foundations in the soils of the area. The pressed pile system usually carries a lifetime transferrable warranty on the foundation. This warranty should satisfy purchasers, insurers, lenders, and government agencies as to the future stability of the structure. When repaired in this manner the foundation should continue to perform its design function for the life of the structure - with the possible future need for additional support in unsupported areas or adjustment of the installed pilings. Unsupported areas of the foundation are susceptible to future movement.

The repair plan proposed on Drawing C is intended to lift the walls back into position and stabilize them. This repair plan is based upon evidence available at the time of the investigation. And is no guarantee that other areas of the foundation will not need underpinning at some future date.
