# Home Inspection Report

4414 West 43rd Street  
Houston, Texas 77092

# Semora Inspections LLC

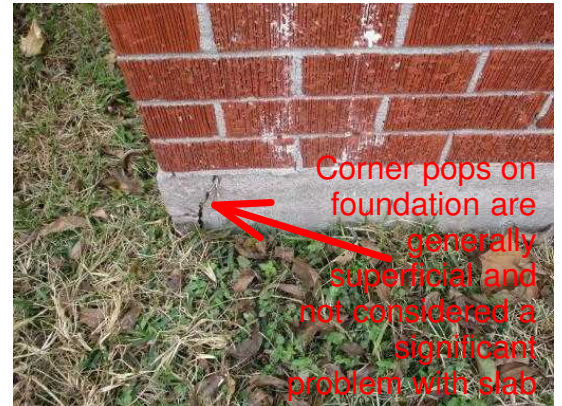
-The foundation appeared to be performing well in support of the house structure at the time of this inspection.

-A review of slab elevation showed less than one inch change across the house at the time of this inspection.

-Corner pops on foundation are generally superficial and not considered a significant problem with slab.

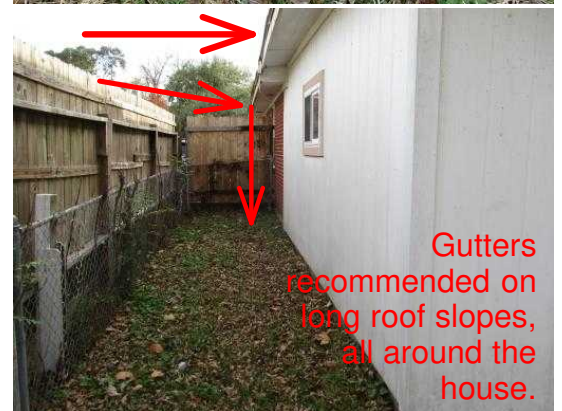
### B. Grading and Drainage - Comments: Gutter Issue,

-Gutters recommended on long roof slopes, all around the house.

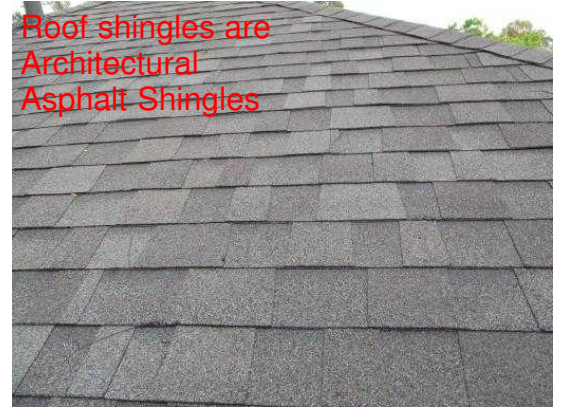
-Roof covering appears to be in good overall condition.

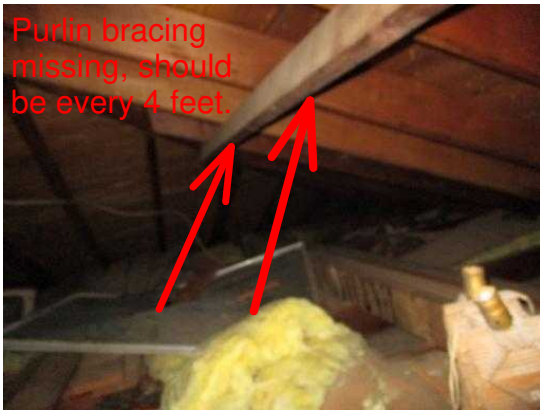
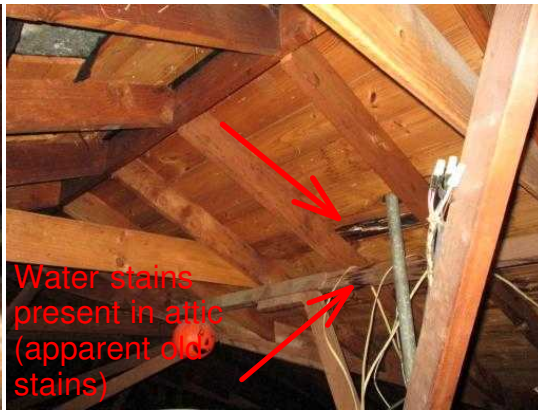
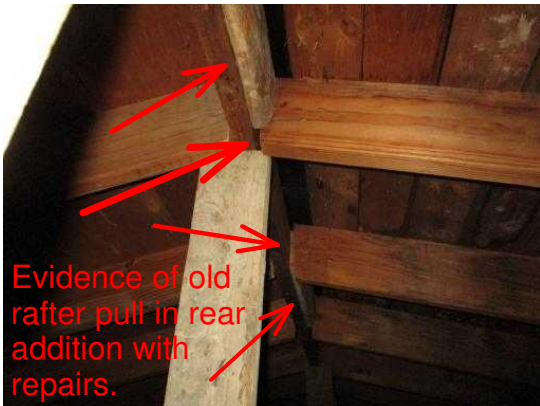
- Purlin bracing missing, should be every 4 feet.
- Less than normal insulation, varies across attic.
- Water stains present in attic (apparent old stains)
- Evidence of old rafter pull in rear addition with repairs.

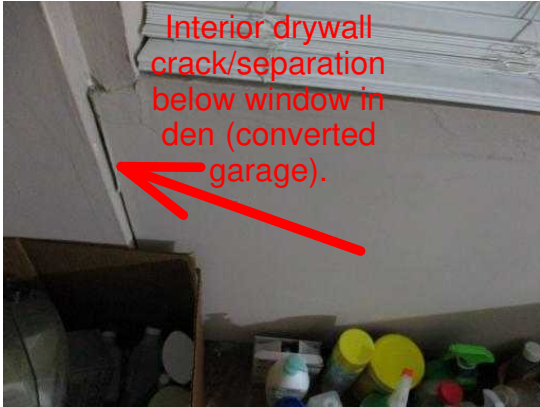
Interior drywall crack/separation below window in den (converted garage).

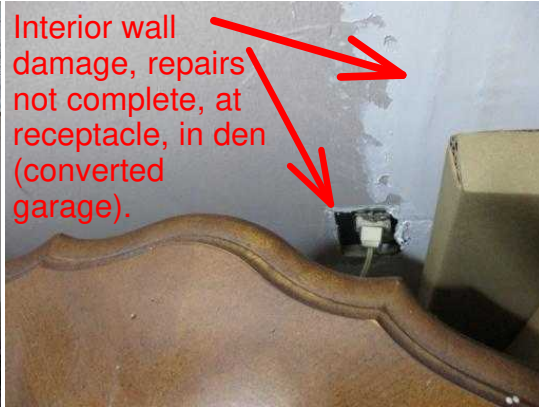
Interior wall damage, repairs not complete, at receptacle, in den (converted garage).

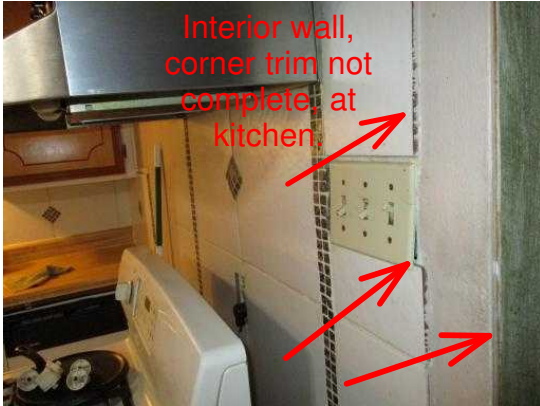
Interior wall, corner trim not complete, at kitchen.

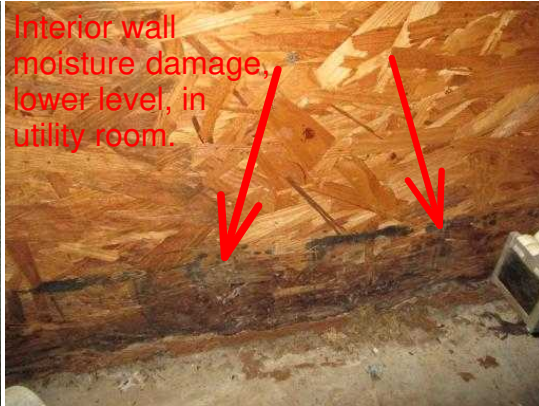
Interior wall moisture damage, lower level, in utility room.

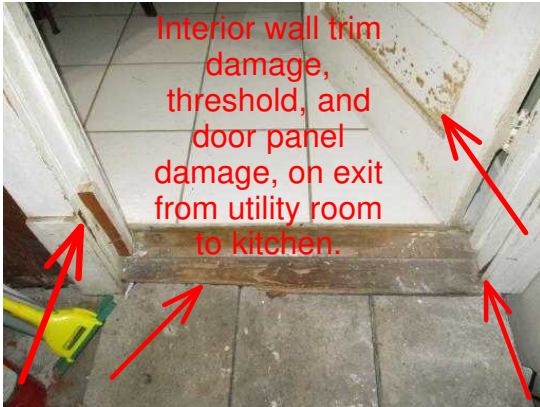
Interior wall trim damage, threshold, and door panel damage, on exit from utility room to kitchen.

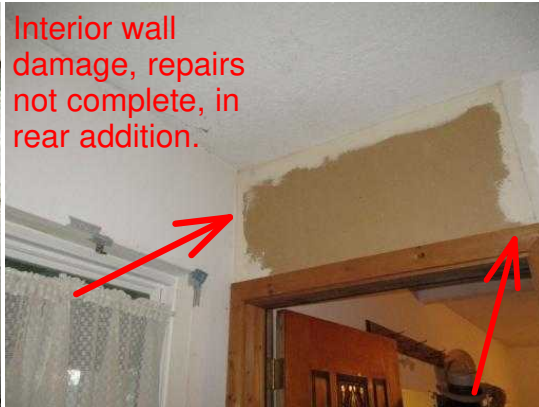
Interior wall damage, repairs not complete, in rear addition.

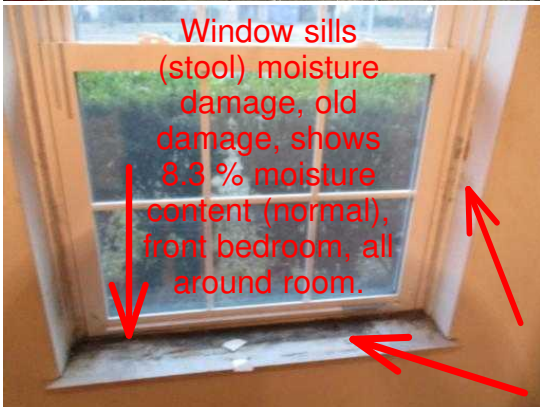
Window sills (stool) moisture damage, old damage, shows 8.3 % moisture content (normal), front bedroom, all around room.

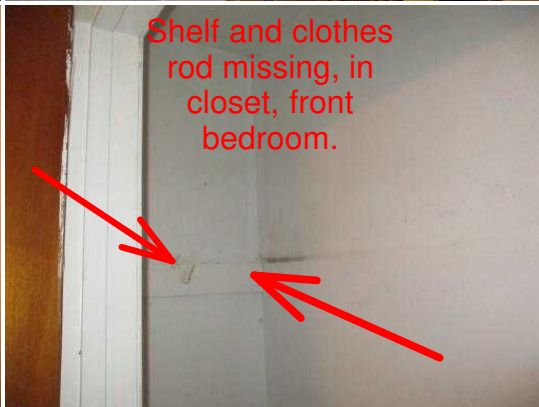
Shelf and clothes rod missing, in closet, front bedroom.

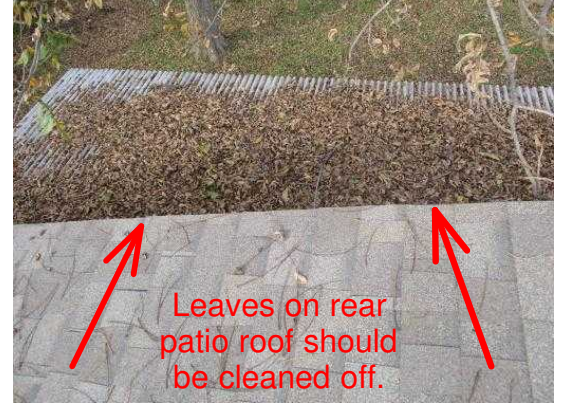
-Leaves on rear patio roof should be cleaned off.

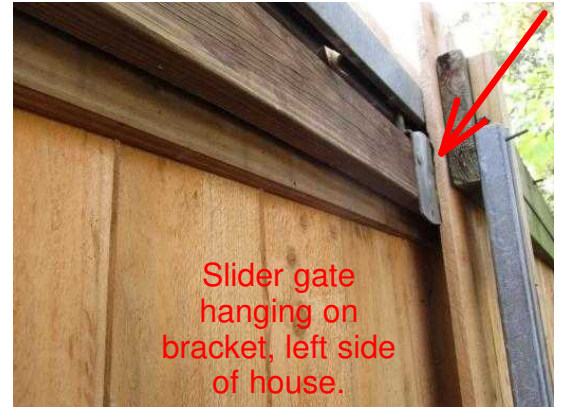
-Slider gate hanging on bracket, left side of house.

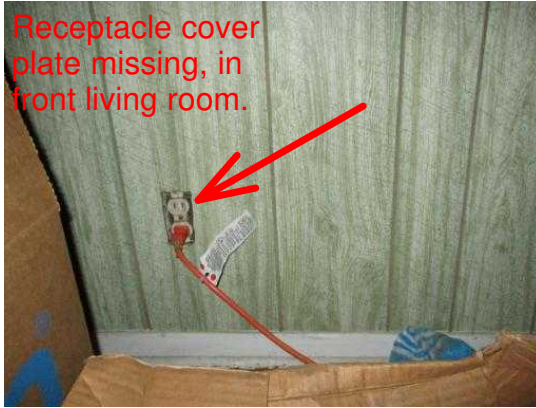
Receptacle cover plate missing, in front living room.

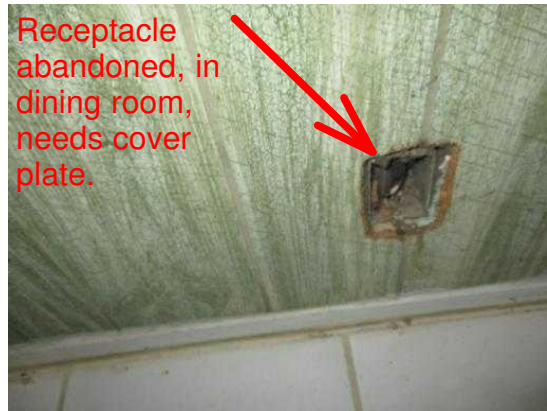
Receptacle abandoned, in dining room, needs cover plate.

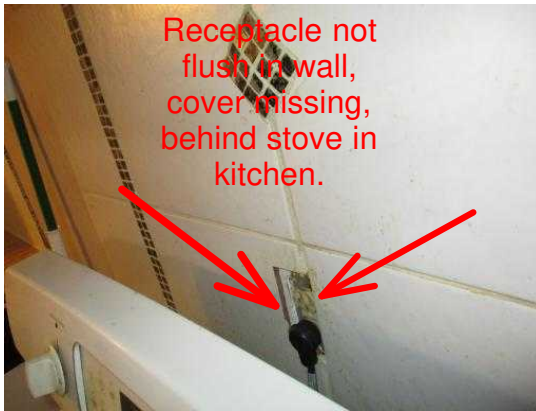
Receptacle not flush in wall, cover missing, behind stove in kitchen.

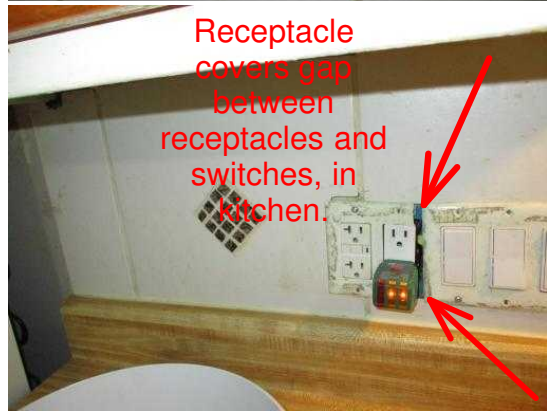
Receptacle covers gap between receptacles and switches, in kitchen.

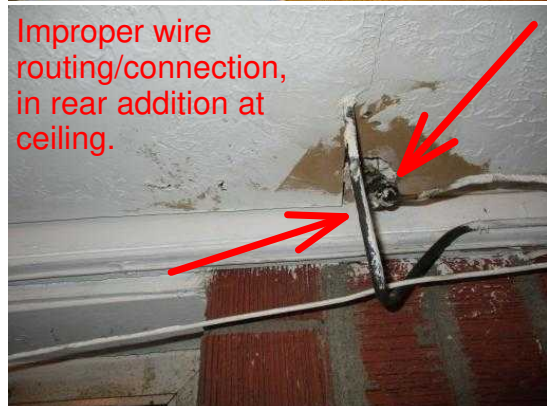
Improper wire routing/connection, in rear addition at ceiling.

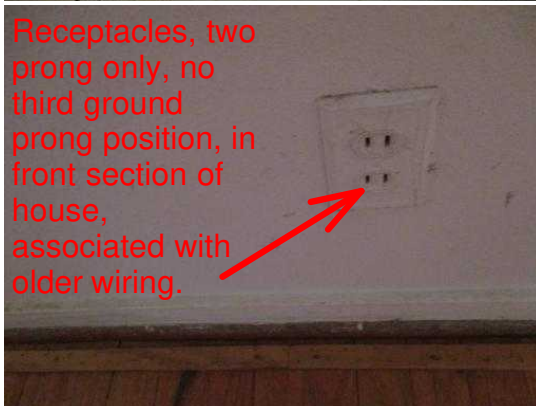
Receptacles, two prong only, no third ground prong position, in front section of house, associated with older wiring.

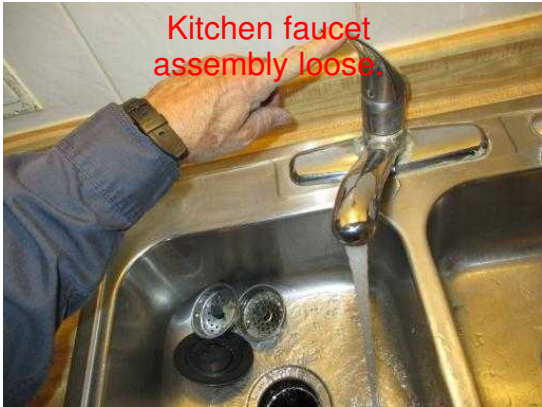
Kitchen faucet assembly loose.

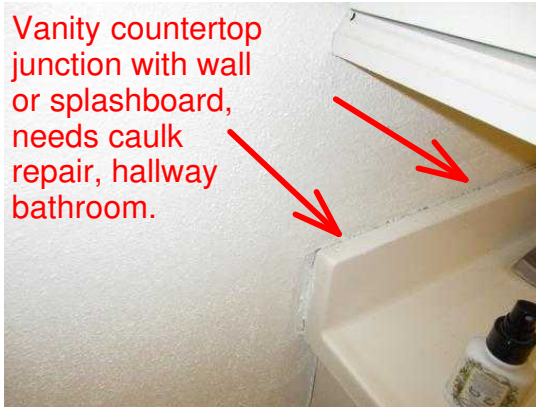
Vanity countertop junction with wall or splashboard, needs caulk repair, hallway bathroom.

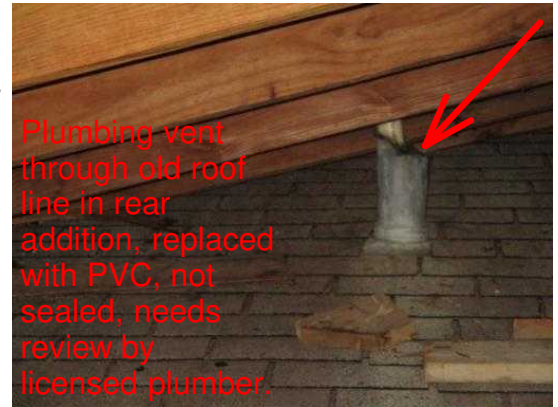
-Plumbing vent through old roof line in rear addition, replaced with PVC, not sealed, needs review by licensed plumber.

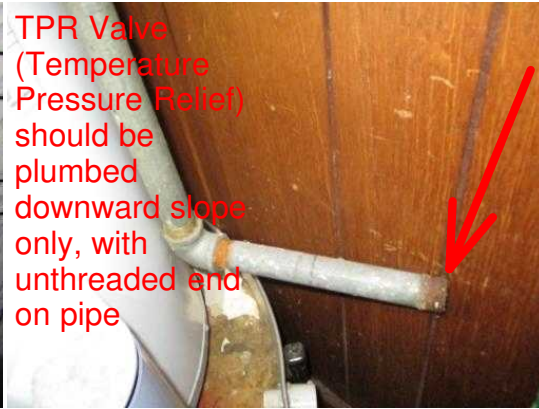
TPR Valve (Temperature Pressure Relief) should be plumbed downward slope only, with unthreaded end on pipe

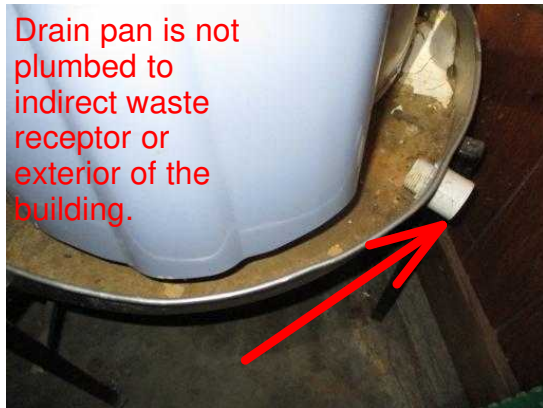
Drain pan is not plumbed to indirect waste receptor or exterior of the building.

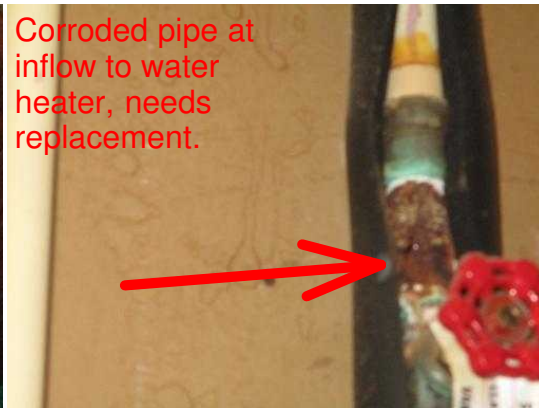
Corroded pipe at inflow to water heater, needs replacement.

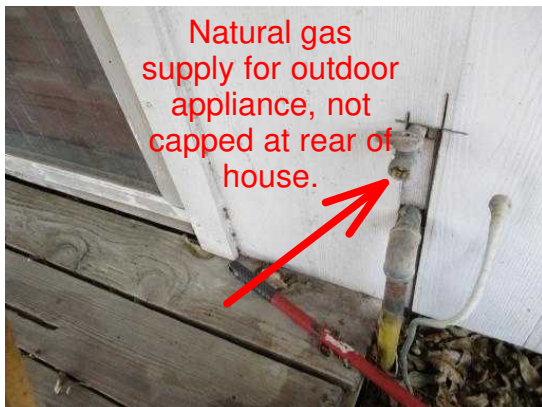
Natural gas supply for outdoor appliance, not capped at rear of house.

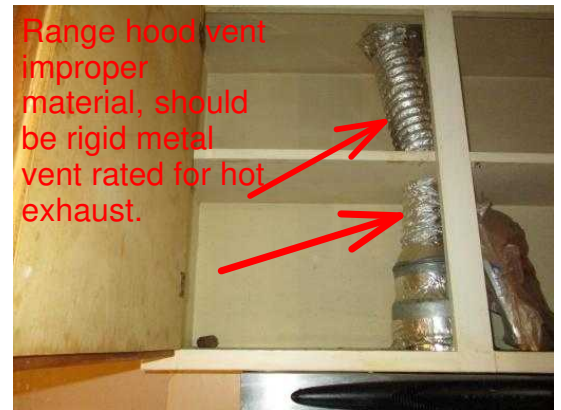
-Fan blade chatter, needs repair.

-Range hood vent improper material, should be rigid metal vent rated for hot exhaust.

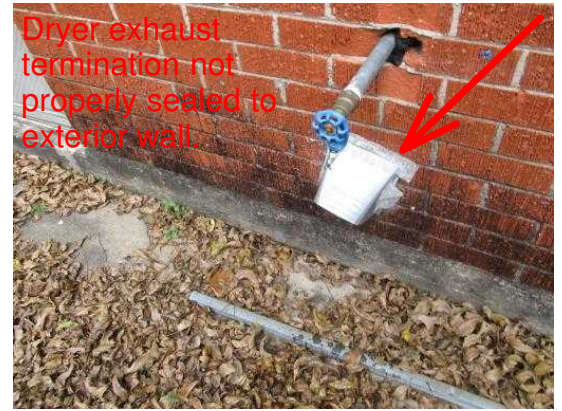
-Dryer exhaust termination not properly sealed to exterior wall.
