PROPERTY INSPECTION REPORT

Concerning: 10815 Lake Raven Ct. Cypress, TX. 77433

Inspected By: Rod Scarborough TREC License # 7189 May 28, 2021

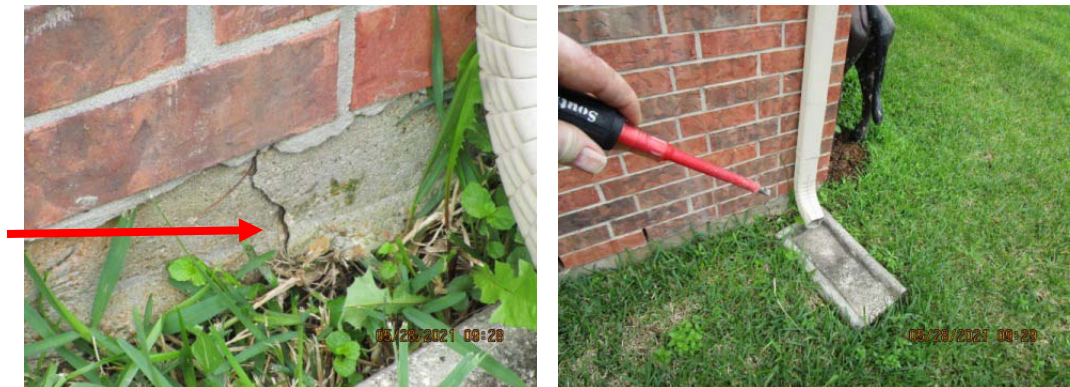
Ⓢ Stress cracks in the foundation wall were observed at one or more corners of the foundation. These cracks are not structurally significant however recommend sealing.

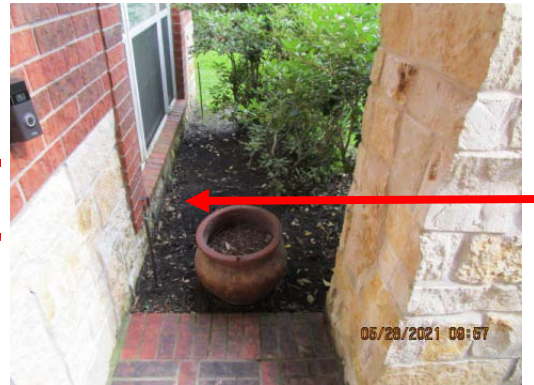
Grading and drainage around the structure does not appear to be functioning as intended in all areas. Flat/improperly sloped areas were observed on the back & front sides of the structure. These conditions may be conducive to ponding which may have an adverse effect on the foundation/structure. It is recommended that the drainage improvements be made in these areas or that sub-surface drainage be installed to allow the water to flow freely away from the structure & to the street as required. After the drainage improvements have been made it is recommended that the drainage around the structure should be monitored during/after heavy rains & if ponding water is observed then additional drainage improvements should be performed.

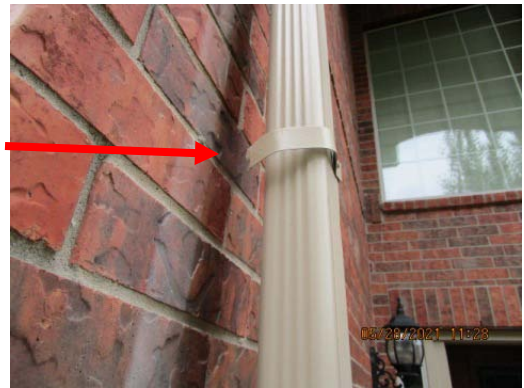
The gutter /down spout on the front side of the structure at the front porch area is not properly secured to the wall. Recommend securing.

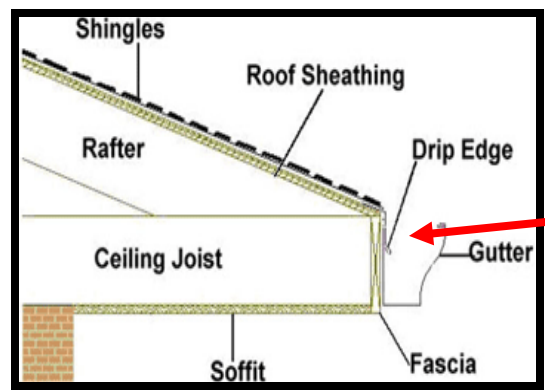
The gutters are not properly installed behind the drip edge as recommended to prevent leaking between the gutter & fascia board.

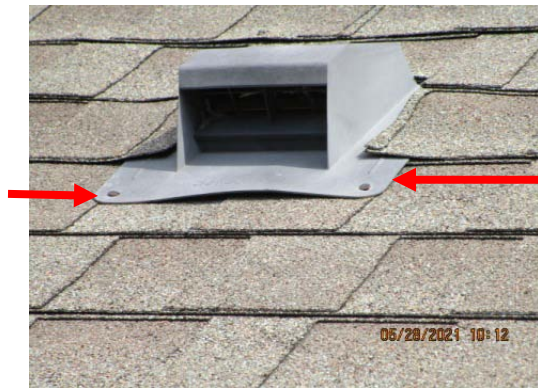
☒ Exposed nail heads were observed in some areas. Recommend sealing exposed nail heads.

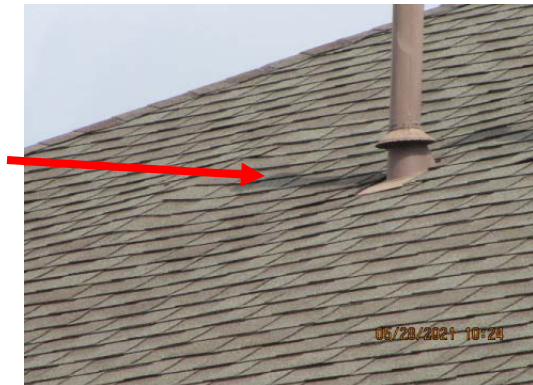
Roof shows evidence of sagging/deflection on the left side of roof by the water heater flue vent pipes. This may be due to improper structural support in the attic space.

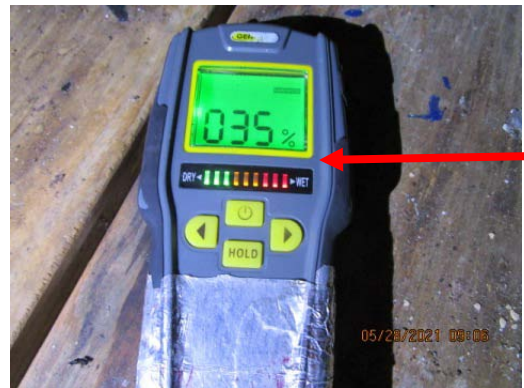
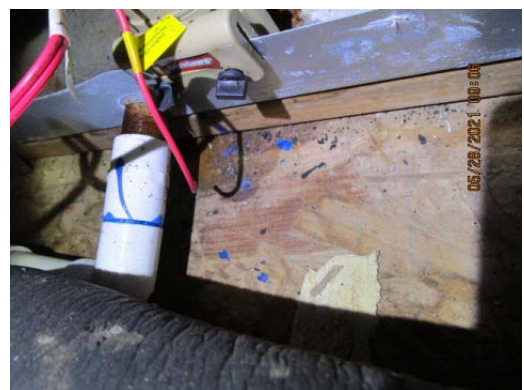
Existing moisture penetration staining was observed in the attic decking below the coil drain lines. A moisture reading was performed & moisture was detected at the time of the inspection. This is caused by condensation dripping from the primary drip pan drain lines.

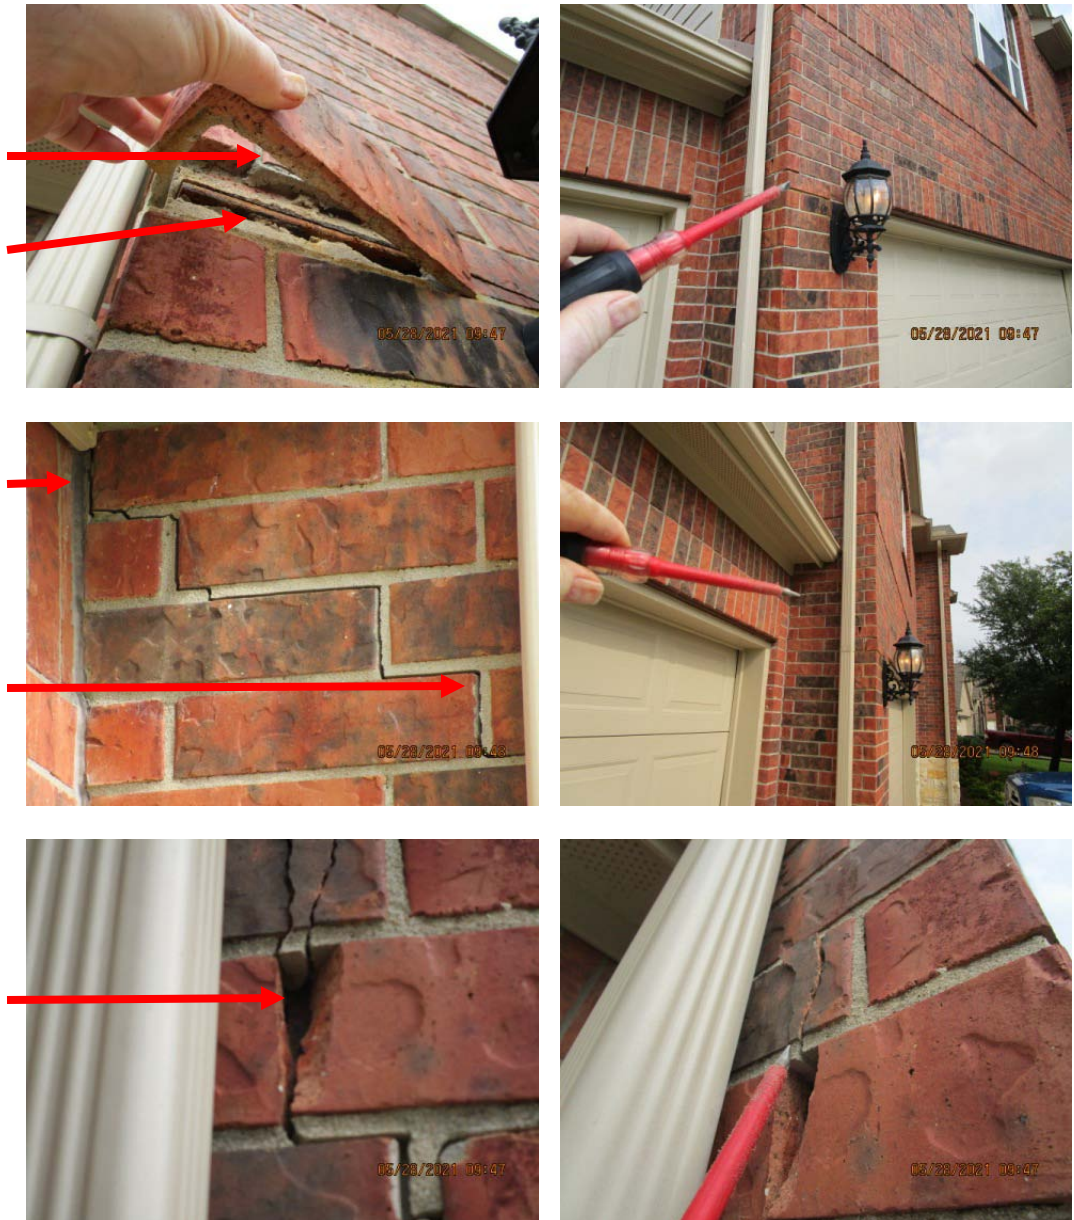
appeared to be due to exposed lintel that has rusted causing damage. Recommend further evaluation/repair.

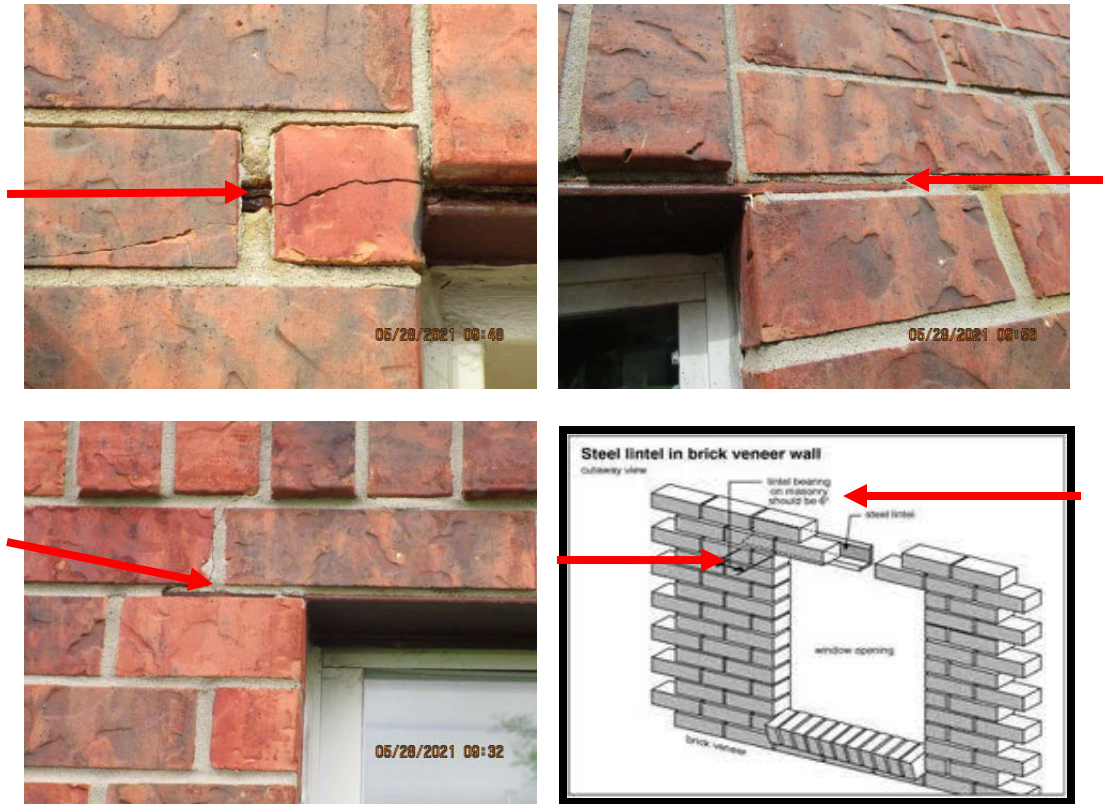
☒ Rust was observed on some of the exposed lintels at the openings above doors/windows etc. in multiple areas on both the front, back & right sides of the structure. Recommend removing rust & priming/painting the exposed lintels.

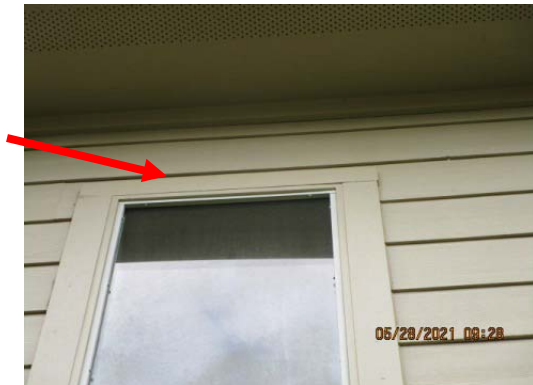
Flashing is not installed above the horizontal trim boards. Flashing is required above all continuously projected trim.

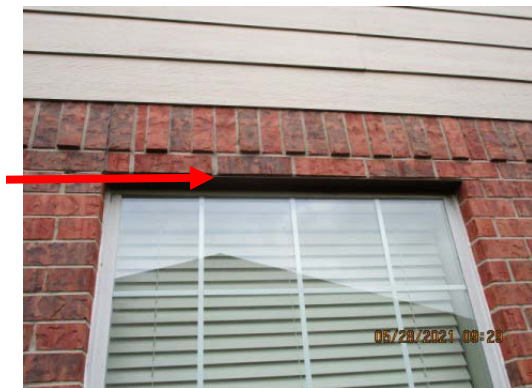
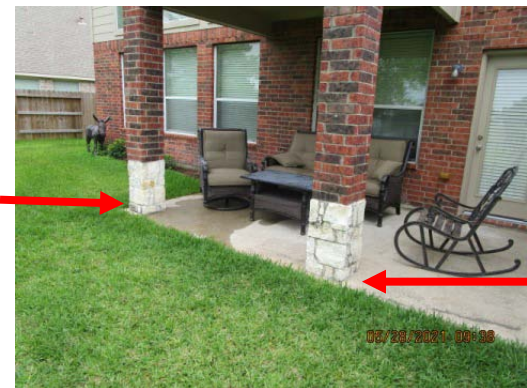
Weep holes are not installed over some of the windows & at the back porch columns.

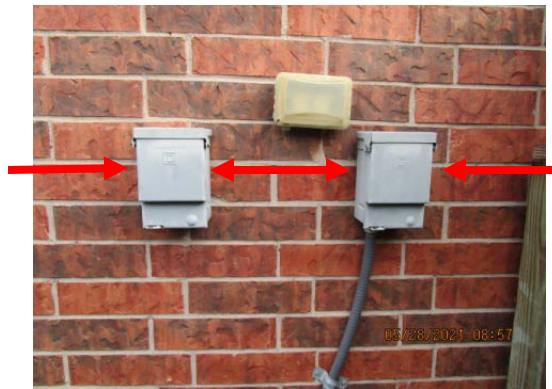
Recommend sealing all exterior penetrations to prevent possible moisture penetration including but may not be limited to: Electrical penetration, exhaust vents, door bell, electrical panel/disconnect/conduit penetrations.

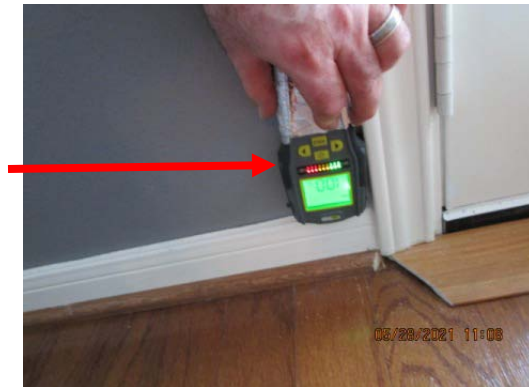
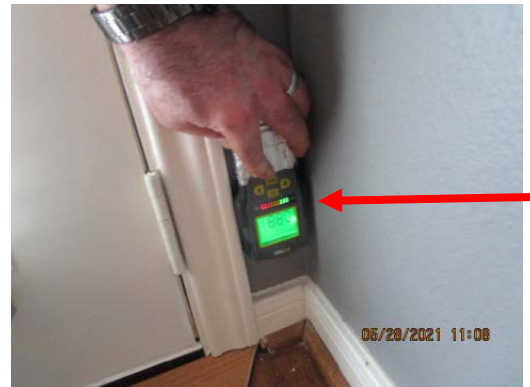
Existing/previous moisture penetration was observed but may not be limited to the base of the wall at the double doors in the game room on the interior of the structure. A moisture reading was performed & moisture was detected at the time of the inspection. Recommend to determine if any hidden structure damage has occurred.

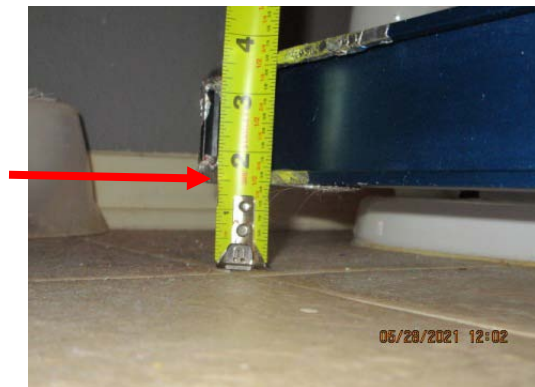
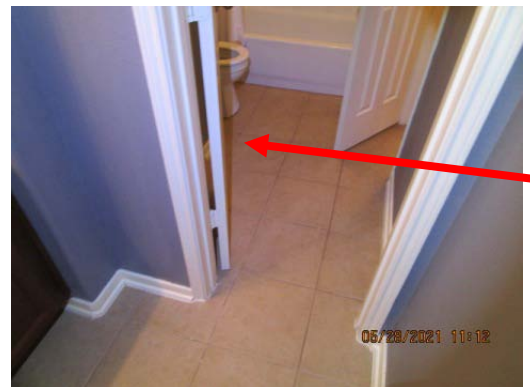
A significant drop in the flooring in the upstairs jack & jill bathroom was observed. The flooring is not level & drops approx. 1 1/2" in a 3'-4' span. Recommend further evaluation to determine the source of the drop & to determine what/if any corrective measures may be required.

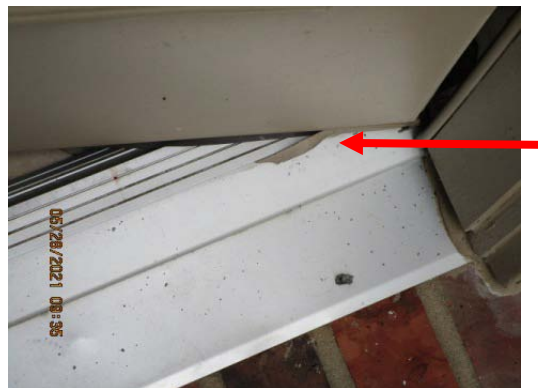
The floor sweep at the back door is damaged.

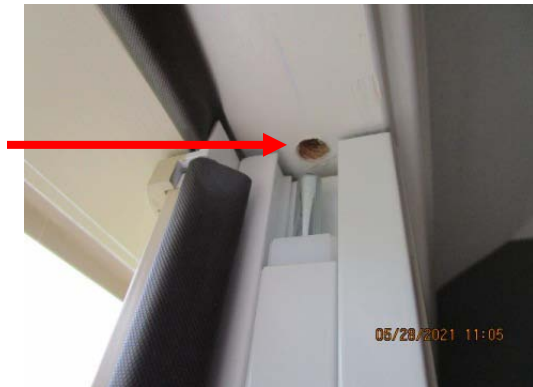
The double door leading from the game room to the balcony is missing the top mortised bolt strike.

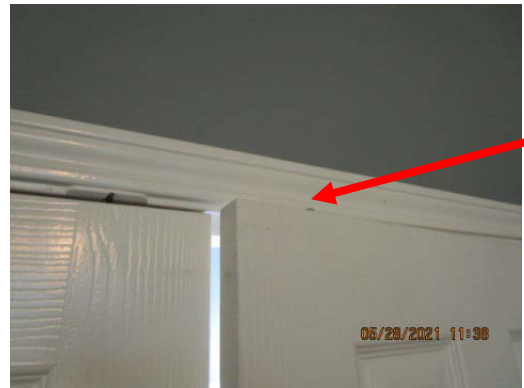
The doors leading into the media room & the master bathroom are extremely difficult to close under normal condition due to the top spring latches. Recommend adjusting/replacing.

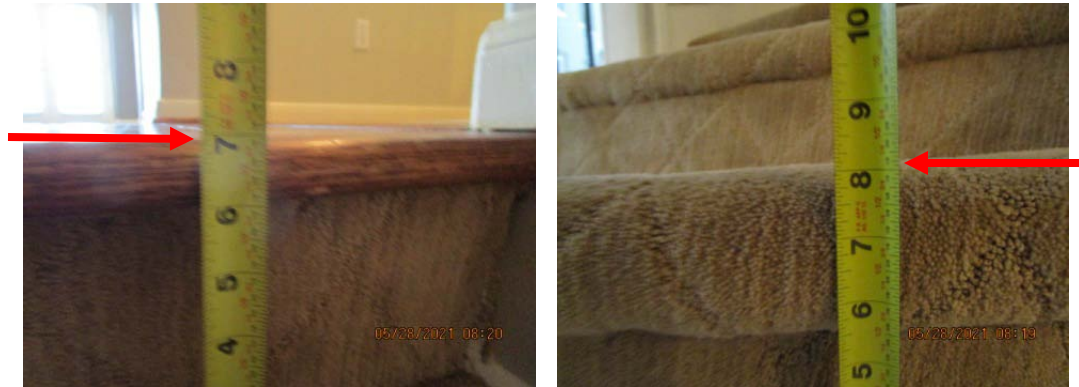
The stair riser heights shall not be more than 7 3/4". The greatest riser height within any flight of stairs shall not exceed the smallest by more than 3/8". The riser heights varied from approx. 7" - 8".

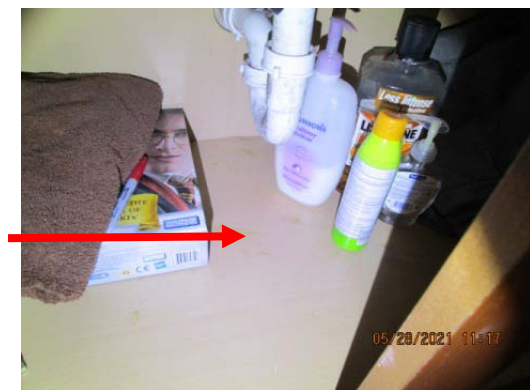
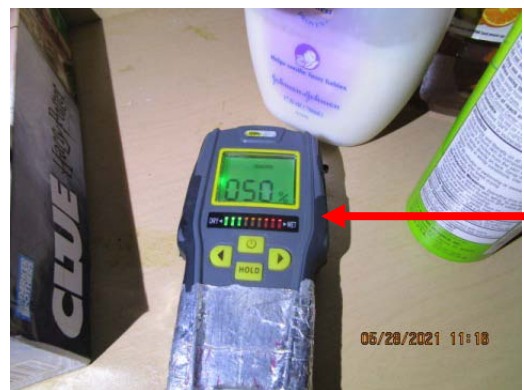
Signs of moisture penetration was observed under the jack & jill bathroom sinks. A moisture reading was performed & moisture was detected at the time of the inspection. The moisture appears to be the result of the p-traps condensating from the cold condensation from the AC coils in the attic.

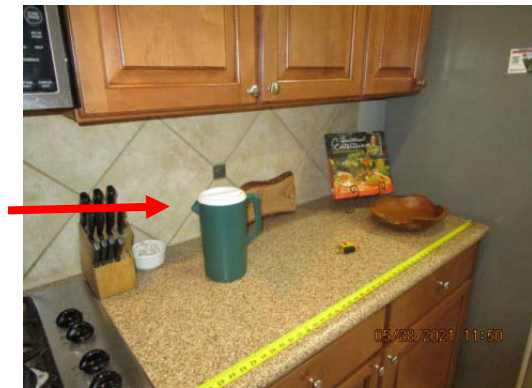
Insufficient number of outlets installed to the right of the cook top in the kitchen by today's standards. Outlets should be provided every 4' of counter space, 2' max. distance between outlets. Counters with a minimum of 2' should have at least one outlet. No point along a kitchen countertop greater that 2' from an outlet.

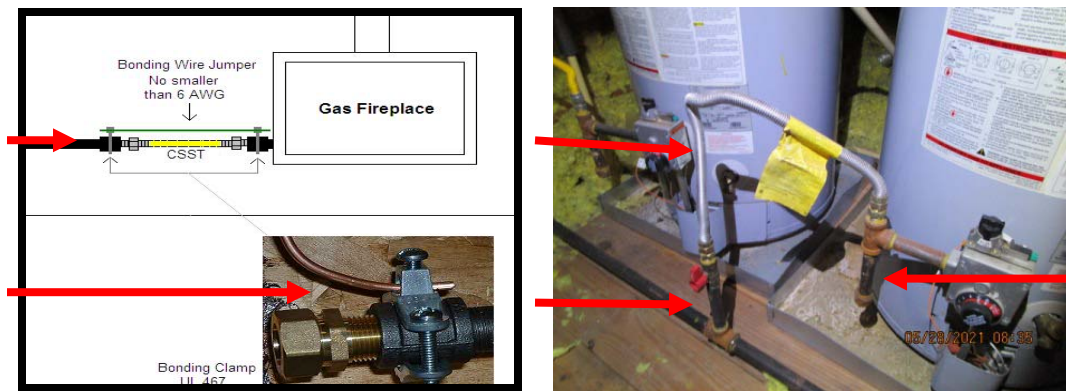
CSST Gas piping was observed at the water heater & heating equipment. There have been reported issues that the CSST metal piping may not be properly bonded & no bonding jumper was observed at the CSST line. Recommend further evaluation/repair by a licensed electrician to determine that the CCST is properly bonded as required & if not properly bonded then it is recommended that a bonding jumper be added.

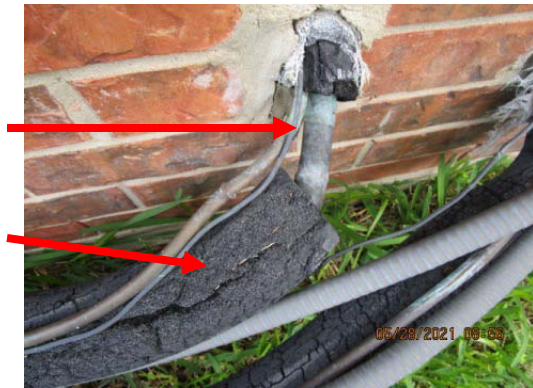
Missing/aging insulation on the refrigeration line was observed at the condensing units. Recommend replacing.

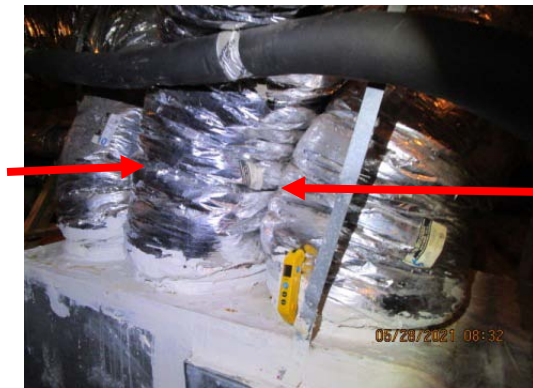
The flex duct was observed to be in direct contact with other pieces of duct in some areas of the attic. Recommend adding insulation between the ducts or rerouting ducts should be considered to prevent condensation between the ducts.

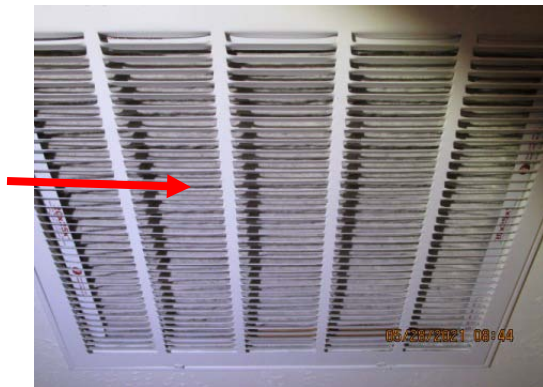
Return air filter is dirty, recommend replacing.

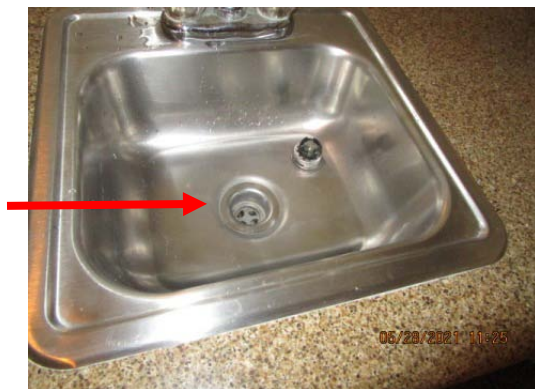
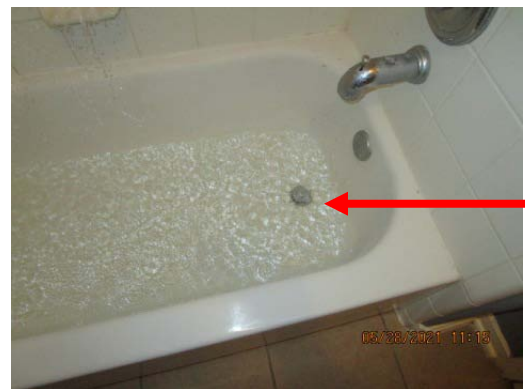
☒ The wet bar sink & jack & jill bathtub are slow to drain.

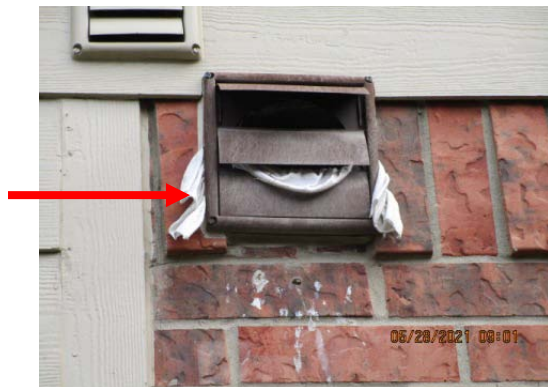
A rag was stuffed into the exhaust vent flap on the left side of the structure. Recommend removal.

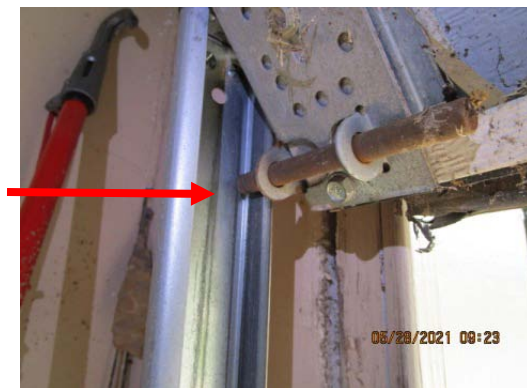
The two car garage door is missing the bottom roller on the right side of the door. Recommend replacing.
