# *Pro House Inspections*

## Property Inspection Report

20907 Blackbristle Ln, Spring, TX 77379  
Inspection prepared for: Zeeshan Mirza  
Real Estate Agent: Baber Pasha - Realty Associates

Date of Inspection: 4/25/2021 Time: 10:00 AM  
Age of Home: 2005 Size: 2384  
Weather: Clear, 70 degrees  
Order ID: 512

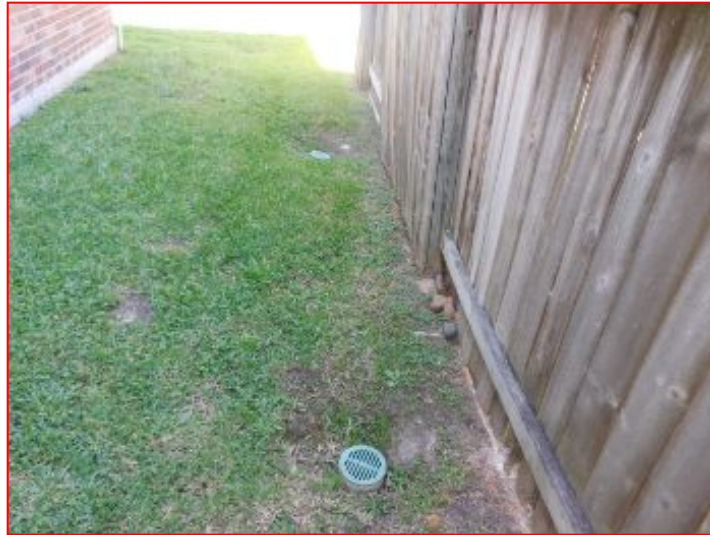
No Problems Found.

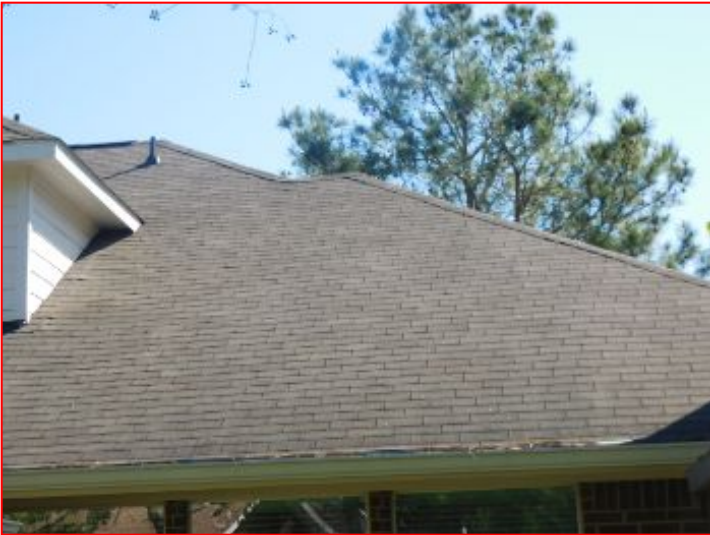
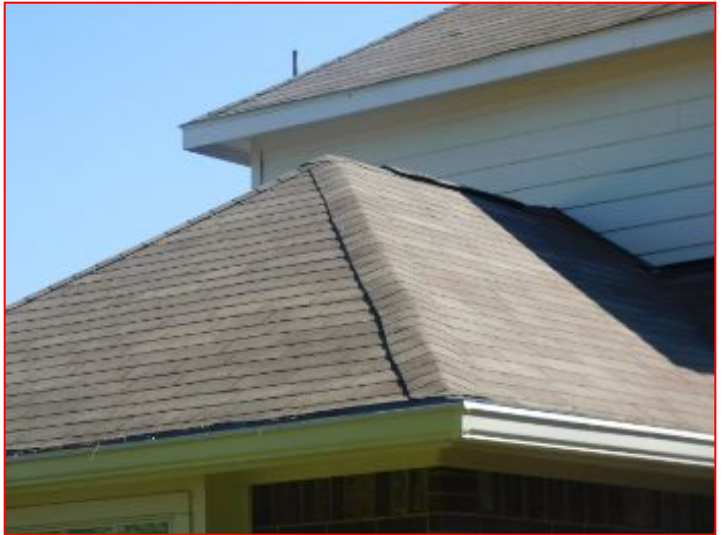
No Problems Found.

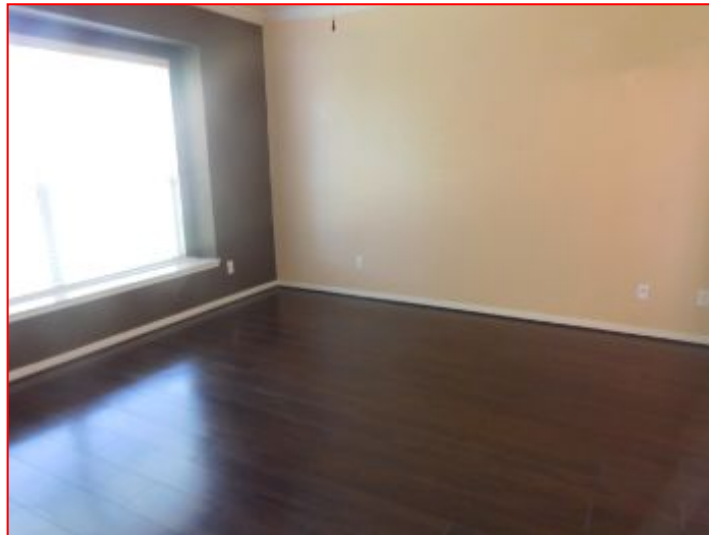
No Problems Found.

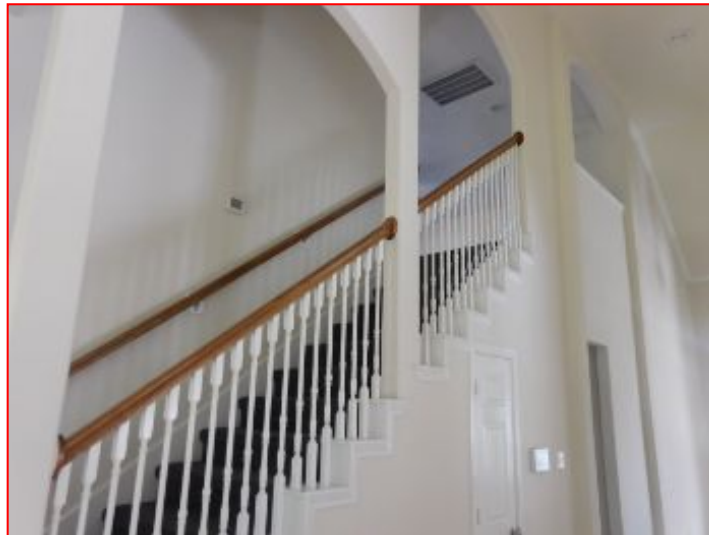
No Problems Found.

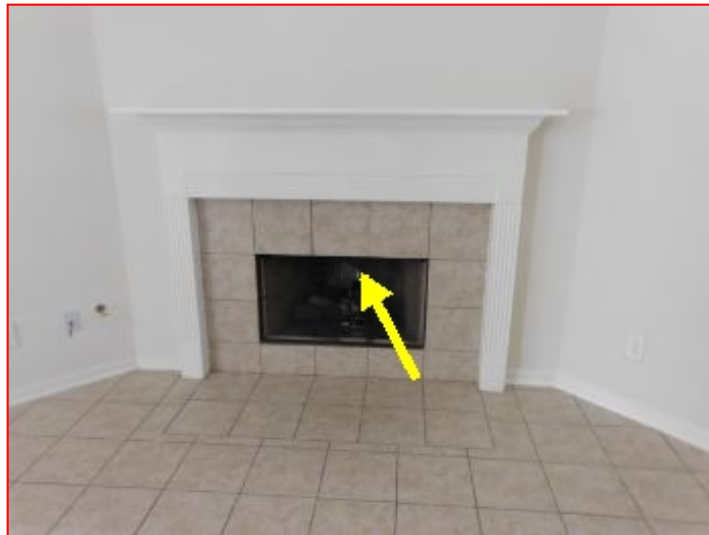
This fireplace is not equipped with a damper stop.

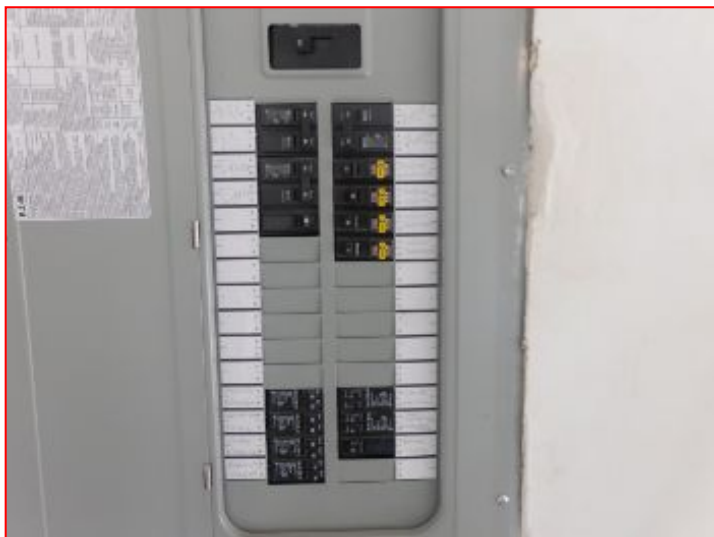
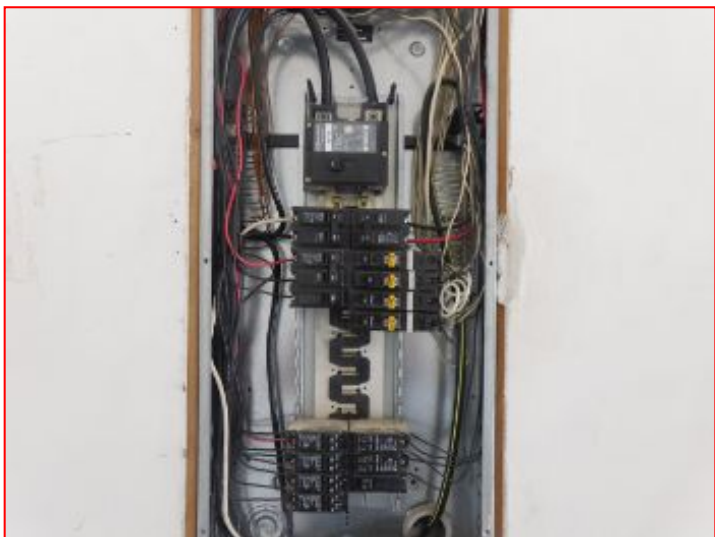
No Problems Found.

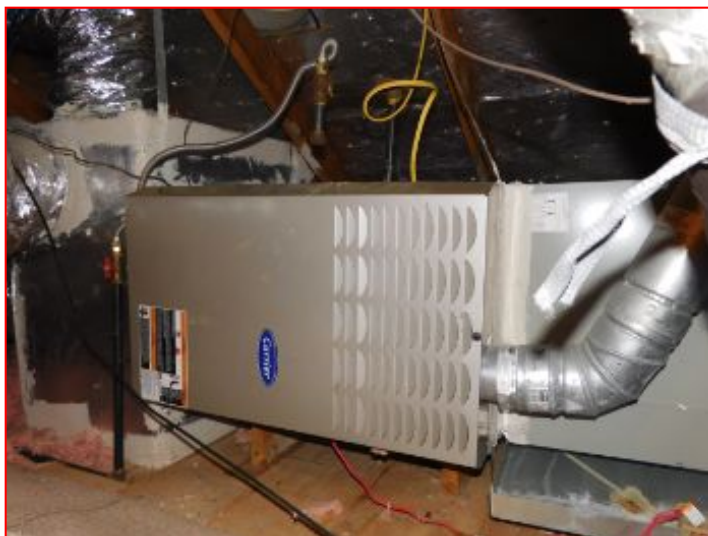
No Problems Found.

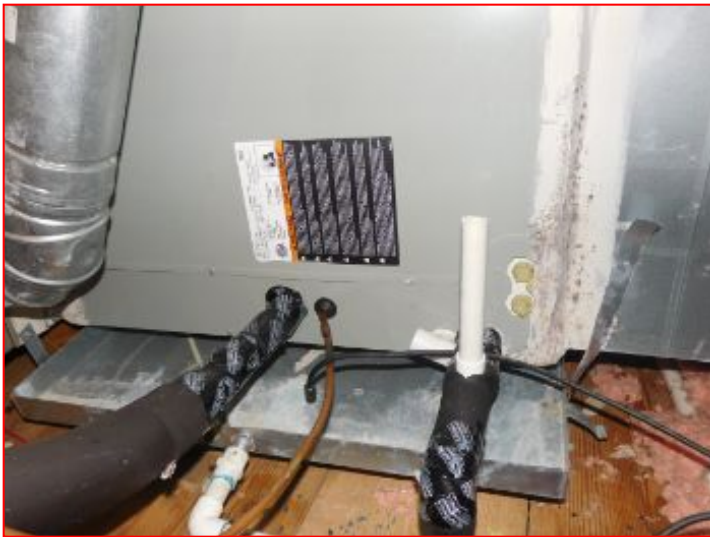
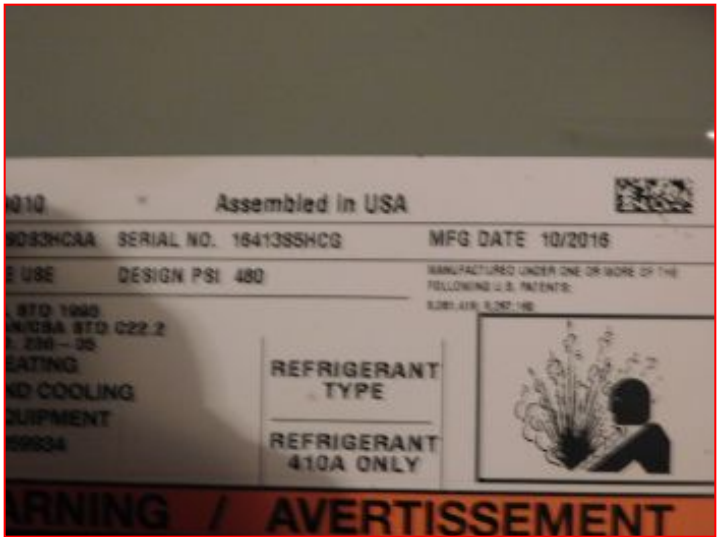
No Problems Found.

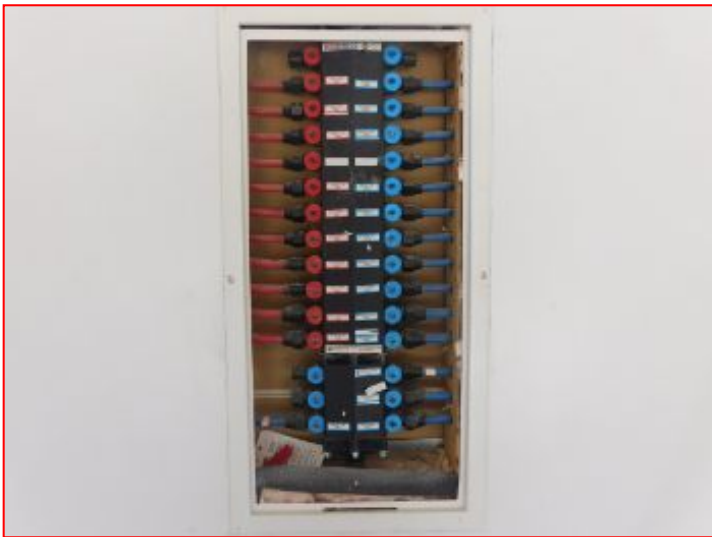
No Problems Found.

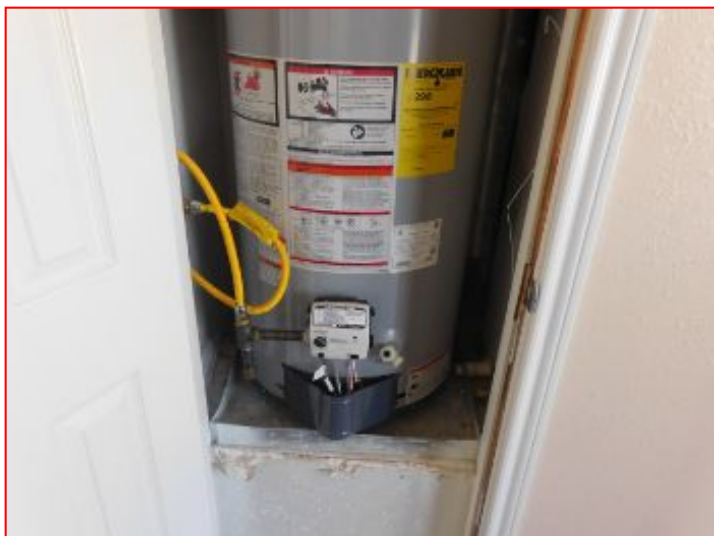
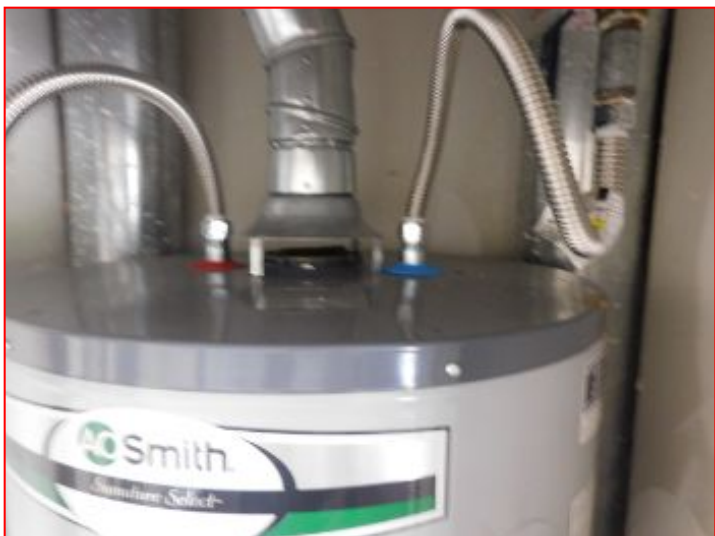
No Problems Found.

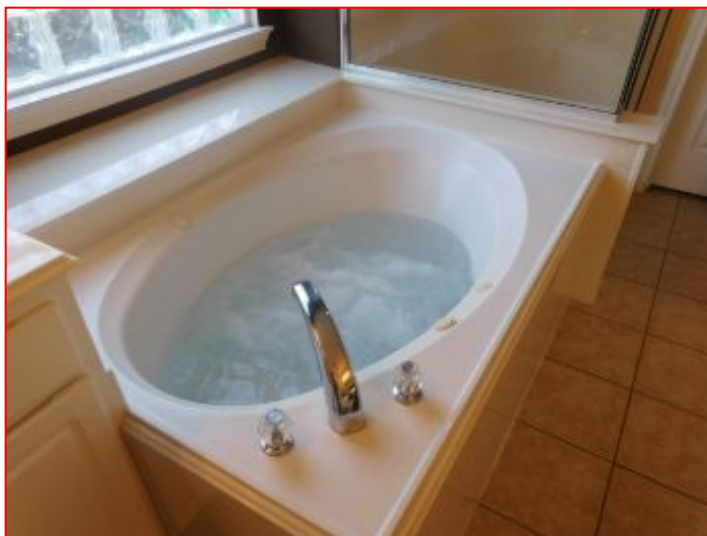
No Problems Found.

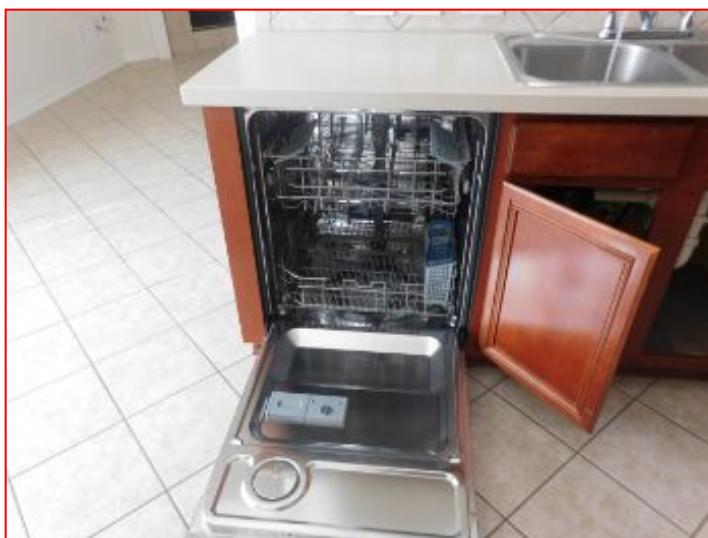
No Problems Found.

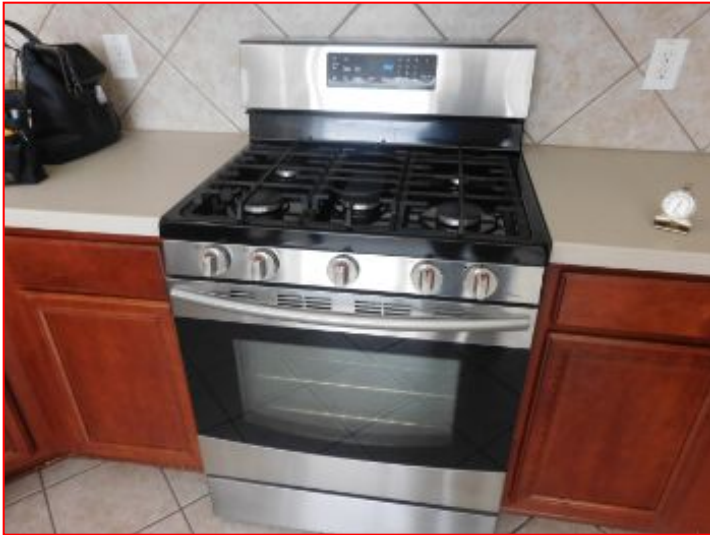
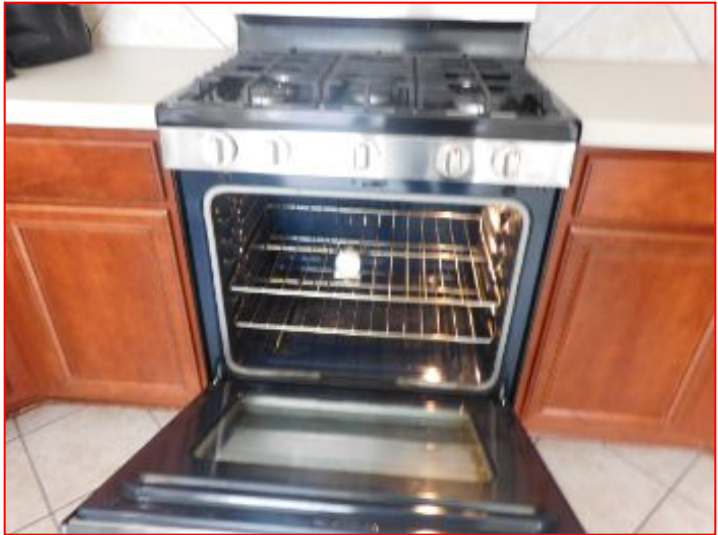
No Problems Found.

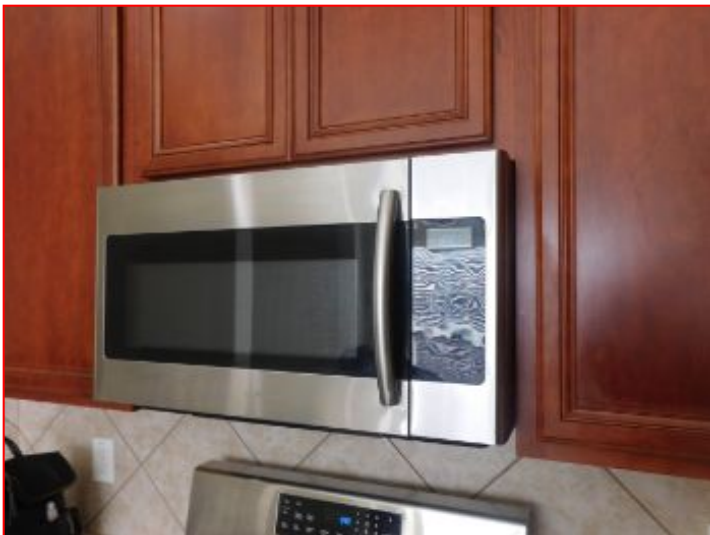
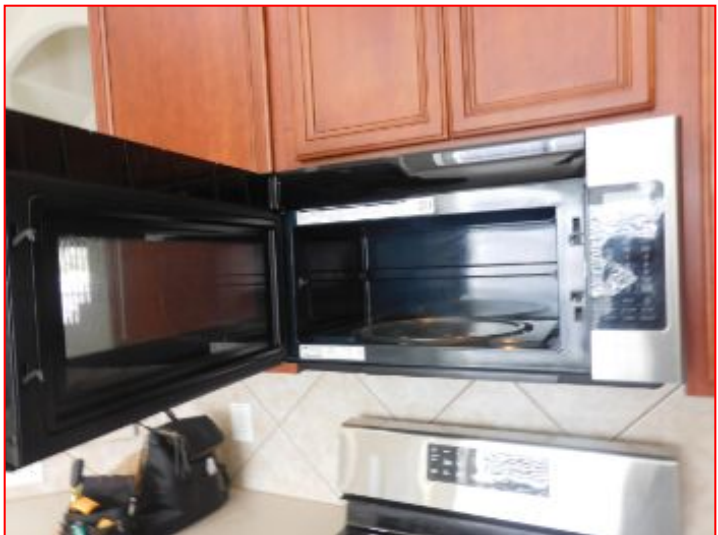
No Problems Found.

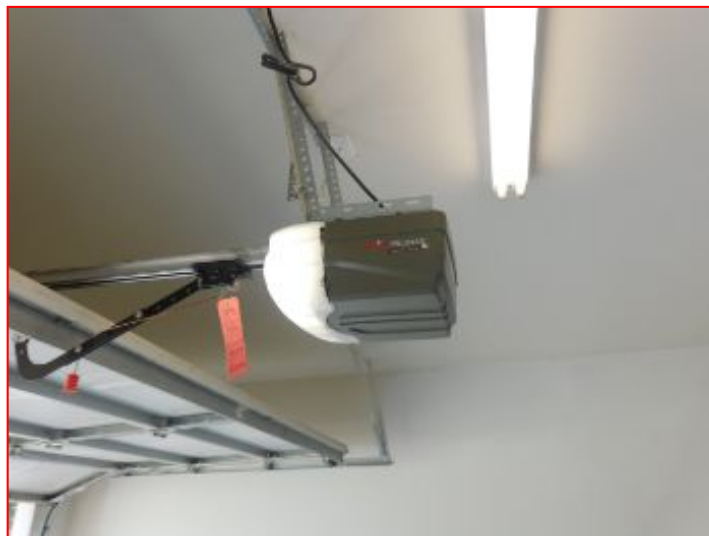
No Problems Found.

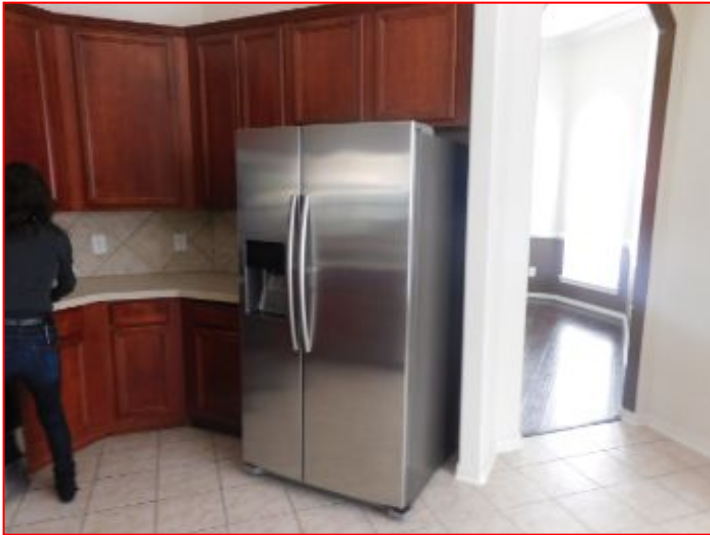
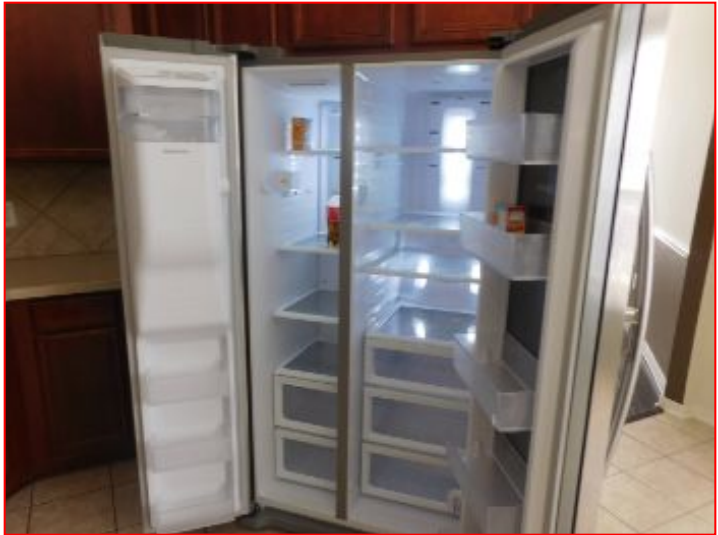
No Problems Found.

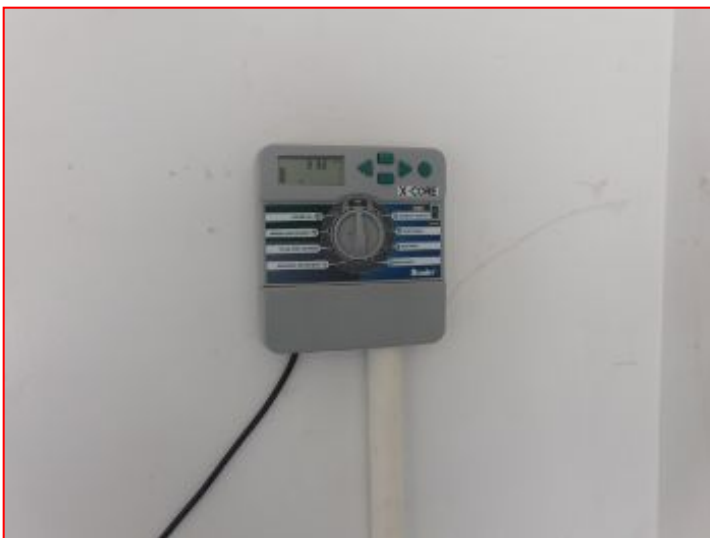
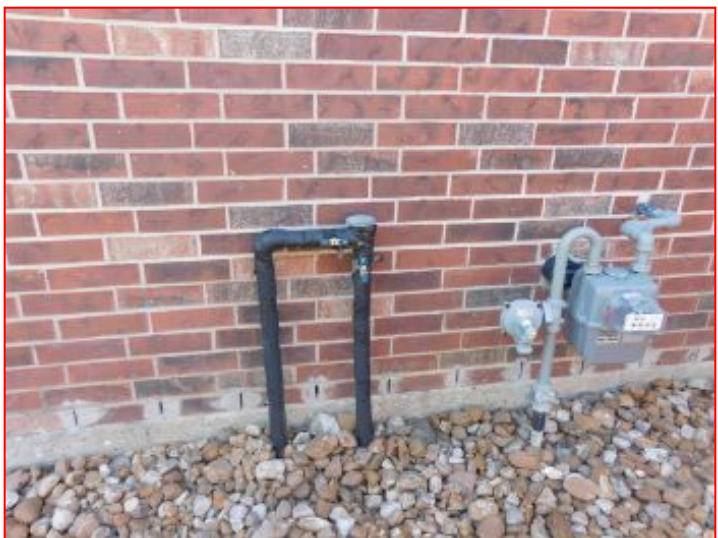
No Problems Found.
