Inspection Report

Property Address:
14202 Grand Manor Ln
Humble TX 77396

Counter Home Inspections

PROPERTY INSPECTION REPORT

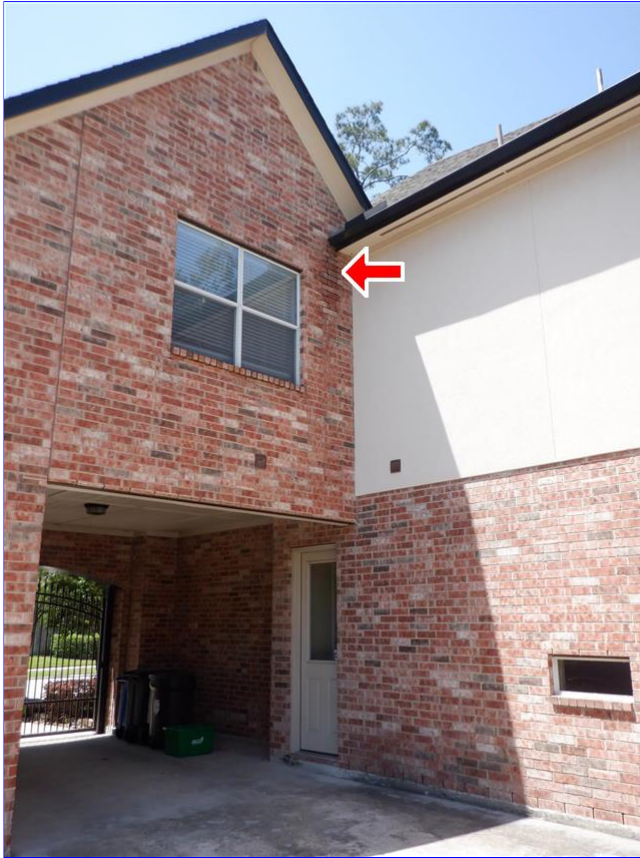
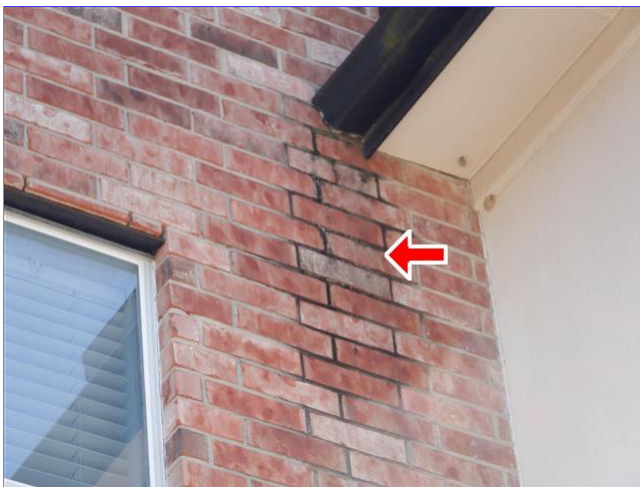
(1) I recommend cleaning the gutter and adding kick-out flashing at the back side of the home (see pictures) to direct the rain water away from the homes exterior siding.

B. Back of home

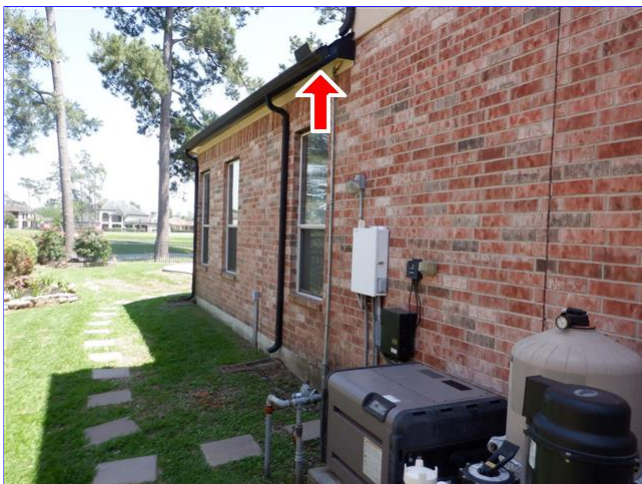
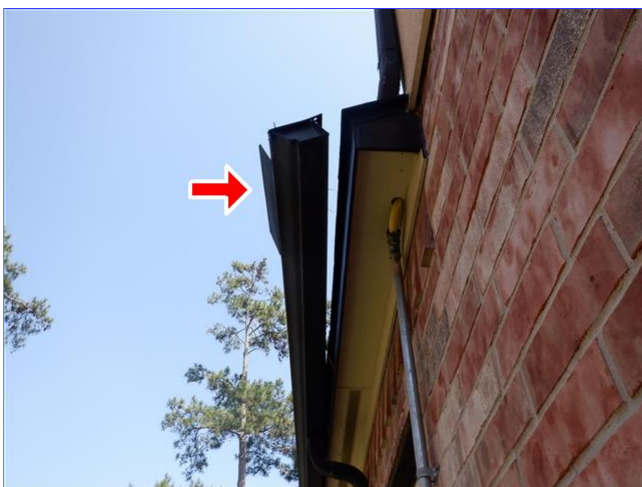
(2) The gutter at the back left side of the home was loose to the fascia board. I recommend further evaluation and repair as needed.

B. Back left side of home, loose gutter

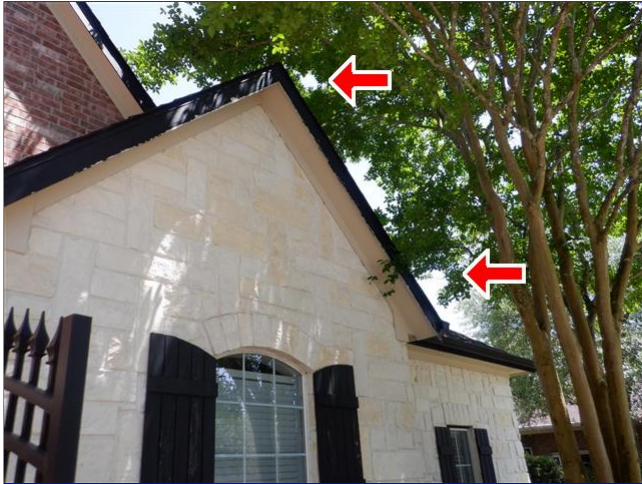
(1) Trees in contact with the front side of the the roof should be trimmed back to prevent damage to the roof/ siding.

C. Front of home

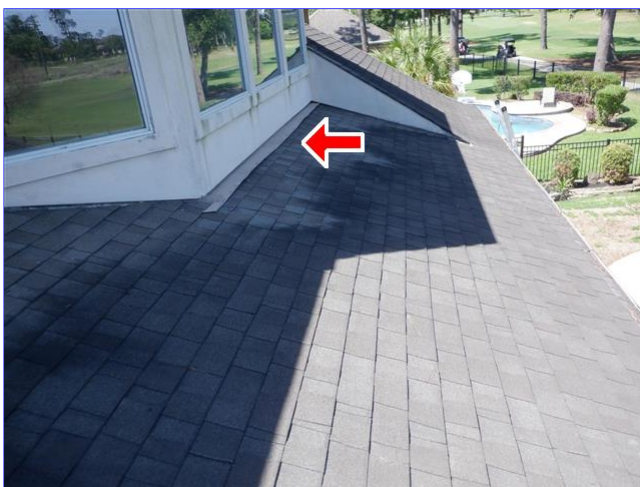
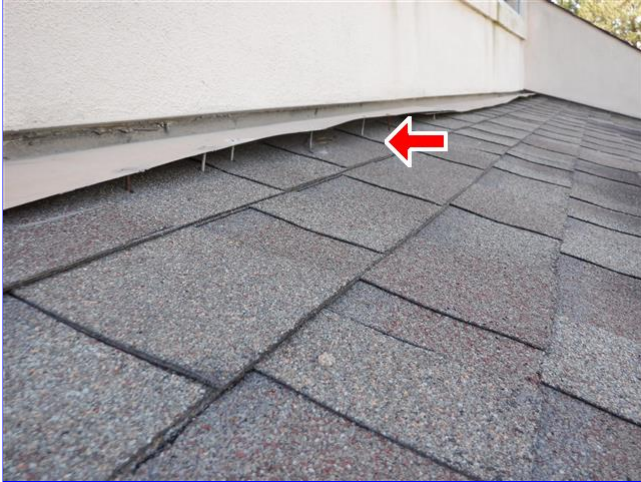
(2) Exposed nail heads and loose flashing was observed on the back and left side of the roof. Exposed nail heads were observed on cap shingles of the roof. I recommend further evaluation and repair of the roofs flashing. Flashing should be properly secured and exposed nail heads should be sealed.

C. Loose flashing, back of home

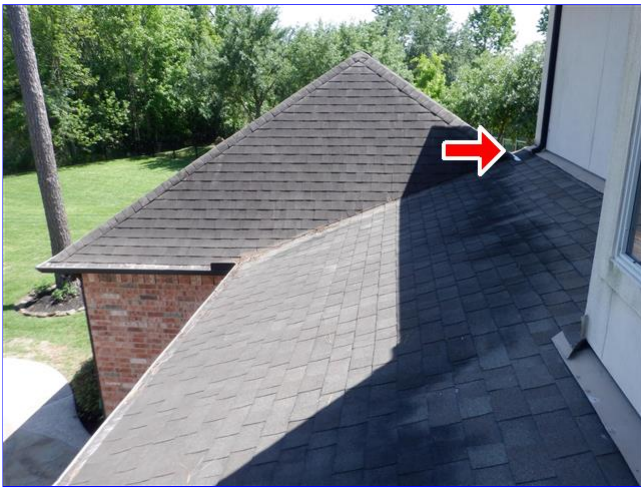
C. Exposed nail heads on flashing, back of home

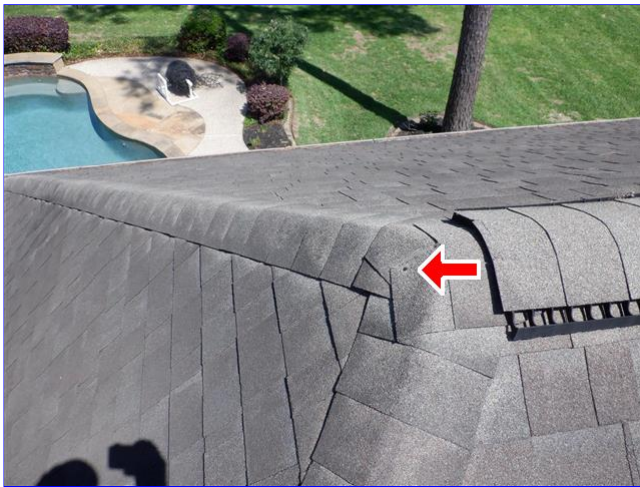
C. Exposed nail head, cap shingle

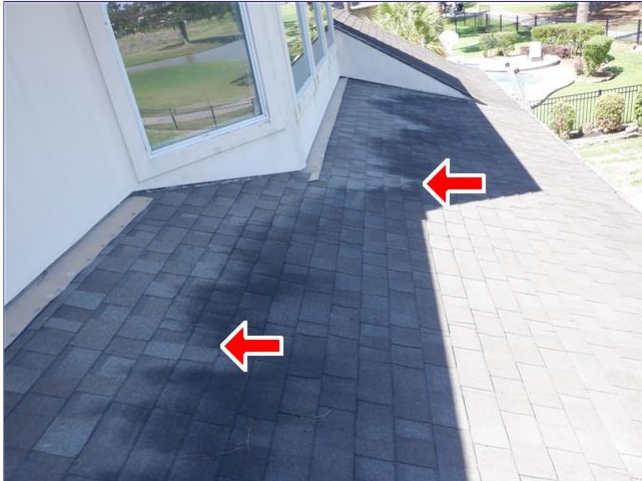
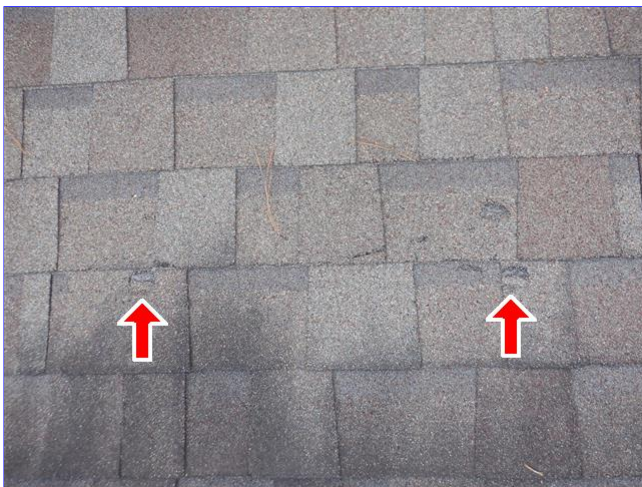
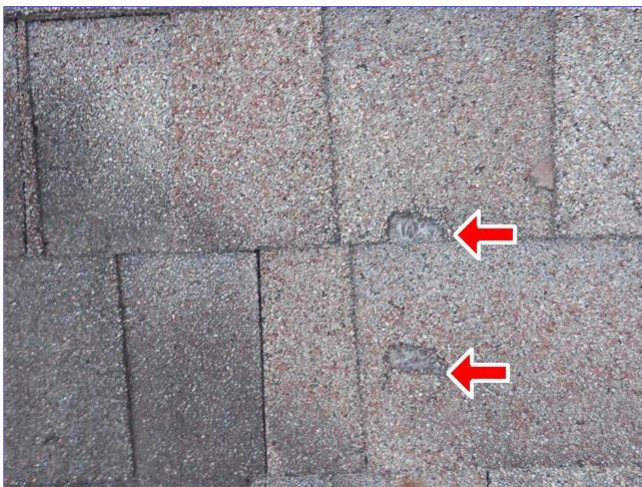
(3) Multiple damaged shingles were observed on the back side of the home. I recommend further evaluation and repair by a qualified roofing contractor.

C. Damaged shingles, back of home

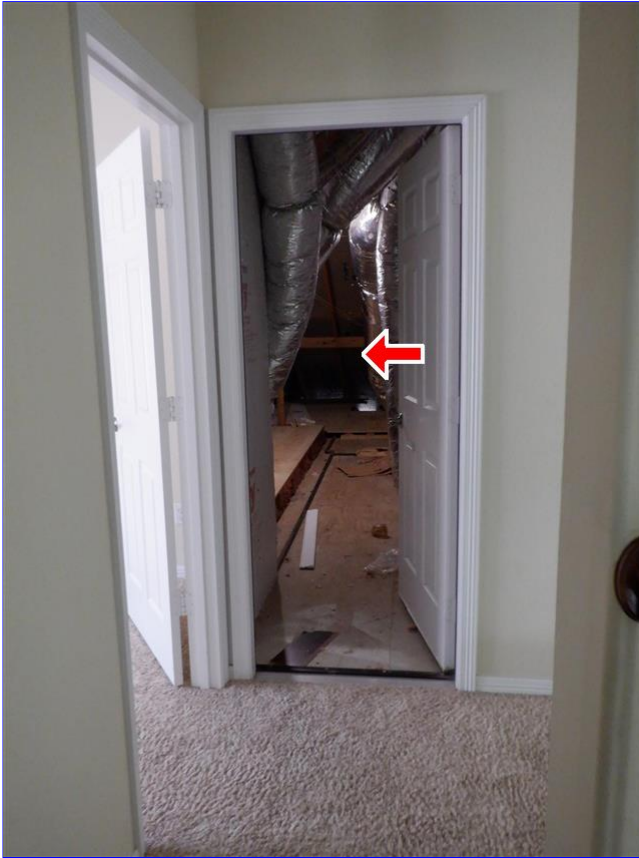
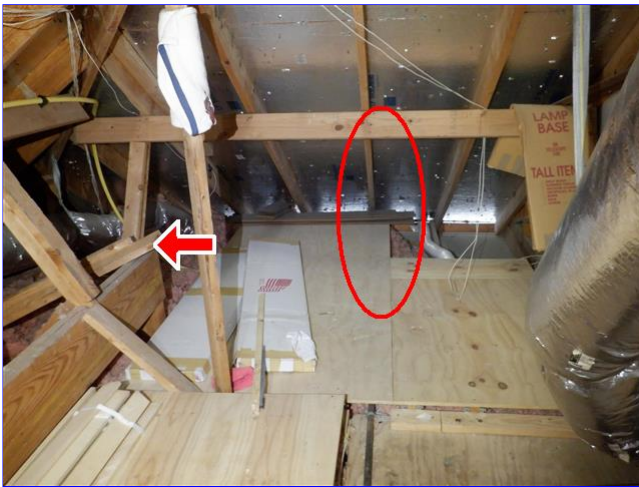
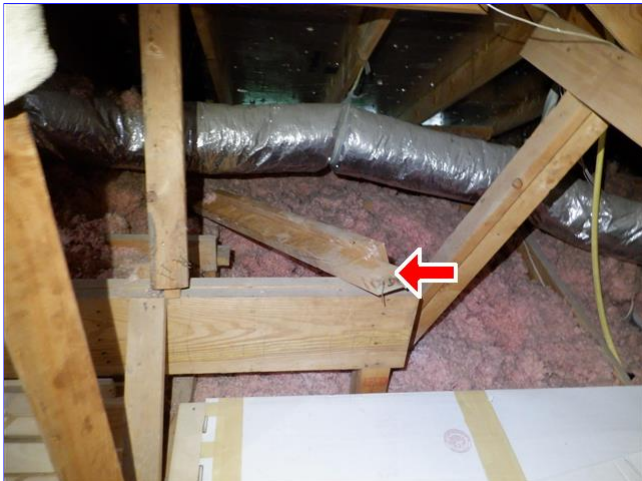
In the upstairs back attic, a purlin support brace appear to have been removed to add decking on the attics floor. I recommend replacing the removed pulin support to properly support the roofs framing.

D. Upstairs back attic, Pulin support removed

D. Pulin support removed

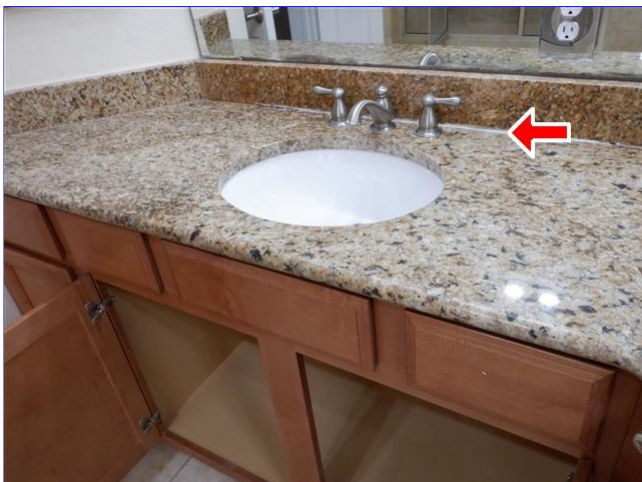
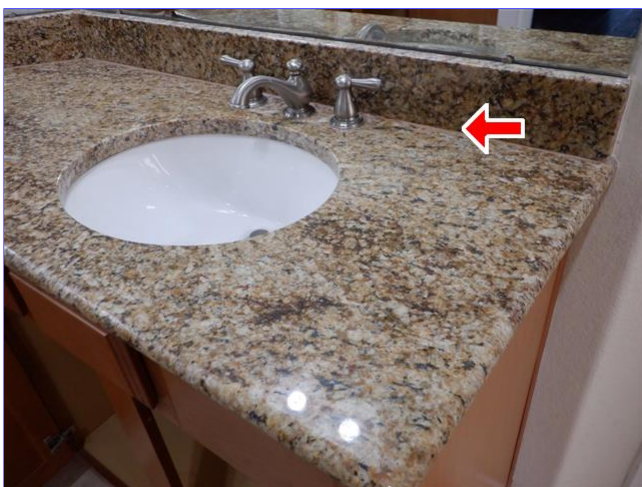
(1) The caulking at the master bathrooms vanities was deteriorated in areas. I recommend re-caulking the master bathrooms countertop/ back splash.

E. Master bathroom vanity

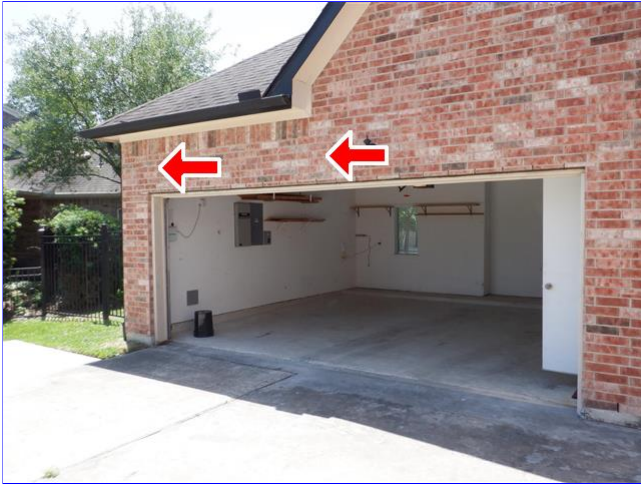
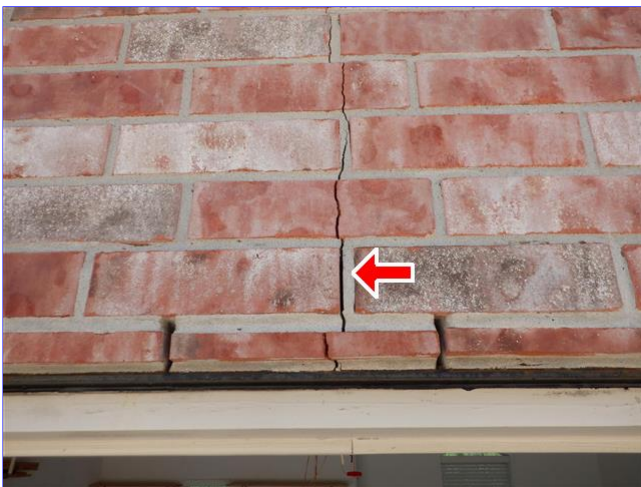
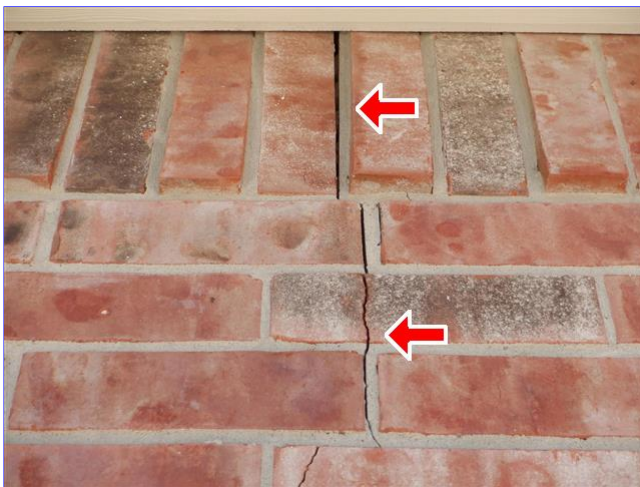
(2) Multiple cracks were observed on the back exterior wall of the front garage. The cracks are signs that the lintel/ header support has settled in my opinion. I recommend further evaluation and repair as needed.

E. Front garage exterior wall

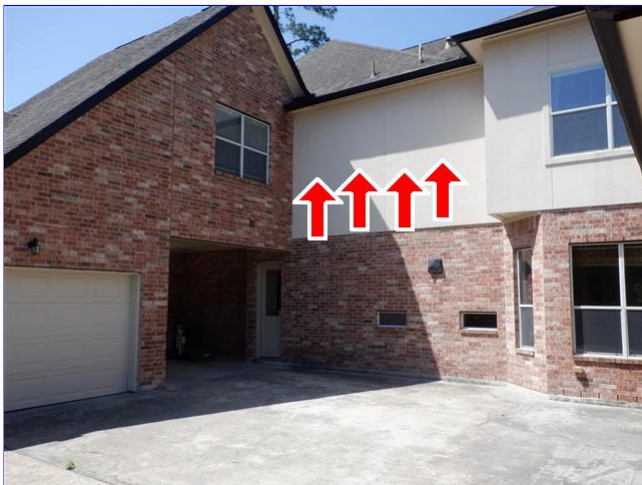
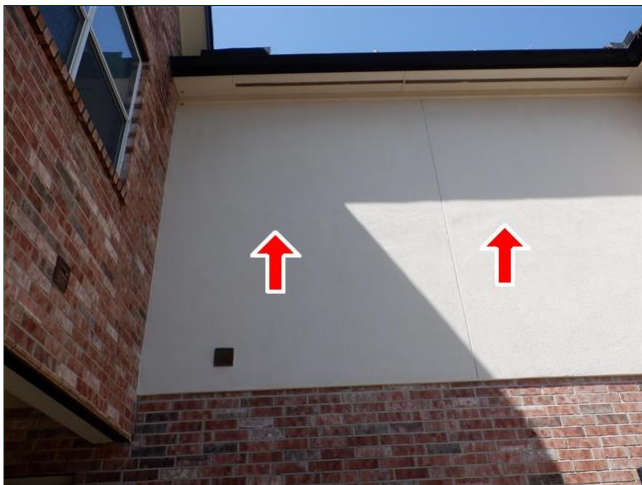
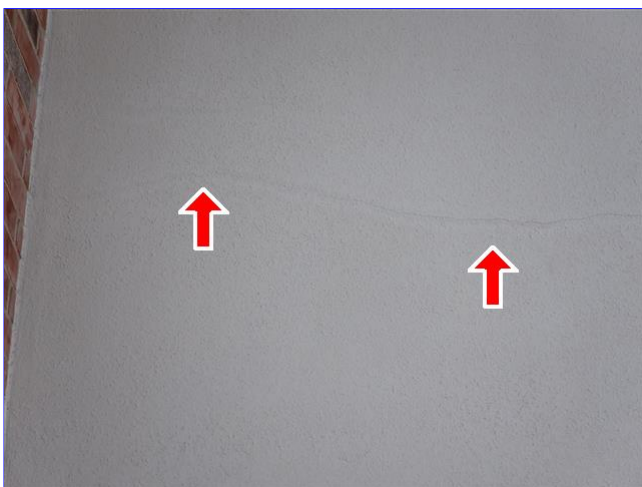
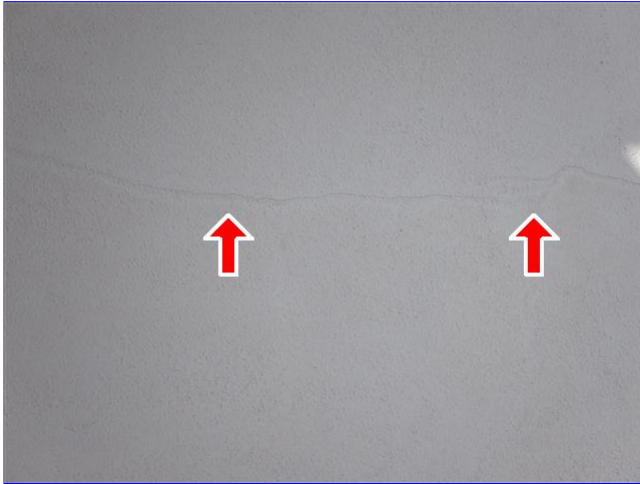
(3) Multiple cracks were observed on the exterior stucco siding (see pics), the home appear to have EIFS

stucco siding. I recommend having an invasive stucco siding inspection. I recommend further evaluation and repair of the exterior stucco siding.

E. Cracks on exterior wall, near driveway

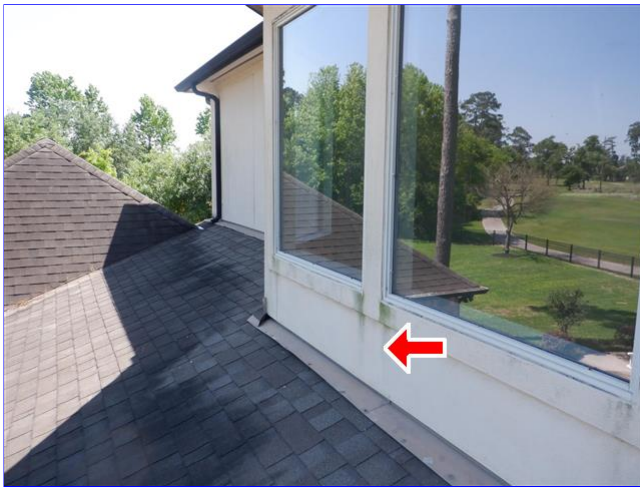
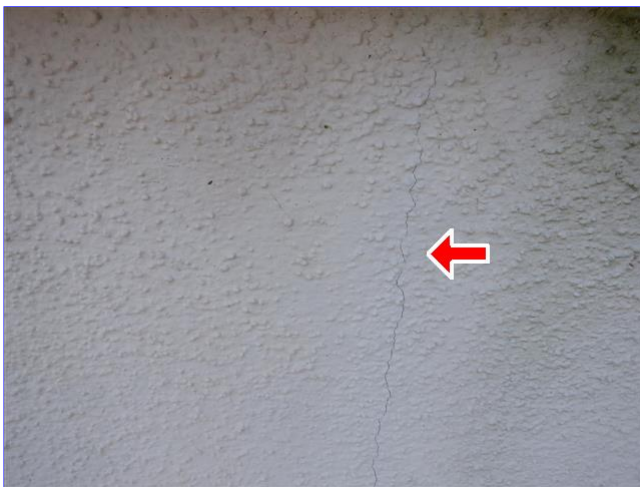
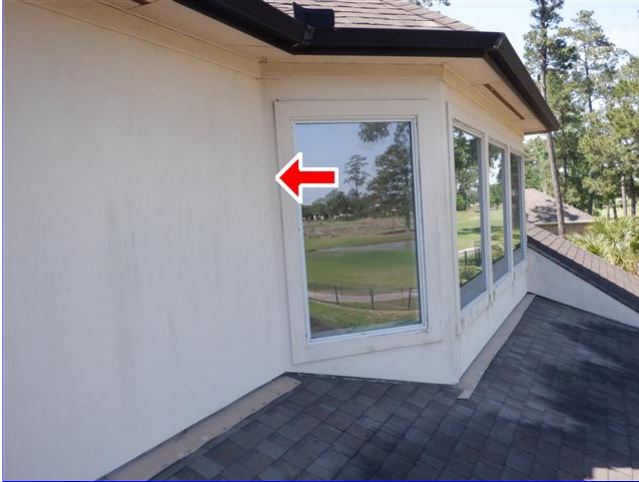
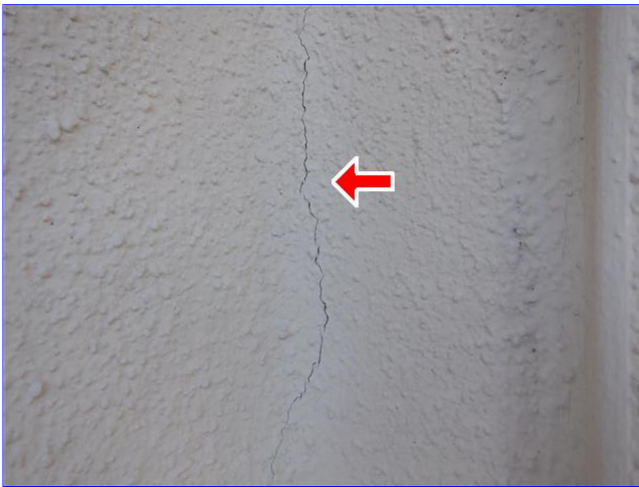
E. Back of home, cracks on exterior siding

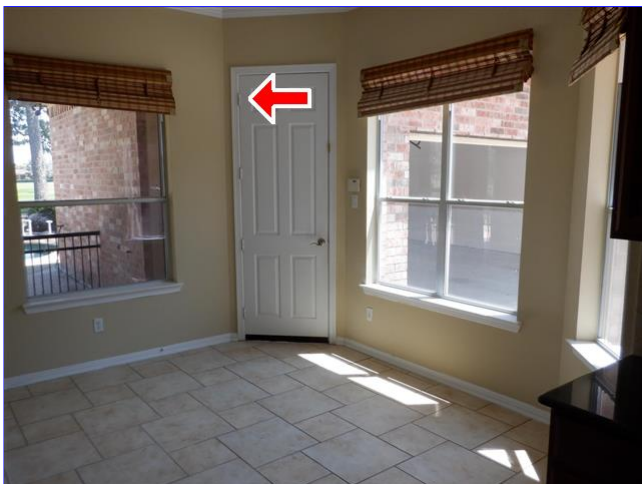
- (1) There were two or more missing door stops throughout the house. I recommend installing door stops to prevent drywall and door damage.
- (2) The occupant door leading from the attached garage into the house was not self closing. I recommend adjusting the self closing hinges on the door leading from the garage to the living space as a safety feature to prevent car exhaust from entering the house.

F. Garage door

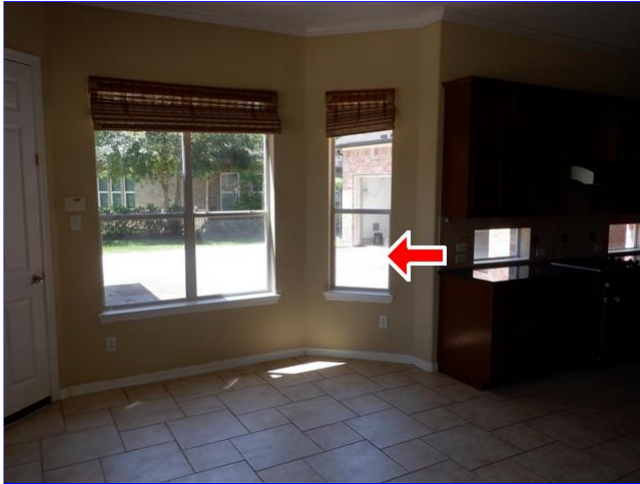
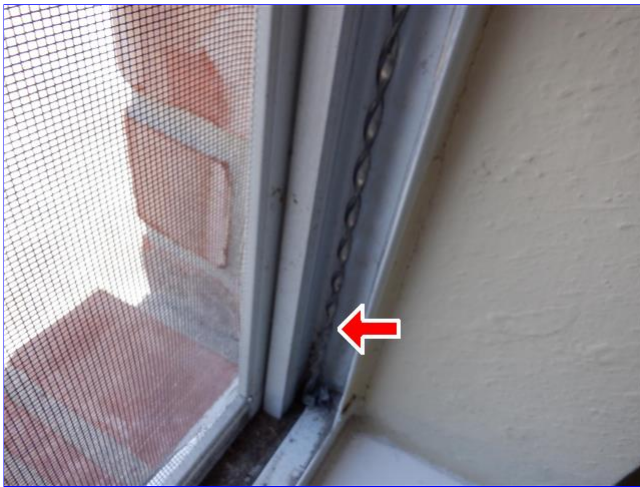
(1) Windows in the dining room and upstairs front left bedroom had broken hardware, windows would not remain open. I recommend repair as needed.

H. Dining room window

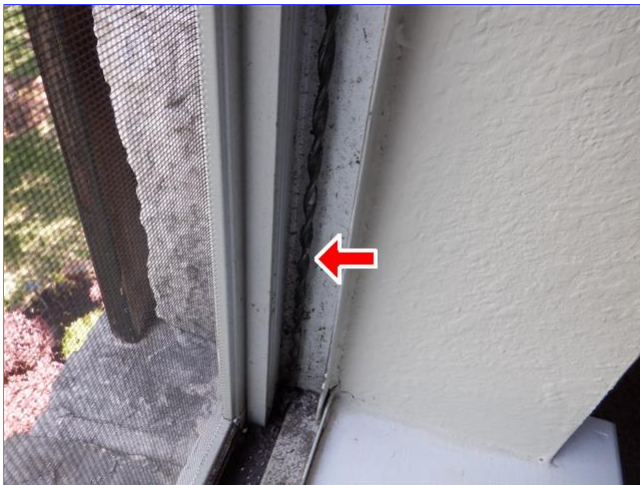
H. Upstairs front left bedroom window, broken hardware

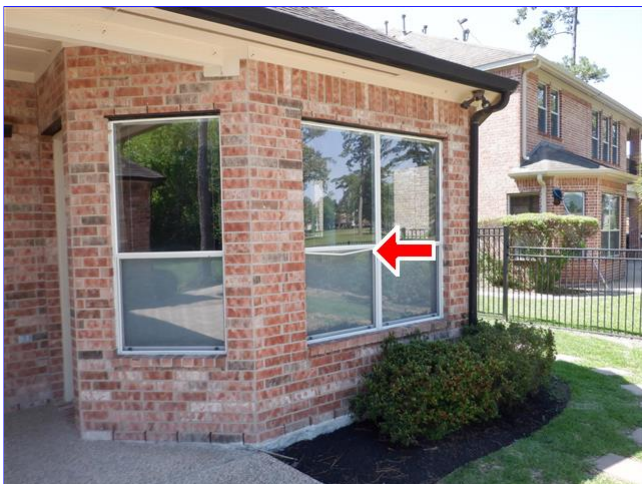
(2) A damaged window screen was observed at a master bedroom window.

H. Master bedroom window, damaged window screen

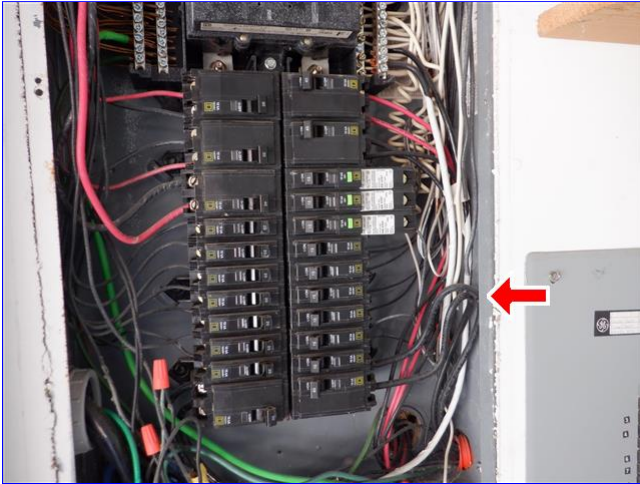
Exposed/ disconnected electrical wiring was observed in the main electrical panel (right side of panel). I recommend further evaluation and repair by a licensed electrician.

A. Exposed electrical wiring, main electrical panel

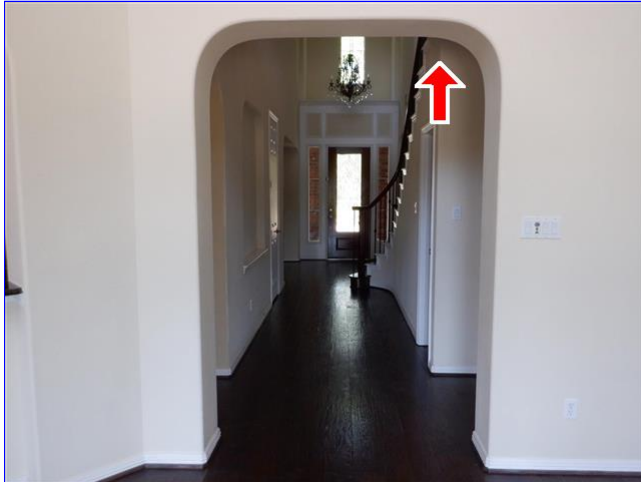
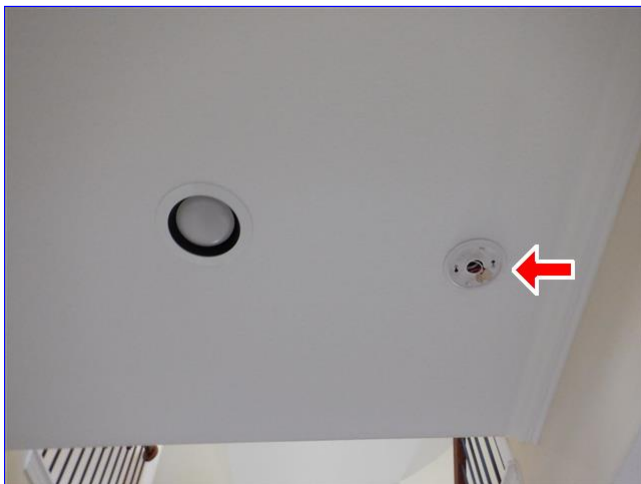
(1) The downstairs hallway smoke detector was missing. I recommend re[placing the smoke detector before moving into the home.

B. Downstairs hallway, missing smoke detector

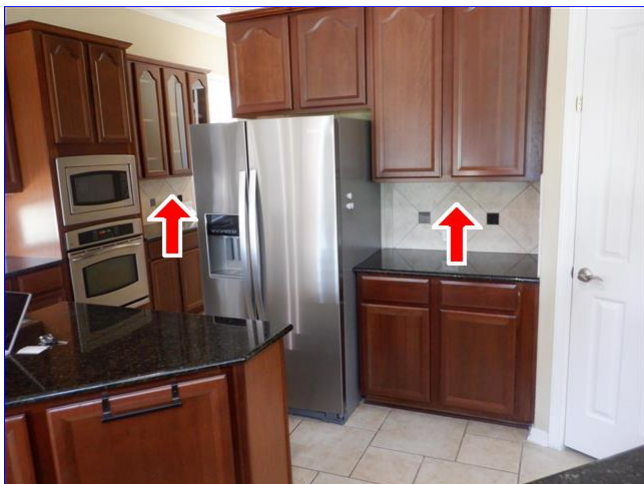
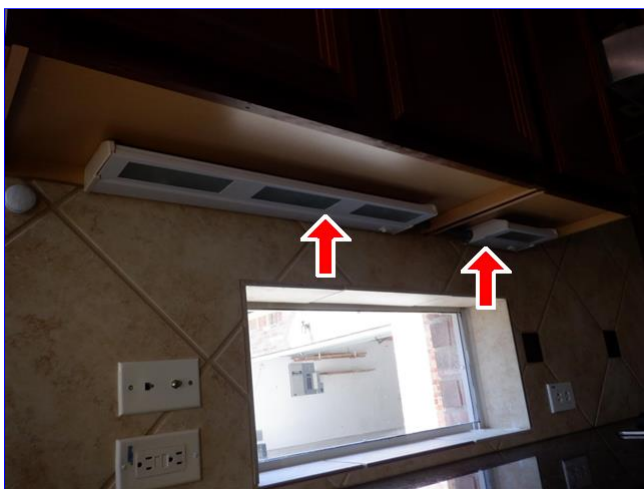
(2) Multiple surface lights (lights mounted under the kitchen cabinets) in the kitchen did not work.

B. Kitchen cabinet lights

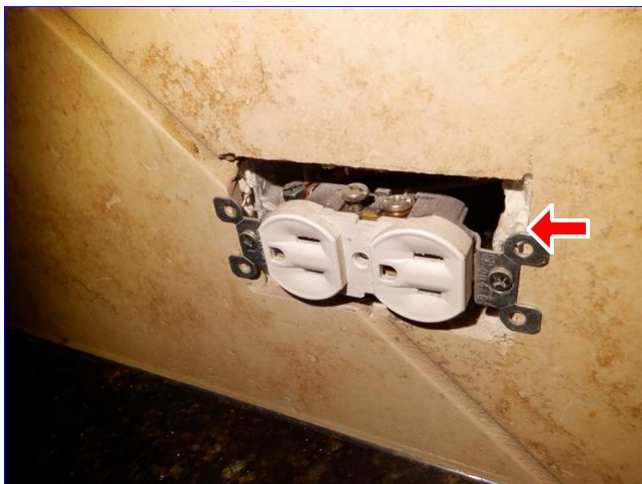
(3) Multiple kitchen back splash electrical outlets were missing electrical outlet box extenders. I recommend installing electrical outlet box extenders to ensure the electrical box is properly sealed and the electrical wiring is protected. I recommend further evaluation/ repair by a licensed electrician.

B. Kitchen back splash electrical outlety

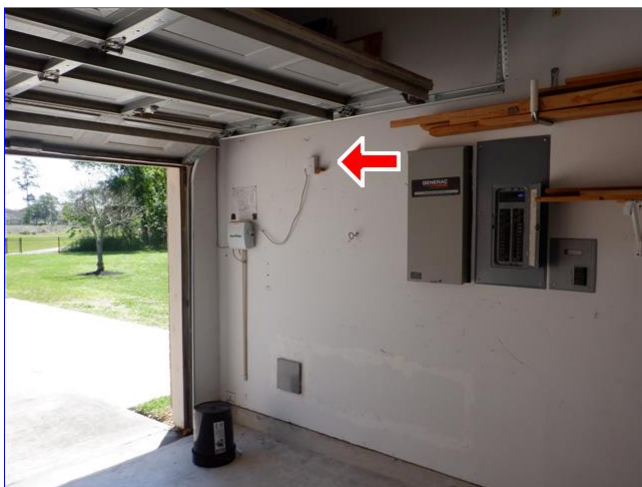
(4) The electrical outlet for the landscape irrigation system in the front garage was not GFCI protected as required. I recommend further evaluation and repair by a licensed electrician.

B. Garage electrical outlet

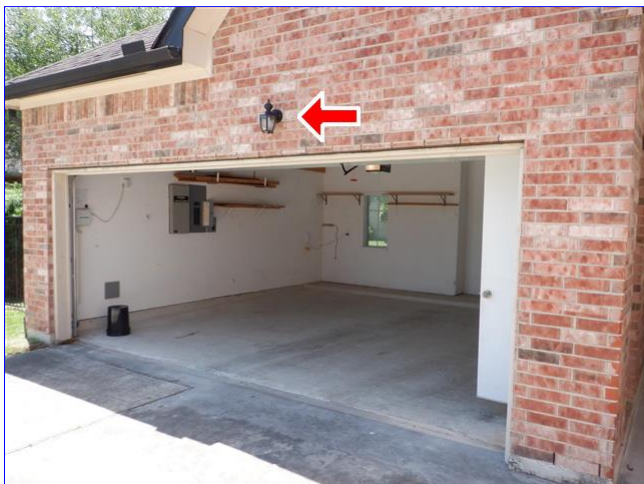
(5) Multiple exterior lights did not work (see pics).

B. Driveway light not working

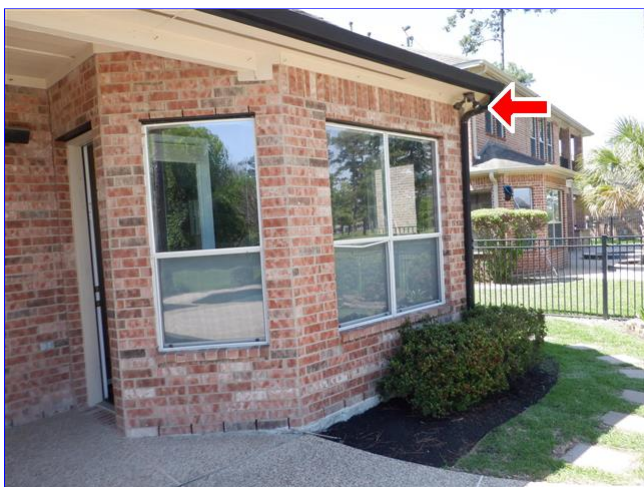
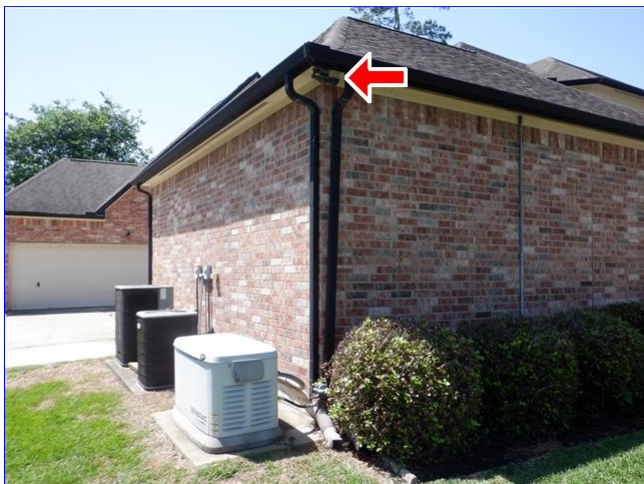
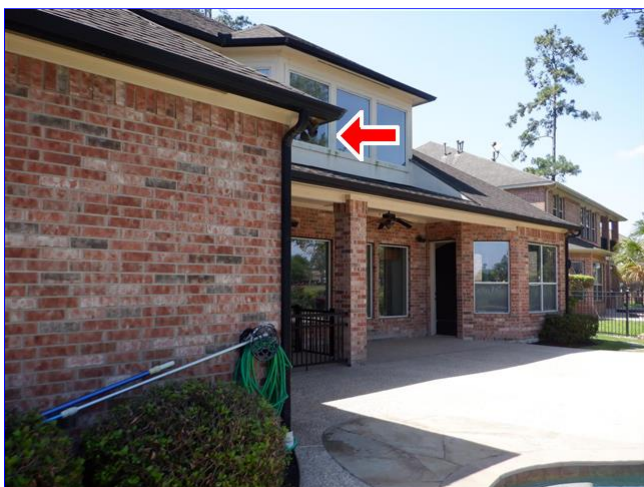
B. Back yard flood lights

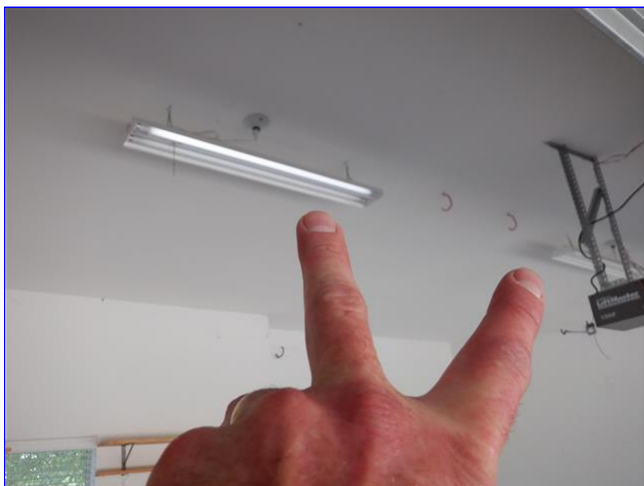
(6) The lights in the front garage appear to be hard-wired, I was unable to locate an electrical switch that controlled the lights. I recommend further evaluation and repair by a licensed electrician.

B. Front garage lights

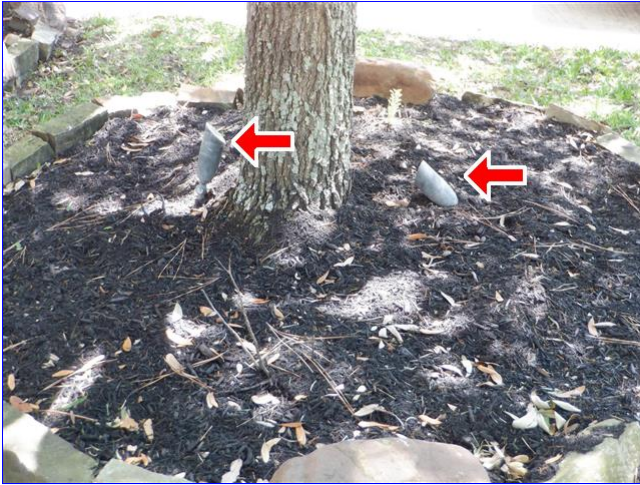
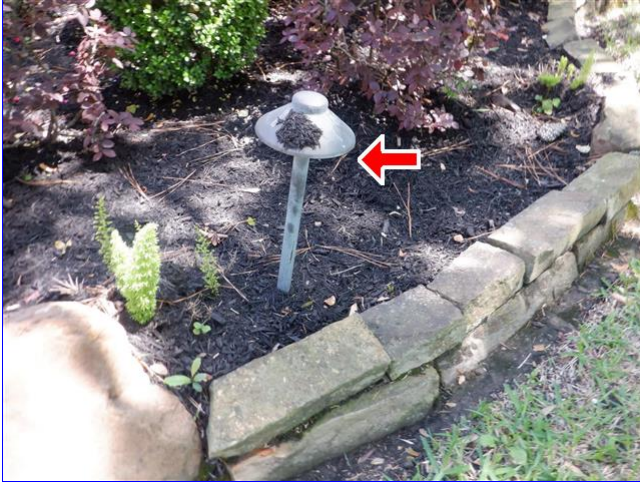
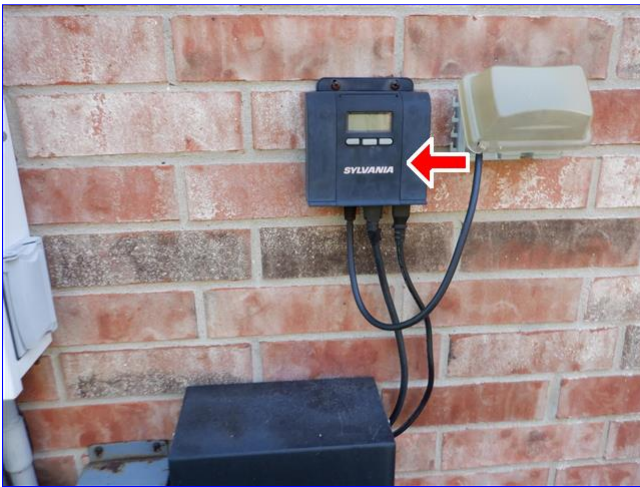
B. Exterior yard lights

B. Exterior yard lights controller

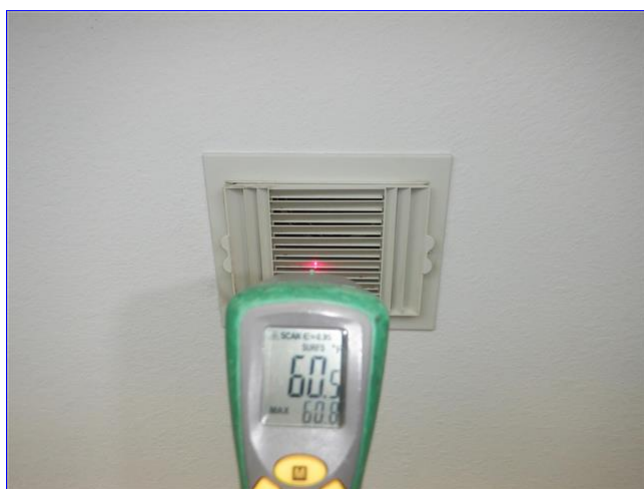
The temperature delta between the return air and the supply air across the evaporator coil on average was 10 degrees F. This is NOT considered an acceptable temperature delta. The Delta on a correctly functioning air conditioner should be approximately between 15 and 25 Degrees F depending on humidity and other factors. The air conditioner stopped running before it reached its temperature setting. The air conditioner did not cool the home properly in my opinion.

B. Upstairs AC temperature reading

I recommend further evaluation of the homes air conditioning system by a licensed HVAC technician.

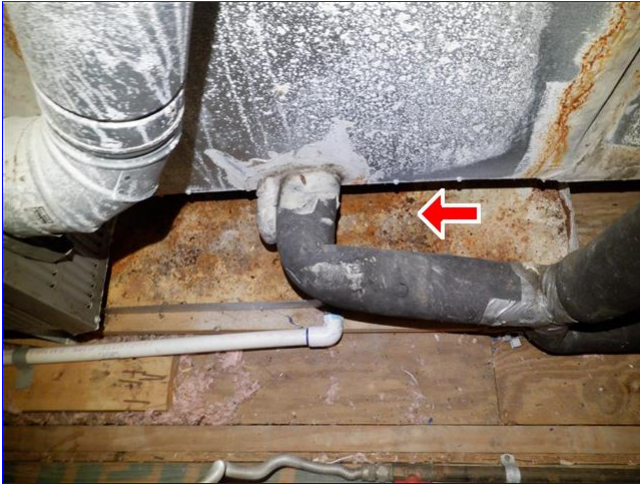
(3) Rust was observed in the downstairs air conditioners auxiliary drain pan in the attic. I recommend replacing the auxiliary drain pan.

B. Downstairs AC auxiliary drain pan

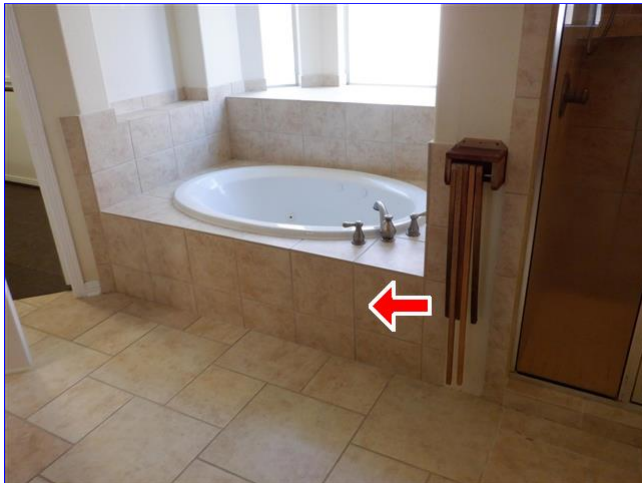
A. Master bathroom hydro-massage tub, no mechanical access panel

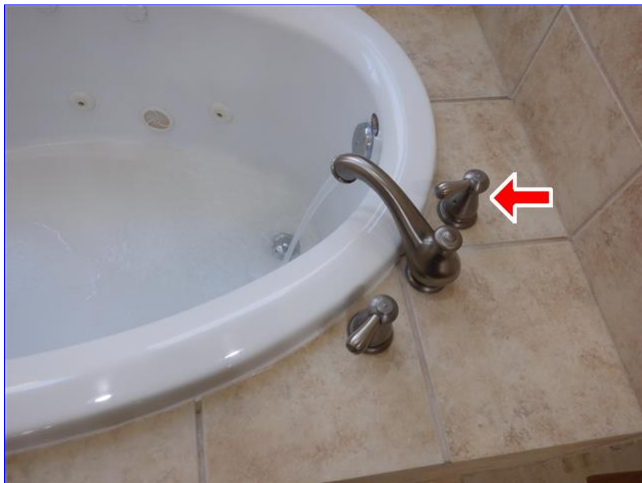
(4) The master bath tubs hot water supply handle was loose to the tile/ tub surrounding. I recommend properly securing the handle.

A. Master bath tub

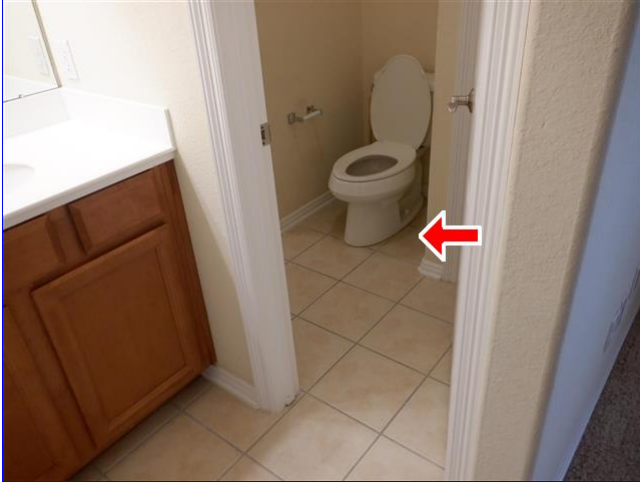
(5) The toilet in the upstairs Jack & Jill bathroom was loose to the floor. I recommend properly securing the toilet to the floor.

A. Jack and Jill bathroom toilet, loose to floor

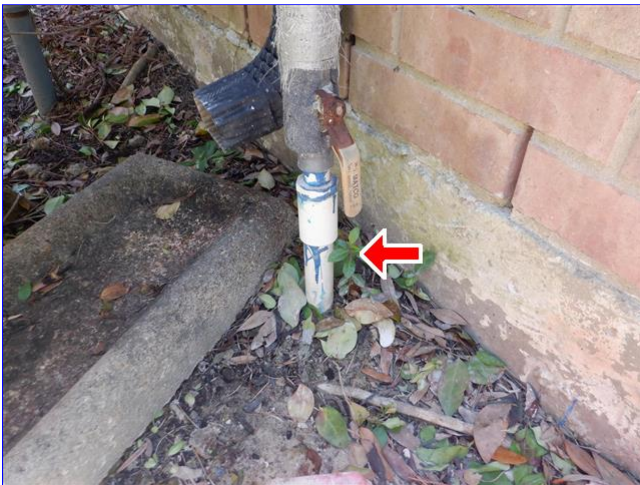
(6) I recommend insulating the exposed water supply line at the front left exterior corner of the home to protect against freezing.

A. Front left corner of home, main water supply line, insulation needed

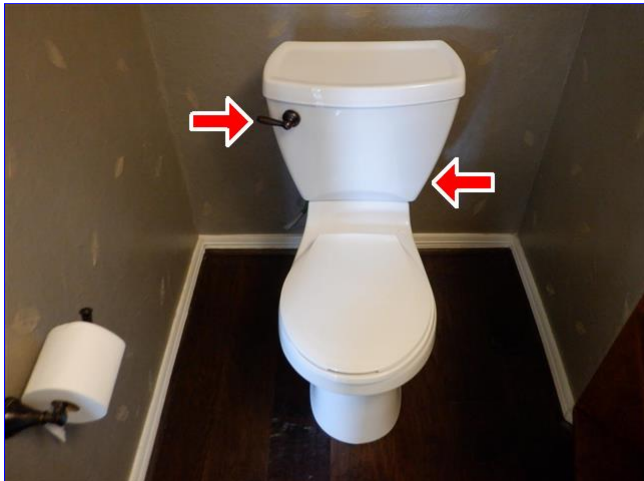
(7) The 1/2 bathroom toilet tank was loose to the toilet. The flush handle was also loose to the tank. I recommend further evaluation and repair by a licensed plumber.

A. 1/2 bathroom toilet

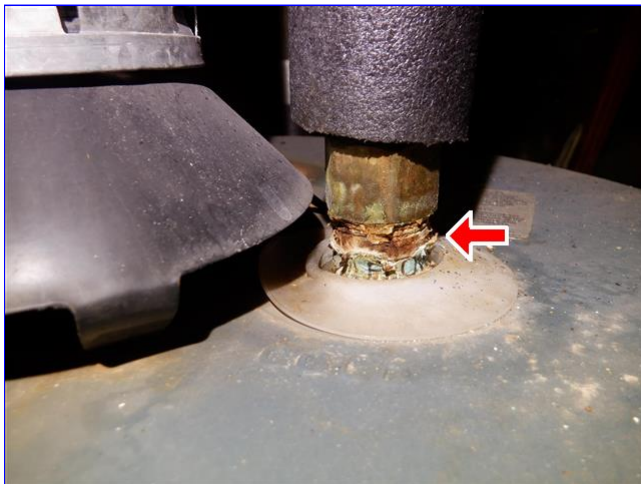
(2) Rust/ corrosion was observed at tone of the supply line for a water heater. I recommend further evaluation and repair by a licensed plumber.

C. Water heater

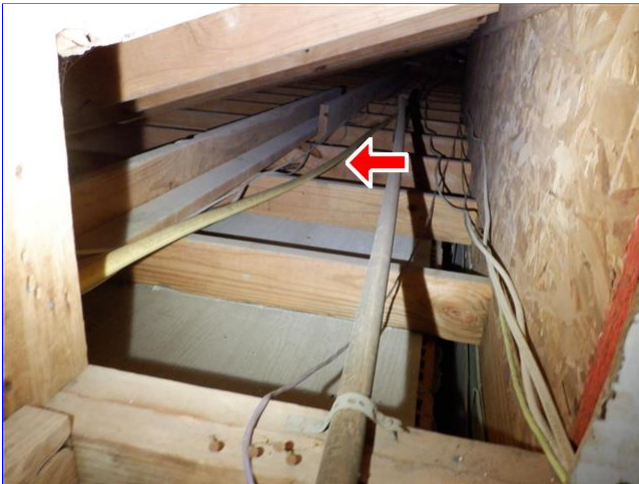
In the upstairs back attic a CSST gas supply line was observed. The gas line appears to have been installed to supply the home generator. I recommend replacing the CSST gas supply line with black iron gas pipe. I recommend further evaluation and repair by a licensed plumber.

E. Upstairs back attic, CSST gas supply line

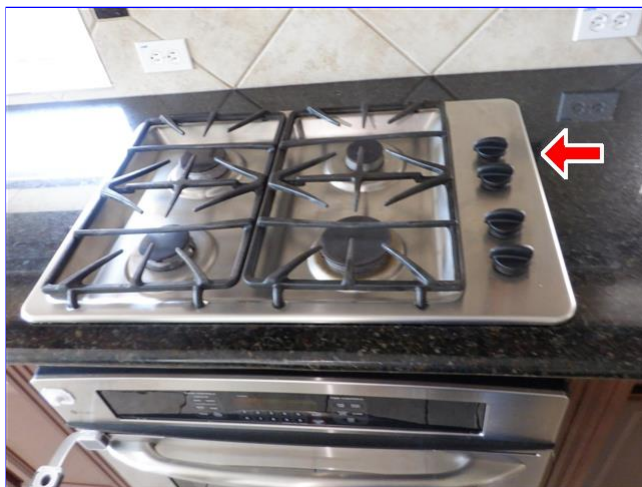
(1) The cooktop was loose to the countertop. I recommend properly securing the cooktop.

D. Cooktop

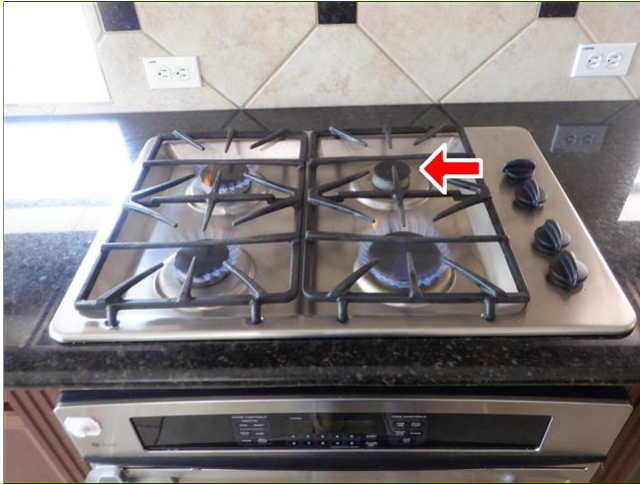
(2) The back right burner on the cooktop did not work.

D. Cooktop

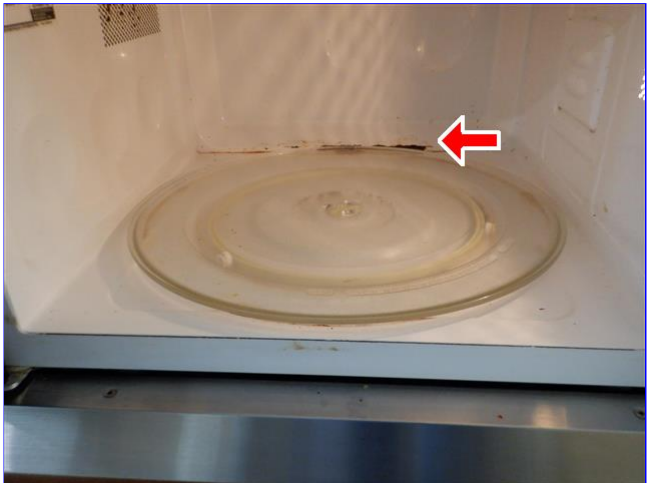
Inside the microwave, the back of the microwave was damaged. The rotating tray appears to be rubbing against the back of the microwave.

E. Microwave

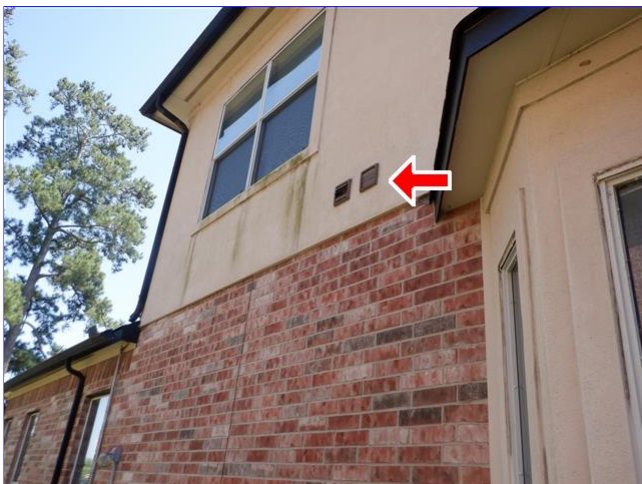
- (1) The mechanical exhaust vent in the laundry room was excessively loud when turned on. I recommend further evaluation and repair as needed.
- (2) The 1/2 bathrooms mechanical exhaust vent at the left exterior wall did not open when fan was tested. I recommend repair as needed.

F. 1/2 bathroom exhaust vent

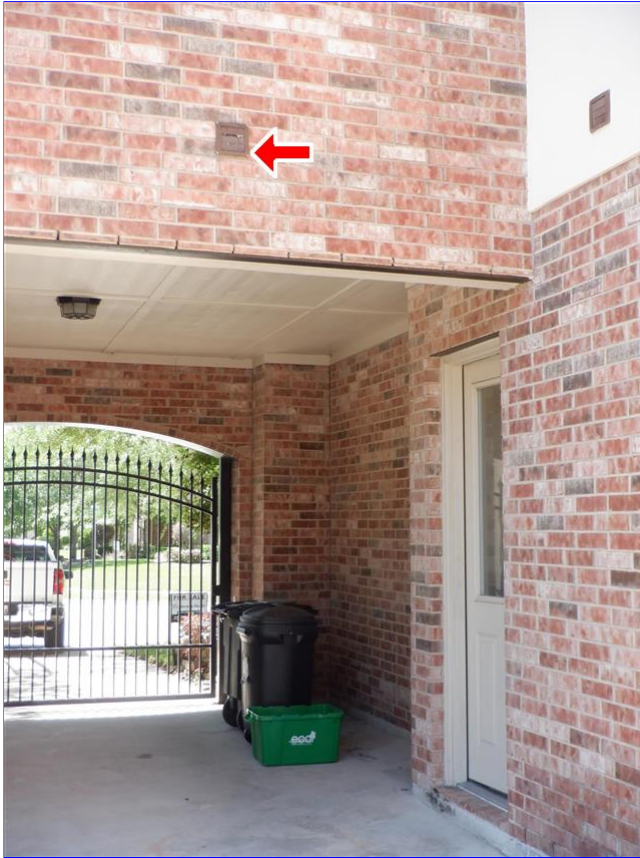
H. Dryer exhaust vent, dirty

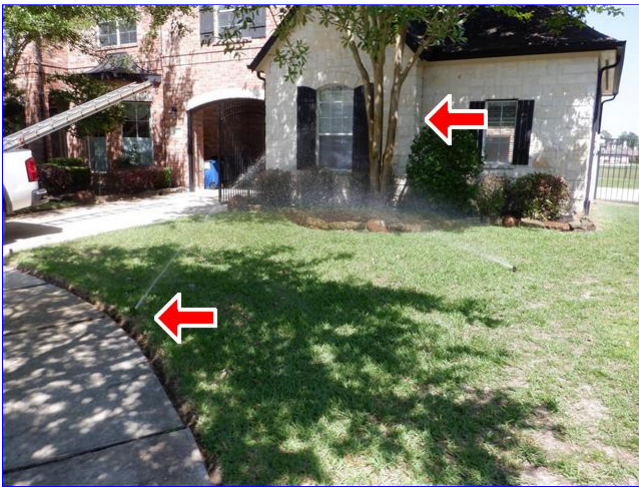
A. Zone 2, over spray on front of garage
