Inspection Report

Property Address:
14202 Grand Manor Ln
Humble TX 77396

Counter Home Inspections

PROPERTY INSPECTION REPORT

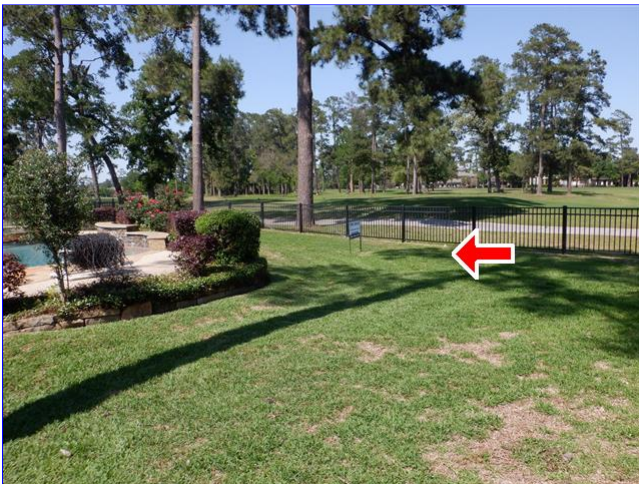
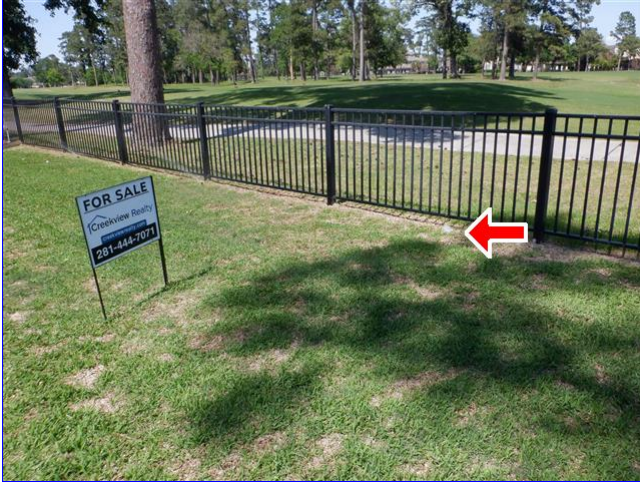
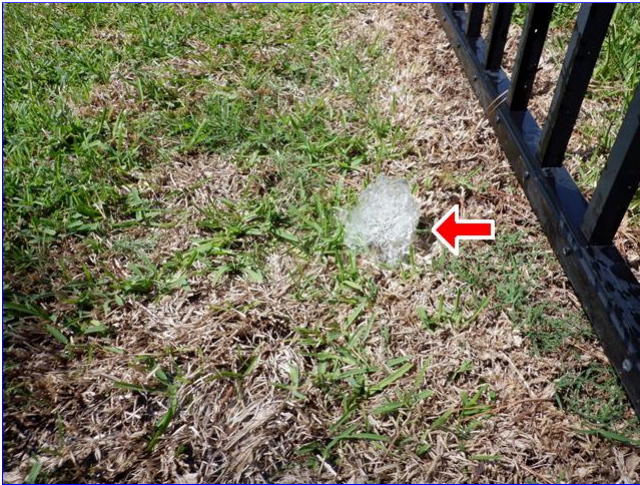
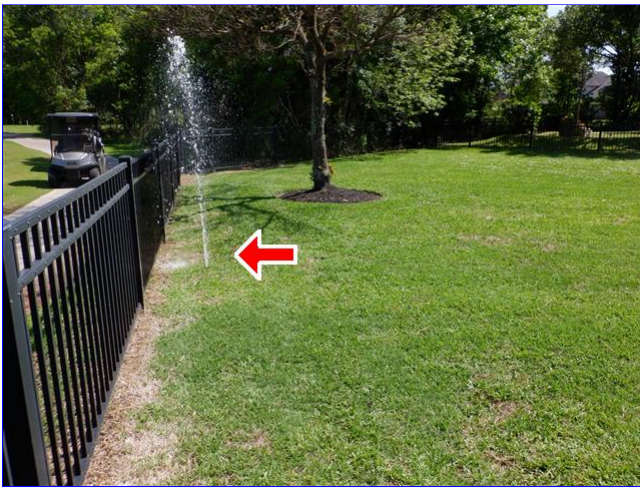
Broken sprinkler heads were observed on zones 6 & 7.

A. Zone 6, broken sprinkler head

A. Zone 7, broken sprinkler head

I recommend further evaluation and repair of the landscape irrigation system.
