Property Inspection Report

12618 Campsite Trail, Cypress, TX 77429
Inspection prepared for: Liesl Demaria
Real Estate Agent: Laura LoGiudice - Next Home Realty Center

Date of Inspection: 3/29/2018 Time: 8:30 AM
Age of Home: 1975 Size: 2780
Order ID: 8843

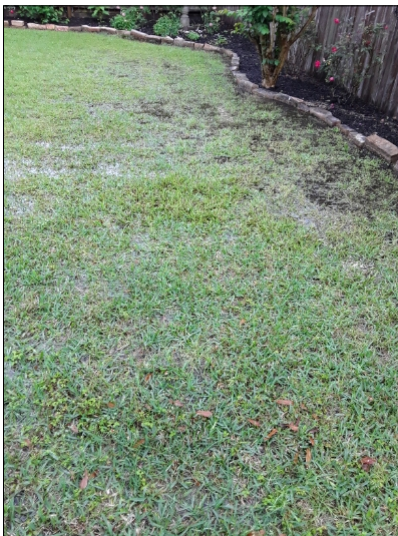
B.2. -The yard is ponding, although this may not cause foundation issues if not against the slab you may want to add drainage or adjust the grading to help remove excess water. Mainly at - right rear

-The yard is ponding, although this may not cause foundation issues if not against the slab you may want to add drainage or adjust the grading to help remove excess water. Mainly at - right rear

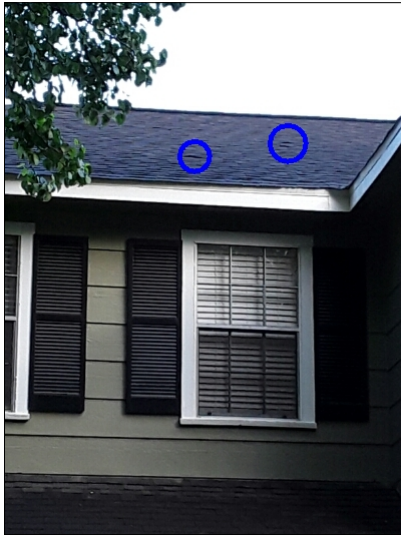
C.7. -Nails are noted backing out through the shingles, recommend repairs to help prevent shingles lifting during high wind conditions. Mainly at - front slope, garage, Left slope, rear slope

-Nails are noted backing out through the shingles, recommend repairs to help prevent shingles lifting during high wind conditions. Mainly at - front slope

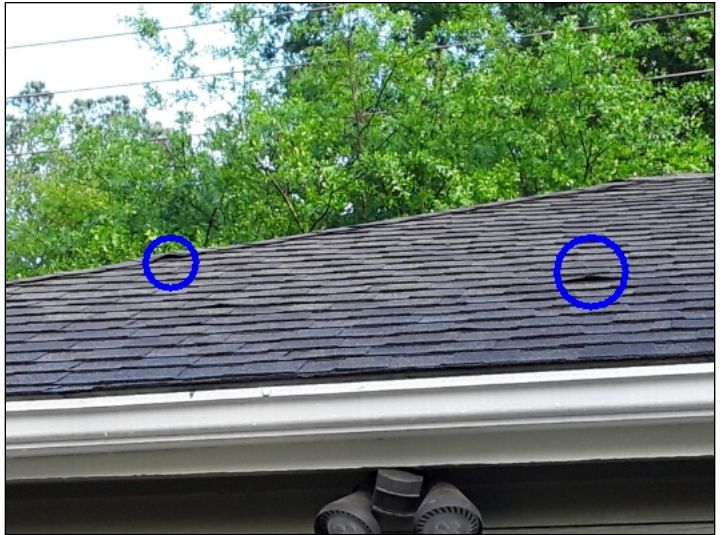
-Nails are noted backing out through the shingles, recommend repairs to help prevent shingles lifting during high wind conditions. Mainly at - garage

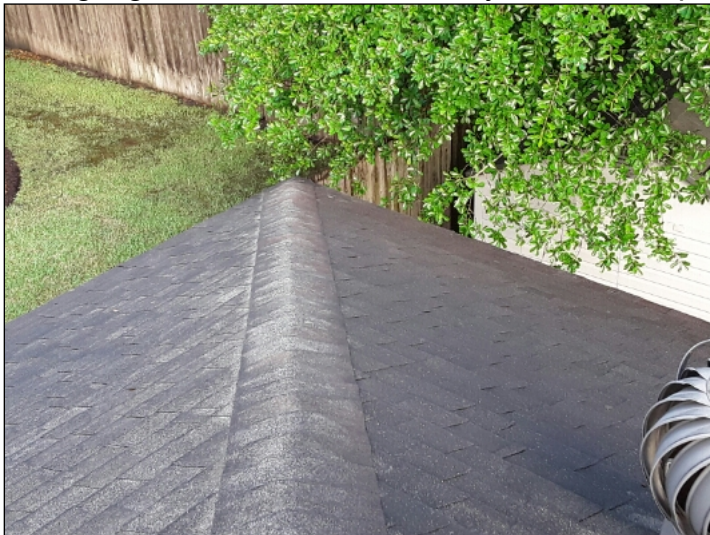
C.3. -Tree limbs should be kept trimmed at least 5' from roof to help prevent damage to the roof during windy conditions.

-Tree limbs should be kept trimmed at least 5' from roof to help prevent damage to the roof during windy conditions.

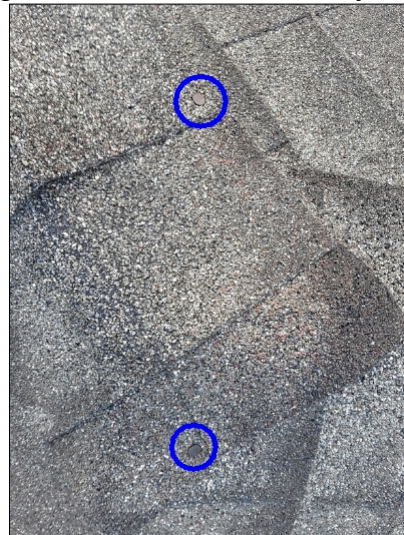
-All exposed nails and fasteners on roof should be sealed at all penetrations, ridges and roof to wall connections.

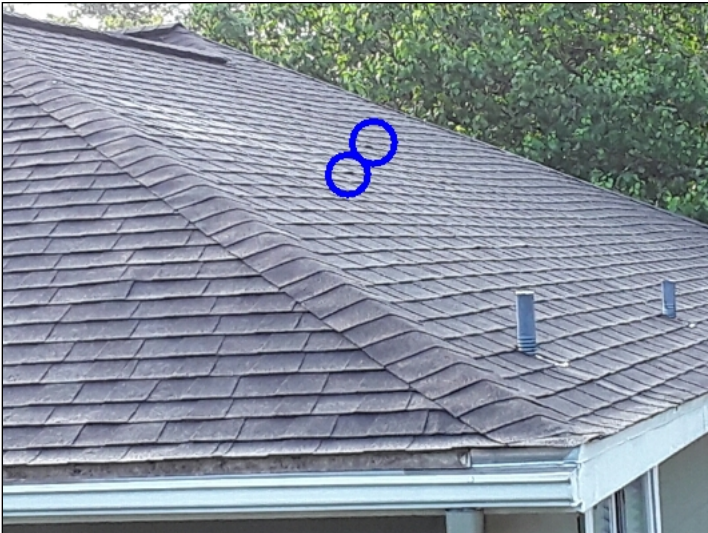
-Nails are noted backing out through the shingles, recommend repairs to help prevent shingles lifting during high wind conditions. Mainly at - Left slope

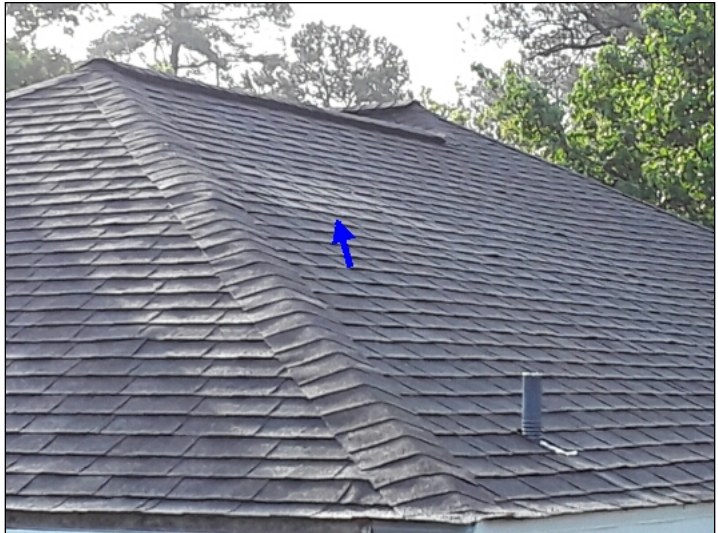
C.1. -Signs of previous repairs were noted on the roof. Indications are that they are working as intended at time of inspection.

-Signs of previous repairs were noted on the roof. Indications are that they are working as intended at time of inspection.

C.2. -Recommend a roofer be consulted for further evaluation/repairs and check for other repairs that may be needed at that time.

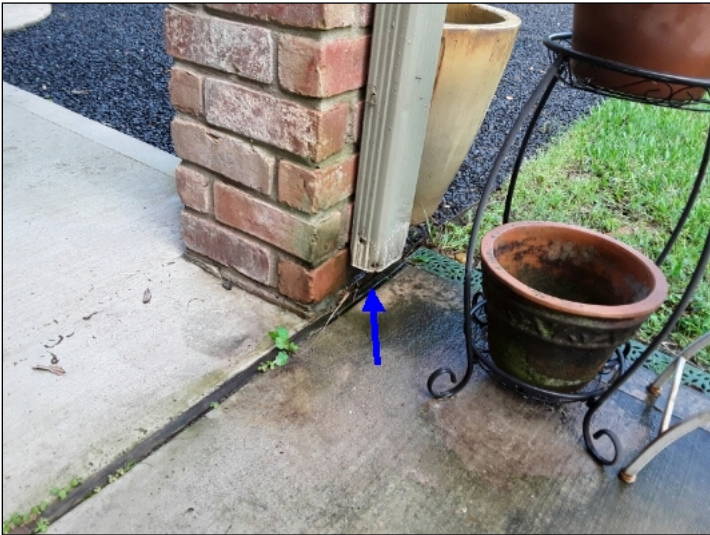
C.9. -The downspout is missing the 90 degree elbow to direct water away from foundation. Mainly at - rear

-The downspout is missing the 90 degree elbow to direct water away from foundation. Mainly at - rear

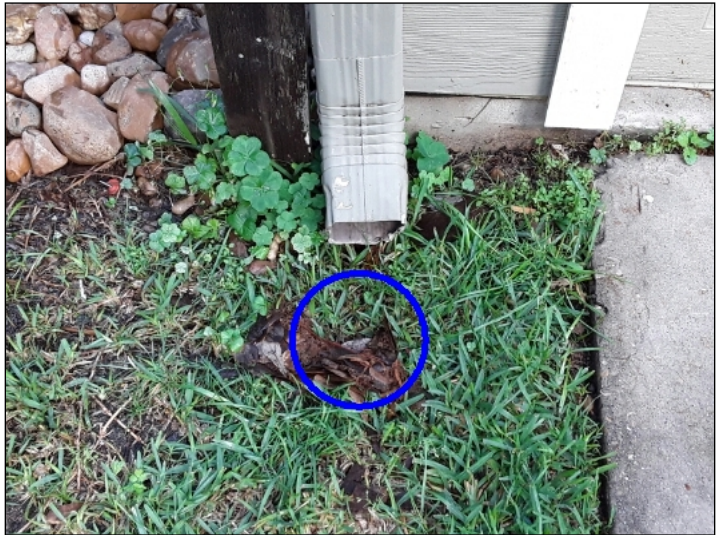
C.8. -Splash blocks or downspout extensions should be installed to direct water away from foundation.

-Splash blocks or downspout extensions should be installed to direct water away from foundation.

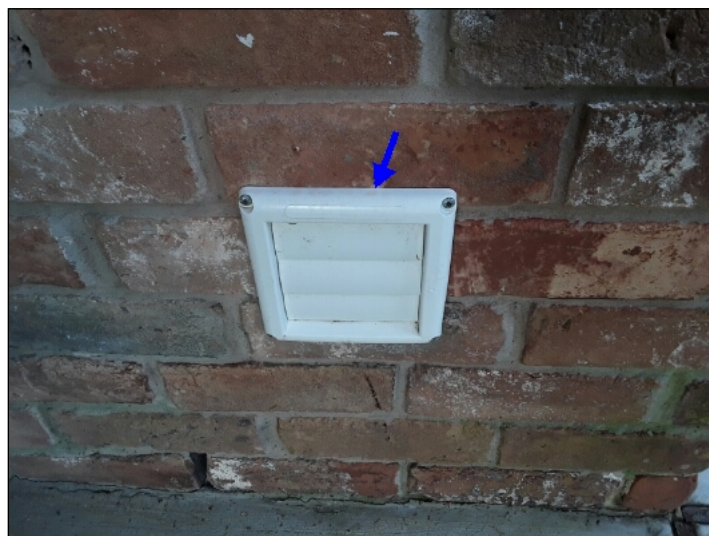
E.1. -Seal all vents at wall connection to help prevent water penetration into walls.

-Seal all vents at wall connection to help prevent water penetration into walls.

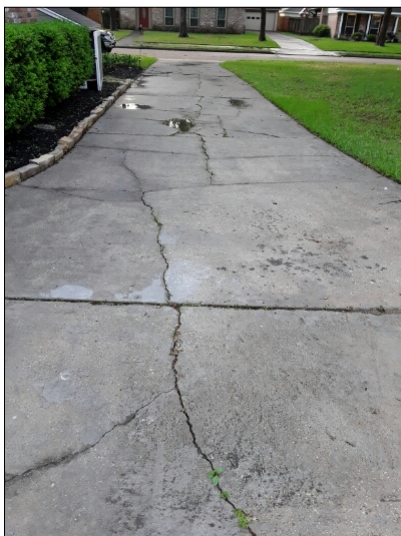
F.2. -Cracks were noted in the pavement. These are cosmetic in nature at this time. Recommend sealing to prevent further deterioration. Mainly at - Driveway

-Cracks were noted in the pavement. These are cosmetic in nature at this time. Recommend sealing to prevent further deterioration. Mainly at - Driveway

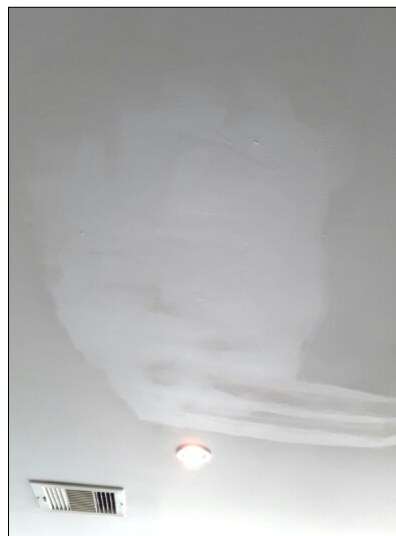
F.1. -Previous repairs were noted in the ceiling. Mainly at - living room

-Previous repairs were noted in the ceiling. Mainly at - living room

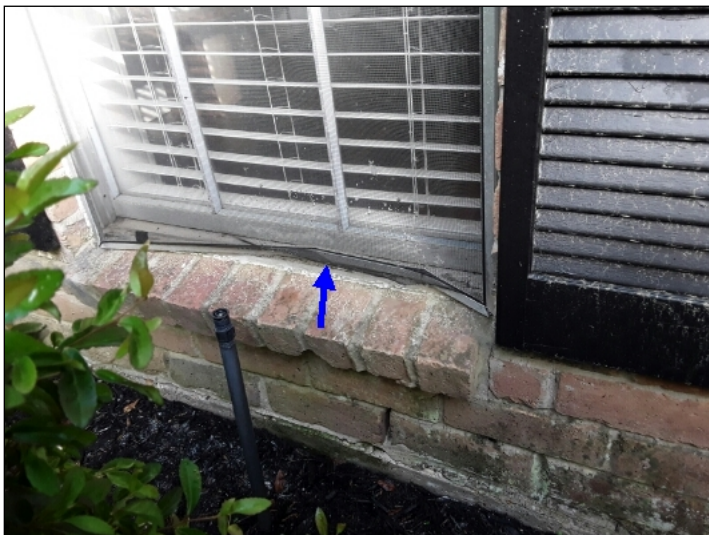
-Window screens are bent or damaged on the home. Mainly at - front right

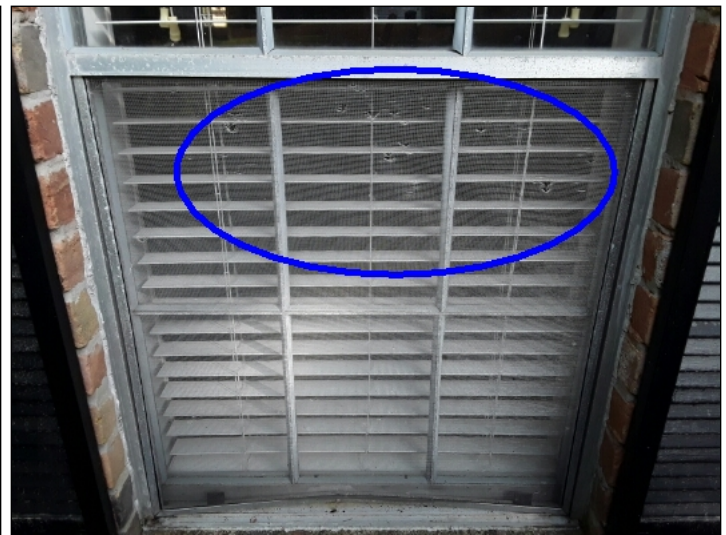
-Window screens were damaged or had holes in them and should be repaired to help prevent insects from entering. Mainly at - front right

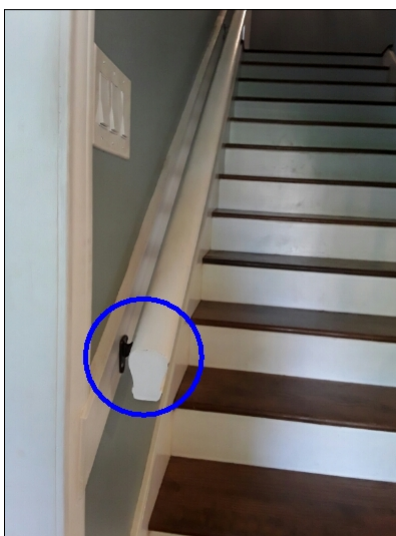
-Rail not extended to wall at the ends. This is a safety concern as clothes or other objects can get caught in this area causing someone to trip and fall.

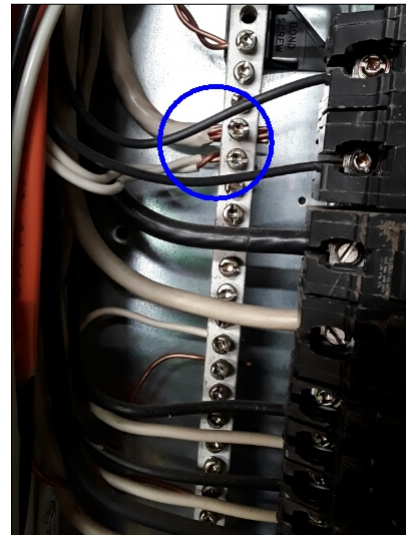
-There are more than one neutral wire located under the same screw. Neutral wires should be separated to individual screws.

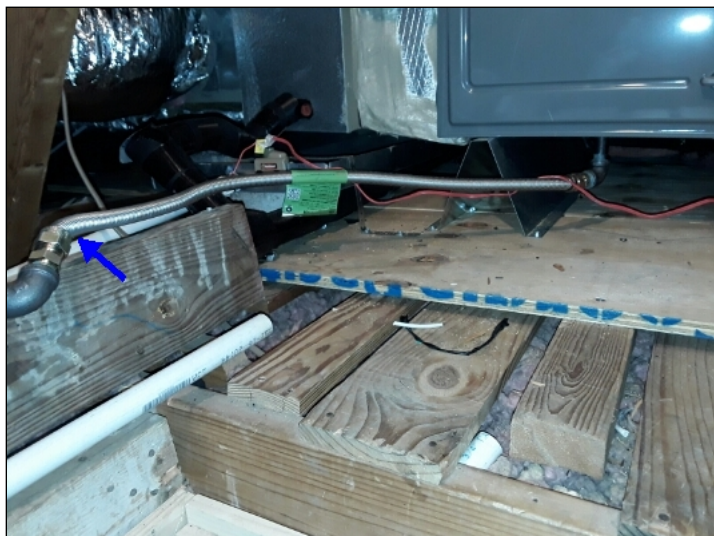
A.3. -There is no drip leg or sediment trap for gas lines on both furnaces. These helps prevent trash from clogging jets.

-There is no drip leg or sediment trap for gas lines on both furnaces. These helps prevent trash from clogging jets.

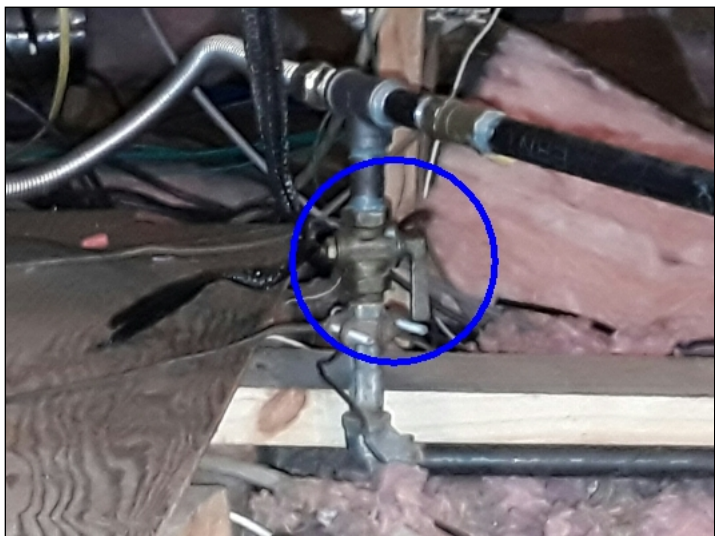
A.2. -There is an unapproved gas valve installed at the furnace unit.

-There is an unapproved gas valve installed at the furnace unit.

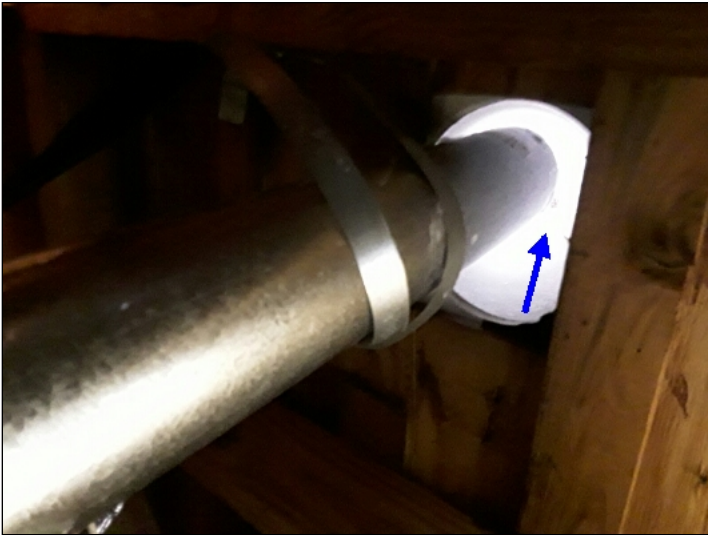
-Both of the gas furnaces are not properly vented, the furnace should be vented with double wall vent pipe through the roof with a rain collar installed above the roof jack sealed and terminated with a type B vent cap.

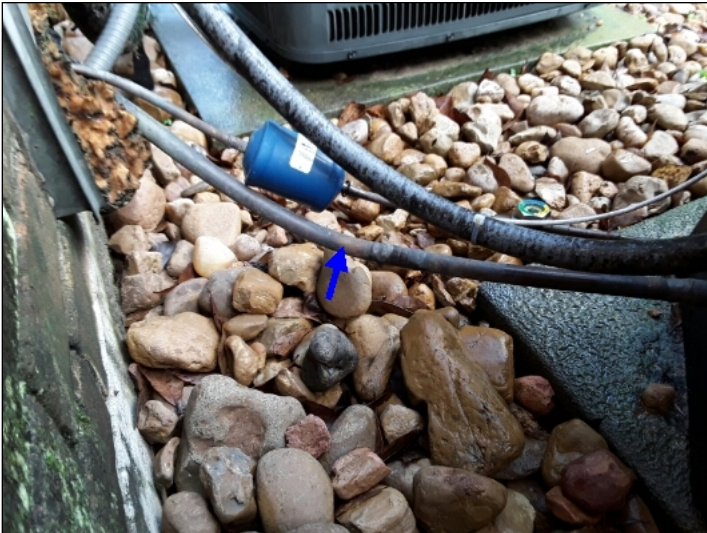
B.2. -The insulation is missing or damaged on the A/C suction line at the condensing unit. Recommend repair or replacement to prevent cooling loss from exterior temperatures.

-The insulation is missing or damaged on the A/C suction line at the condensing unit. Recommend repair or replacement to prevent cooling loss from exterior temperatures.

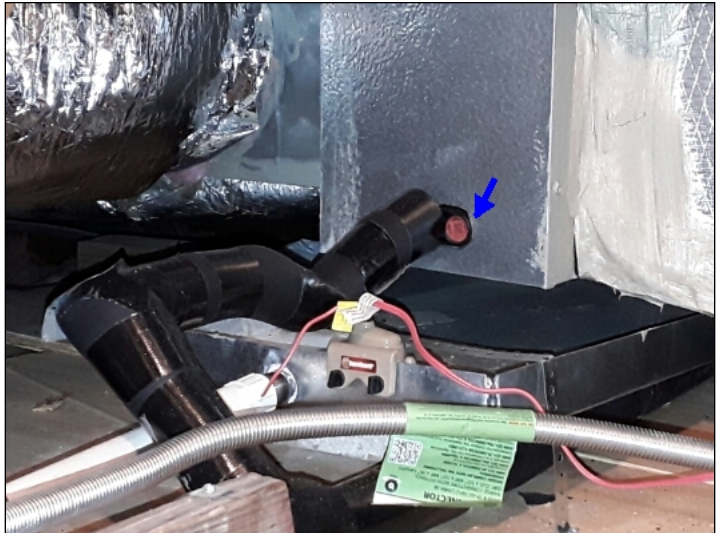
B.3. -Both of the evaporators are missing the secondary drain line to the exterior or to the pan incase main condensation line becomes clogged, recommend adding a secondary drain or high water shutoff to drain line to help prevent water damage to ceilings.

-Both of the evaporators are missing the secondary drain line to the exterior or to the pan in case main condensation line becomes clogged, recommend adding a secondary drain or high water shutoff to drain line to help prevent water damage to ceilings.

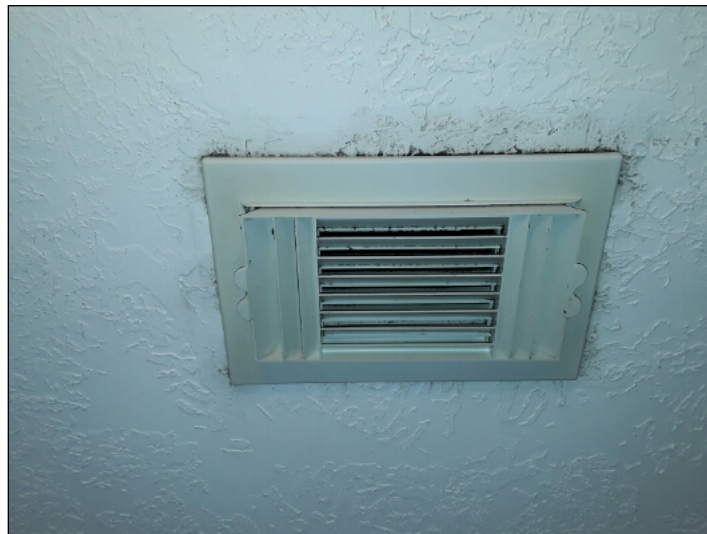
C.2. -Registers are showing signs of growth, recommend cleaning vents and ducts as needed.

-Registers are showing signs of growth, recommend cleaning vents and ducts as needed.

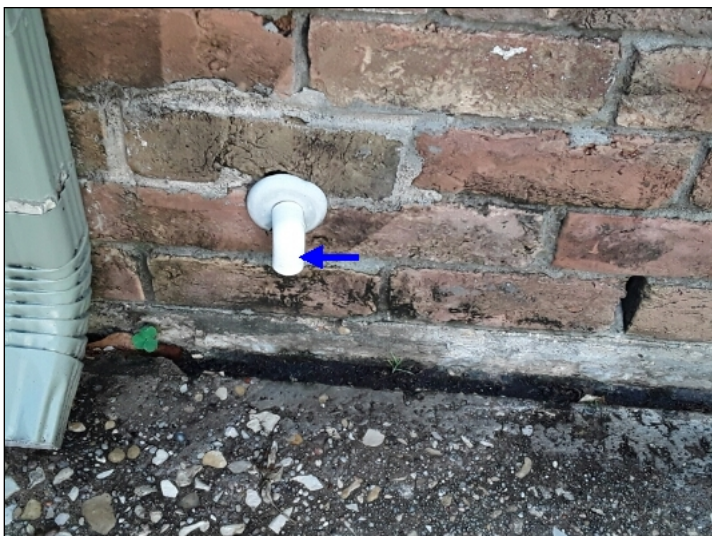
-Recommend painting all exposed plastic pipe to prevent premature deterioration from UV rays.

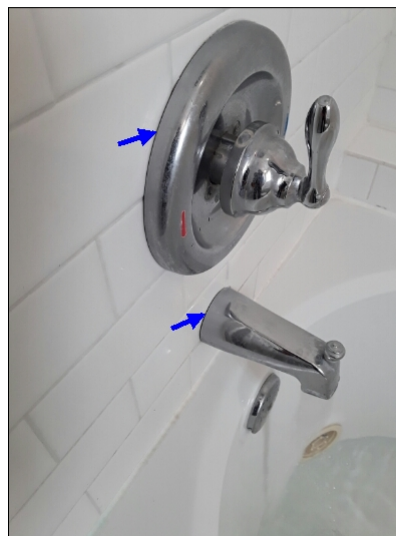
-All tub shower faucets and spouts should be sealed to help prevent water penetration behind the fixture.

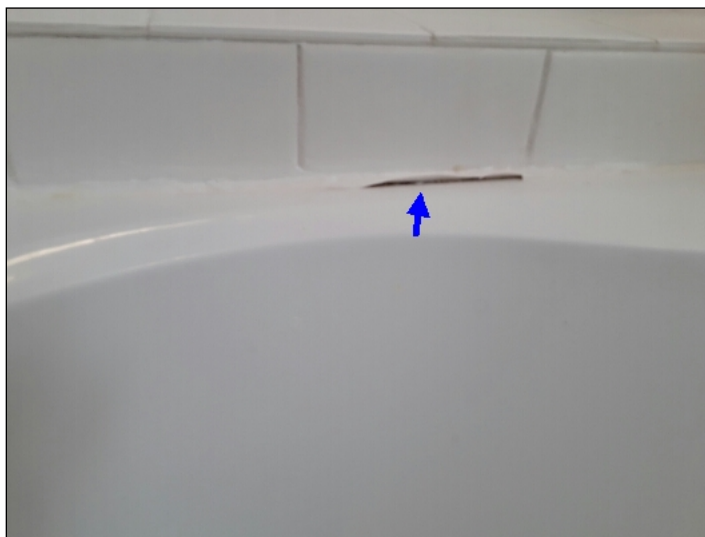
-Recommend re-sealing the tub to help prevent water penetration to underlying materials. Mainly at - upstairs right rear bathroom

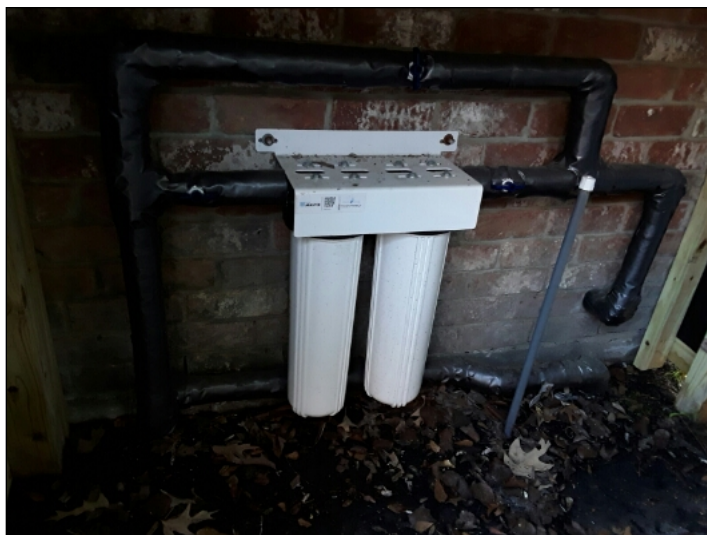
E.1. -There is a water softener installed on the property. Water softeners are not part of a normal home inspection, therefore we recommend a full evaluation of the water softener system by a licensed plumber.

-There is a water softener installed on the property. Water softeners are not part of a normal home inspection, therefore we recommend a full evaluation of the water softener system by a licensed plumber.
