## PROPERTY INSPECTION REPORT

**Prepared For:** Courtney Mullen  
(Name of Client)

**Concerning:** 5514 Christina Path, San Antonio, TX 78247  
(Address or Other Identification of Inspected Property)

**By:** Mark Lawson, Lic #4471 02/13/2018  
(Name and License Number of Inspector) (Date)

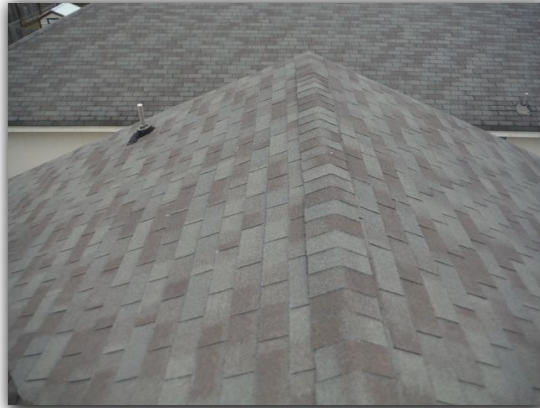
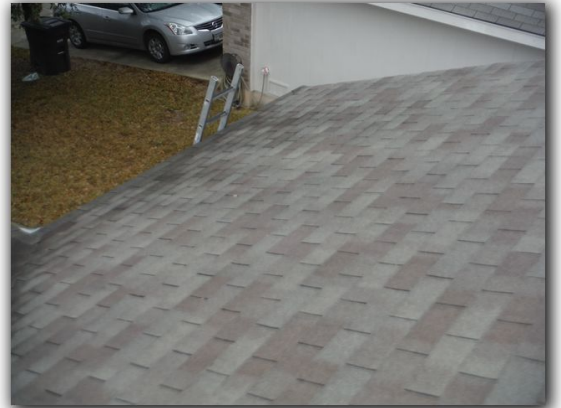
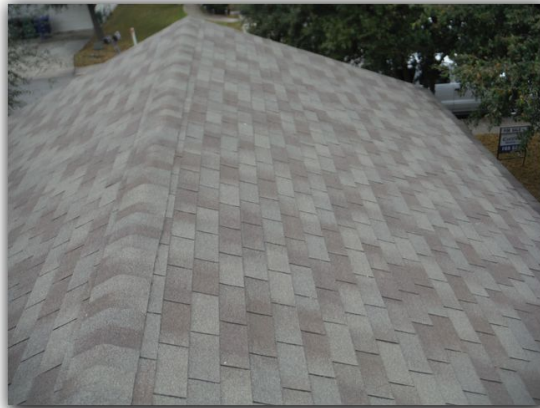
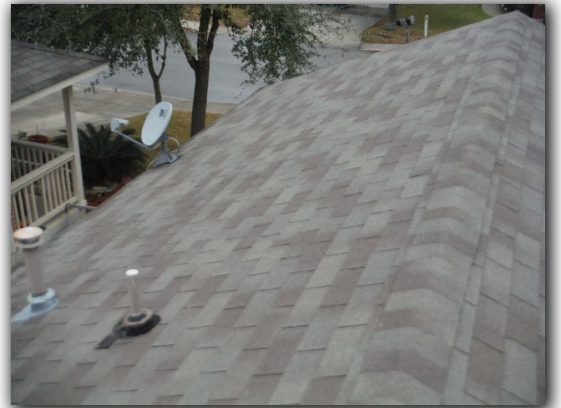
6 - 7 shingles damaged at front slope near ridge.

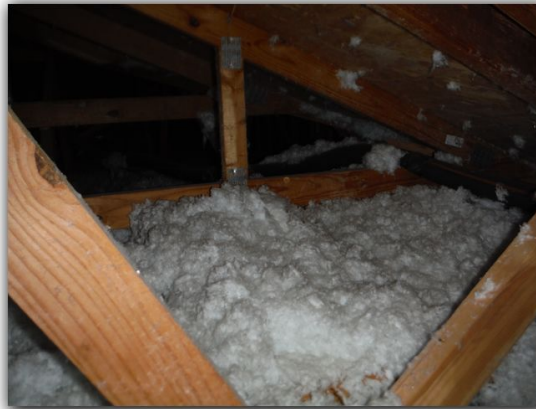
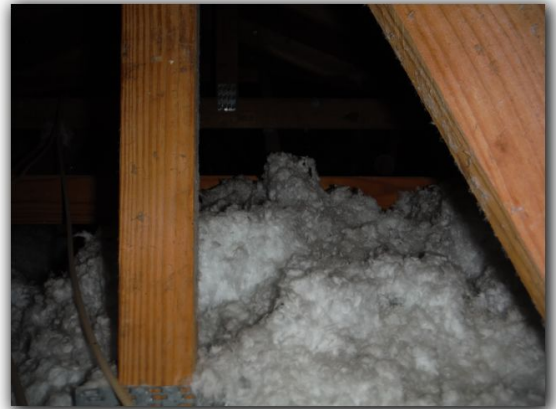
**ATTIC OBSERVATIONS-** Truss Framing  
Attic access improperly installed under gas line.

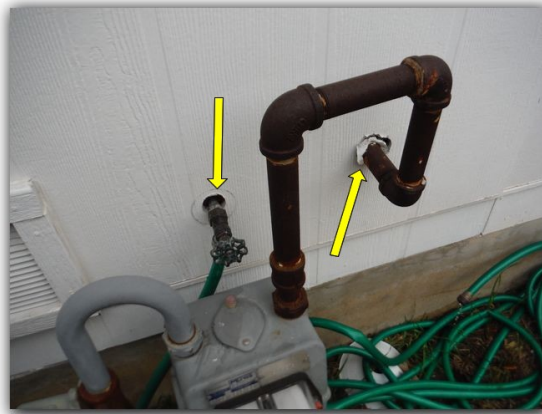
Seal around hose bib and gas pipe at right side.

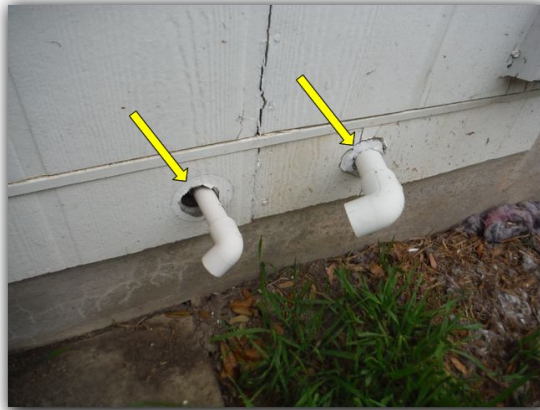
Seal around PVC drain line at right side, or add metal "collar". Turn elbows downward.

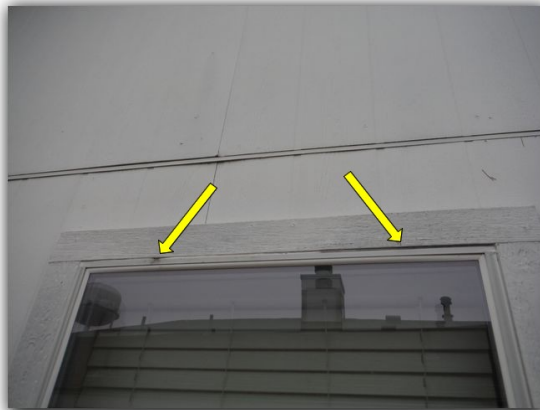
Missing header flashing over windows.

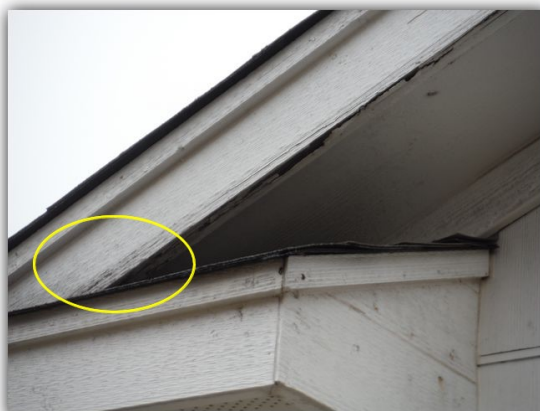
Small spot of fascia rot beginning over left rear lower roof joint to siding.

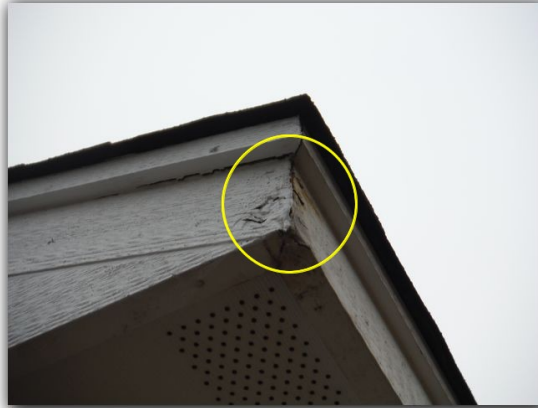
Fascia rot noted all along lower rear porch roof.

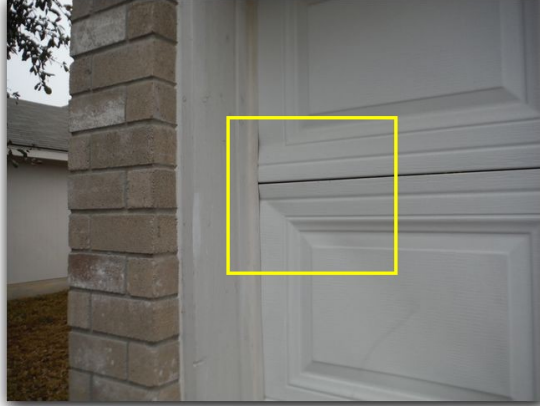
Door is dented/damaged at left edge.

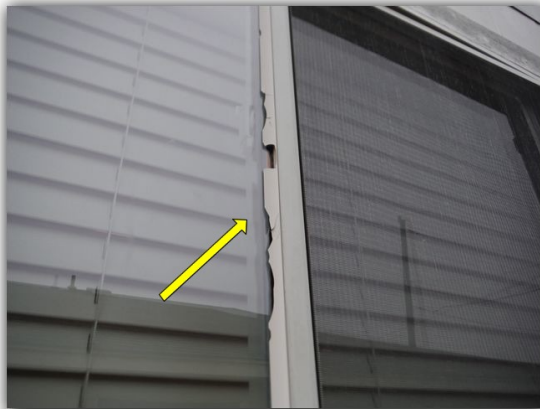
Window glazing strips are cracked/damaged/ at right side.

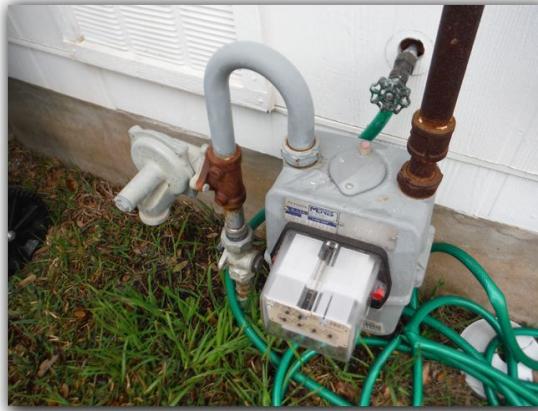
No visible bonding wire installed at gas line exterior of house. Add properly after meter.

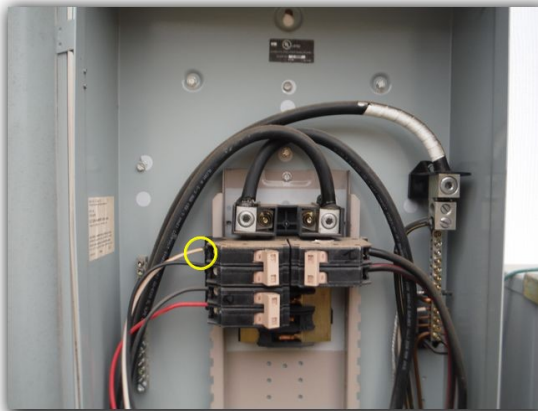
White wires (or colors other than red and black) are being used as hot legs in the panel. These wires need to be labeled as hots (marked with red or black).

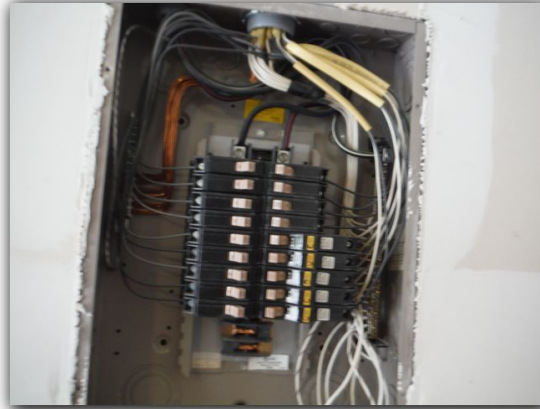
Arc Fault Protection is not present for living areas, dining and hall areas of the house. This was not required during the construction of this dwelling. Consider upgrade to enhance safety.

Note: 5 Eaton arc fault breakers in sub panel box.

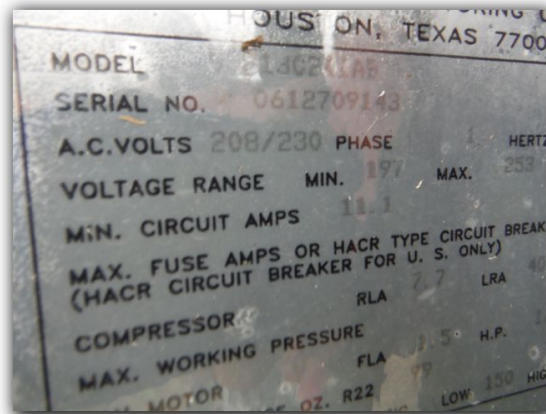
System is an older model and may not be cooling as efficiently as newer models.

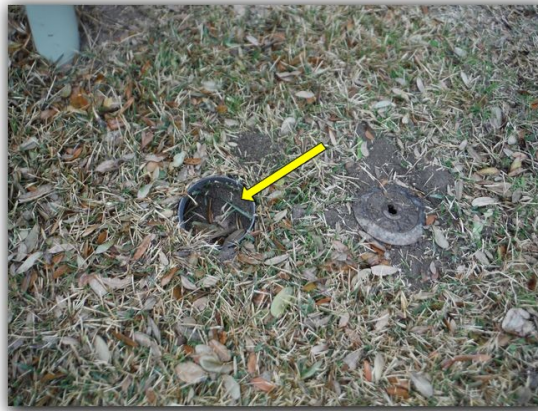
Missing valve cover at water meter.

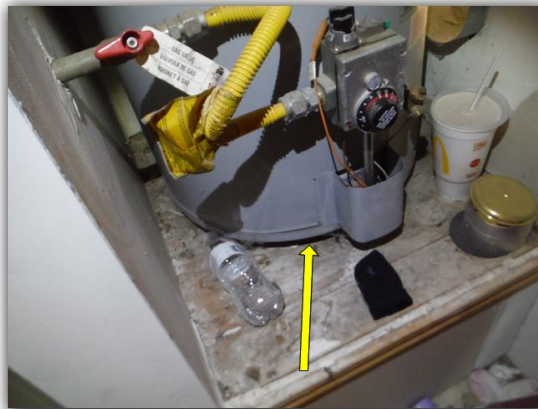
No Safety pan present. Consider adding in case of leakage.

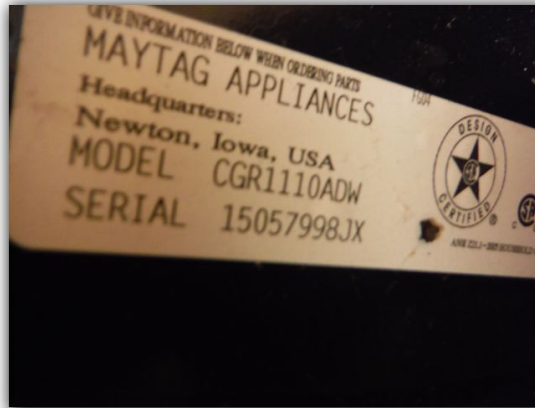
No anti tip device installed at unit. Add to prevent accidental tip of unit.

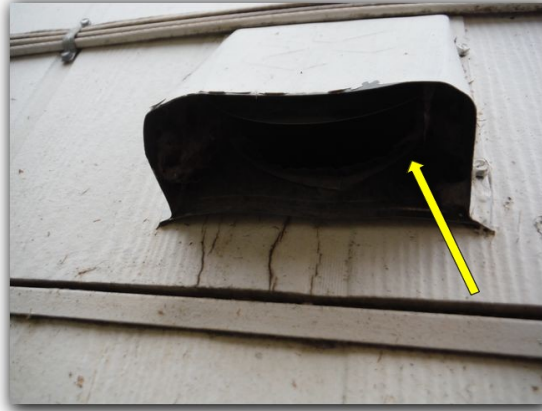
Debris/lint buildup observed at vent unit. Clean/remove for safe operation of unit.
