PROPERTY INSPECTION REPORT

**1915 Rosewood St
Inspection Prepared For: William Omenson
Agent: Cesar Calderon - Camelot Houston Realty**

**Date of Inspection: 4/27/2021
Age of House: Built in 2014 Size: 2700 SF
Weather: 80 Degrees and Cloudy**

Concerning: 1915 Rosewood St, Houston TX, 77004
 (Address or Other Identification of Inspected Property)

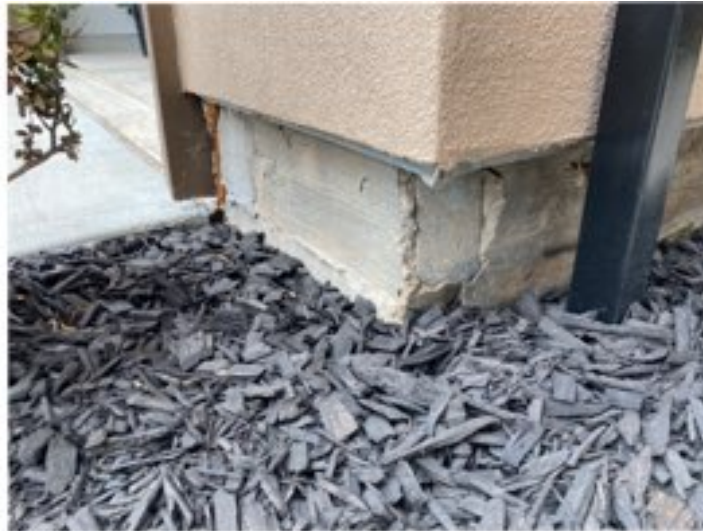
- **Front right corner of foundation has a galvanized metal plate. (Appears to be hurricane strapping - Recommend further evaluation)**

Front right corner of foundation has a galvanized metal plate. (Appears to be hurricane strapping - Recommend further evaluation)

Page 3 Item: A	Foundations	<ul style="list-style-type: none"> • Front right corner of foundation has a galvanized metal plate. (Appears to be hurricane strapping - Recommend further evaluation)
Page 8 Item: E	Walls (Interior and Exterior)	<ul style="list-style-type: none"> • There is loose siding on one or more areas on the west wall.

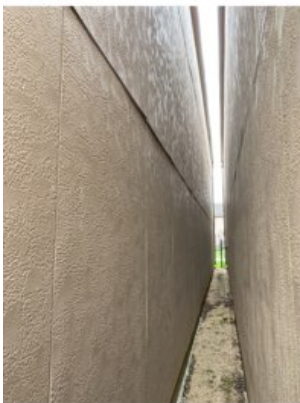
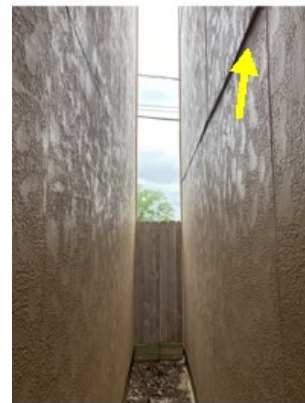
Loose Siding

- There is loose siding on one or more areas on the west wall.

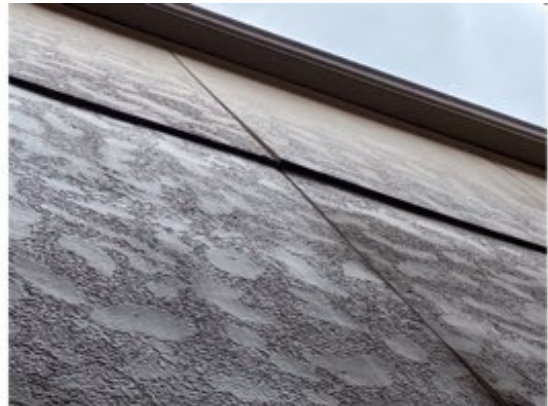
Siding appears to be loos or bowing out. (This may not be a real problem and could be the Z flashing creating an uneven look.)

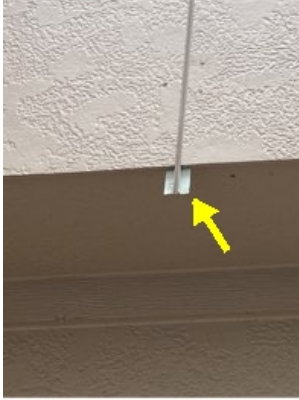
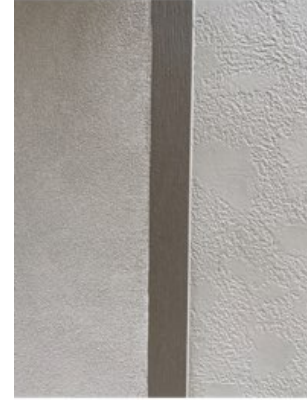
Trim piece is extending below the siding above and left of the front entrance door.

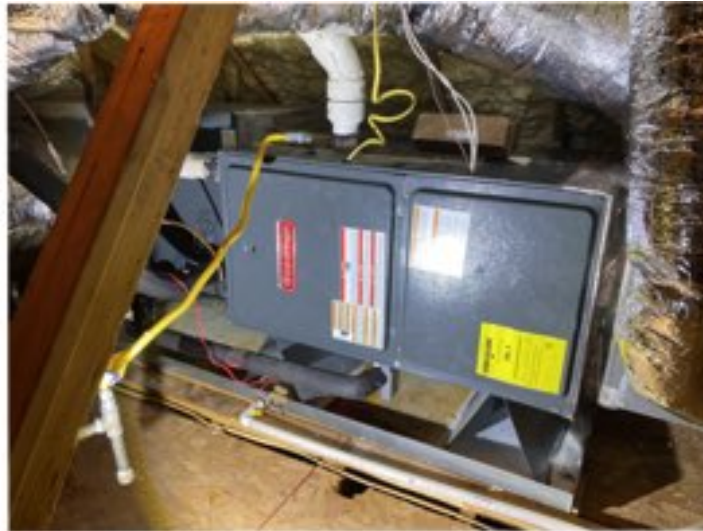
90 Percent Furnace Located in attic

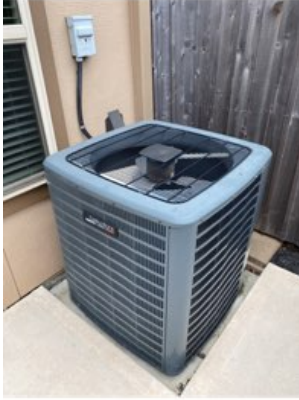
Amana/Goodman AC Unit (4Ton/2014)

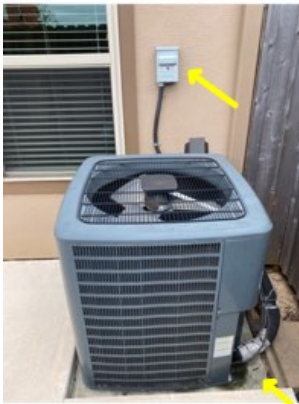
Type of Systems:
 • The home has a split system.
 Comments:
 • Service disconnect is required to be to the side of the unit and not directly behind the unit. AC foundation pad is required to be 3 inches above grade.

Service disconnect is required to be to the side of the unit and not directly behind the unit. AC foundation pad is required to be 3 inches above grade.

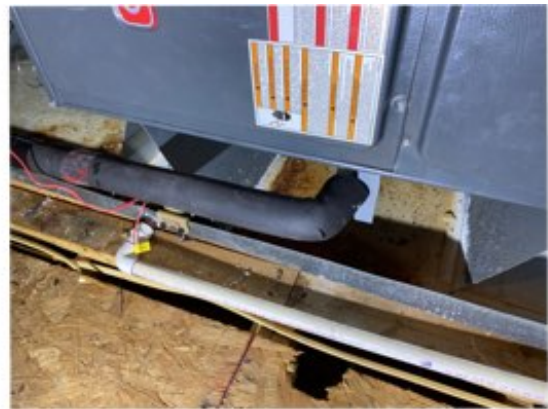
Rust in drip pan

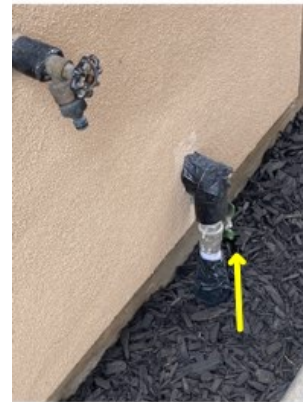
Main water shutoff located inside gate on side of garage

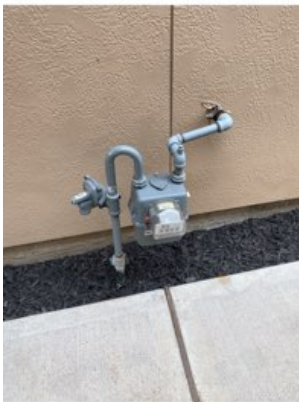
Gas meter located inside gate

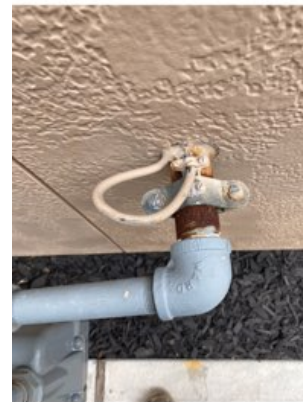
Gas meter appears to be properly bonded

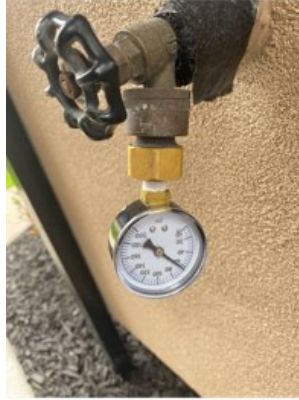
Static water pressure is 60 psi

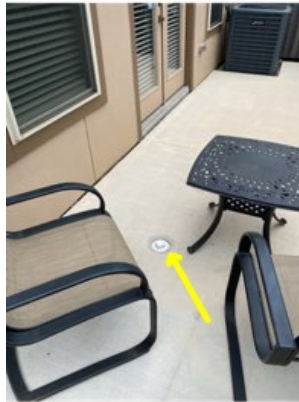
Main drain clean out located at rear of structure

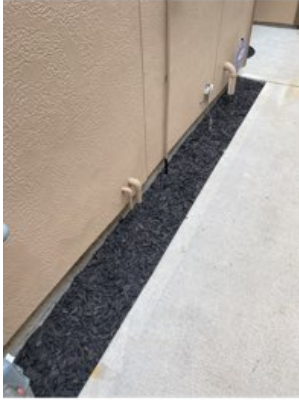
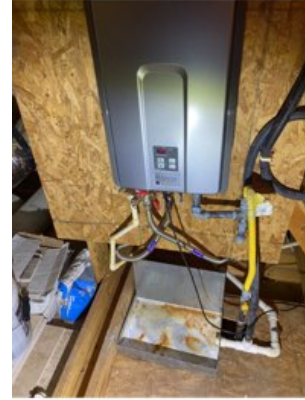
Water heater overflow pipes terminates to the exterior within 6 inches of the ground as designed.
