PROPERTY INSPECTION REPORT

Concerning: 604 Northwood Street, Houston, TX 77009
 (Address of Inspected Property)

By: Steven Gibson, RI #20994 08/09/2019
 (Name and License Number of Inspector) (Date)

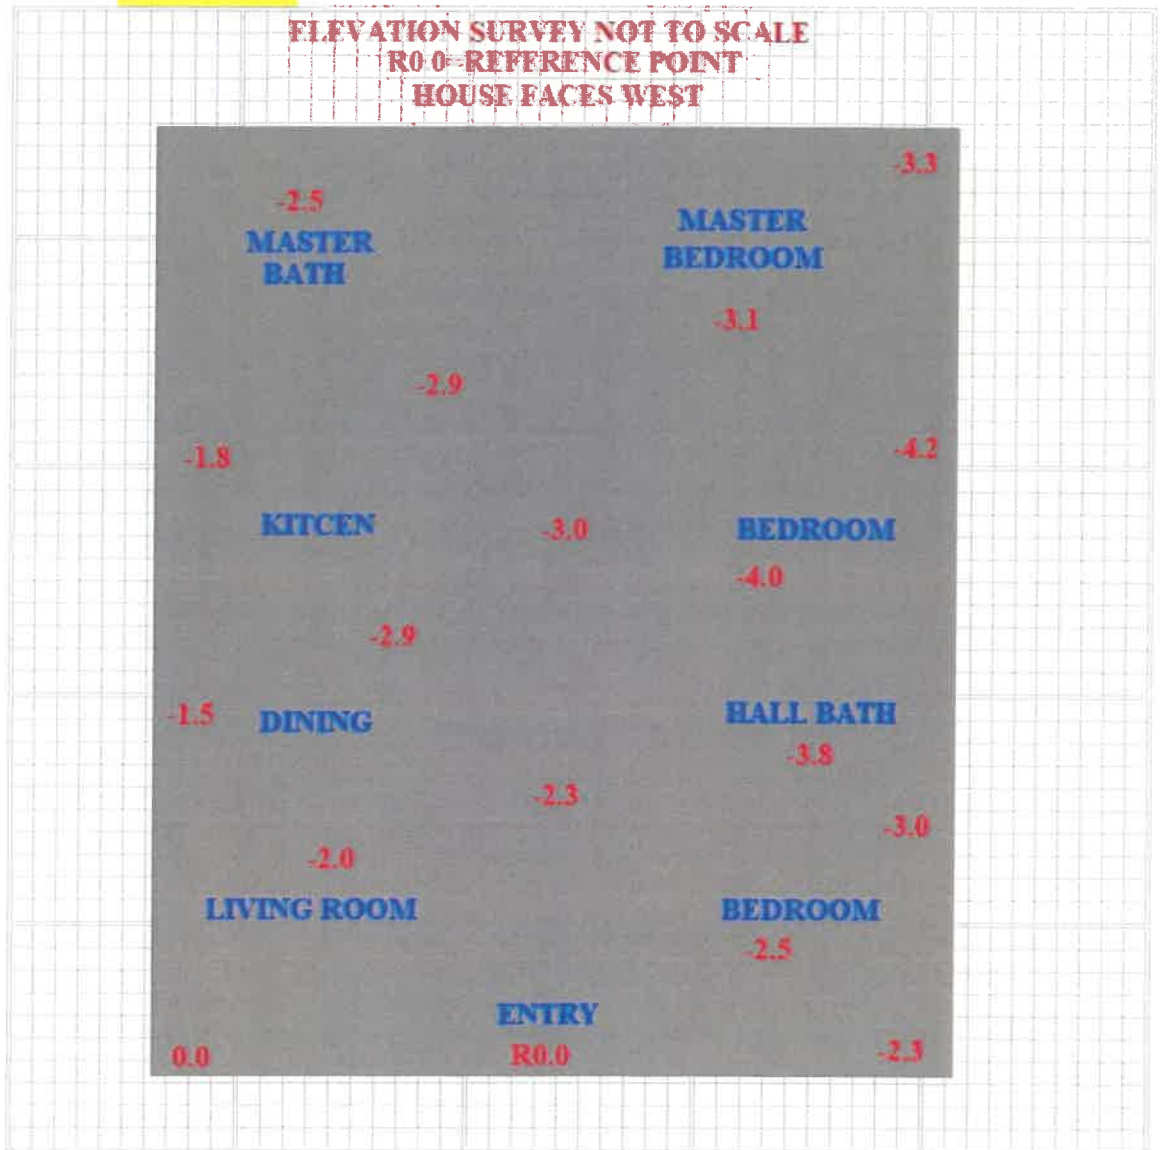
A foundation elevation survey was conducted during the inspection. The floorplan below represents data gathered using a Zip Level or similar instrument and adjusting for floor covering height differences. i.e. differences between tile, carpet and wood flooring. Measurements are listed to the nearest 1/10th of an inch. Greatest variance was 4.2 INCHES

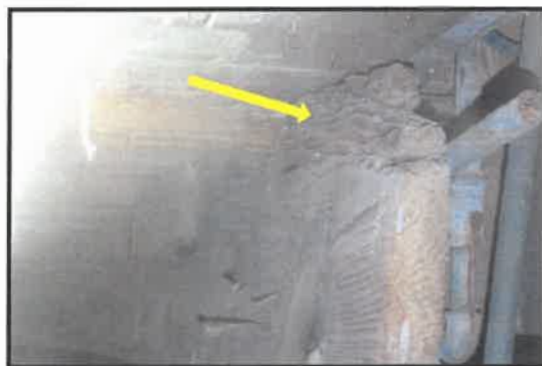
One or more areas observed below house with various degrees of damage from wood destroying insects. No damage found was significant enough in my opinion as in need of repair.

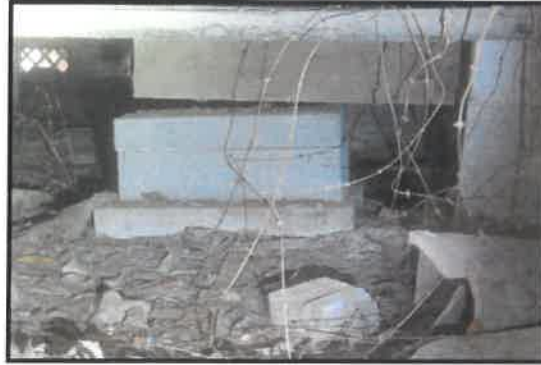
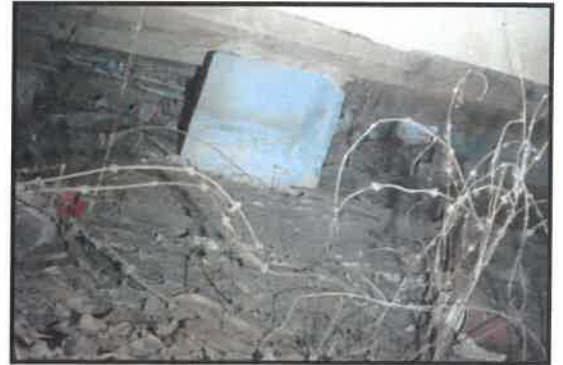
One or more pears not level under house.

Observed wood framing under house has inadequate clearance from soil to prevent wood rot according to code. Minimum soil clearance to untreated wood joists is 18". Minimum soil clearance to untreated wood beams is 12". IRC R317.1

Had foundation company quote work

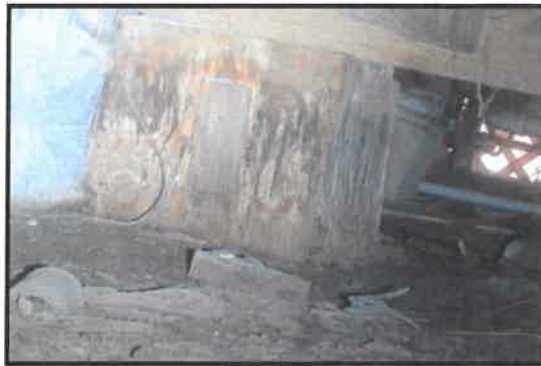
Wood form board(s) observed around one or more piers.

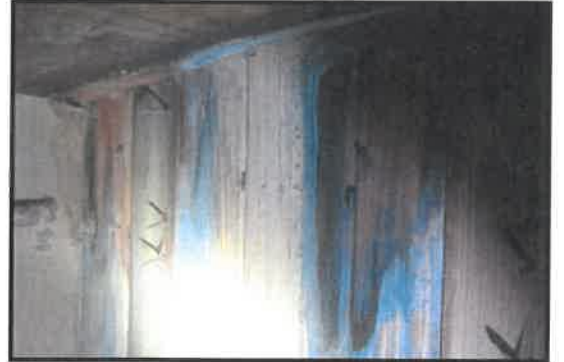
Wood rot/fungus on various wood members in crawl space observed below house. This condition if left untreated will eventually result in structural damage to wood members. The rot / fungus feeds off the cellulose fibers of the wood.

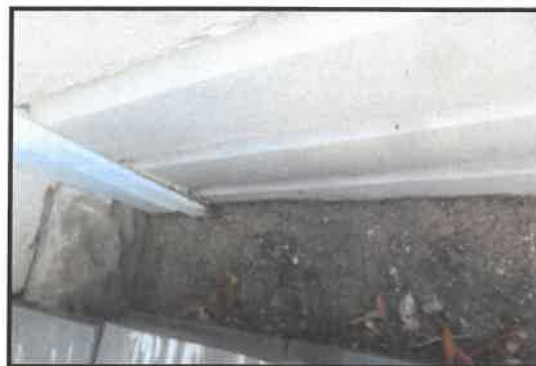
Soil level too high around areas with wood siding. Code and common industry practice requires a clearance of 6-8 inches from bottom of wood veneer to soil. High soil level near wood siding promotes water/termite penetration and wood rot.

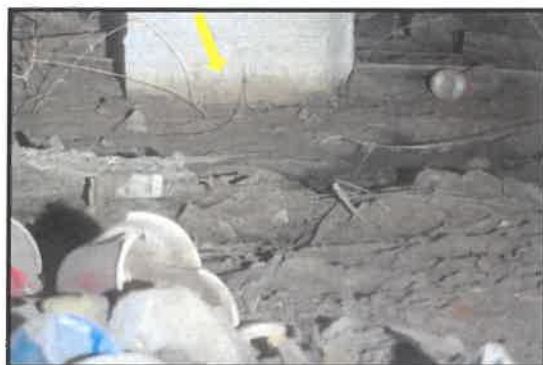
Evidence (water staining) below house indicates history of substantial standing water below house during rainy season. This condition is detrimental to adequate foundation performance of pier and beam foundation systems and should be corrected thru proper site drainage / grading.

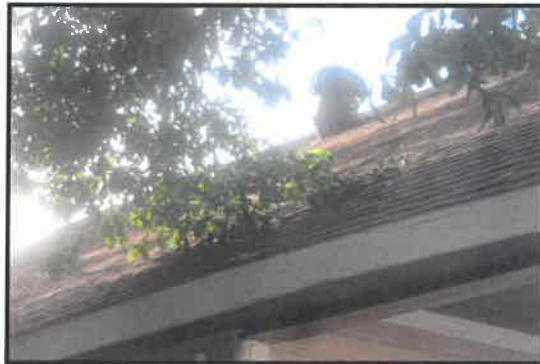
Tree limbs in contact with roof can/ will damage the roof.

No tree limbs in contact with the roof

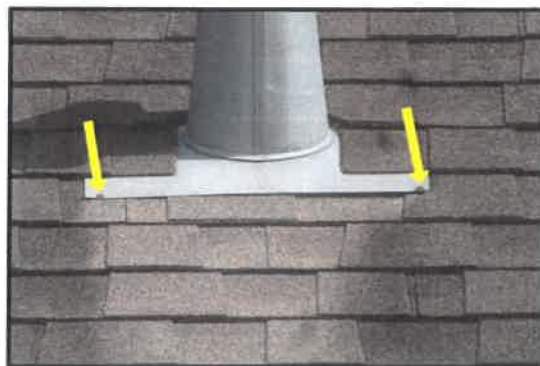
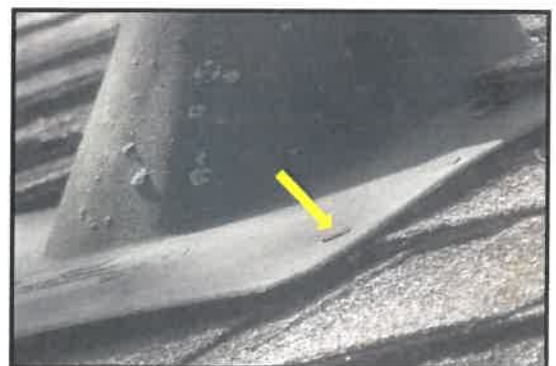
Exposed staples / nail heads / fasteners observed on roof are not properly sealed. Water entry possible.

Exposed items have been sealed

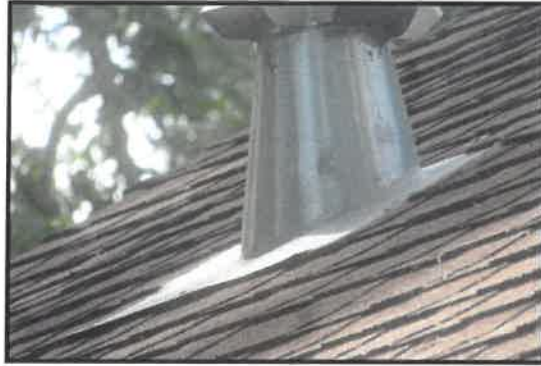
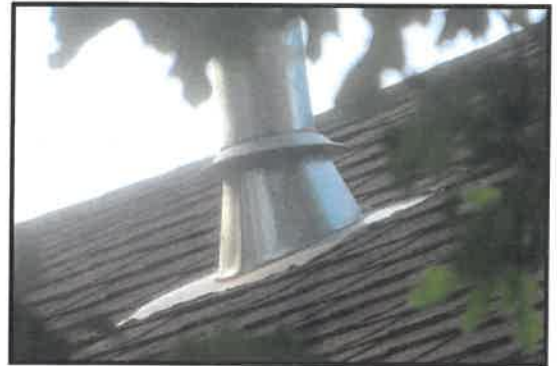
Improper flashing observed around drain waste vents and roof penetrations due to roof overlay without addressing proper flashing requirements.

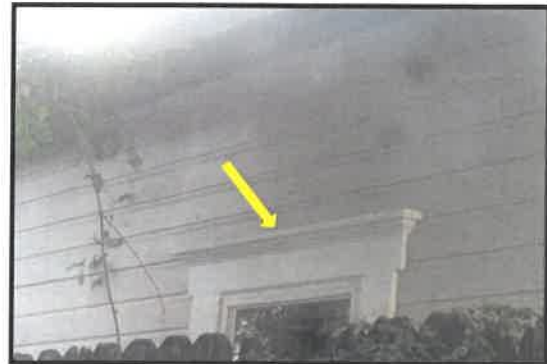
Head flashing missing over window/door trim pieces. Without head flashing over window trim, sealing must be maintained as a defense against water penetration.

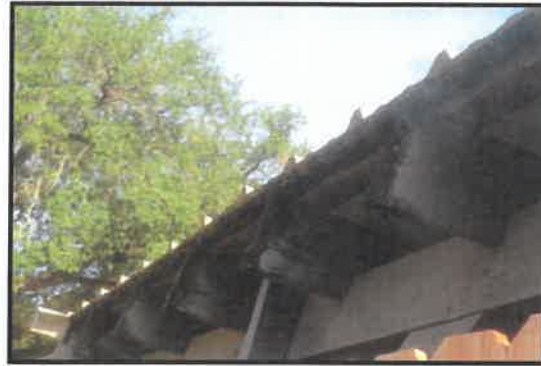
No metal drip edge visible at roof edge. When drip edge is not installed, water dripping off of the edge of the roofing can be drawn by capillary action into the exposed edges of the plywood which can cause the plywood sheathing and fascia begin to rot.(Car port)

Drip edge has been installed on garage

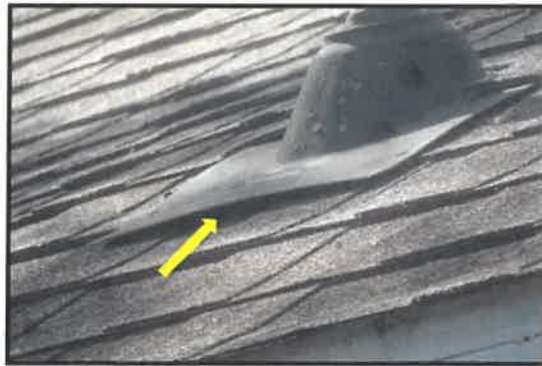
Lower side of drain waste vent flashing is not sealed down, wind driven rains can cause water penetration.

Vents have been sealed

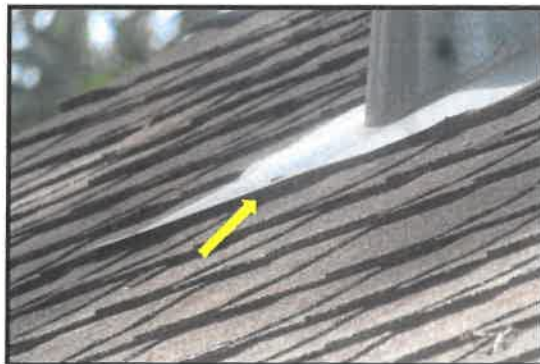
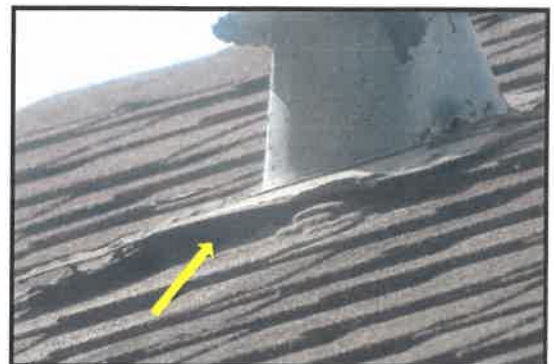
Lower side of flashing is not sealed down, wind driven rains can cause water penetration.

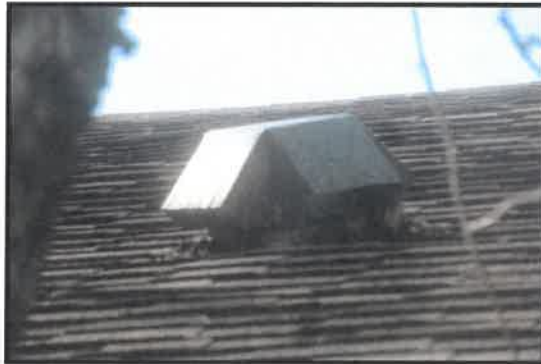
Improperly vented. Vents shall terminate not less than 1-foot above the roof, and not less than 4-feet from any portion of the building that extends at an angle of more than 45 degrees upward from the horizontal.

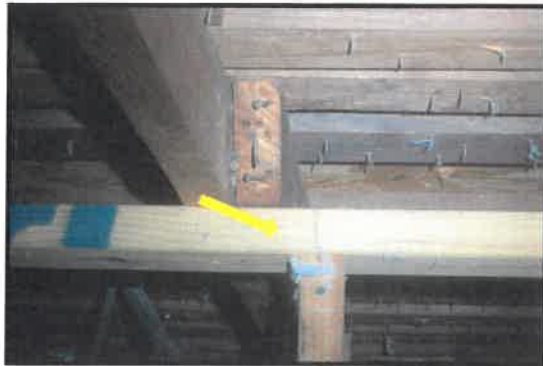
Observed purlin(s) {roof bracing} of improper / inadequate size and/or not installed on strength axis in attic, needs repair.

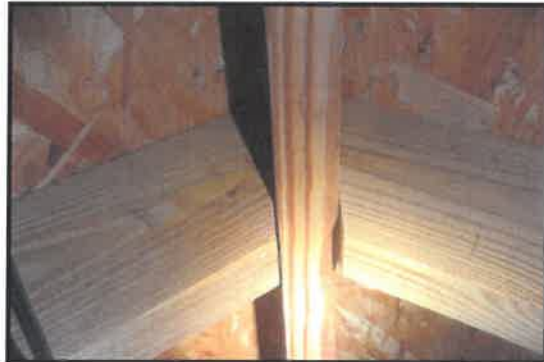
Ridge and/or valley board(s) not deep enough to support ends of rafters, recommend addition of 2x4 below bottom end of ridge/valley board to support end of rafters.

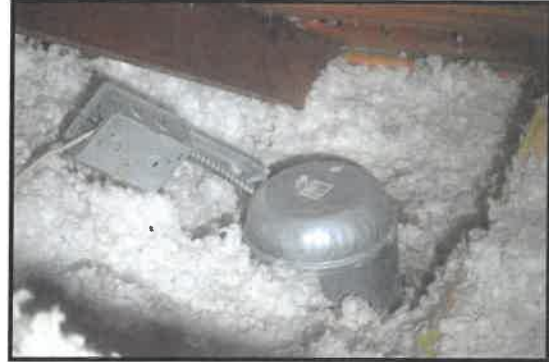
Ensure insulation is maintained a minimum of 3 inches and wood a minimum of 1 inch from around all recessed lights to reduce possible fire hazard.

Potlights in insulated ceilings

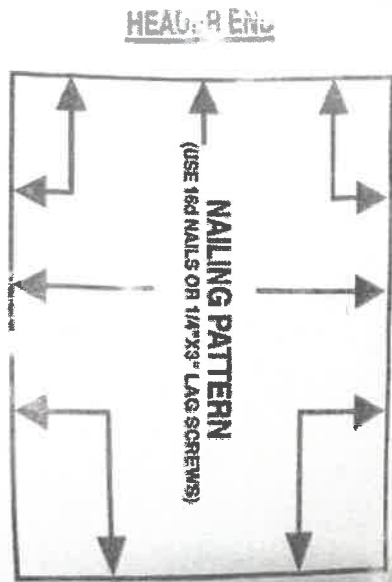
Stairway frame is inadequately secured into ceiling opening with screws, recommend complying with manufacture specifications calling for 16d nails or 1/4 inch diameter lag screws be added to secure stairway frame to ceiling at specific locations.

Additional screws have been installed

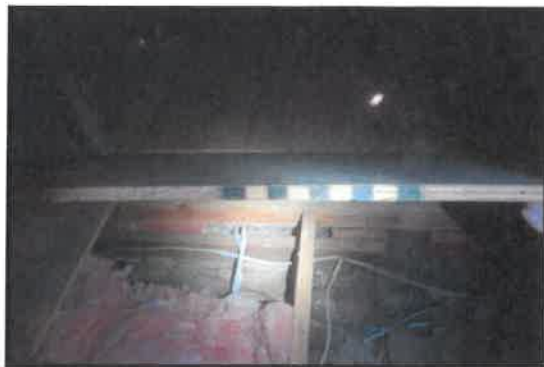
Attic floor decking not adequately secured and/or supported at board ends in some areas and/or decking is not rated for use as flooring. Stepping on board ends can result in board flipping up or bowing down.

Flooring has been secured

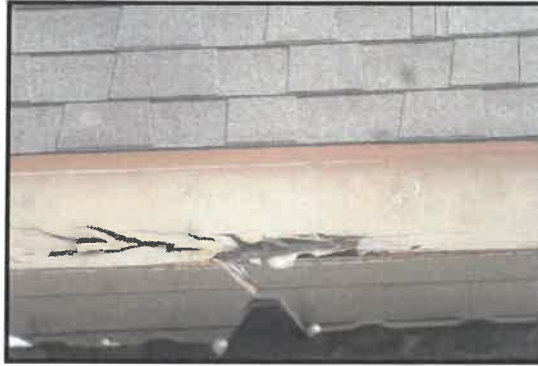
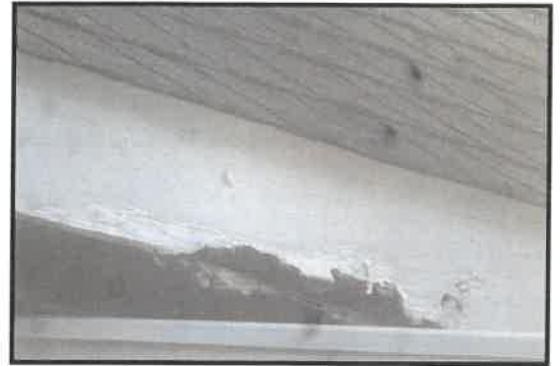
Wood rot/damage around exterior in fascia, soffit.

Fascia/soffit has been addressed

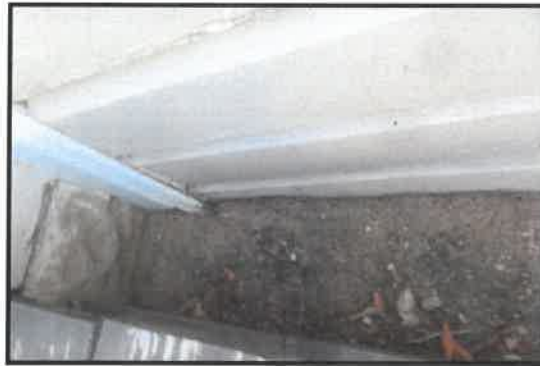
Earth wood contact in some areas, conducive condition to termite activity and wood rot.

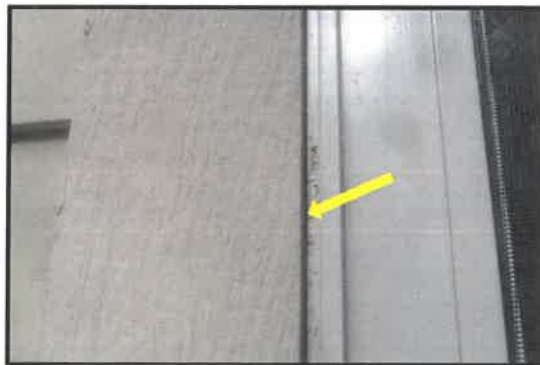
Caulking deficient around one or more windows, will allow water penetration during heavy / wind driven rains.

Caulking complete

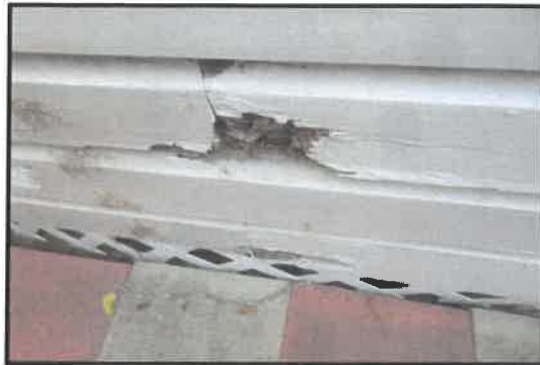
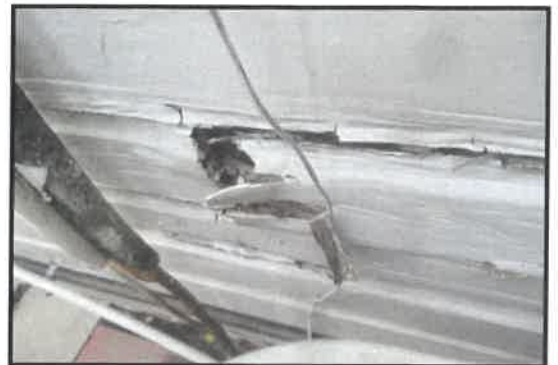
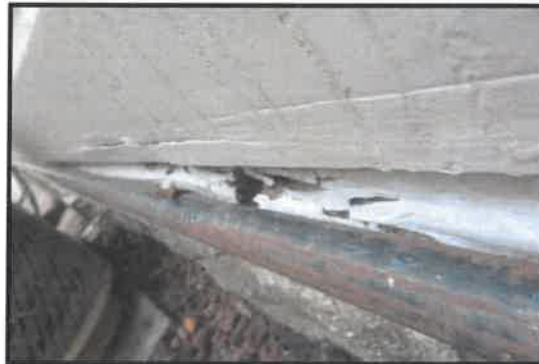
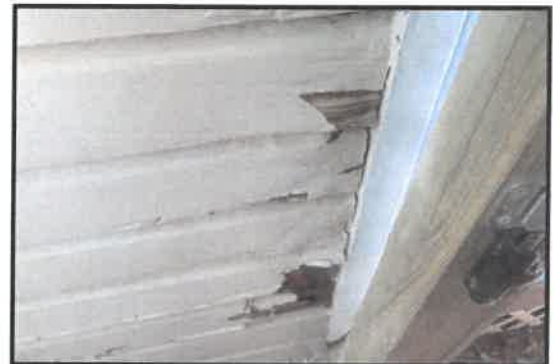
Wood rot observed on areas of house / garage.

Siding has been replaced, with the exception of the shed at the garage.

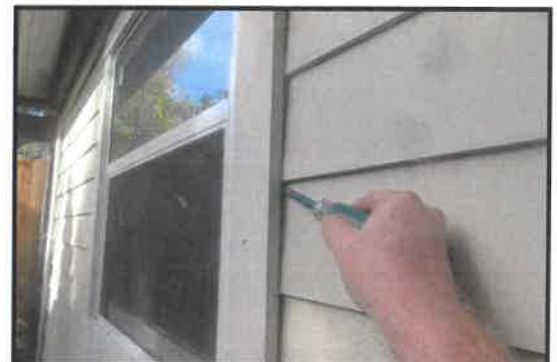
Caulking missing and/or deficient around vertical trim boards may allow wind driven rain entry.

Caulking complete

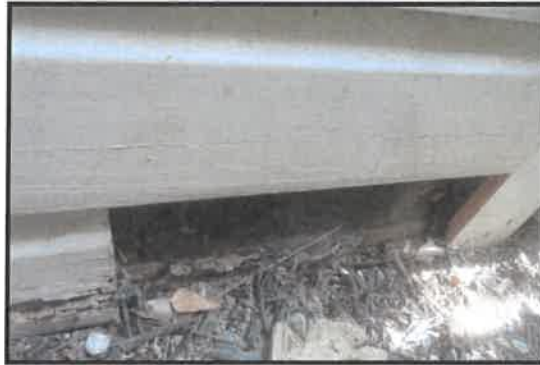
Wood siding observed to be not secured down at one or more areas of house / garage.(Storage shed)

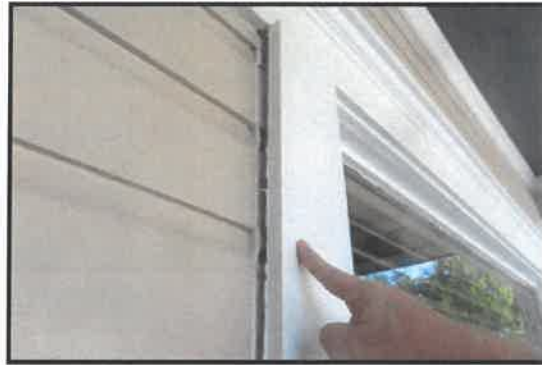
Loose trim at window on front porch.

**Repaired
loose trim.**

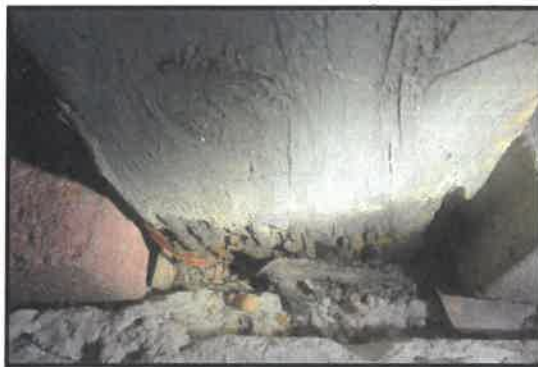
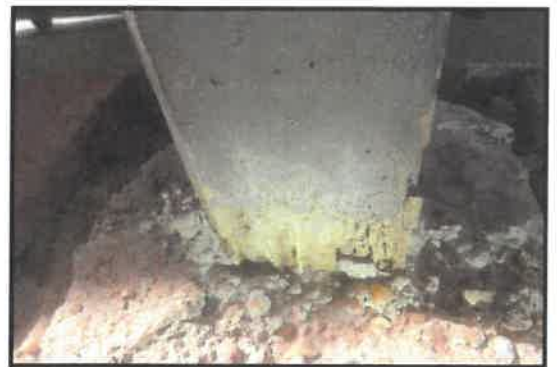
Wood rot / damage observed bottom/base of one or more wood columns. (Car port)

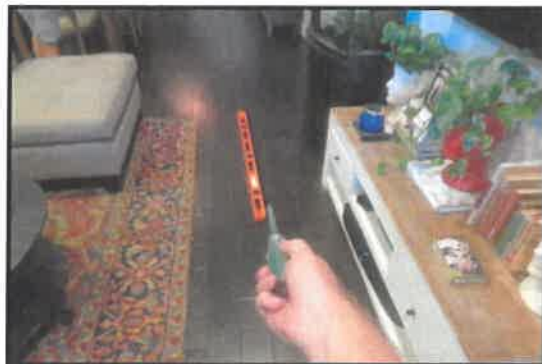
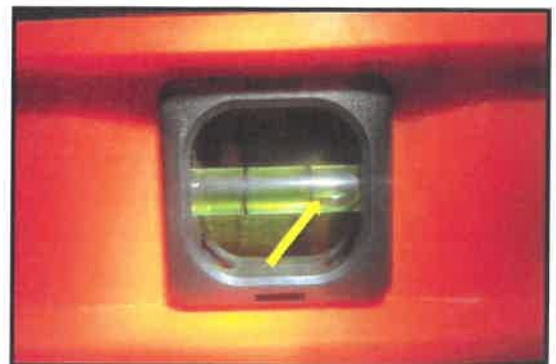
Floor is not level downstairs, possibly due to foundation settlement.

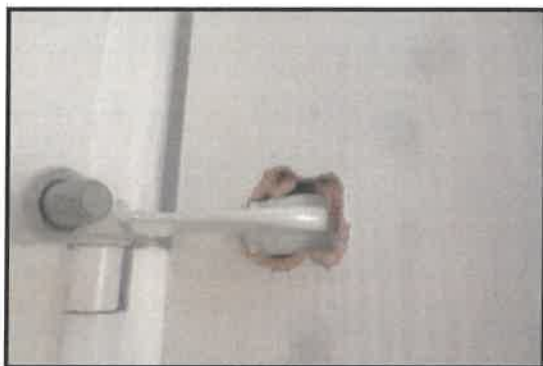
One or more doors in house will not latch. (Hall bath)

Door damaged. (Hall bath)

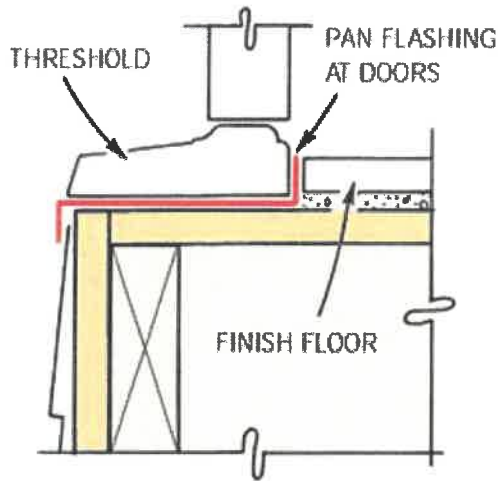
Improper threshold used on exterior doors. wind driven rains will probably result in water damage from intermittent water entry. Recommend replacement with metal type threshold with rain water channels that directs water back to exterior.(Front)

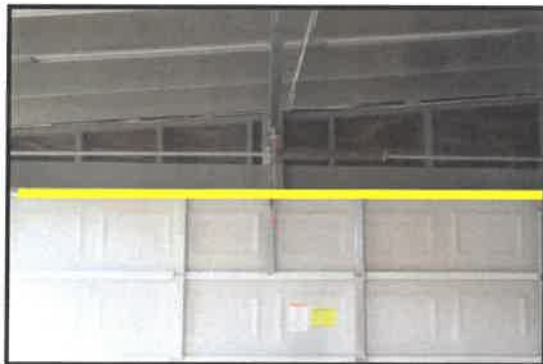
Garage door missing manufacturer required field installed additional bracing whenever a garage door opener is attached to prevent damage to top of door.

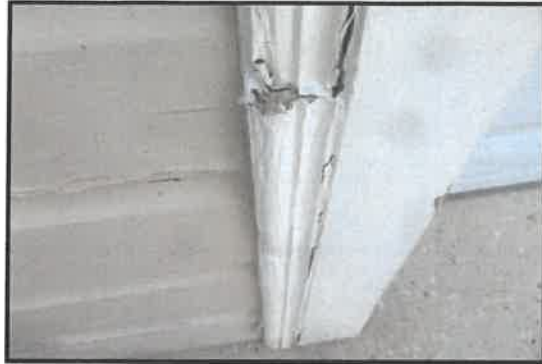
Wood rot, lower section of garage door vertical 2x6 trim board(s).

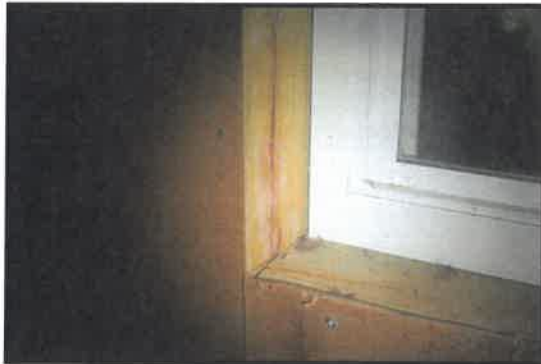
Observed storage shed window not properly installed. Building wrap does not wrap through opening at sides and / or rough sill not properly covered with poly or self-sealing flashing (aka Peel-N-Stick). Potential for water leak during wind driven rains. Similar detail not observable in other windows.

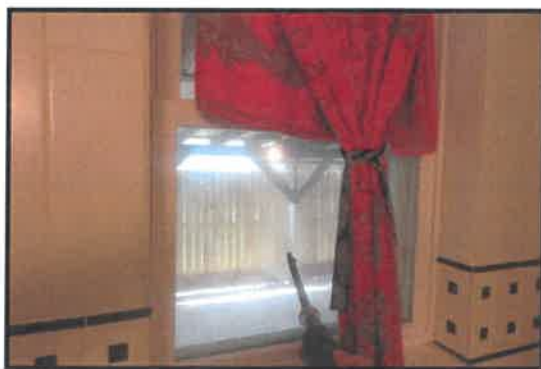
One or more of the thermal pane windows observed to have lost their seals. This has resulted in condensation and/or a fog like film to develop between the panes of glass. The thermal pane windows no longer function as designed when they loose their seals. The windows that have noticeably lost their seals are listed but may not be limited to the following: (Hall bath)

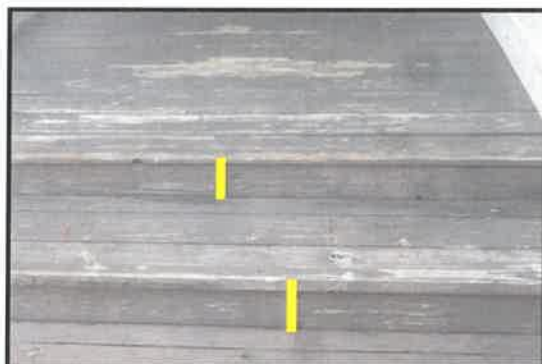
Stairway has tripping hazard. Risers are not same height along the entire height of steps. Stairway does not comply with current industry standard, (code). CABO 314.2 & UBC 1006.3 requires “The greatest riser height within any flight of stairs shall not exceed the smallest by more than 3/8 inch.”

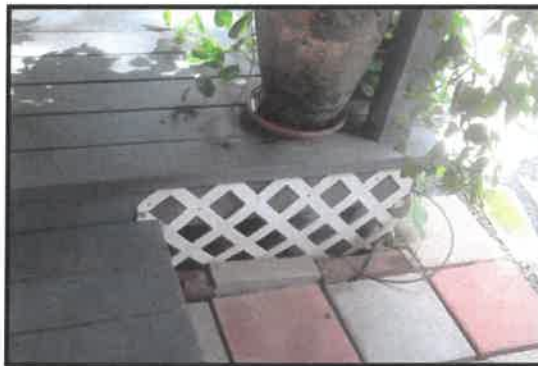
Earth wood contact in some areas, conducive condition to termite activity and wood rot.

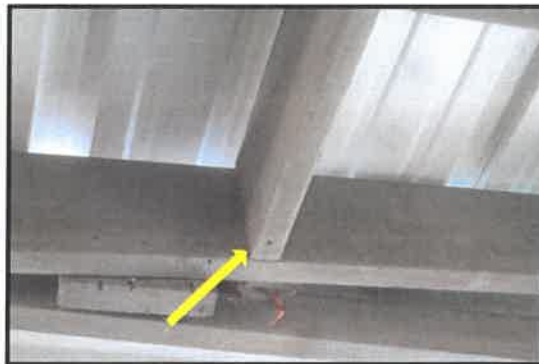
Missing joist hanger brackets at one or more areas at back patio.

Additional support added

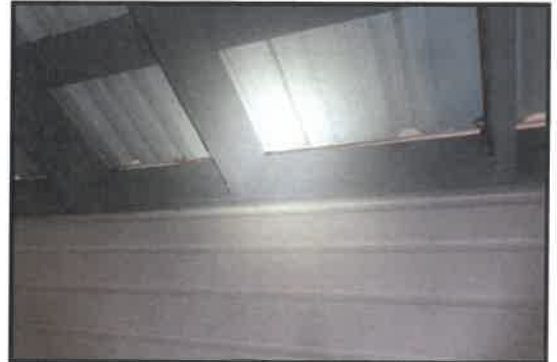
Car port cover does not appear to be properly secured; Missing lag bolts to secure ledger board to structure and or missing Joist Hangers to secure rafter to ledger board; possible hazard.

Additional support added

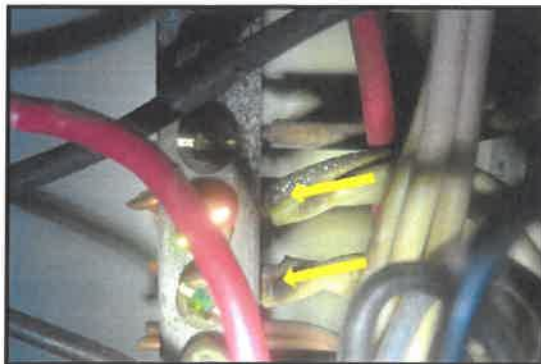
Observed two or more neutral conductors under one screw lug on the neutral bus.

Current industry standards and National Electric Code permit one neutral conductor per screw lug.

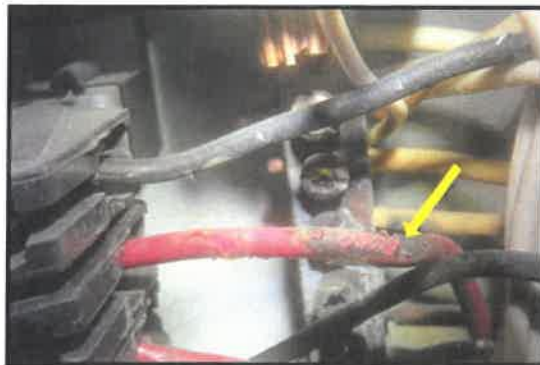
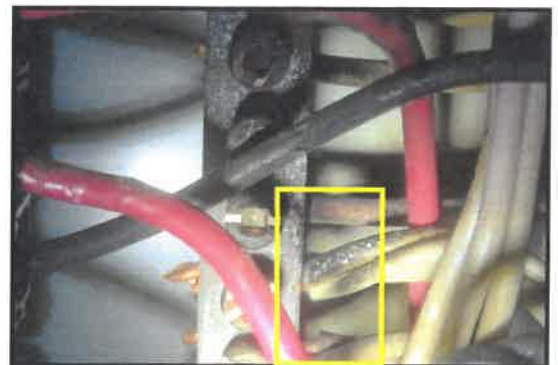
Wire insulation damaged from over heating.

Replaced wire

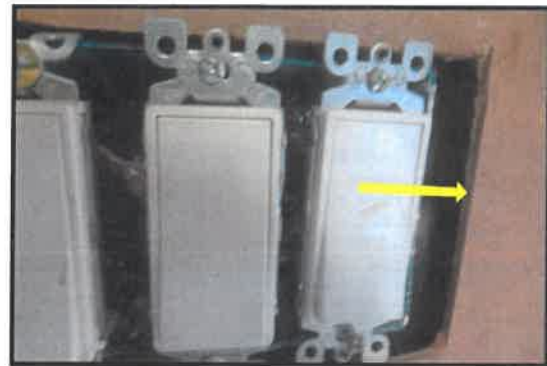
Outlets / switches / devices installed in / through combustable material were not flush mounted as required by code. space exists between face plate and edge of electrical junction box. Missing required spacer (spark ring) on following outlet(s): (Storage shed) Reference NEC 370-20 & IRC E3806.5. In walls constructed of wood or other combustable material, cabinets (outlet & switch boxes) shall be flush with the finished surface or shall project there-from.

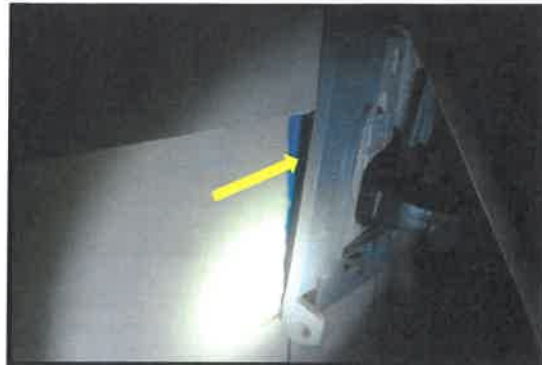
Exterior outlet(s) not sealed well against rain water entry. (Storage shed)

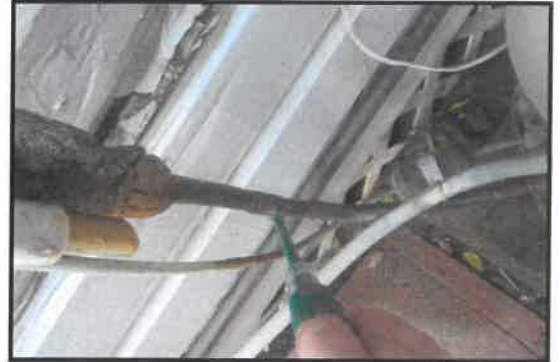
Section of suction line insulation missing or deteriorated near condenser.

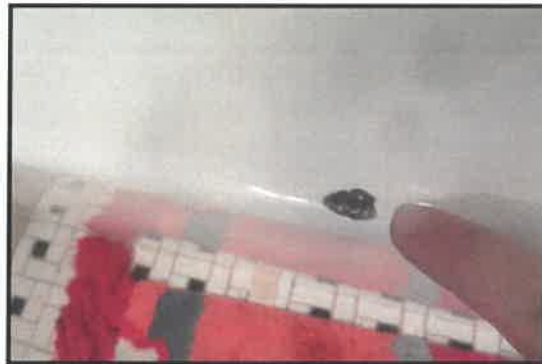
Porcelain damaged/chipped on steel tub: (Hall bath)

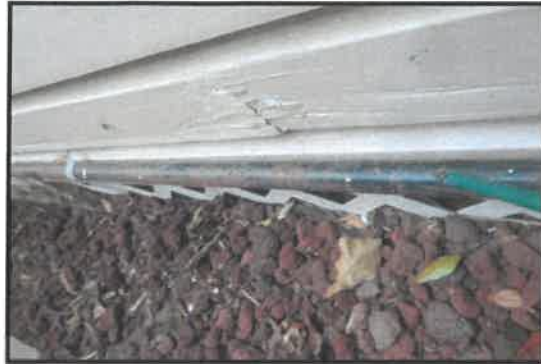
Observed the use of black iron gas pipe used; (North exterior). Black iron is not rated for exterior use.

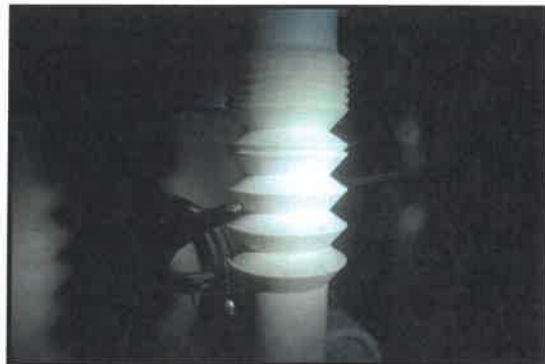
Amateurish plumbing observed:(Master bathroom under sink.)

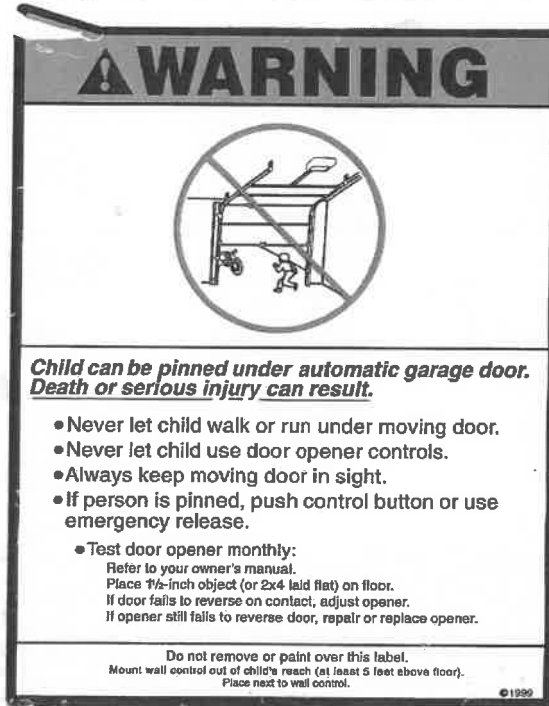
Missing required safety sticker / decal next to operator button.
