MEP REPORT

604 Northwood St
Houston TX 77009

MARCH 2, 2020

PROPERTY INSPECTION REPORT

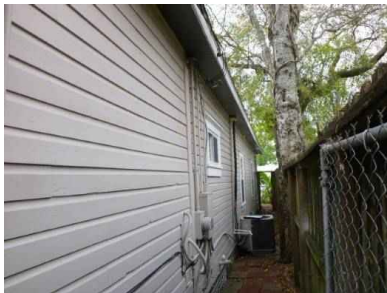
North Side of the house.

The service entrance conductors were observed to be too low and need to be raised so the lowest point is a minimum of 10 feet above grade.

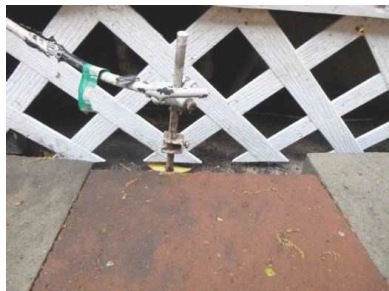
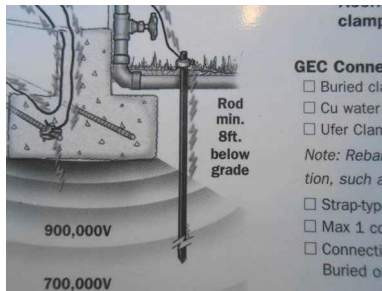
The ground rod was sticking out of the ground a few inches, and, since ground rods are typically 8 feet long and all 8 feet of the rod are required to be in the ground, it is recommended that the ground rod be pounded down flush with the top of the ground. The clamp on the rod should be an acorn clamp approved for direct burial in the ground.

Obtain Cost Estimate

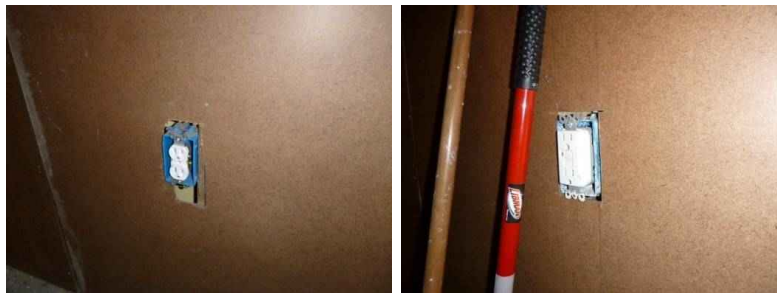
1: Cover Plate - Damaged/Missing

A missing or damaged cover plate was observed.

Obtain Cost Estimate

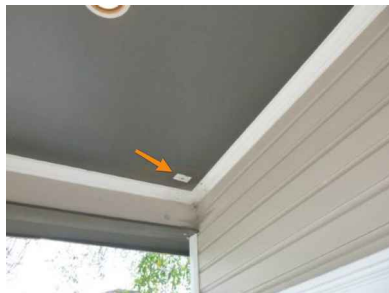
2: GFCI - Not tripping off

The electrical power to one or more ground fault circuit interrupt (GFCI) devices did not shut off when the "test" buttons were depressed, or when the devices were tested with a GFCI testing device. Have an electrician make any necessary repairs to the devices, and then check the appropriate outlets that should be protected by a GFCI device, to verify that they are protected.

Locations included: The hall bathroom and the front porch soffit.

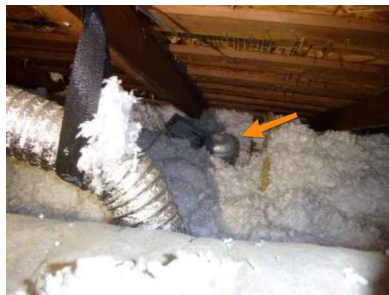
The recessed lights did not have clearance to the attic insulation to prevent overheating. Typically, a minimum clearance of three inches is recommended for safety purposes. It is noted that some recessed light fixtures are rated for contact with insulation. Further investigation is recommended with an electrician to determine if these lights need clearance from the insulation.

Further investigation is recommended.

Obtain Cost Estimate

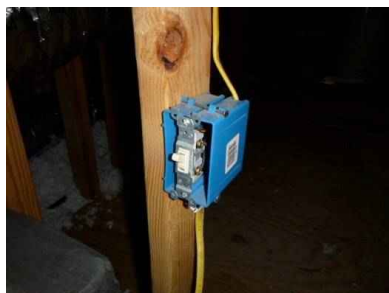
8: Switch - Missing cover plate

The cover plate was missing on the switch.

Obtain Cost Estimate

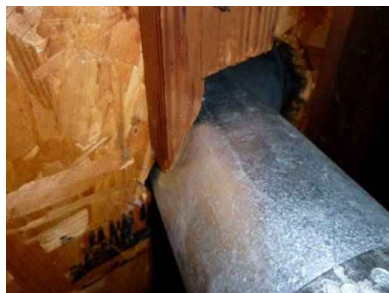
**2: Vent Pipe - Fastened with tape.**

The vent pipe was fastened with tape, which is improper. The vent pipe is to be mechanically fastened only, and repair is needed. Have a service company provide a cost estimate to properly install the vent pipe.

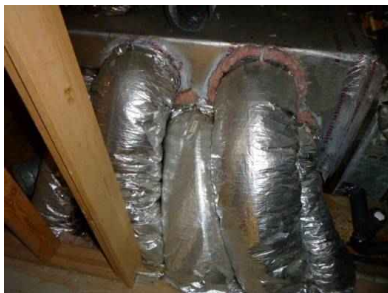
2: Ductwork - Not supported properly

The ducts were laying on the insulation and ceiling joints and are not supported properly. The ducts should be supported in accordance with the manufacturer's installation instructions, which typically includes hanging the ducts from the rafters supported by 1 1/2 inch straps spaced approximately every four feet. Have a service company make the necessary repairs.

Obtain Cost Estimate

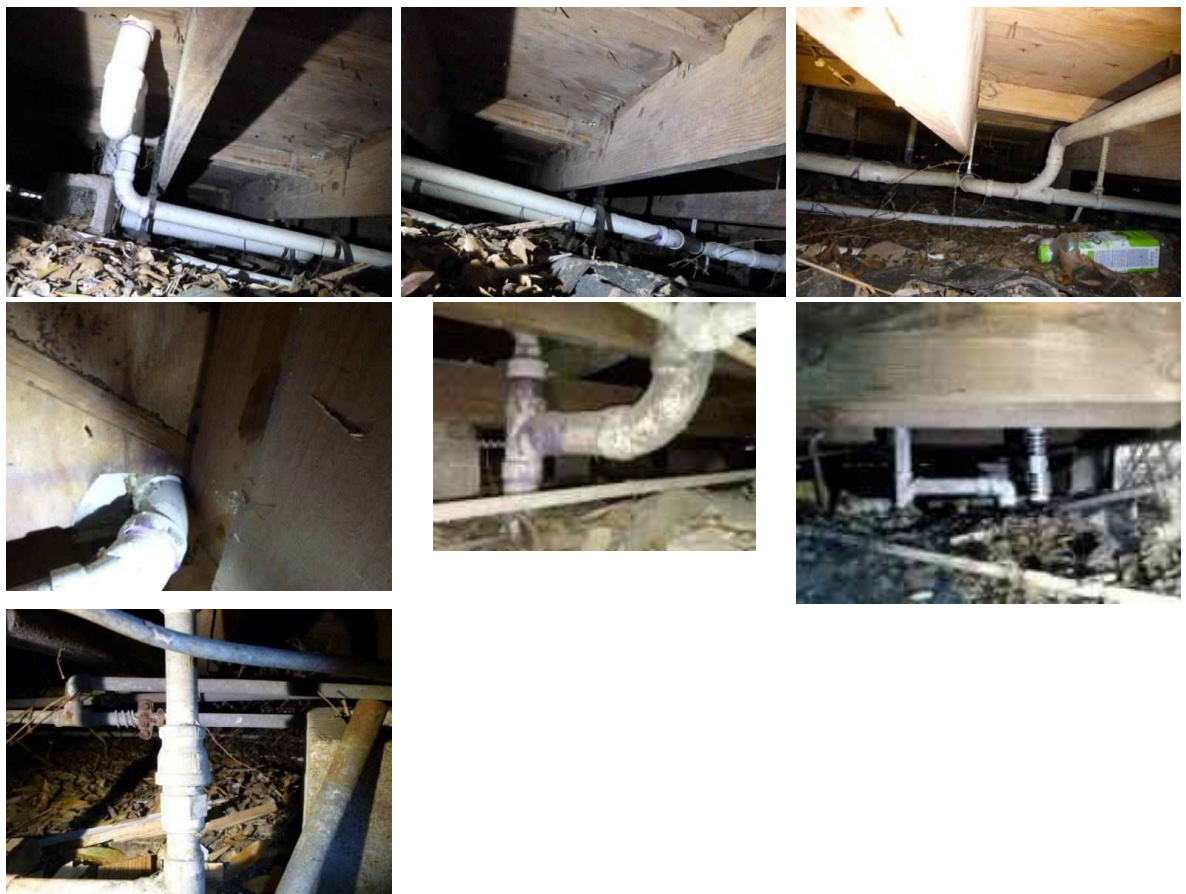
The visible sewer piping at the crawlspace under the house was observed to be PVC piping. The PVC extended underground and a PVC clean out was visible at the paver walkway at the south side of the house. We could not determine if all of the underground sewer piping between the house and the sewer main has been replaced with PVC. Further investigation is recommended with the homeowner to determine the extent of the underground sewer pipe replacement. It is also recommended that a sewer inspection be performed by a plumber to determine the extent of the repairs and the condition of the underground piping.

Further investigation is recommended

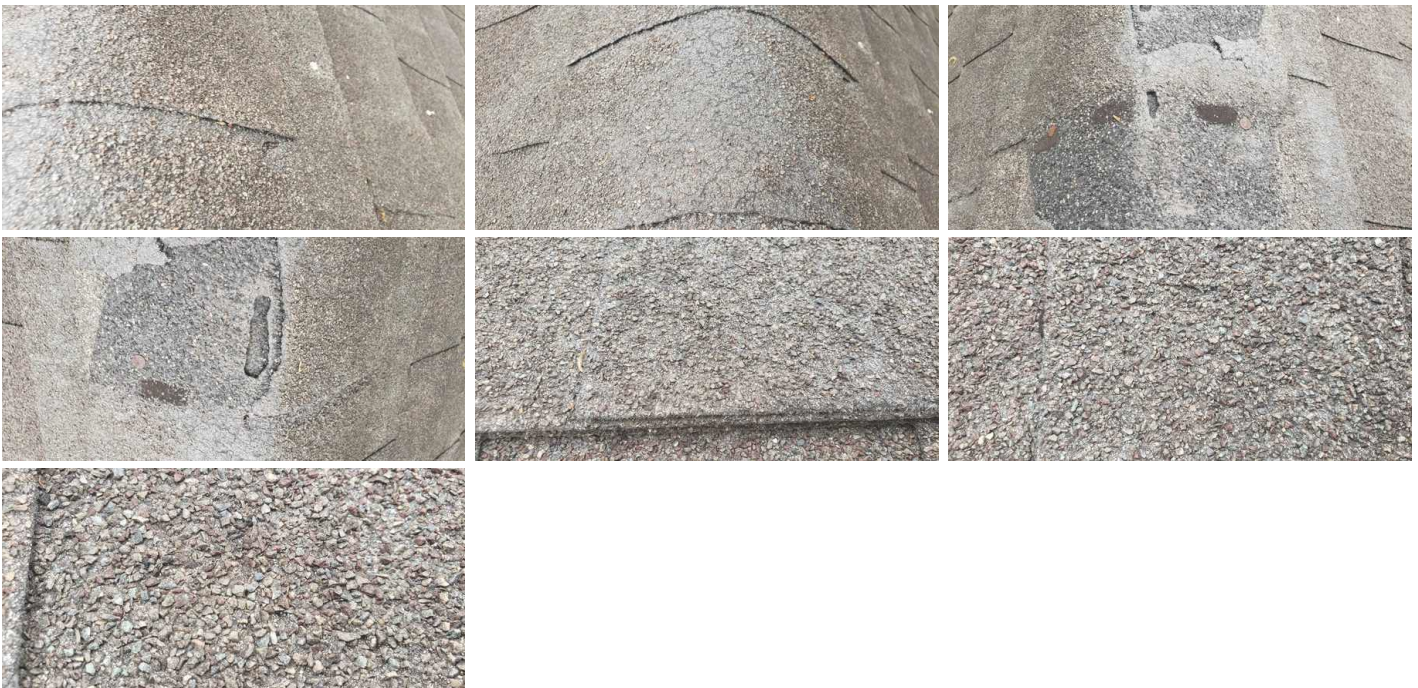
The composition roof surface was showing evidences of advanced deterioration of the roof surface as shown above.

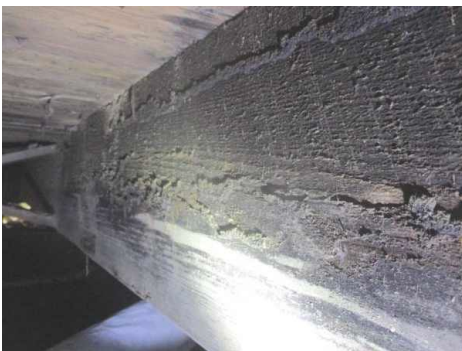
We observed damage from wood destroying insects to the framing members under the house at the crawlspace. The degree of the damage was minor and has not significantly affected the structural integrity of the framing members.

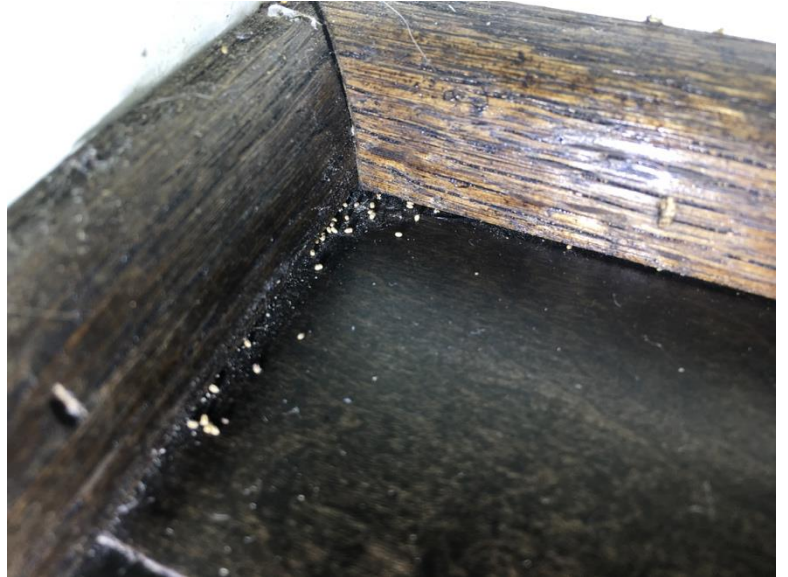
Previous Subterranean termites.
