## PROPERTY INSPECTION REPORT

**Concerning:** 18 Evanston Street, Houston, TX 77015

**By:** Kevin Akins : 22211

11/17/2017

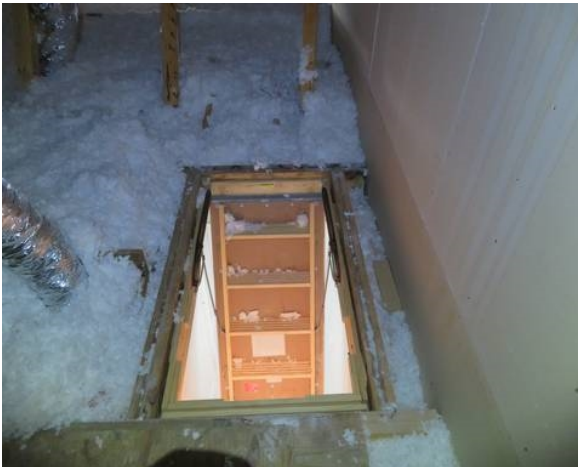
*Inadequate attic walkway provided from attic access opening to the furnace and the water heater. Recommend the installation of a continuous solid surface walkway; minimum 24" in width.*

Attic stairs missing the required landing and walkway.

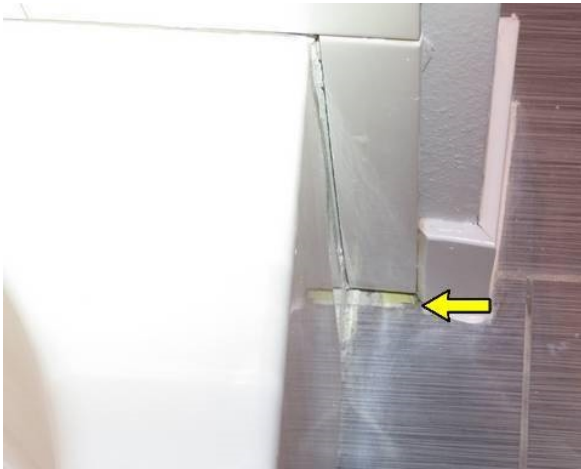
*Observe general painting needs, gaps and caulking touch-ups around the structure (see a representative number of photos below). Recommend corrective actions by a painting and general contractors as needed.*

Example gap - upstairs Jack & Jill bathtub.

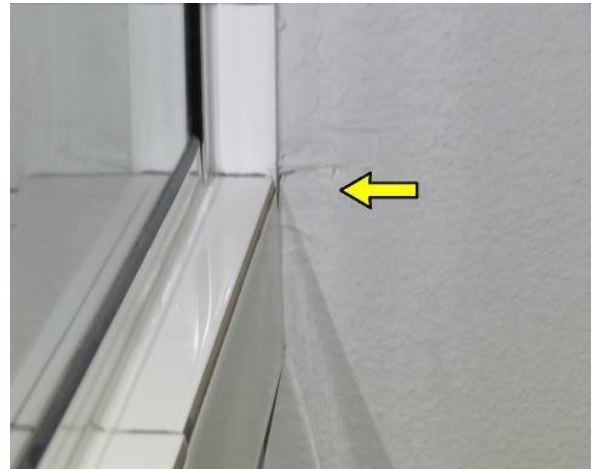
Drywall damage noted - master shower area.

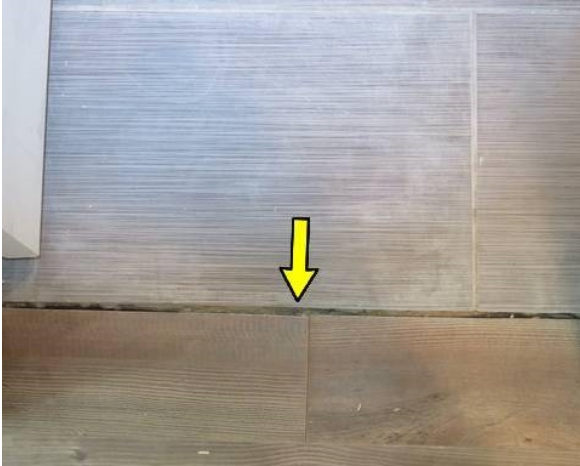
*Observed the absence of transition strips around the structure where tile intersects with the wood flooring. Recommend corrective actions by the installation flooring contractor.*

Gaps at all tile and wood flooring intersections.

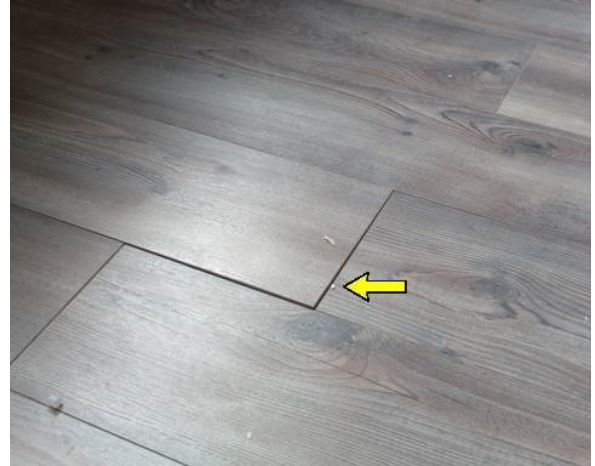
*Observed raised wood floor panels at several areas around the 1st floor. Recommend repairs by the installation contractor.*

Example raised wood floor panel - breakfast area.

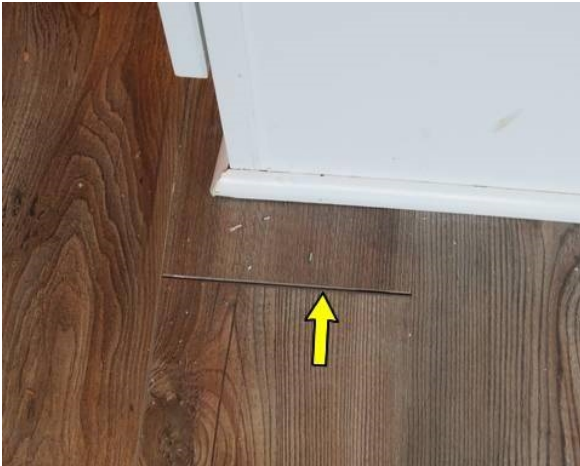
Example raised wood floor panel - near kitchen island.

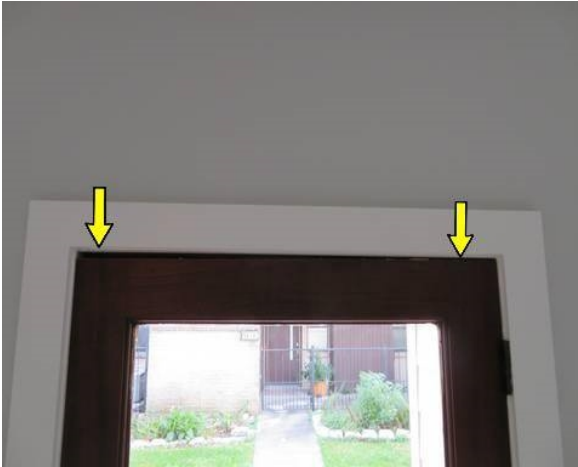
*Front door is out-of-plumb (see photo). The installation carpenter should make all necessary repairs as needed.*

Front door out of level.

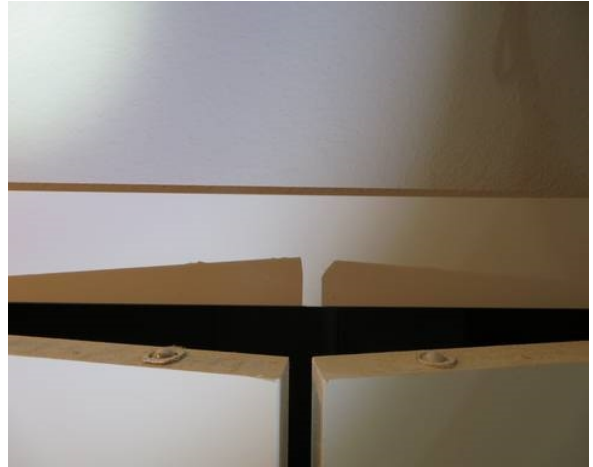
*Utility room double doors are not latching. Repairs should be performed by a trim*

*contractor.*

Utility room latching balls will not engage.

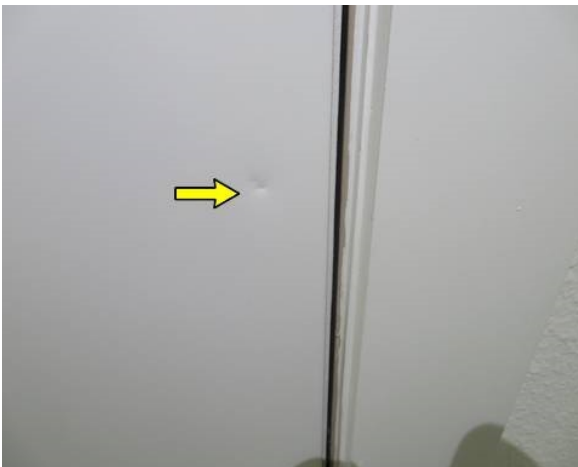
Example dent noted - master bedroom door to the balcony.

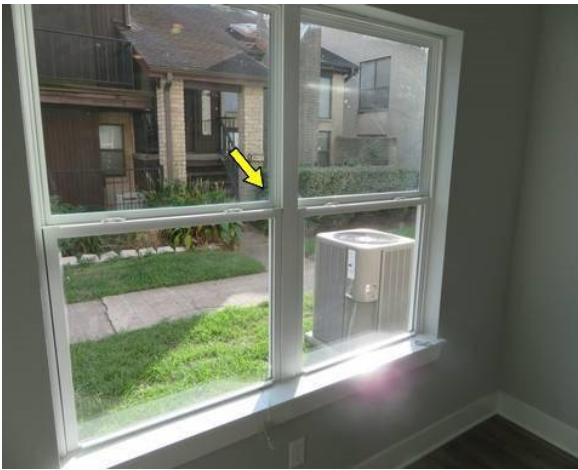
*Breakfast area window sash was non-operational at the time of the inspection. Repairs should be made by the installation contractor as needed.*

Broken window sash - breakfast area.

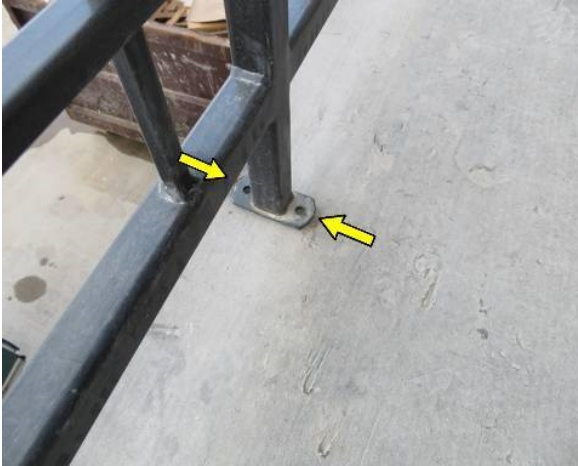
*Upstairs balcony wrought iron is missing the middle securing bolts (see photo below). Recommend corrective actions by a qualified contractor.*

Missing securing screws - upstairs balcony.

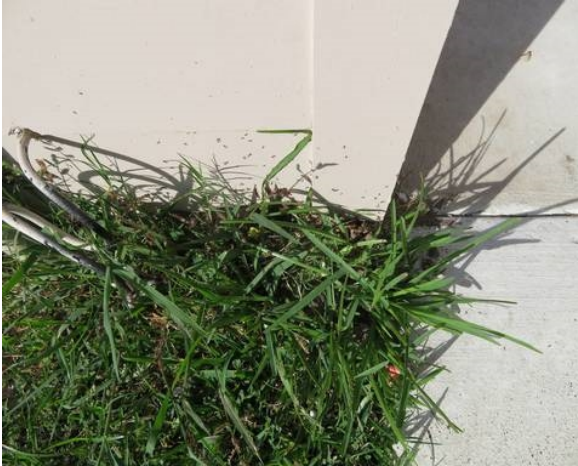
*Ant bed observed at the front of the structure. Recommend removal and treatment as needed.*

Active ant bed noted - front elevation.

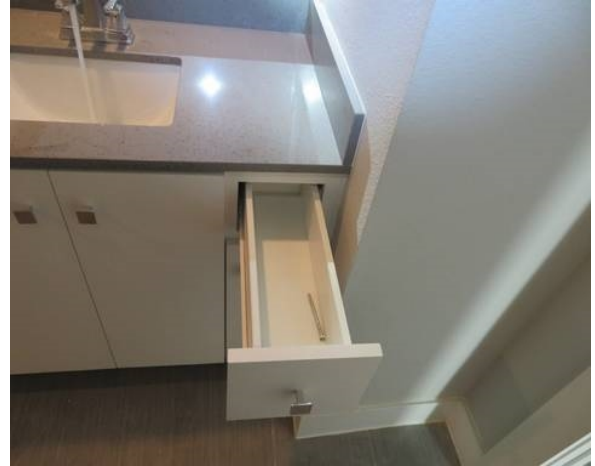
*Upstairs Left side Jack & Jill vanity draw did not open and close smoothly. Recommend adjustments by the installation cabinet contractor.*

Draw does not operate smoothly - upstairs Right Jack & Jill vanity.

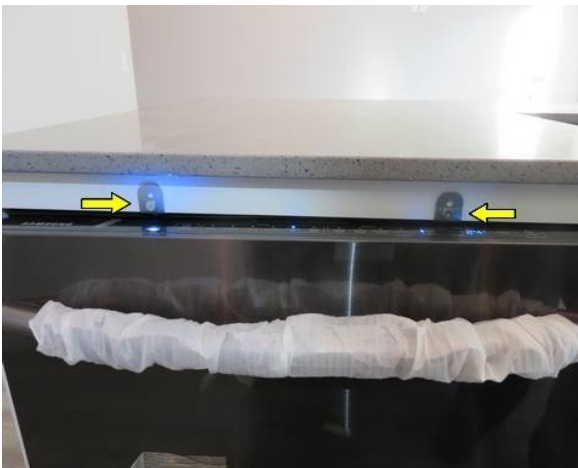
*Observed the dishwasher with the mounting brackets visible at the cabinet reveal. Recommend securing the dishwasher at the inside of the cabinet in accordance with typical building practices.*

Securing brackets noted - front of the dishwasher.

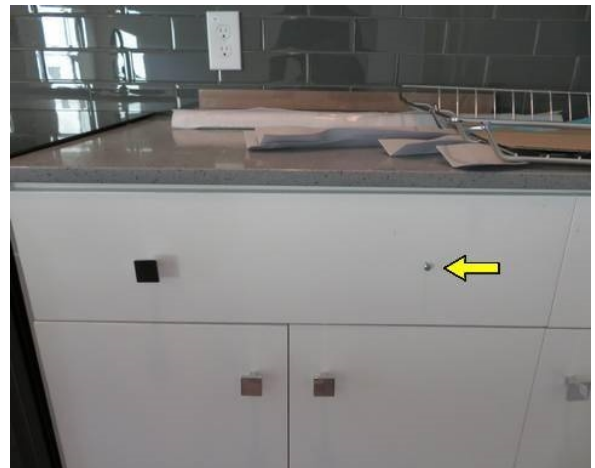
*Kitchen draw (Right of the oven) is missing the pull handle. Handle should be replaced as needed.*

Cabinet pull missing - kitchen draw.

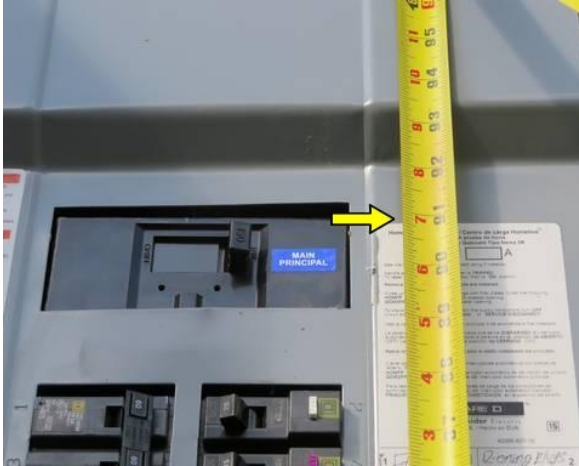
*Observed excess height of the service panel shut-off switch. The height can not be more than 6 feet 7 inches to the middle of the grip handle (currently 7 feet 7 inches). Recommend a licensed Electrician for corrective actions.*

Main electrical shut off switch above 6'7" height - service panel.

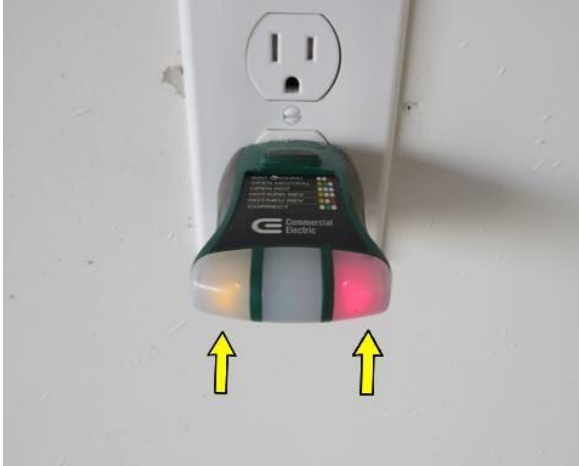
*Garage Right side outlet has reversed polarity which means the hot and neutral wires are reversed. This could create a safety hazard. Corrective actions should be made by the installation electrical contractor.*

Hot and neutral reversed - garage wall.

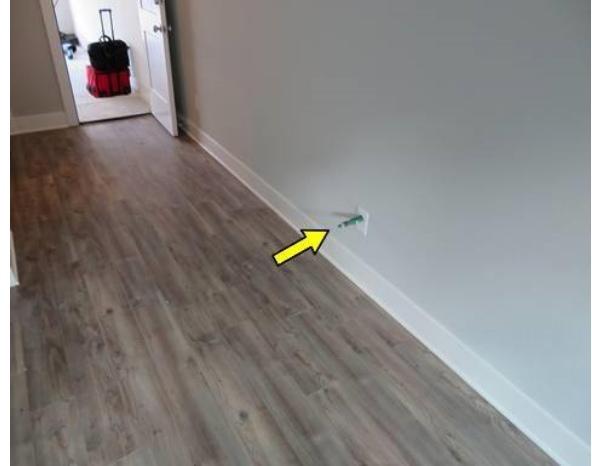
*Family room outlet has a loose outlet box (see photo below for exact location). Recommend the installation contractor for repairs as needed.*

Loose outlet box - family room.

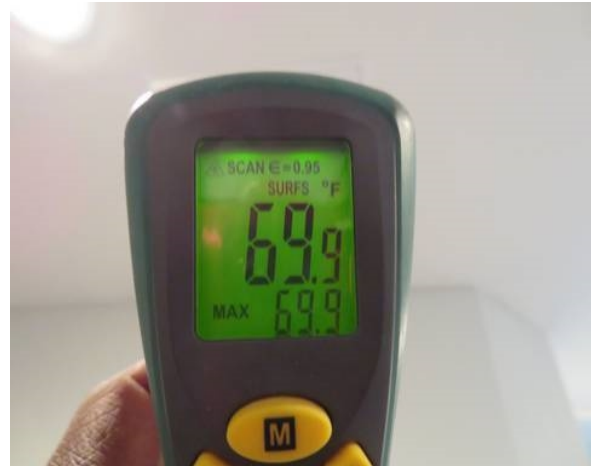
Return air reading is outside supply and return differentials - unit should be serviced.

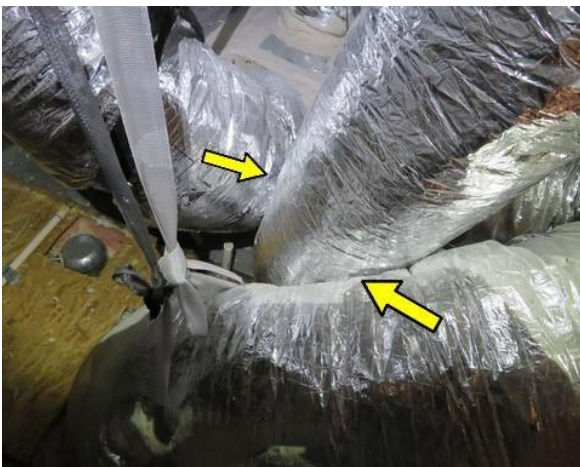
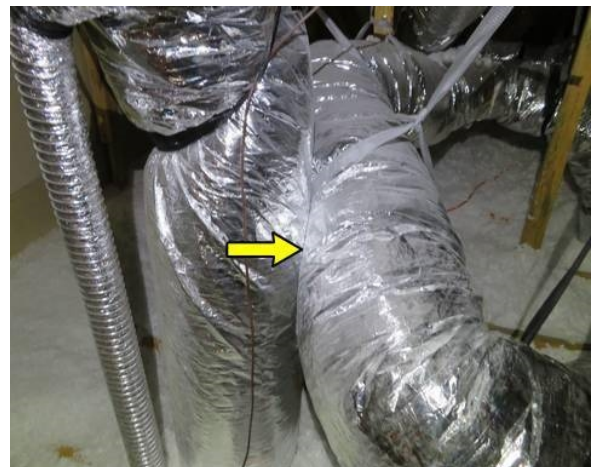
*Supply ducts were observed in direct contact with one another in the attic. This condition can cause condensation to develop at contact points. Recommend separating ductwork so that a visible air space exists or place insulation between ducts that cant be separated.*

Example ducts in contact - attic.

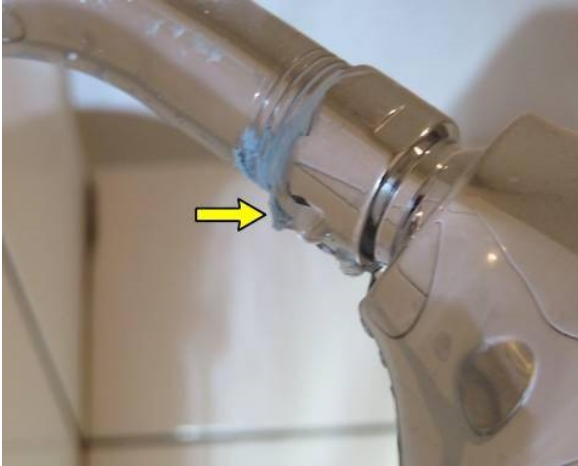
*Leak observed at the upstairs Jack & Jill bath shower head. Recommend corrective actions by a licensed Plumber.*

leak noted - upstairs Jack & Jill bath tub.

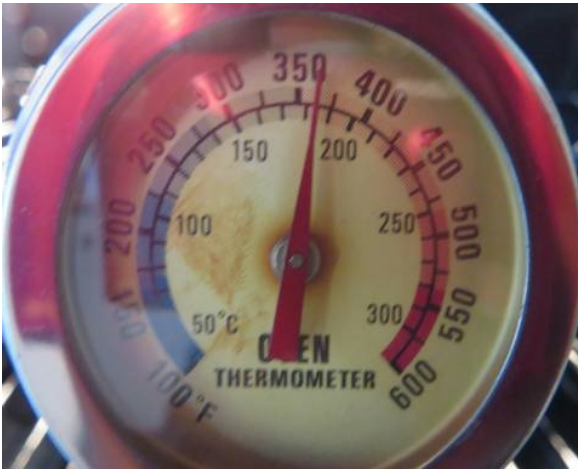
Oven was tested at a temperature setting of 350 degrees. The oven measured 365 degrees; which is considered within normal operation parameters (+ / - 25 degrees). Recommend keeping temperature differential in mind when baking or re-calibration.

Oven set to 350 degrees and measured at 365 degrees - Unit should be re-calibrated.

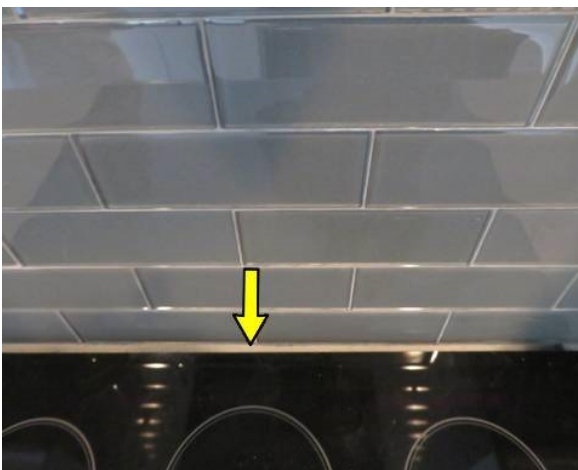
*Observed a gap at the rear of the electric cook top. Recommend sealing all gaps by a qualified contractor.*

Gap noted at the rear of the cook top.

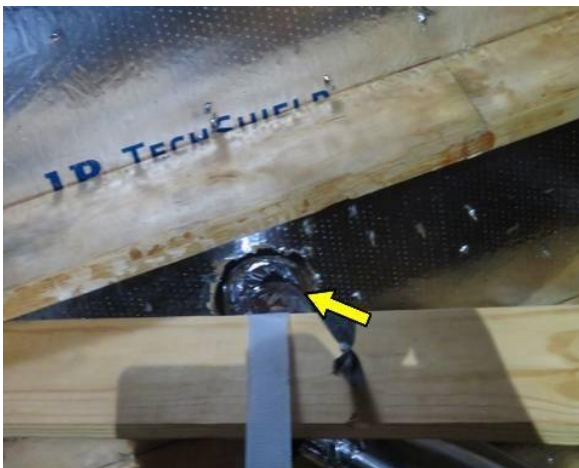
*Dryer pipping has a gap near the roof decking (see photo below). Recommend repairs by the installation contractor.*

Gap noted at the dryer vent - attic.

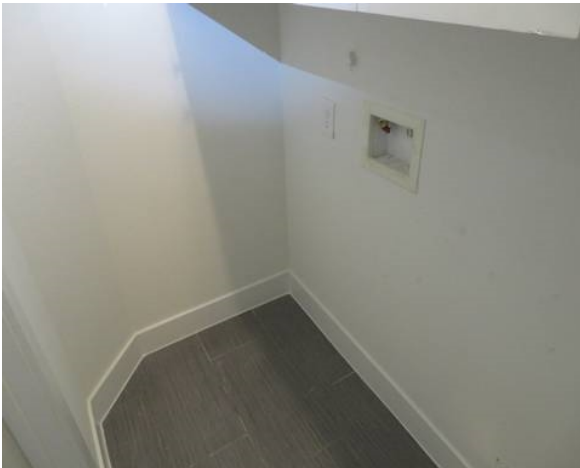
*Observed the upstairs washing machine area without an emergency drain pan.  
Recommend installing a drain pan to prevent drywall damage in case of a leak.*

Missing washing machine pan - upstairs utility room.
