**Comprehensive Evaluation Report
(Structural/Mechanical)
for
1401 Winnie Street (Avenue G)
Galveston, Texas 77550**

October 16, 2017

Re: 1401 Winnie St. (Ave. G), Galveston, TX 77550

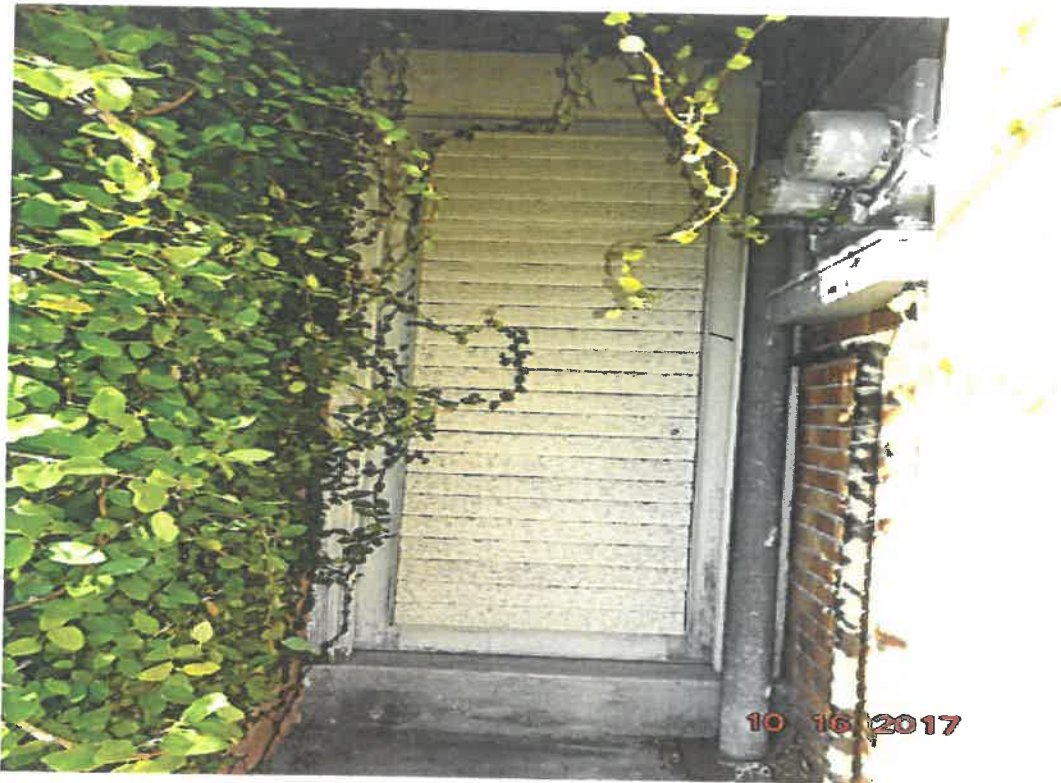
Photo # 3 Electrical service entry at garage

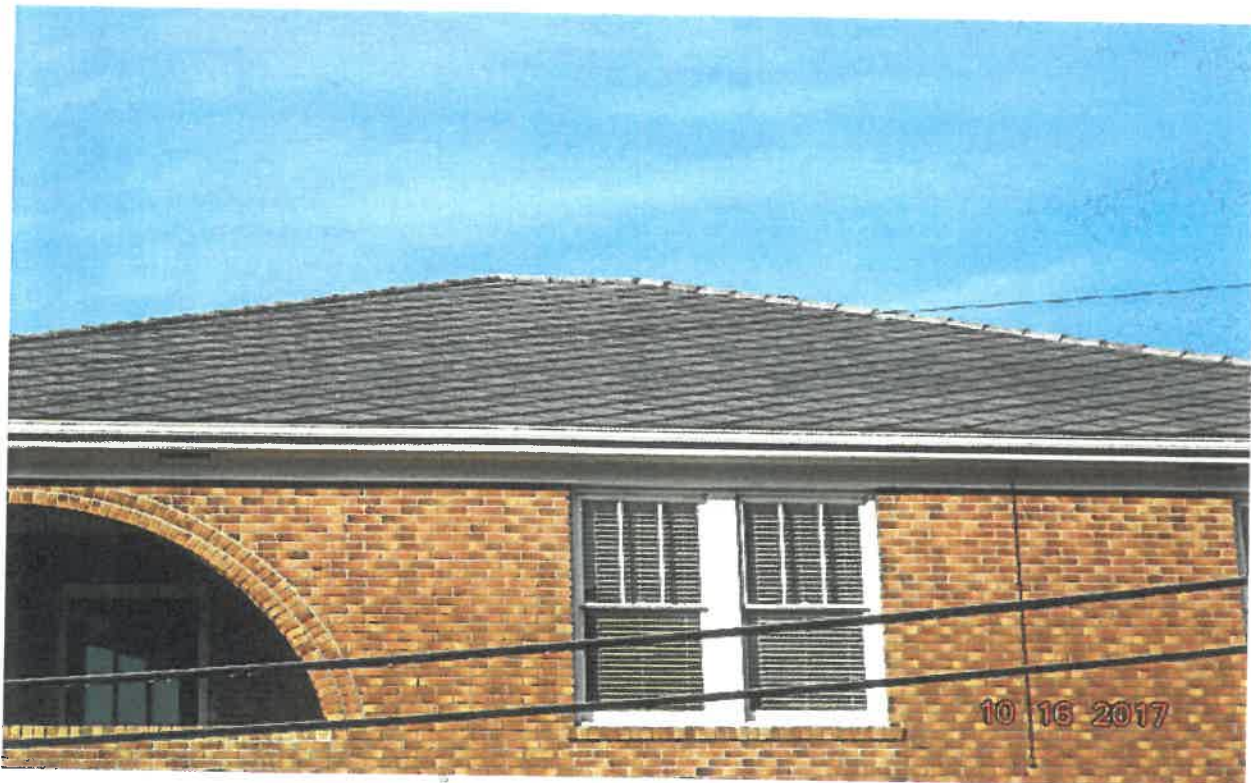
4. Roof, attic and cornice: The roof of the house is of hip configuration, with a covering of what appears to be asbestos or slate tile shingles. The roof of the garage is flat, with a covering of rolled, bituminous roofing, apparently sealed with tar. Roofing was examined from the ground, balcony floor, and garage roof because of height and steep-pitched surfaces on the original building. Tile shingles, both on flat surfaces and on hips, appear to be fully serviceable and properly installed. Roof vent seals, appliance vents, and attic vents appear to be serviceable. Cornice components appear to be properly installed and serviceable.

Photo # 4 Roof from ground, left side

- It is recommended that a qualified roofing contractor
 - Inspect the tile shingle roof to determine if repairs are needed and estimate the remaining life of the roof. Recommendations of the contractor should be considered and, if appropriate, implemented.

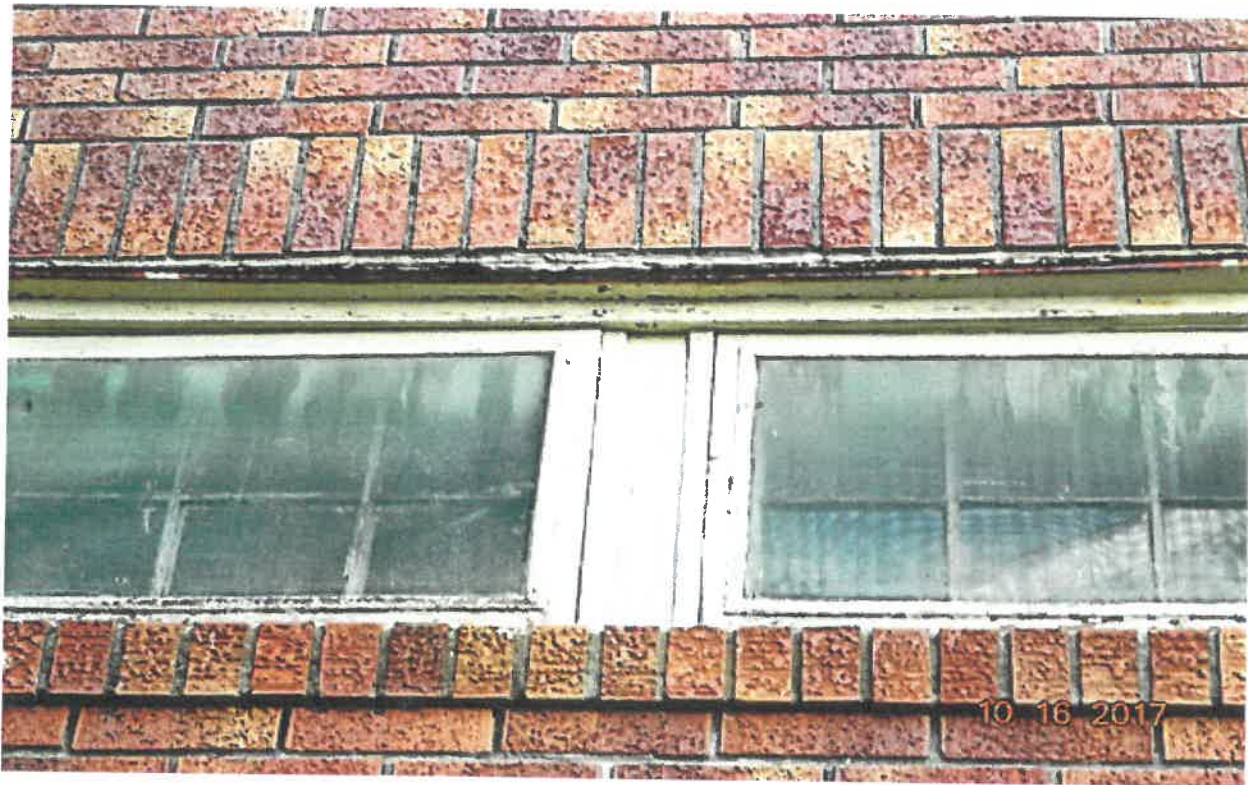
Photo # 7 Typical of badly corroded still lintel over transom windows

The above notwithstanding, it is recommended that steel lintels over Transom windows on the right side and front of the building, viewed facing the building from Winnie St, be repaired or replaced, as recommended by a qualified brick mason. In addition, it is recommended that

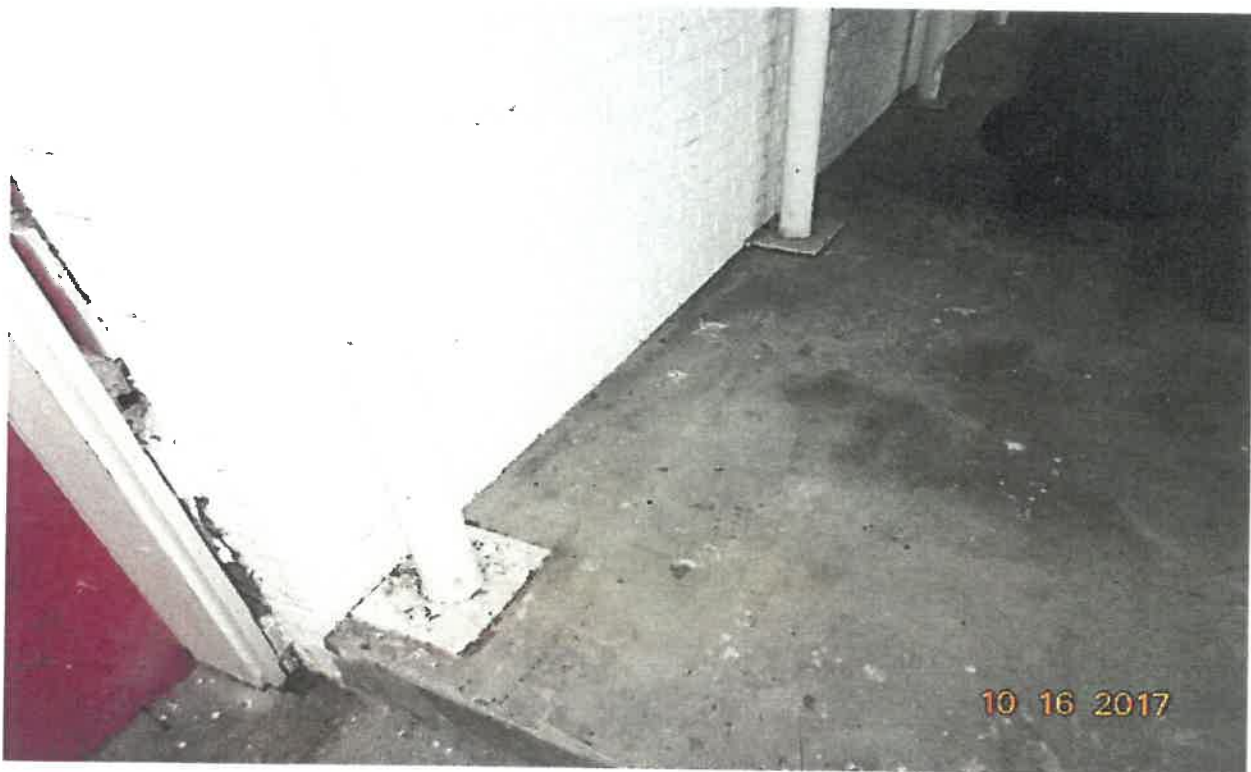
The roof of the garage is supported by the CMU walls and steel columns that are bolted to the foundation at the wall between the garage and office building. Though not observed on the left side exterior wall of the garage, as viewed from the vehicle door, it appears that steel columns such as observed on the opposite wall, are probably enclosed in CMU pilasters that extend inward along that wall. No damage or irregularities were found in garage walls, other than a few minor mortar cracks to the right and left of the overhead door. Neither were any irregularities found in roof framing.

Photo # 8 Typical of steel support columns in garage

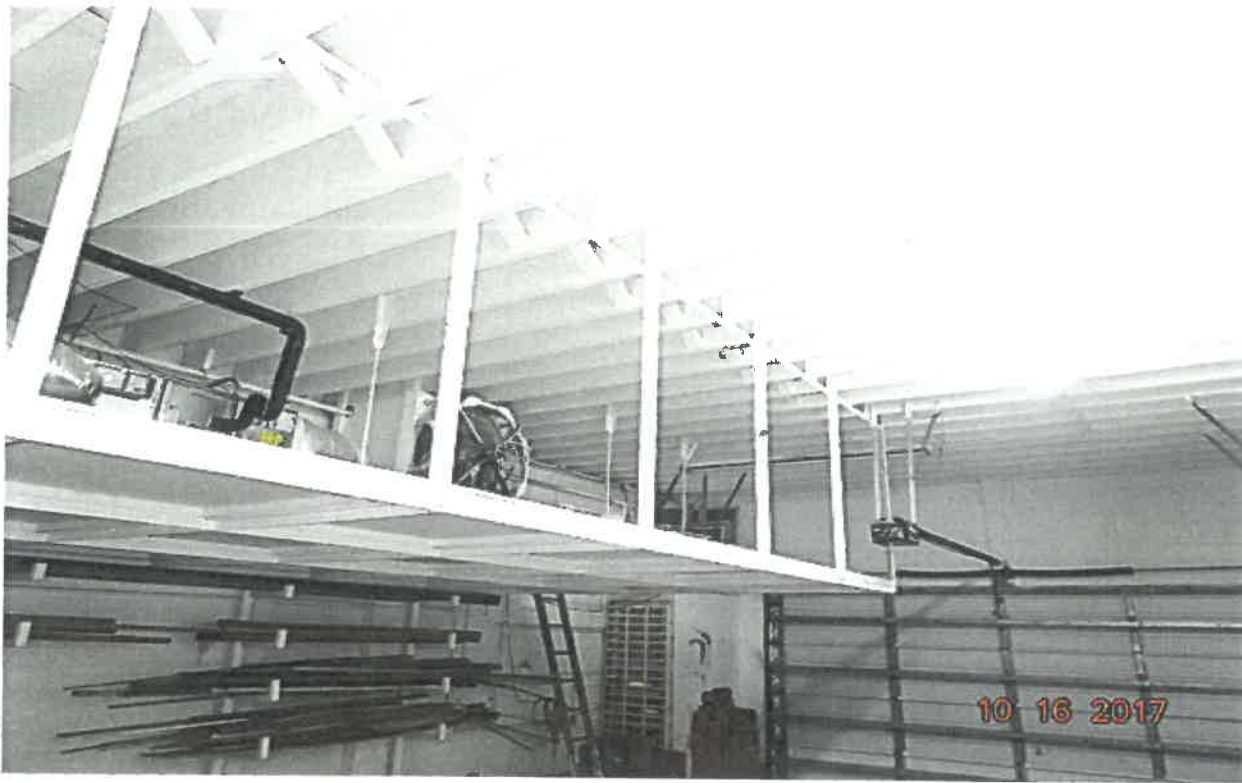
In the garage, minor cracks were found in mortar lines at the rear of the overhead door and to the front of the overhead door. No open cracks were found, however. A large raised platform is hung from the ceiling on the right side of the garage. An HVAC furnace and air handler and water heater are installed on this platform. In addition, a large ventilation fan, exhausting through the ceiling and garage roof, is also supported on the platform. The platform is hung by steel rods, bolted to the platform frame, with plywood flooring supporting the loads of equipment on the platform. No evidence of structural weakness was found in this platform.

Photo # 9 Garage with raised platform

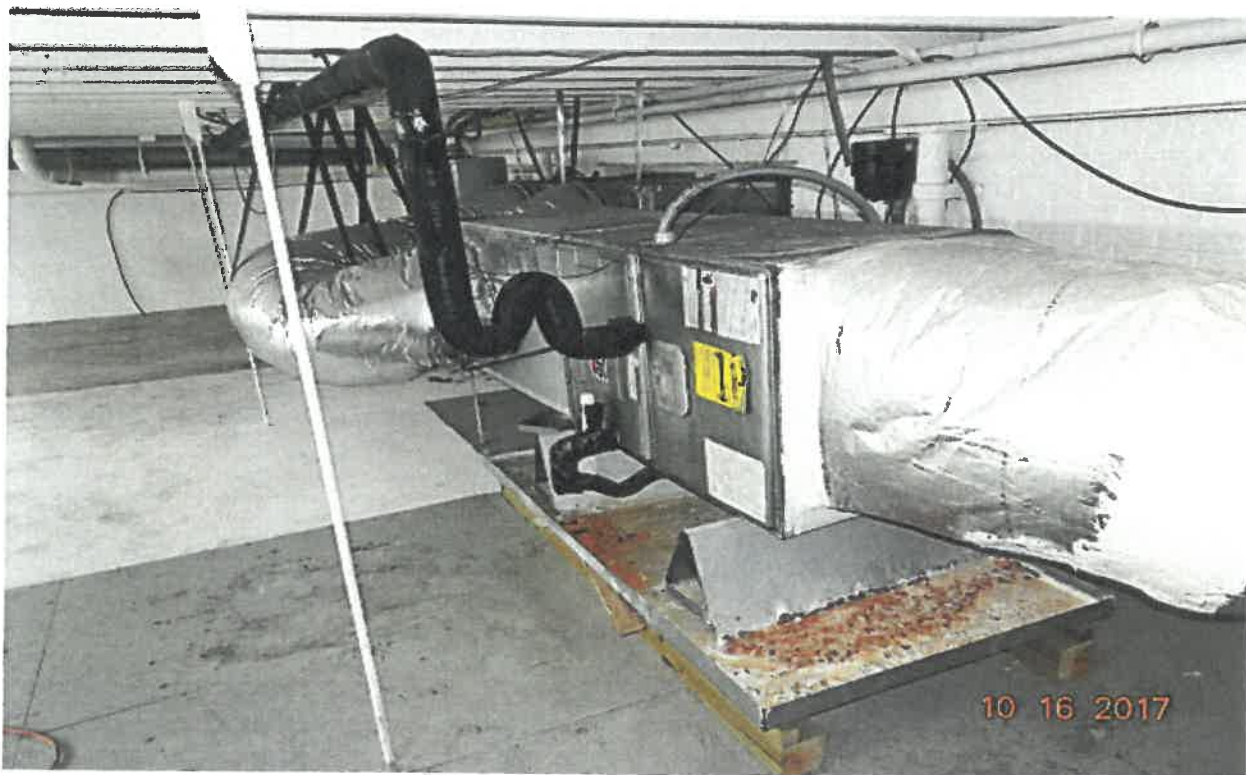
Photo # 10 HVAC unit on raised platform in garage

7. Heating and air conditioning: The heating and cooling systems for this house were functioning properly. That said, it is recommended that a high water shut-off switch be installed in secondary condensate drain pan for the unit in the garage.

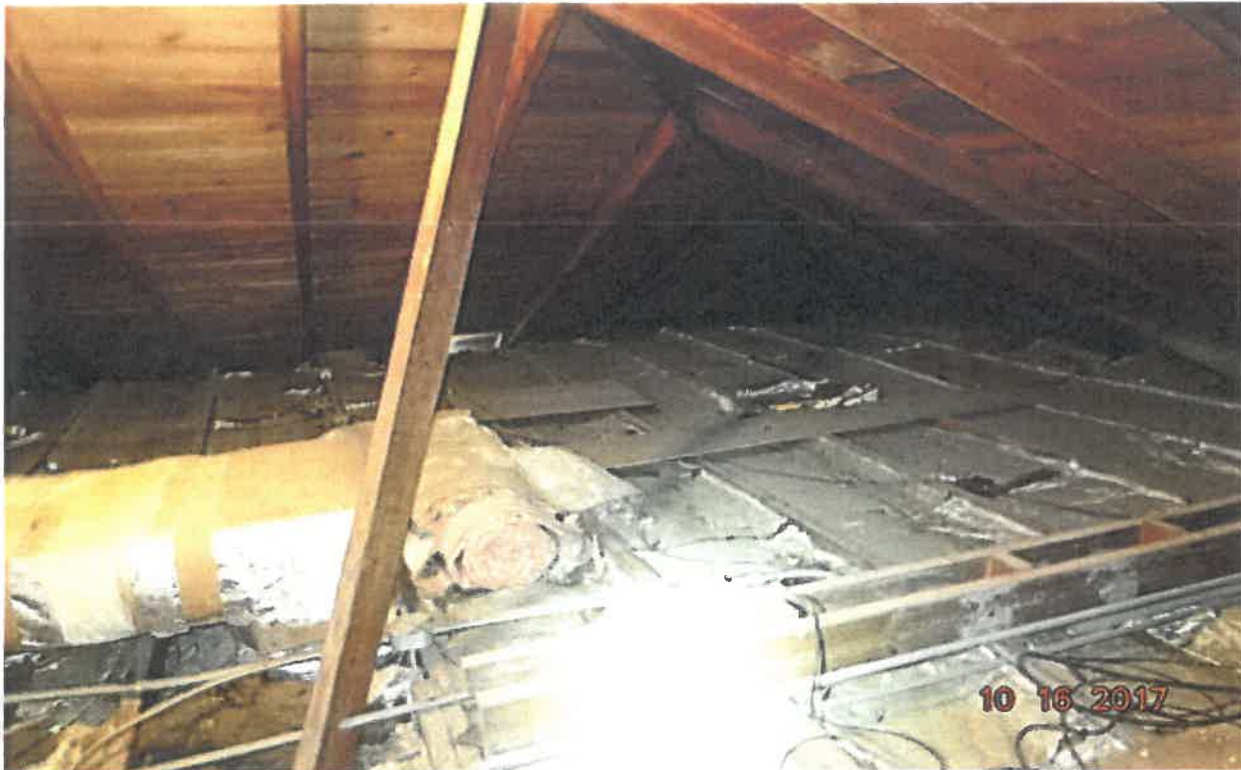
Attic ventilation is provided by soffit vents and a thermostat controlled power vent, though it was reported that the power vent system is not functional. Attic insulation appears to be rockwool batt insulation placed between ceiling joists on the floor of the attic, though the material was not confirmed. It appears that the rating of attic insulation is about R-11 or less, though this was not confirmed.

Photo # 15 Typical of attic and insulation

The frame of the roof is performing adequately. Attic insulation is not sufficient for today's needs. It is therefore recommended that attic insulation be augmented to a rating of R-30 or better. Attic ventilation is also insufficient and it is recommended that the inoperative power vent system be repaired.

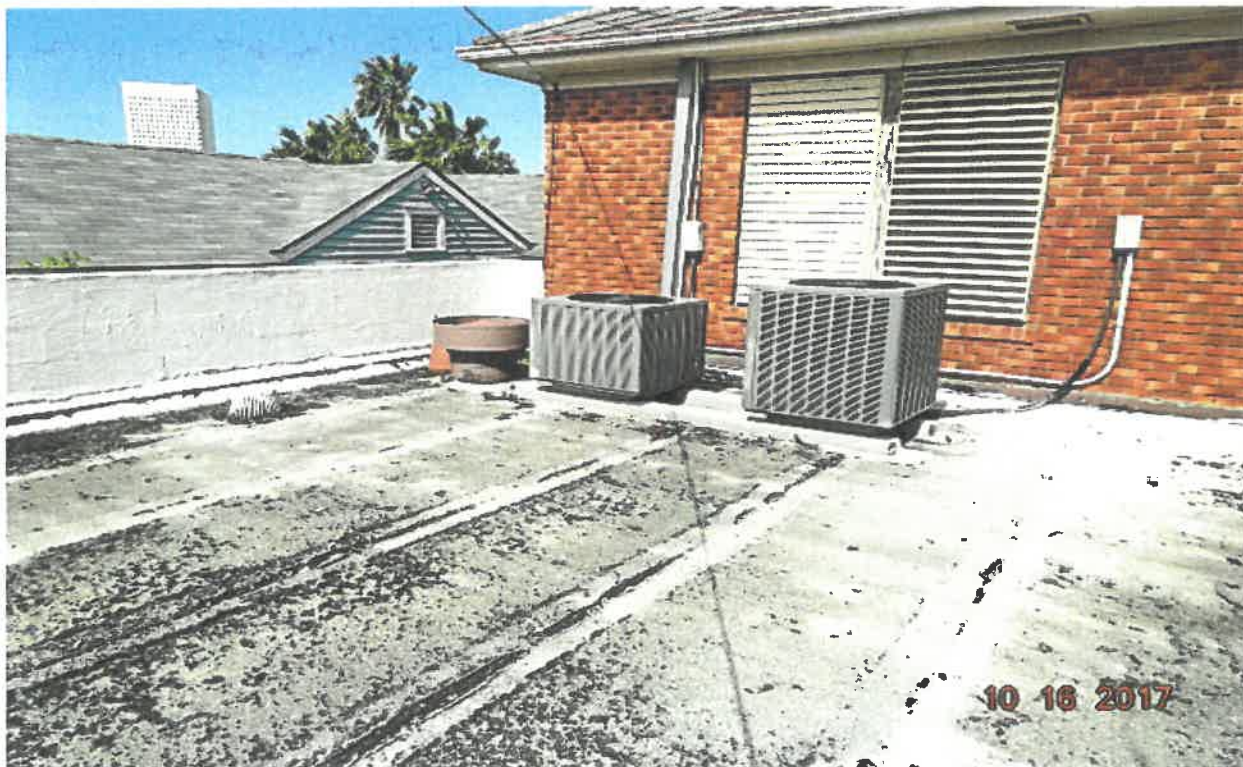
4. Roof, attic and cornice: Based upon observed conditions, it is our opinion that shingles of the roof are serviceable, though they appear to be the original shingles installed when the house was built. Because of their age, however, it is recommended that the tile shingle roof be inspected by a qualified roofing contractor to determine the remaining life of the roof covering. It is suggested that recommendations for repair or replacement made by the contractor be implemented. The flat roof covering is at the end of its serviceable life and should be removed and replaced with an appropriate material, possibly TPO or similar material.

Photo # 16 Flat roof over garage

- Remove and replace the flat roof covering on the garage with an appropriate roofing material such as TPO or similar material.
- It is recommended that

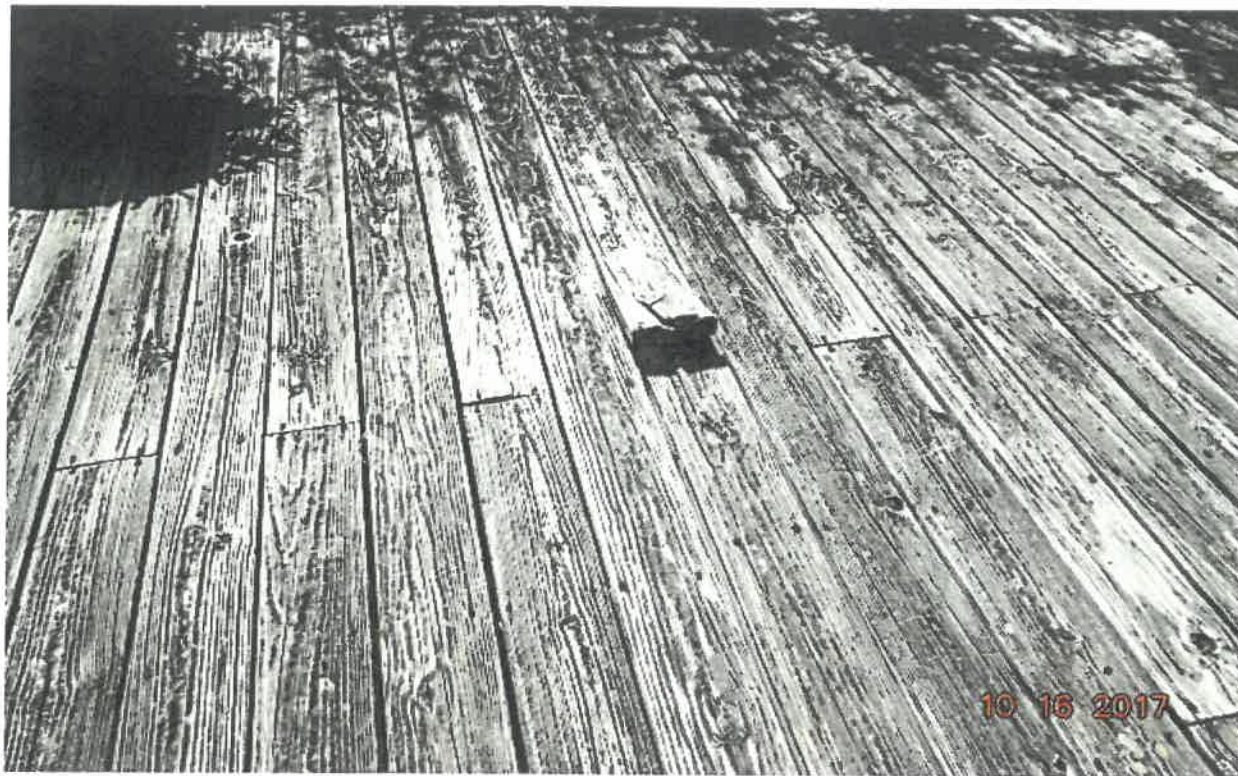
There is no yard space for this building, as it is built on zero lot lines with adjacent properties and other walls facing the streets. Drainage of the site is to the streets at the front and left side, as viewed from Winnie Street. Good swales on the sides of the house convey water to the front. The eaves of the roof are fully guttered, with a few loose nails in gutters. Drainage is facilitated by an underground drain system, with downspouts discharging into the underground drain. A drain scupper was observed at the left rear corner of the building, at the corner of the patio. The roof over the garage is flat, with a drain inlet at the rear of the garage roof. A wood deck on the roof of the garage is in poor condition.

Photo # 17 Deck roof of garage

1. General: Site drainage appeared to be reasonable for proper foundation maintenance and lot drainage. No repairs are needed to drainage and grading. Loose nails in gutters should be secured. It is recommended that the wood deck on the garage roof be removed and replaced, to include the roof material under the deck.
