REPORT OF FOUNDATION INSPECTION, EVALUATION, AND REPAIR

1720 South Park Drive, Alvin Texas

October 15, 2003

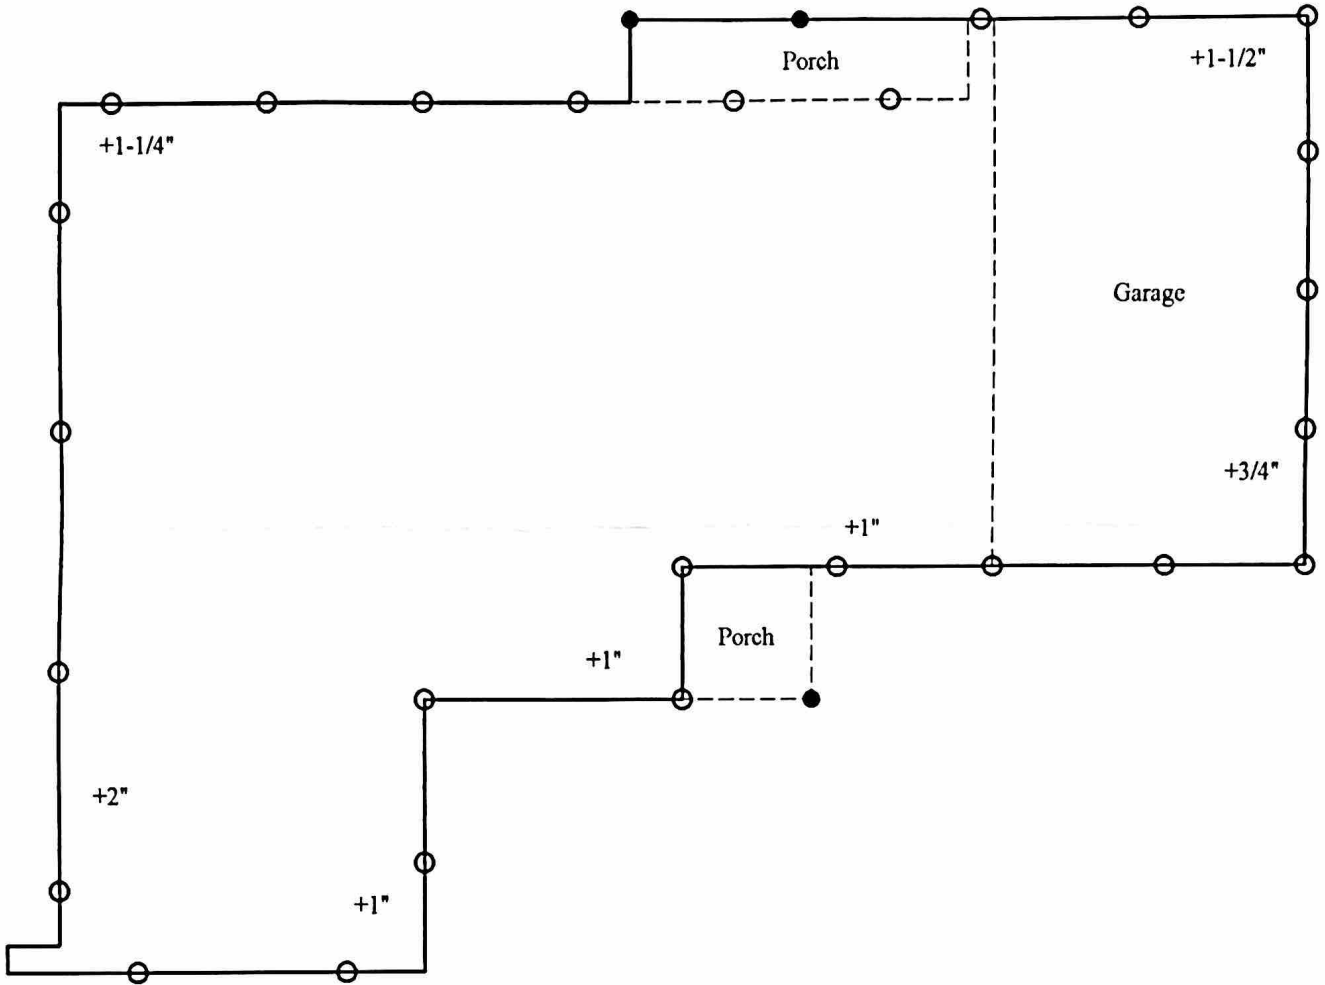
Foundation Plan
 1720 South Park Drive, Alvin, TX

1) The property appears to have been stressed by the movement of soil beneath the foundation. Movement was most severe along the perimeters, where stresses induced by the shrink/swell cycles caused the foundation to sag as much as two inches. Perimeter sags are very common among older houses.

5) Following the installation of the piers, the floor was level, cracks in the drywall were closed, and the door and window frames were aligned. Maximum lift was approximately two inches, as previously explained. Lift heights are noted on the Foundation Plan.

4) The stabilization and leveling of the foundation was best accomplished with piers. A total of 26 pressed piers and 3 pads were installed along the perimeters of the house at the locations shown on the Foundation Plan [a pad is simply a pier that does not require a rammed base]. Piers could not be placed precisely at the three exterior corners at the left side of the house because of the presence of buried blocks or slabs of concrete, but could be placed sufficiently close to those corners to allow the foundation to be lifted and leveled.
