## Inspection Report

**Property Address:**  
2219 Rambling Brook Dr  
Spring Texas 77373

# PROPERTY INSPECTION REPORT

**By:** Stephen Weston TREC #21249 / Weston Inspection 6/2/2021

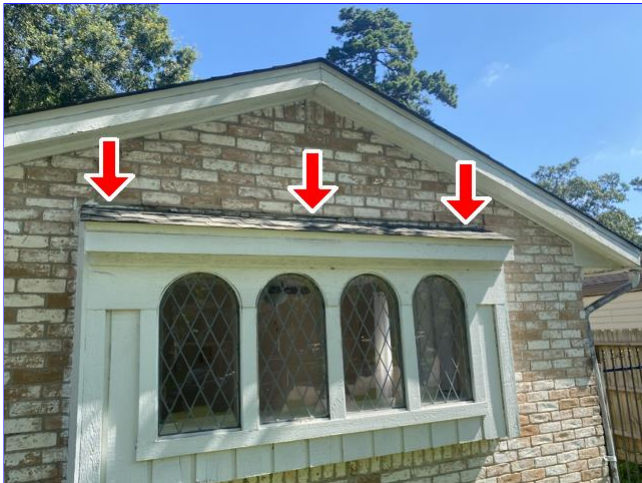
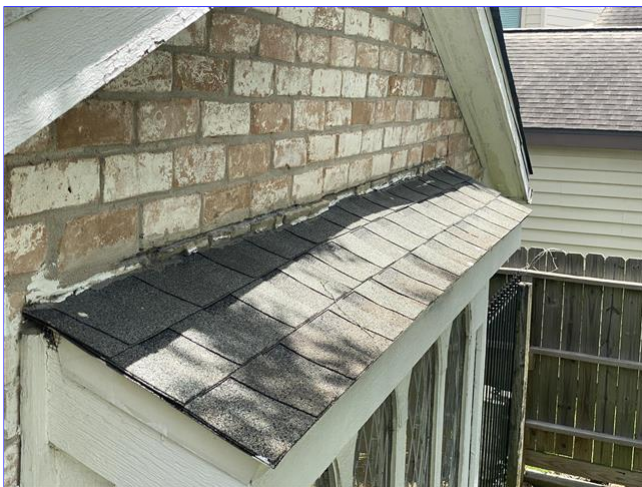
(2) Headwall flashing above the front right window appeared to be missing or was incorrectly installed. This condition will increase the chance of leakage. The Inspector recommends correction by a qualified roofing contractor.

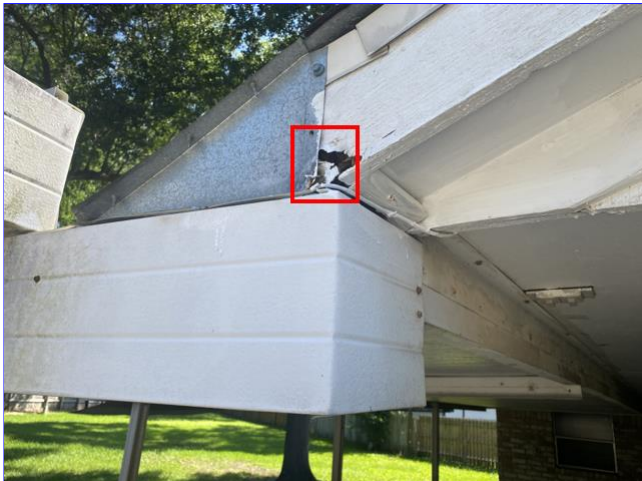
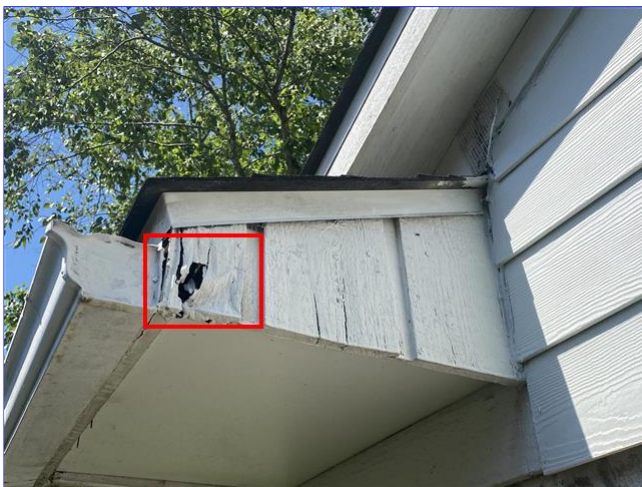
(3) Observed one or more damaged or deteriorated soffit and/or fascia boards. Inspector recommends repair or replace as necessary.

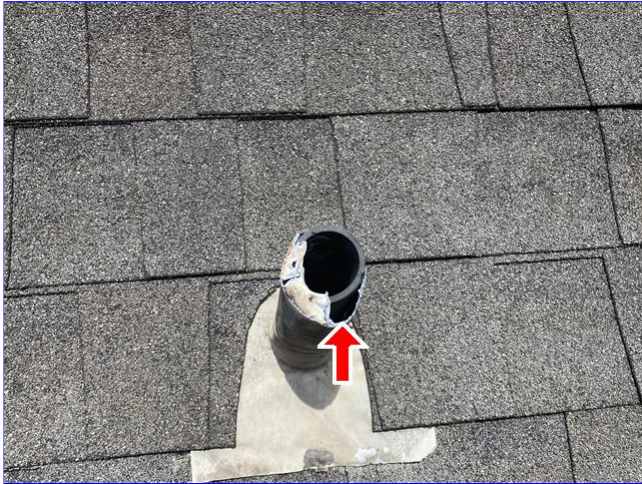
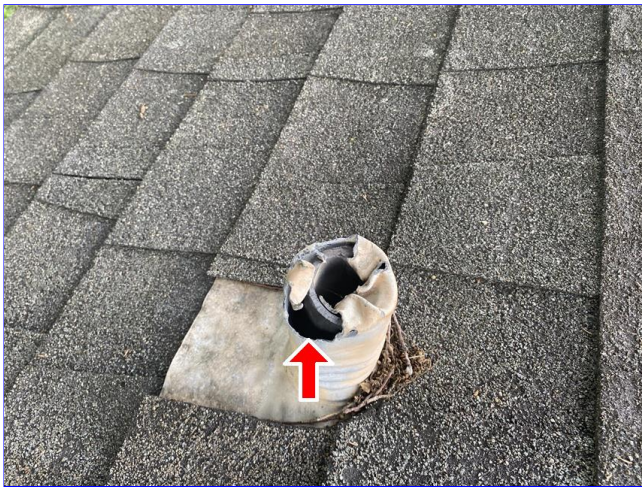
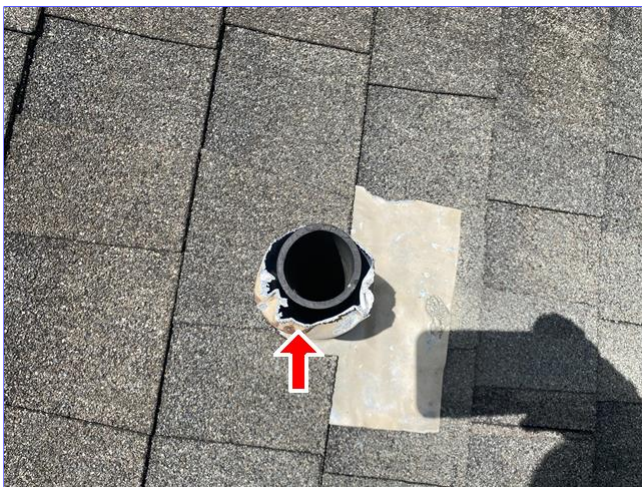
(4) Holes observed at multiple plumbing vent lead flashing sleeves. These are active leak locations and flashing should be replaced immediately.

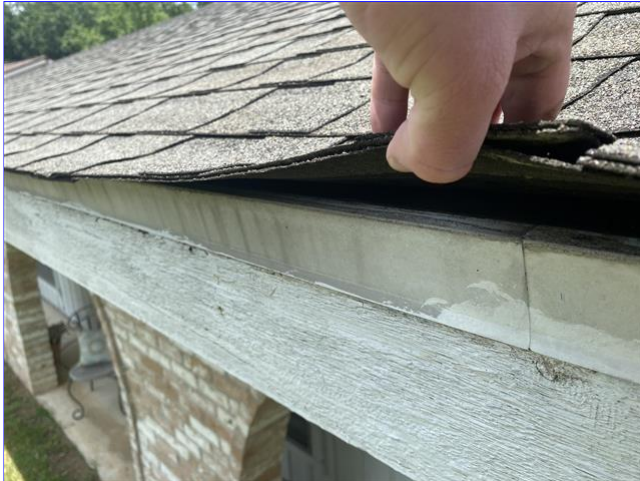
C. Item 8(Picture)

(5) Bottom row shingles are not bonded down at the roof eaves. This makes these shingles vulnerable to uplift in heavy winds. Recommend improvement by a qualified roofing contractor.

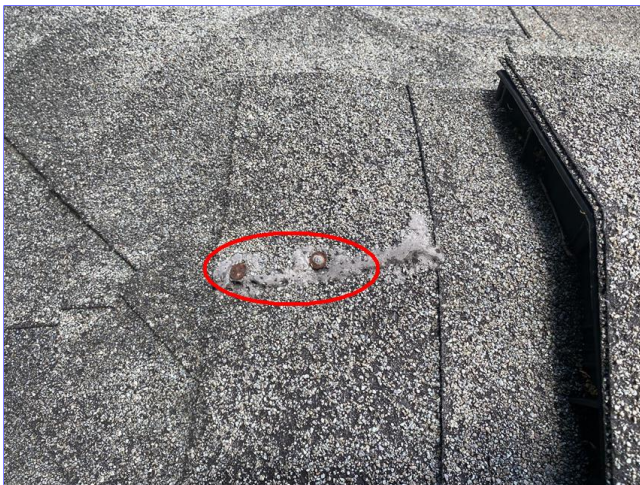
C. Item 9(Picture)

(6) Exposed and rusted nail heads observed at one or more flashing detail or ridge shingle. Rusted nail heads can break and cause leaks. Recommend sealing over nail head to avoid potential roof leaks.

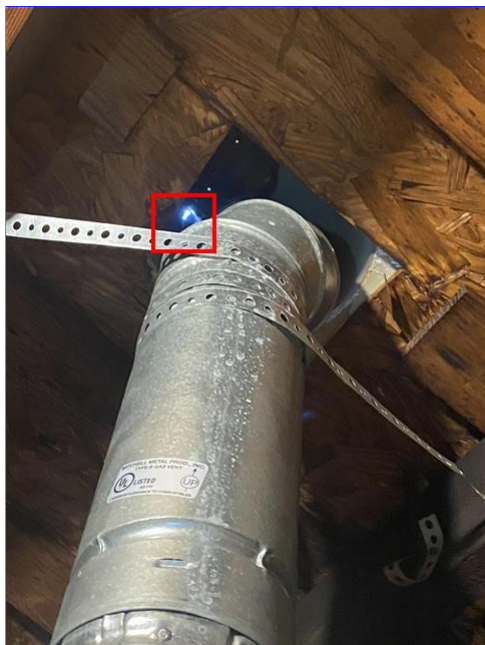
C. Item 10(Picture)

(7) Hole observed where furnace vent pipe passes through the roof. Hole should be sealed to prevent leaks.

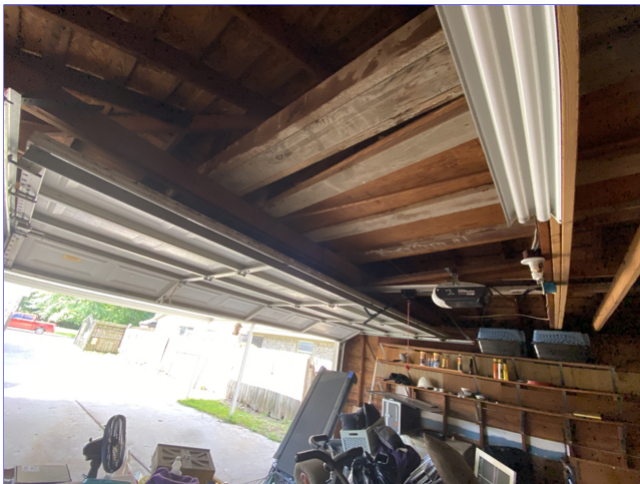
D. Item 2(Picture)

(6) Observed improper installation of bracing from one or more roof rafter to ceiling joist. Roof loads are not to be supported by ceiling joists. Recommend proper installation of of purlins with bracing down to load bearing walls to prevent sagging of roof and/or interior walls.

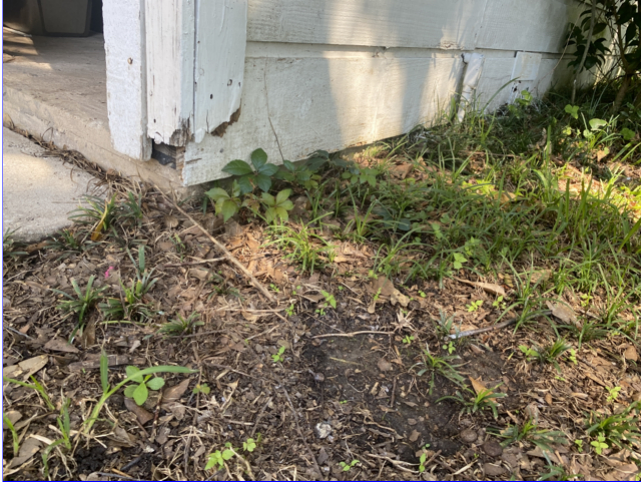
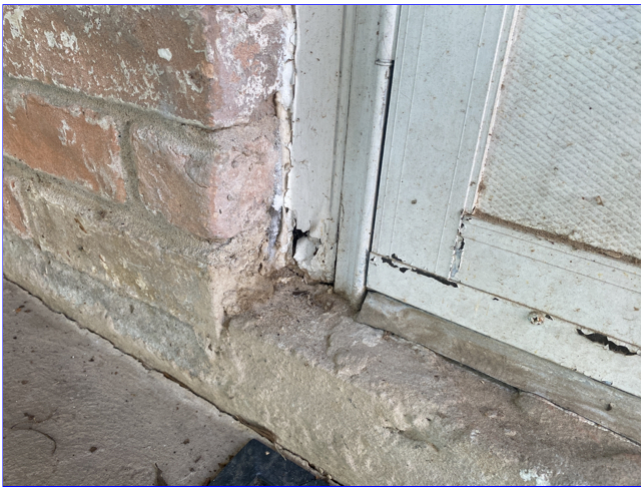
(1) One or more exterior siding and/or trim boards damaged or deteriorated. Recommend repair or replace as necessary.

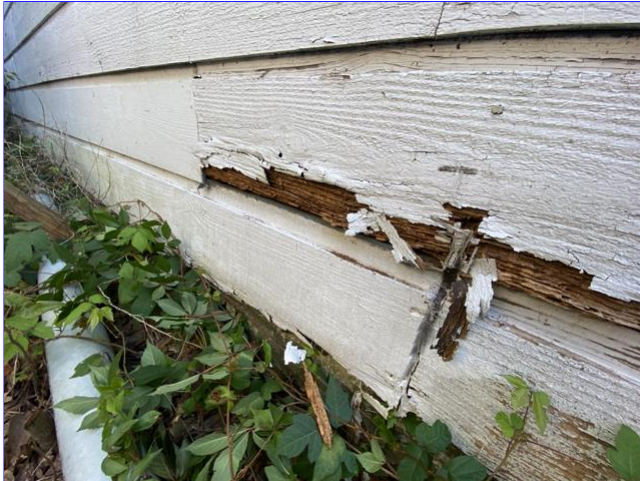
(4) The damage observed at some wood siding and framing members was consistent with damage from wood destroying insects. Inspector recommends further evaluation by a licensed termite technician to advise on any necessary treatments.

E. Item 5(Picture) Garage, left side

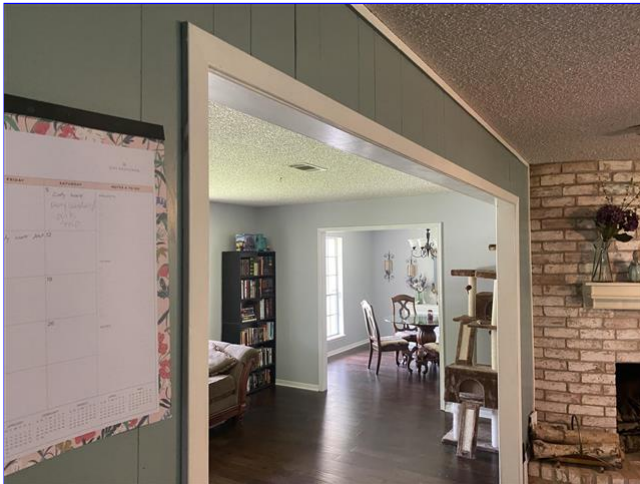
E. Item 6(Picture)

(5) Living room load bearing wall may have been altered and did not appear to have a support beam above the opening. Although the inspector observed no evidence of structural distress at this area of the home. Further evaluation by a structural engineer is recommended.

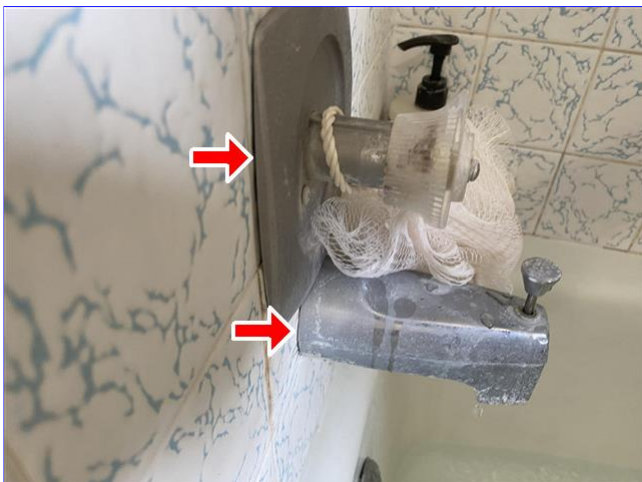
E. Item 7(Picture)

(6) Sealant where bathroom fixtures or enclosure meet the wall was old or had sections of missing sealant that may allow damage from moisture intrusion of the wall assembly. Inspector recommends applying fresh sealant at these locations.

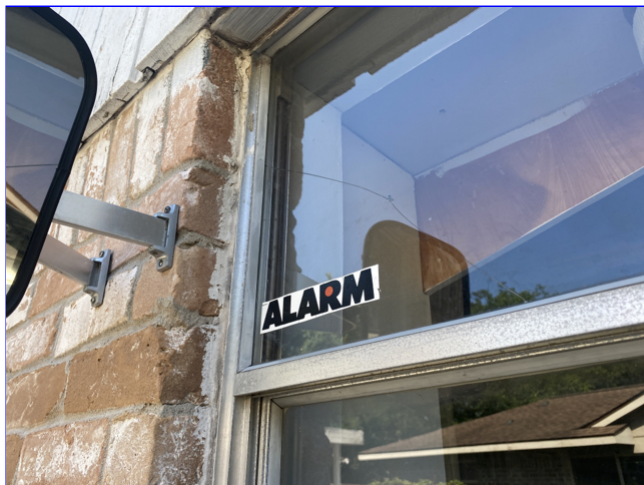
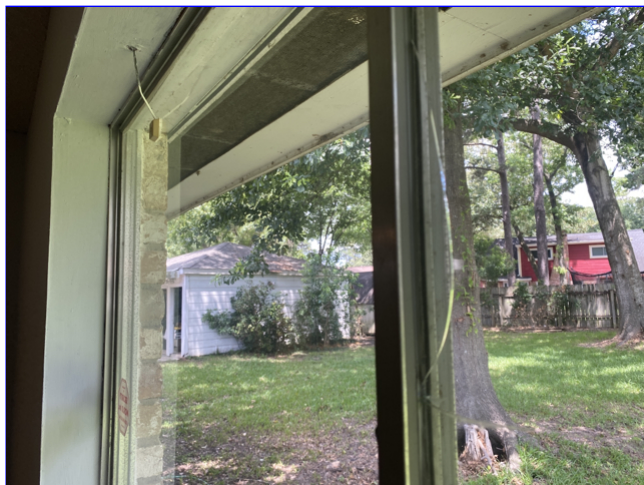
- (1) Inspector observed one or more cracked or damaged window panes.

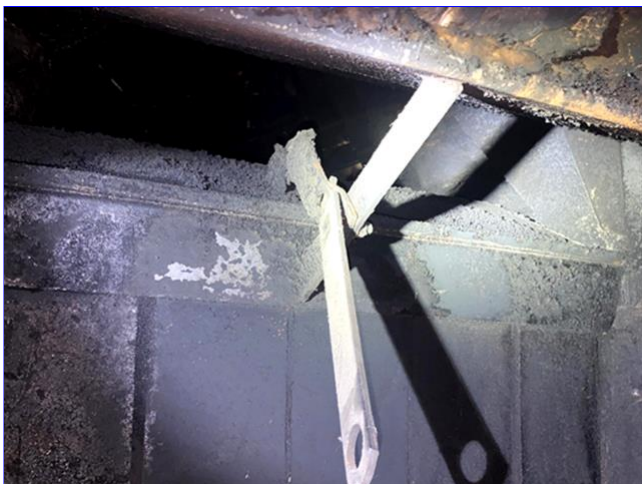
J. Item 1(Picture)

(1) The exhaust flue of the fireplace appeared to need cleaning. Dirty flues are potential fire hazards. The flue should be cleaned by a qualified contractor.

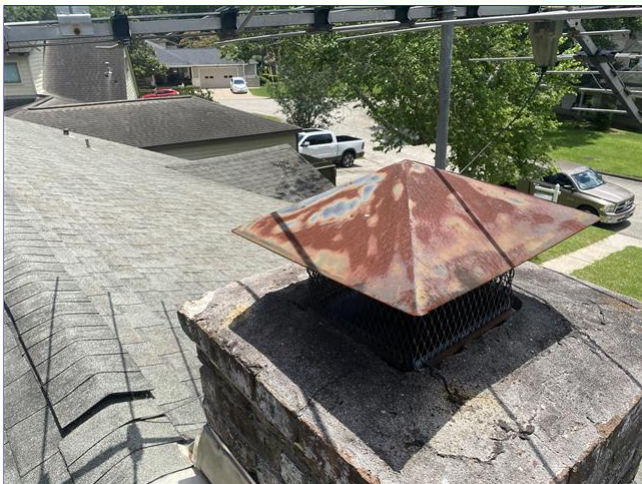
J. Item 2(Picture)

(3) Severe corrosion observed on chimney cap. Cap should be replaced before leaks form.

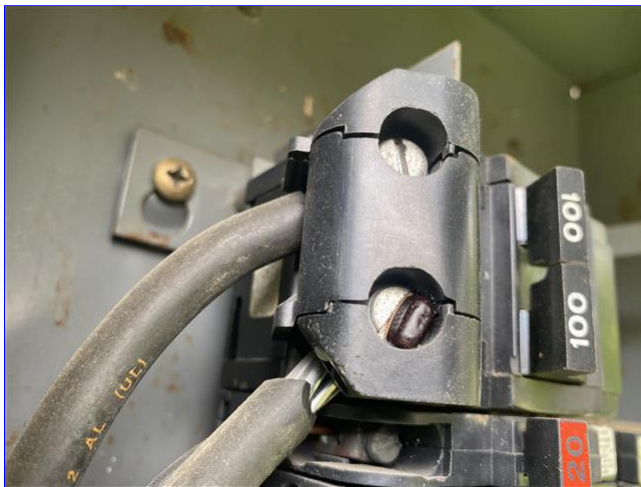
A. Item 1(Picture)

(2) Anti-oxidizing paste is needed on the aluminum service wires. Aluminum wires in outdoor breaker boxes can over heat and corrode in the hot summer months. Aluminum wires have been known to catch fire as a result. Anti-oxidizing paste will prevent over heating and corrosion.

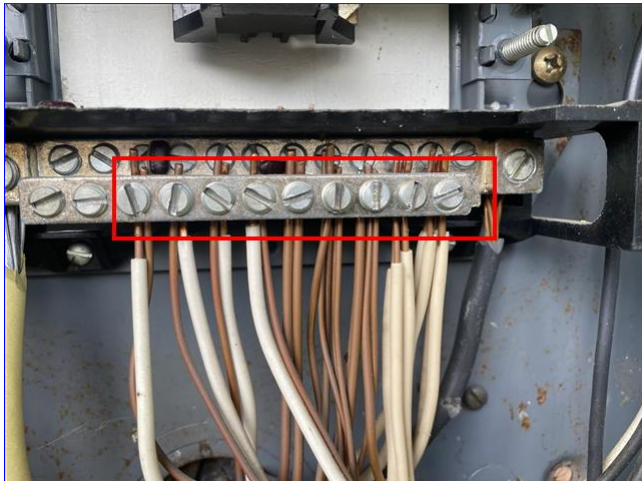
A. Item 2(Picture)

(3) One or more neutral wires are incorrectly connected under a single screw on the grounding or neutral bus bar at the main panel. This is prohibited and should be corrected by a licensed electrician.

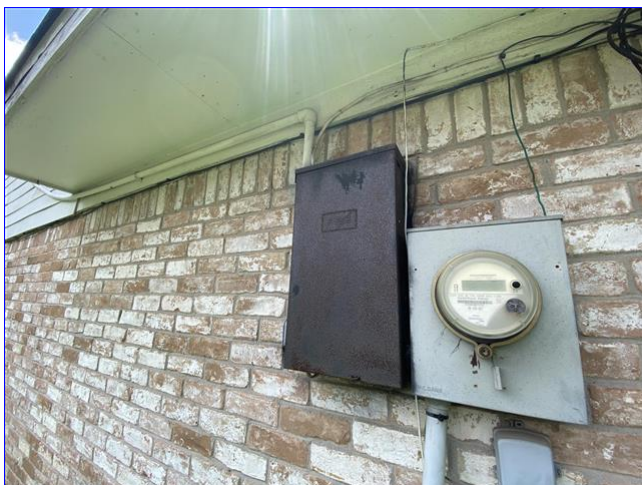
A. Item 3(Picture)

(4) The electrical service panel was severely corroded.

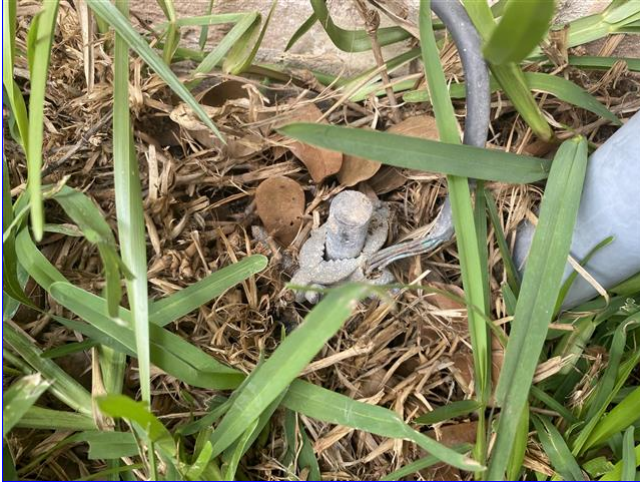
A. Item 4(Picture)

(5) Grounding rod clamp is the incorrect type and should be an acorn clamp.

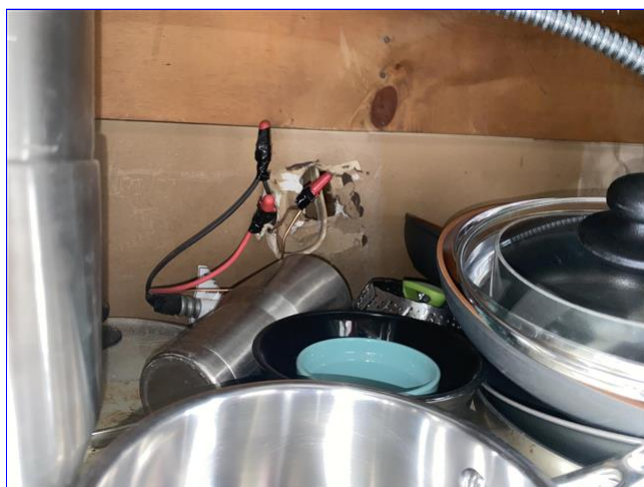
(7) Unprotected wire splices observed at on or more location. All wire splices should be stored inside an approved junction box. This is considered a **FIRE HAZARD AND ELECTRIC SHOCK HAZARD.**

B. Item 1(Picture) Below stove

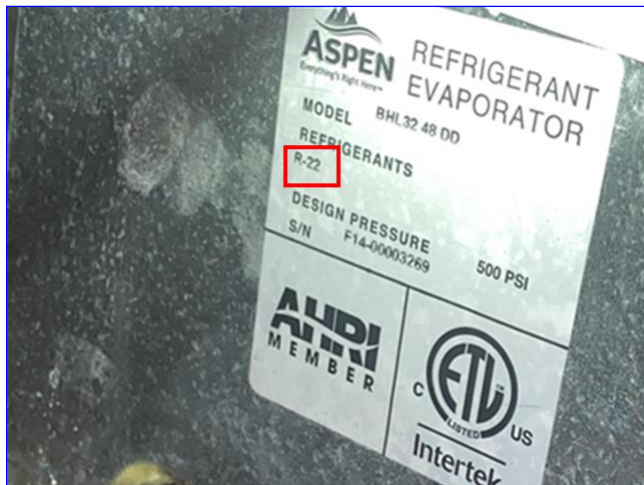
B. Item 1(Picture)

(1) **NOTICE-** The AC unit operates on R-22 coolant. R-22 was phased out and is now illegal to sell in the U.S. as of January 1, 2020. The industry has now switched to R410a (Puron). Some units can be retrofitted to R410a and do not require complete replacement of the cooling equipment. Inspector recommends further evaluation by a licensed HVAC technician to confirm if the current system can be converted or if complete replacement is required. (This is not considered a deficiency and is purely FYI)

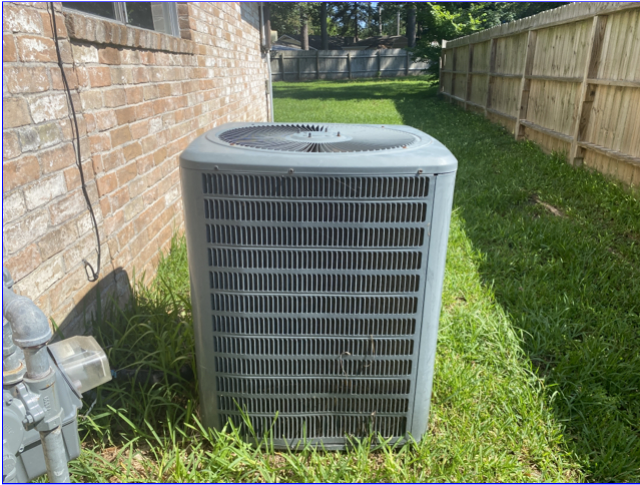
B. Item 2(Picture)

(2) The pad supporting the air-conditioner compressor housing was not level. Over time, this may result in

damage to the fan bearings and a shortened fan lifespan, or it may result in movement of the compressor housing which can stress the refrigerant lines resulting in damage and expensive service. The Inspector recommends that the compressor housing be leveled by a qualified HVAC contractor.

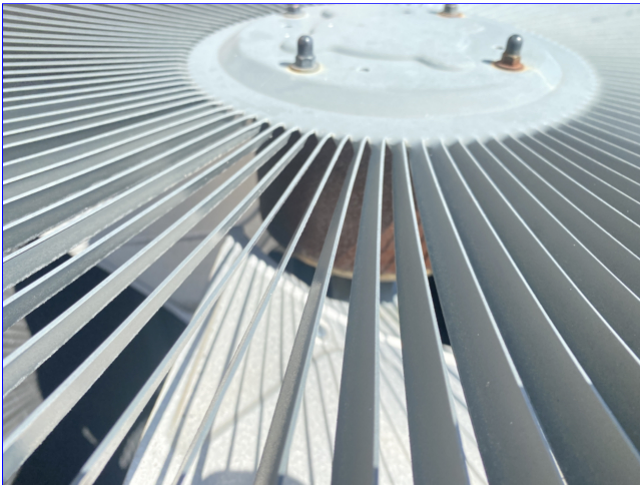
B. Item 3(Picture)

(3) Moderate corrosion was observed on condenser unit fan motor.

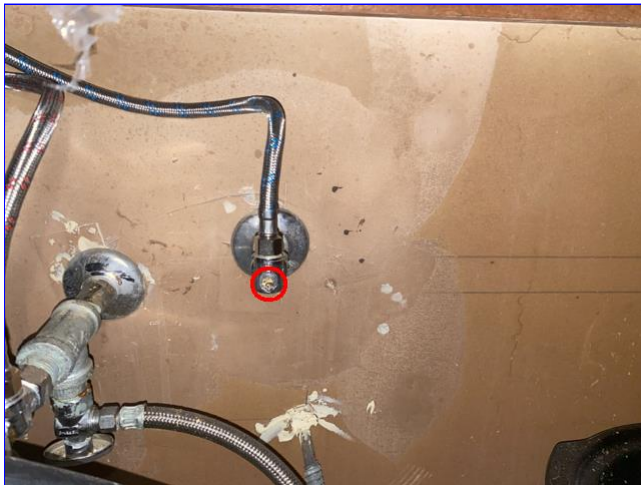
A. Item 1(Picture)

(3) Valve handle was missing at the kitchen sinks cold water supply.

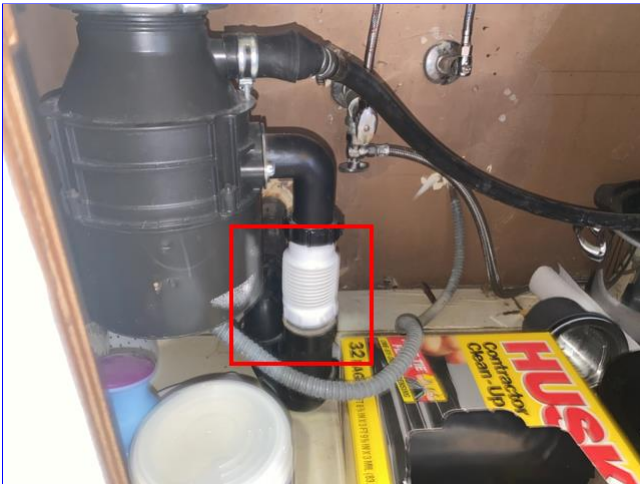
B. Item 1(Picture)

(1) A flexible accordion style drainpipe was observed at one or more sink. This is a maintenance concern as these pipes can trap debris which can lead to drain obstructions. Additionally, flexible accordion style drainpipes often are not rigid enough to resist damage and are prone to leakage. Recommend upgrading to standard ridged pipe

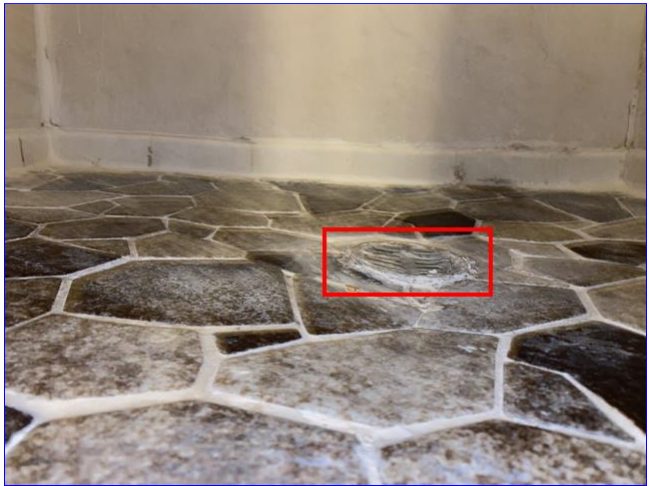
B. Item 2(Picture)

(2) Master shower drain opening was elevated above the the shower floor.

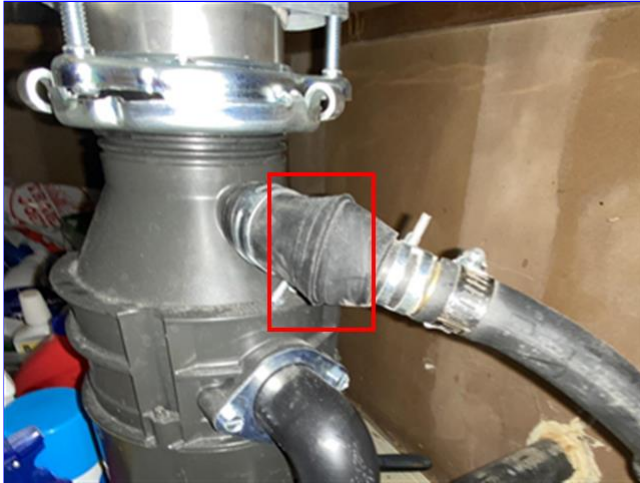
A. Item 1(Picture)

(1) The dishwasher drain appeared to be kinked and should be adjusted to prevent leaks.

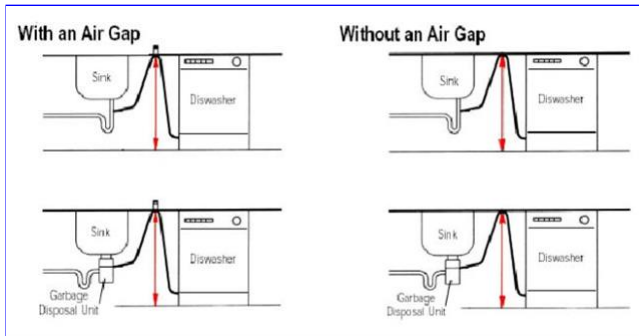
A. Item 2(Picture)

(3) No air gap or high loop was present on the dishwasher drain line. Air gaps are required to prevent back flow of dirty water back into the dishwasher. An air gap can be achieved by installing a back flow prevention device (air gap) or by creating and elevating a loop in the the drain line.
