True Grit Home Inspection

Property Inspection Report

20523 Shadow Mill Ct, Katy, TX 77450

Date of Inspection: 5/7/2021 Time: 11:00 AM

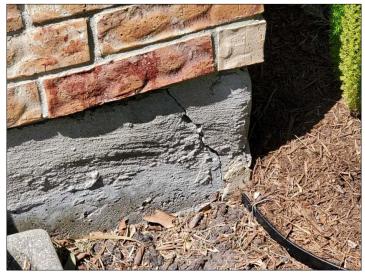
Corner pop noticed. Corner sections of the foundation are not supported as much as rest of foundation. This is not typically an issue, but take notice if cracks begin to form in bricks or mortar above corner pop.

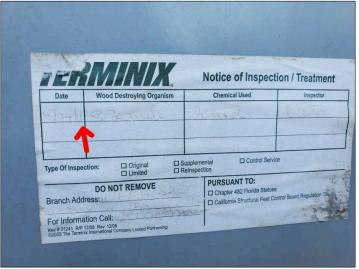
Previous termite treatment noted. Year could not be read.

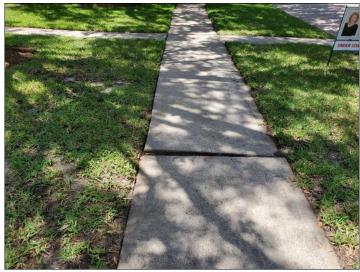
Driveway / sidewalk is cracked and has some tripping hazards.

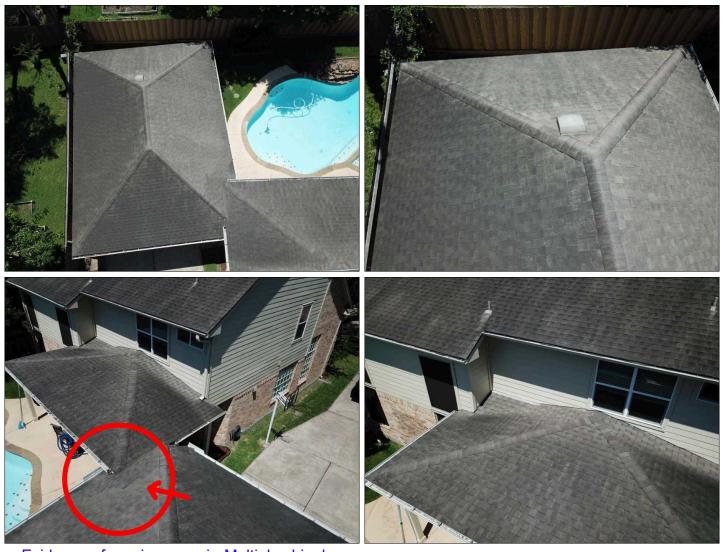
Evidence of previous repair. Multiple shingles present.

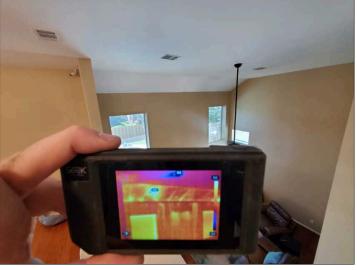
Missing insulation in several places. Noted Via thermal camera.

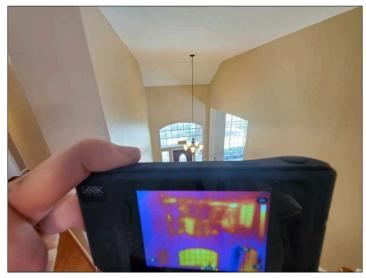
Missing insulation in several places. Noted Via thermal camera.

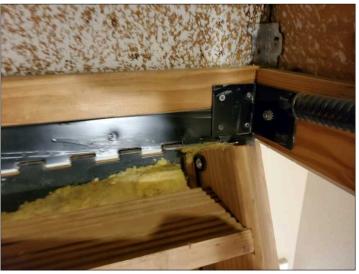
Ladder should be secured with 16d nails where indicated by manufacture, not screws.

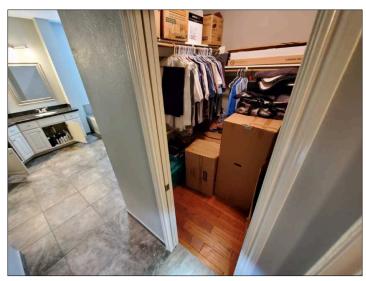
Limited access to some areas due to personal property.

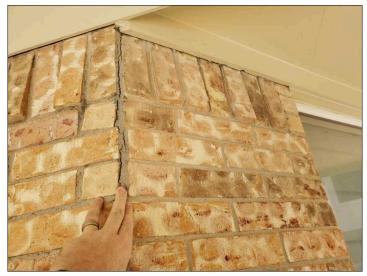
Exterior cracks in brick mortor noted.

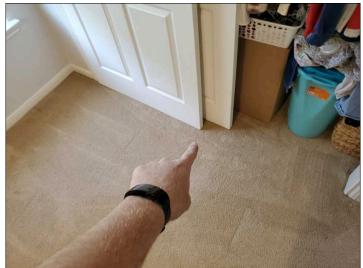
Sliding door missing lower guide. Doors may easily come off track.

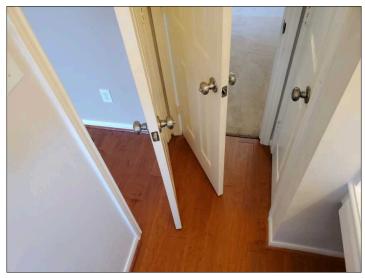
Doors hitting.

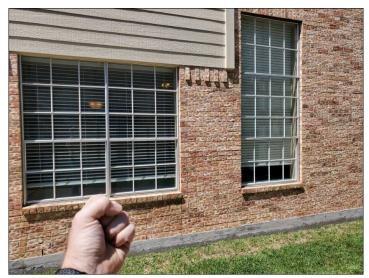
Missing / damaged screens noted.

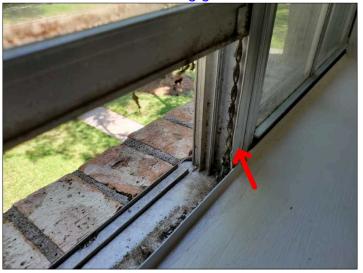
Older aluminum windows are difficult to operate.

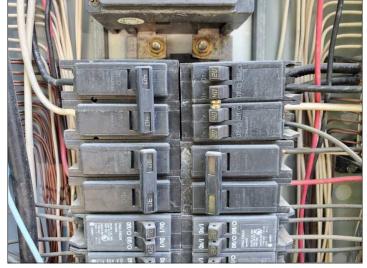
There are white wires in the panel that should be labeled as hot wires

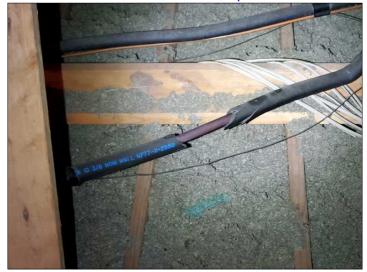
Coolant lines missing insulation in attic space. This will condensate and drip onto attic floor / ceiling.

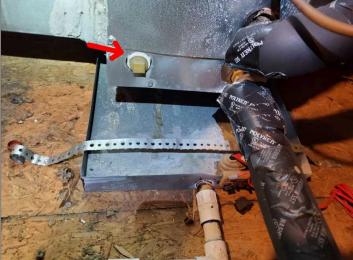
No secondary drain installed. This should drain into a new pan if the primary is clogged.

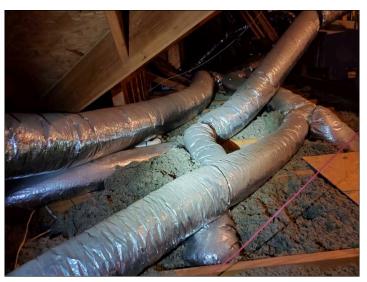
Flex ducting in contact with blown in insulation. This can cause mold growth. Flex ducting should be fully suspended.

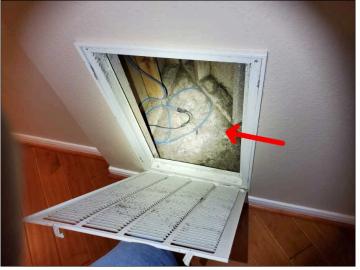
Chase is full of cat and pet hair. Highly suggest cleaning in improve air quality.

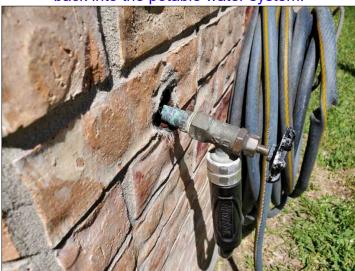
Exterior piping not insulated.

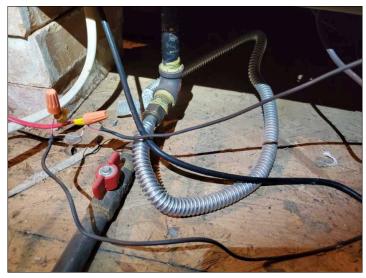
Sediment trap missing / not correct at fuel fired appliance.

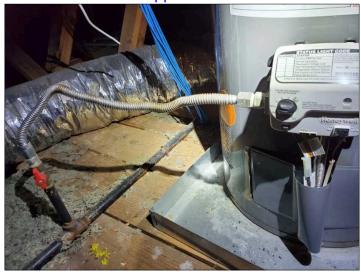
Sediment trap missing / not correct at fuel fired appliance.

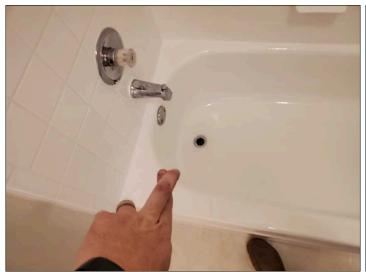
Missing stopper in sink / tub.

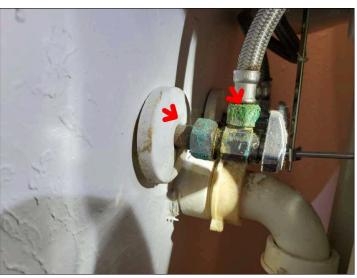
Corrosion and oxidation noted on a few valves. No leaks present during inspection.

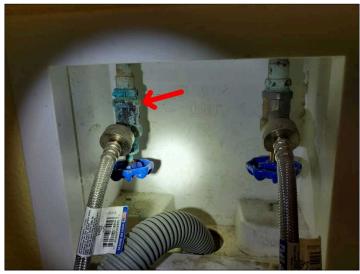
Corrosion and oxidation noted on a few valves. No leaks present during inspection.

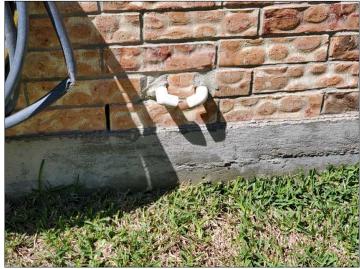
Temperature an pressure relief valve should discharge less than 6" from ground to prevent possible scolding.

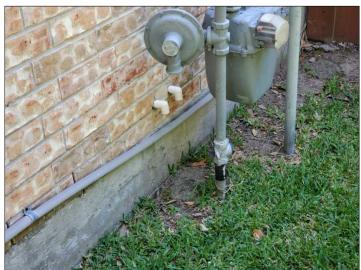
Temperature an pressure relief valve should discharge less than 6" from ground to prevent possible scolding.

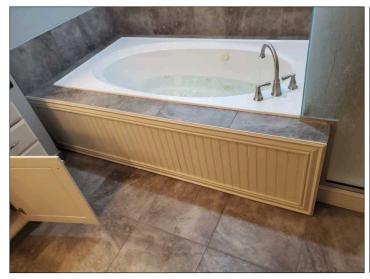
No access panel to pumps or receptacle.

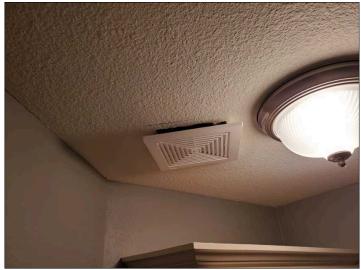
Loose exhaust vent fan.

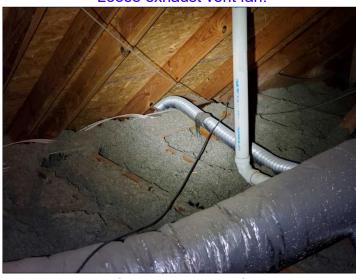
The vent pipe from the exhaust fan terminates and is pointed at the attic roof ridge vent/soffit vent/gable vent. Although, this was within standard building practice at the time this house was built--This is less efficient and can cause a buildup of moisture and eventually mold in the attic. Recommend upgrading to properly route vent(s) to the exterior of the home.

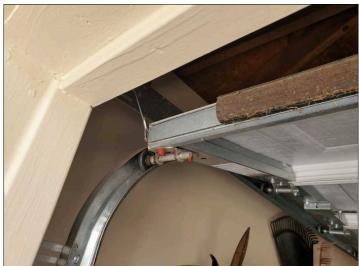
Missing safety test instructions on wall next to the operators.

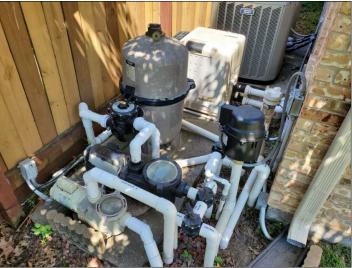
All PVC piping should be painted with UV protectant paint to prevent sun damage and cracking. Along with proper labeling.

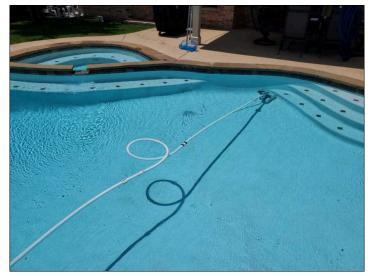
Leak noted in cleaner hose.

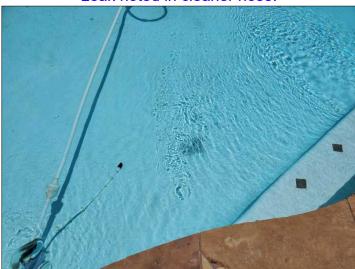
Stains noted in pool surface. Cleaning suggested, Stains noted in pool surface. Cleaning suggested, no cracks noted.

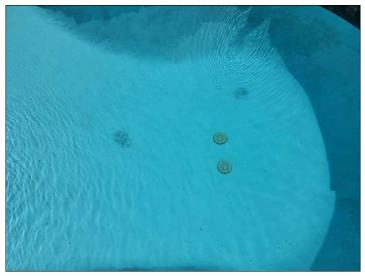
Stains noted in pool surface. Cleaning suggested, no cracks noted.
