# PROPERTY INSPECTION REPORT

Concerning: **1400 Herman Drive Unit 16C, Houston, Texas 77004**

By: **Daniel Selvidge #6120**

**July 24, 2019**

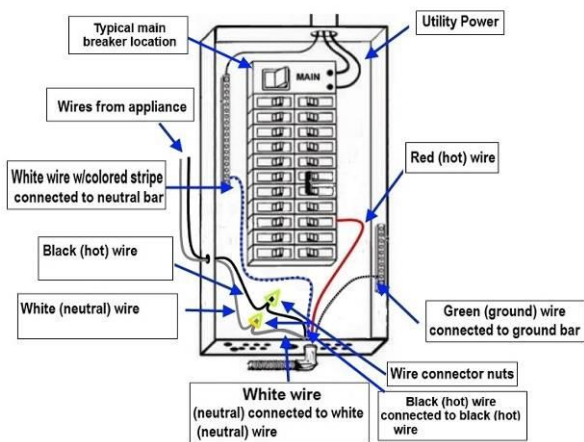
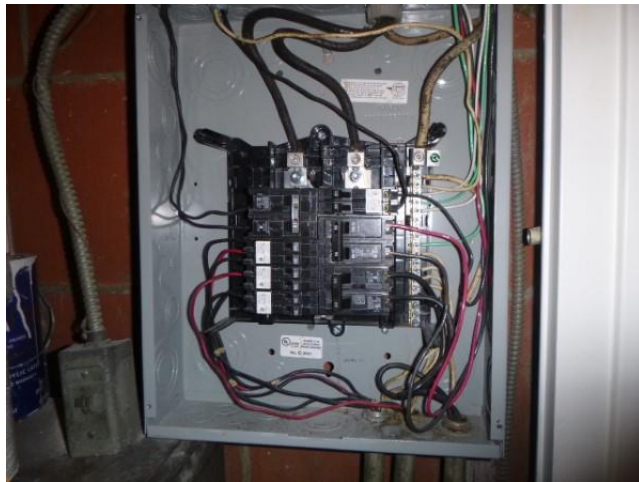
Circuit Breaker Wiring Diagram

The electrical service is provided by a 120/240 volt, single-phase service to a breaker panel located at the foyer closet. The breaker panel was manufactured by Siemens and was rated at 125-amperes. The main service entrance conductors into the breaker panel were nickel plated copper and the branch circuit wiring from the panel was copper. The wiring in the condo was a 3-wire grounded system. (Information)

No items requiring repair were visible at the time of the inspection. The breakers were all properly sized, the panel was properly grounded, and the wiring inside the panel did not need repairs. (Information)

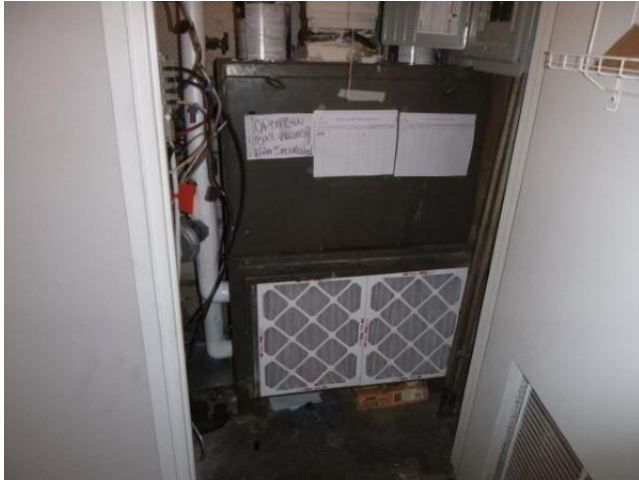
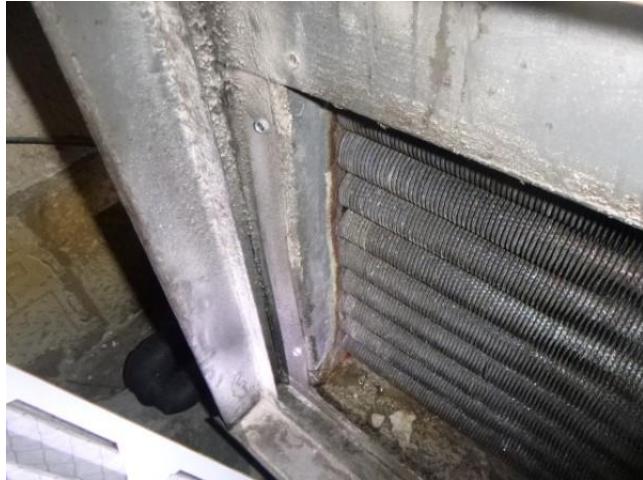
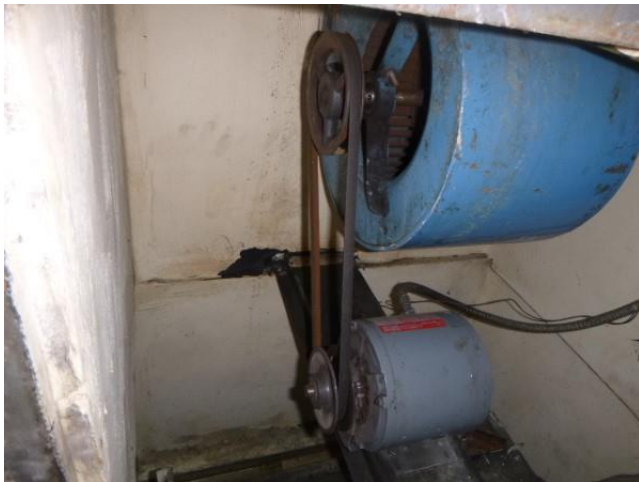
The heating and cooling for the condo was provided by a central supplied heated and chilled water system that provided conditioned water to a fan coil unit located in the foyer closet. The manufacturer of the equipment and age of the equipment was not determined at the time of the inspection, however the equipment appeared to be 20+ years old. (Information)

The equipment was functional at the time of the inspection. However, due to the age and/or condition of the equipment, it is the opinion of the inspector that the equipment has only a limited amount of life remaining. (Information)

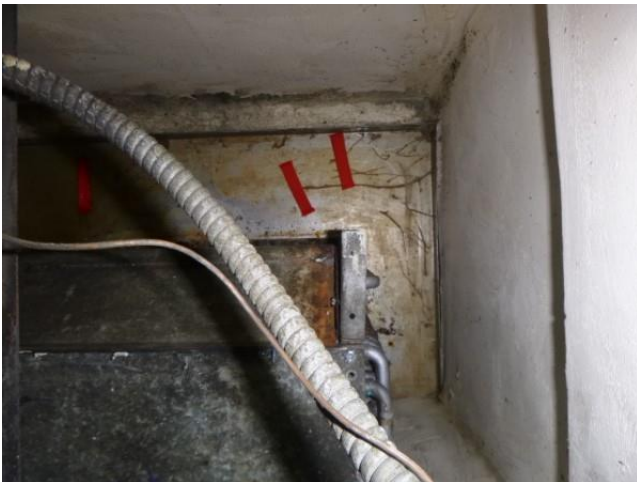
**Fan Coil Unit**

Rust was observed in the bottom of the equipment indicating previous standing water inside the equipment. No water was observed in the pan at this time. Further investigation with the owner and/or a service company is recommended.

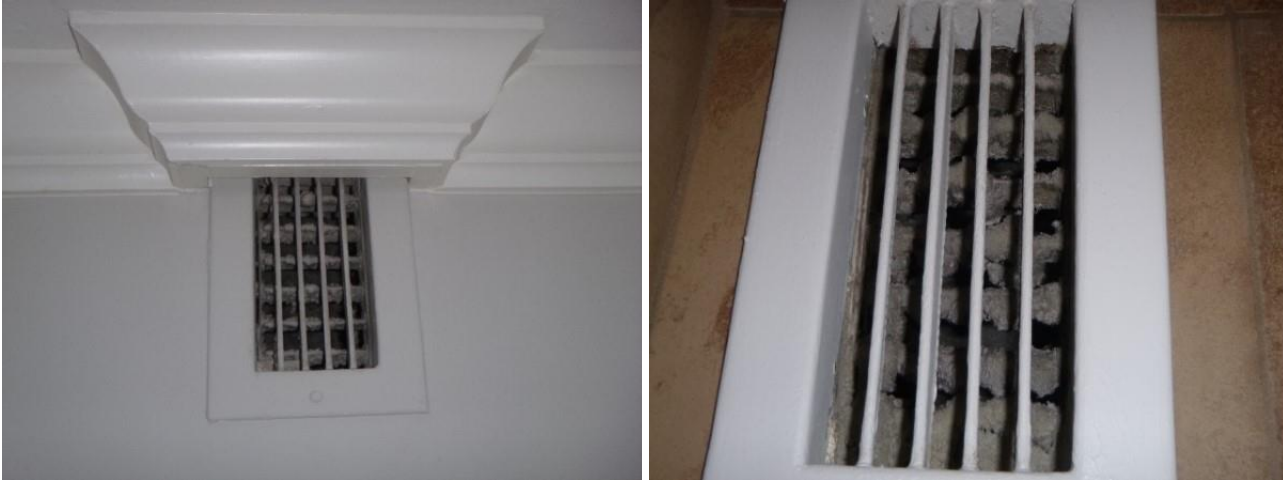
The intake air registers were dirty at the kitchen and bathroom and need to be cleaned. It is recommended that you contact a contractor to provide a cost estimate for any needed repairs.
