REF: CONDITION OF PROPERTY SURVEY

# PROPERTY INSPECTION REPORT

Concerning: **1400 Hermann 16C, Houston, Texas 77004**

**December 9, 2016**

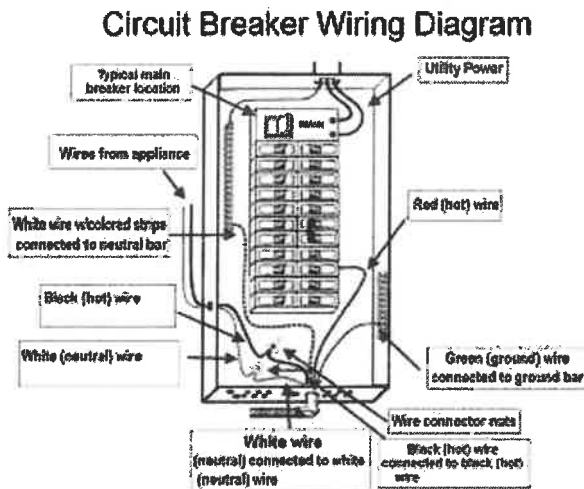
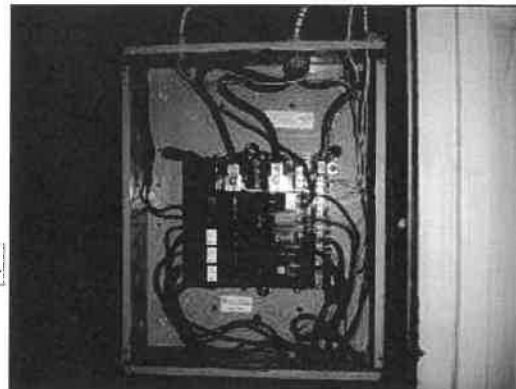
### Breaker Panel Box

The electrical service is provided by a 120/240 volt, single-phase service to a breaker panel located at the foyer closet. The breaker panel was manufactured by Siemens and was rated at 125-amperes. The main service entrance conductors into the breaker panel were nickel plated copper and the branch circuit wiring from the panel was copper. The wiring in the condo was a 3-wire grounded system. (Information)

No items requiring repair were visible at the time of the inspection. The breakers were all properly sized, the panel was properly grounded, and the wiring inside the panel did not need repairs. (Information)

Arc Fault Circuit Interrupters (AFCI) were not installed for the condo at the time of the inspection. The devices are intended to shut off the power to the non-GFCI 120-volt circuits should an electric arc be detected in the circuit. It is noted, from 2002-2008 it became mandatory for all new construction to be equipped with AFCI breakers for the bedroom areas. Currently all non GFCI 120-volt circuits should be protected by AFCI breakers. (Information)

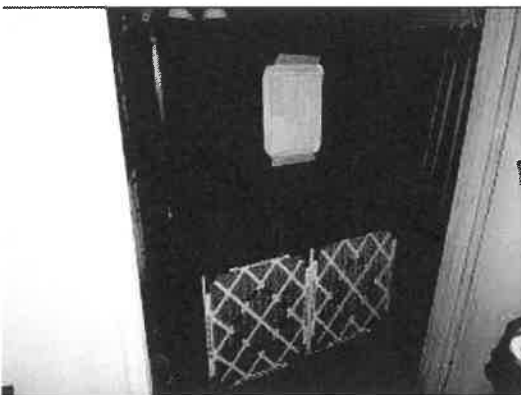
The heating and cooling for the condo was provided by a central supplied heated and chilled water system that provided conditioned water to a fan coil unit located in the foyer closet. The manufacturer of the equipment and age of the equipment was not determined at the time of the inspection; however the equipment appeared to be 20+ years old. (Information)

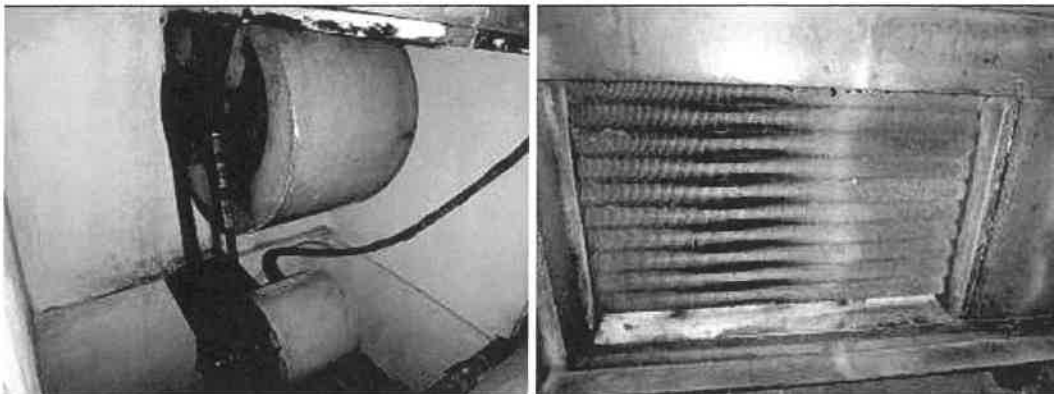
### **Fan Coil Unit**

The equipment was functional at the time of the inspection. However, due to the age and/or condition of the equipment, it is the opinion of the inspector that the equipment has only a limited amount of life remaining. (Information)

The coil and fan blades were dirty and should be cleaned and serviced at this time. It is recommended that you contact a contractor to provide a cost estimate for any needed repairs.

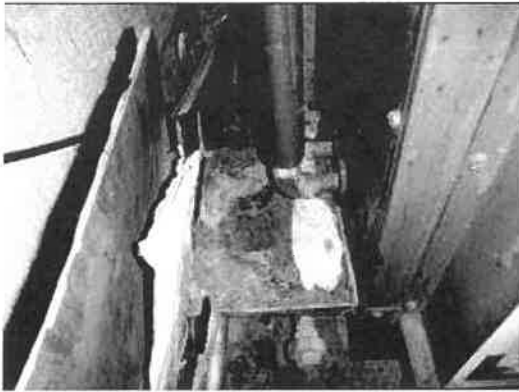
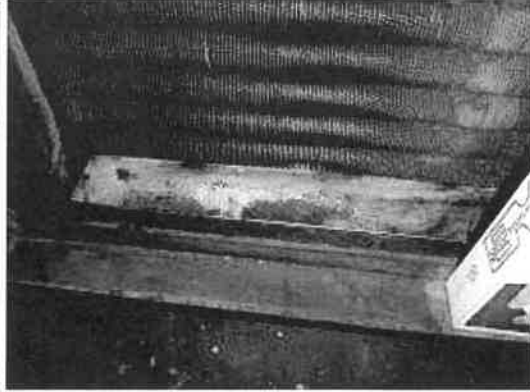
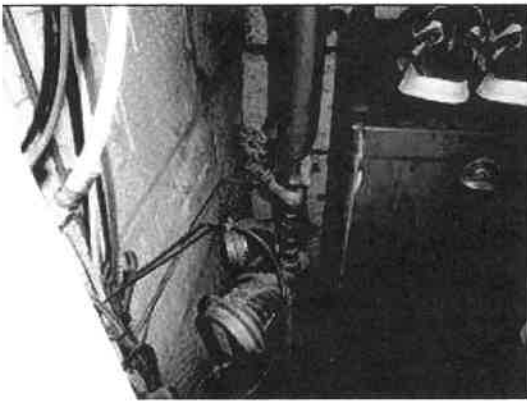
Rust was observed in the bottom of the equipment indicating previous standing water inside the equipment. No water was observed in the pan at this time. Further investigation with the owner and/or a service company is recommended.

The insulation for the water lines is partially missing at the equipment and should be replaced. It is recommended that you contact a contractor to provide a cost estimate for any needed repairs.

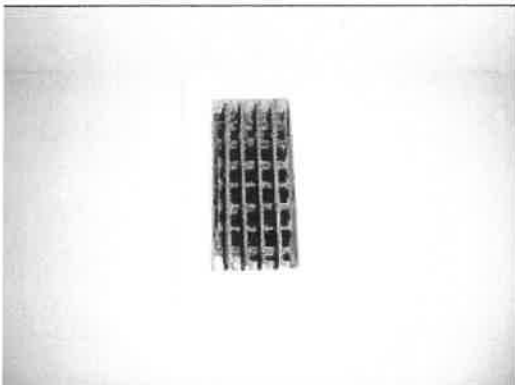
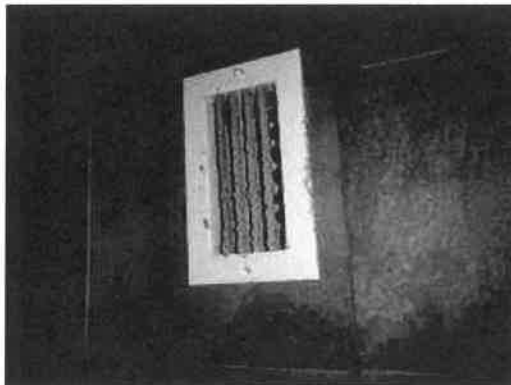
The intake air registers were dirty at the kitchen and bathroom and need to be cleaned. It is recommended that you contact a contractor to provide a cost estimate for any needed repairs.

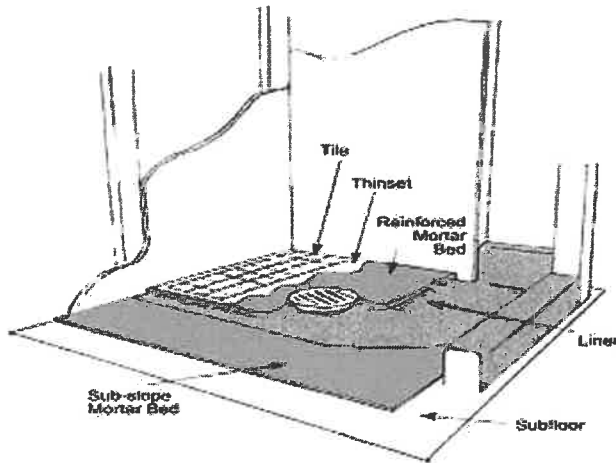
### Tubs/Showers

No visible evidences of a current shower pan leak were visible at the time of the inspection for the shower located at the master bathroom. It is recommended that a plumber be contacted for a comprehensive shower pan leak check. (Information)

No items requiring repair were visible at the time of the inspection to the plumbing on the shower. (Information)
