**Your Professional Inspection Report Has Been Prepared Exclusively For You.**

**Blaik Wisenbaker  
115 Colton Ct  
Montgomery, TX 77316  
May 11, 2021**

# PROPERTY INSPECTION REPORT

**Concerning:** 115 Colton Ct, Montgomery, TX 77316  
(Address or Other Identification of Inspected Property)

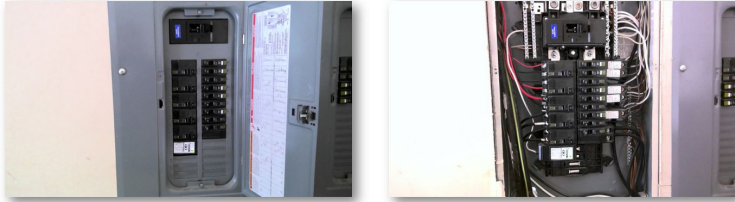
A. Service Entrance and Panels

**Panel Box : Square D**  
**Box Rating : 200 amps**  
**Box Location: Garage**  
**Main Service Entrance: underground**  
**Type of Main Service Wiring: Aluminum**  
**Main Disconnect Rating: 200 amps**

In the Inspectors opinion is the **Main Electrical System** appeared to be in **Operable Condition on the day of the Inspection.**

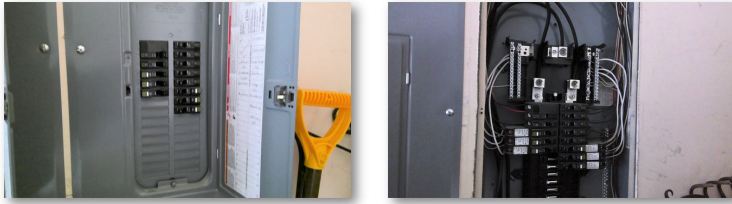
**Sub-Panel:**

**Sub Panel Box : Square D**  
**Box Rating : 200 amps**  
**Box Location: Garage**  
**Main Service Entrance: Adjacent to Main panel**  
**Type of Main Service Wiring: Copper**  
**Main Disconnect Rating: 100 amps**

In the Inspectors opinion is the Sub-Panel Electrical System appeared to be in **Operable Condition** on the day of the Inspection.
