Inspection Report

Property Address:
6411 Waldron Dr. Unit A and B
Houston TX 77084

GOLDEN SCOPE INSPECTION SERVICES

PROPERTY INSPECTION REPORT

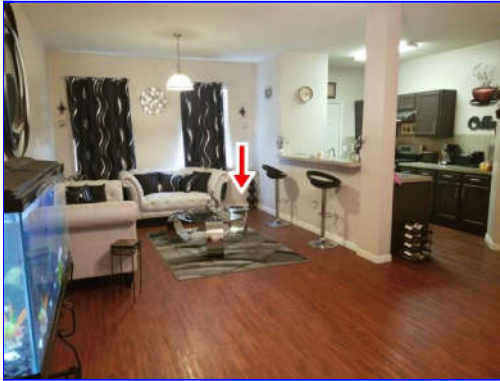
- The foundation has evidence of excess movement. In my opinion this foundation should be further evaluated by structural engineer or foundation specialist. Some observed evidence of excess

movement are: floors found to be excessively out of level, floor is sloping toward the rear right corner of the house, structure on the second level is also sloping toward the right rear corner.

A. Item 1(Picture) Floor is slopes toward the rear right corner of the house

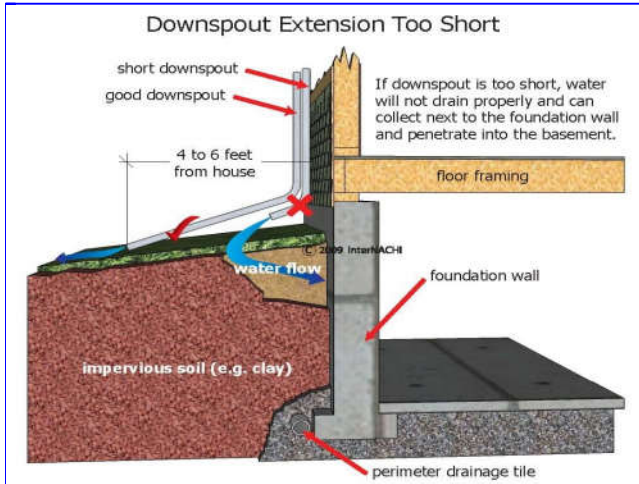
- The downspout need an extension with splash block to carry water away from the foundation. Failure to add these extensions may potentially adversely affect the foundation performance long term.

B. Item 1(Picture) Downspout

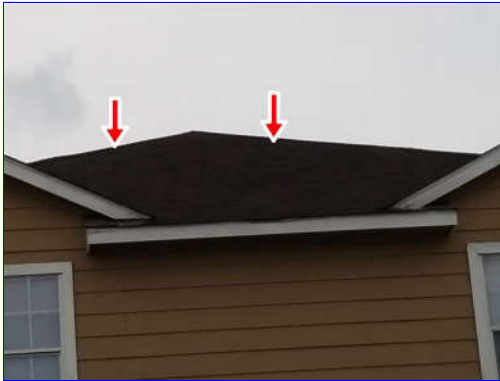
- Shingle(s) was/were observed to have the following defect(s): abrasion damage, damaged, loose granules, lost adhesion with the shingles below them. Repairs are needed. A qualified roofer should be consulted to further evaluate these conditions and provide an estimated cost of repairs.

C. Item 6(Picture) Examples of damaged shingles

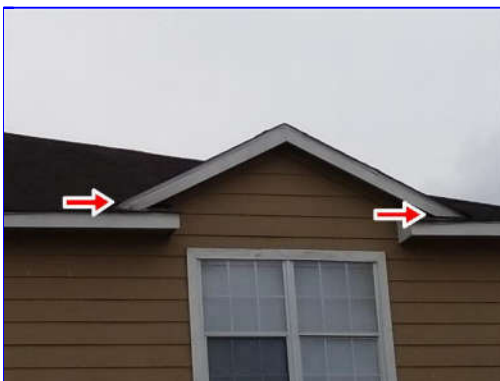
C. Item 10(Picture)

- The clearance of the siding and/or trim at the flashing was observed to be insufficient. This condition leaves the siding and/or trim vulnerable to rot. This detail is usually repaired when siding and/or trim needs repair or replacement or when re-roofing work is performed.

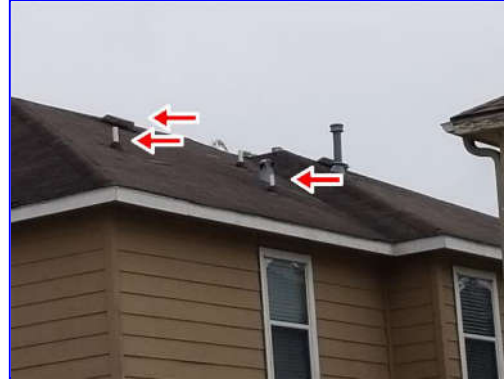
C. Item 13(Picture)

- Most plumbing vent jacks and roof jacks at various locations were observed to be raise, and damaged. They should be replaced to prevent water intrusions.

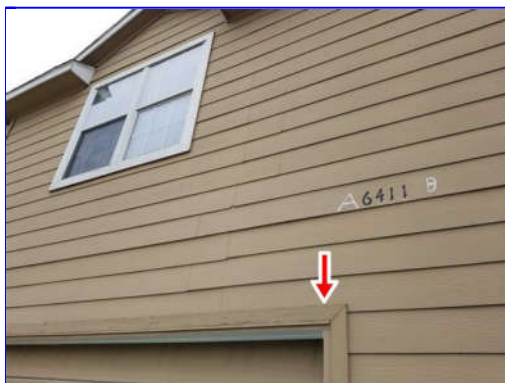
E. Item 6(Picture)

- The siding and/or trim was/were observed to have the following defect(s): are damaged. I recommend repair as needed.

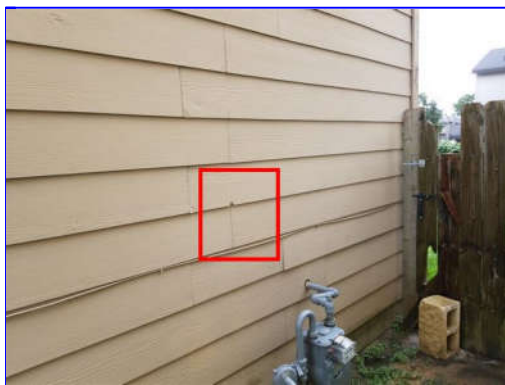
E. Item 38(Picture)

- The siding and/or trim was/were observed to have the following defect(s): damaged loose. I recommend repair as needed.

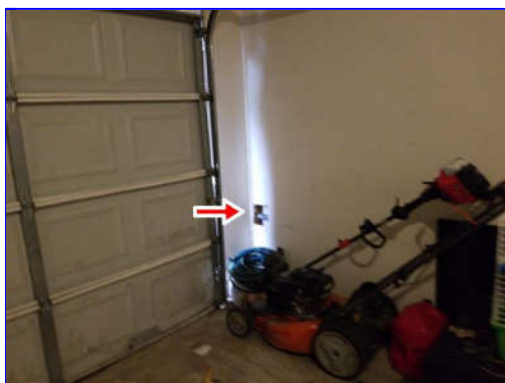
E. Item 59(Picture)

- Damaged interior walls was detected in the garage. It should be repaired.
- The trim at the front entrance is water damaged. It should be replaced.

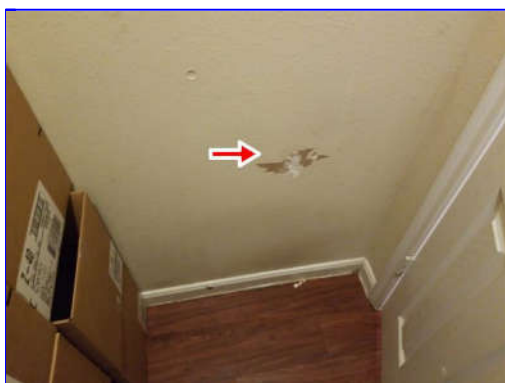
E. Item 61(Picture) first level storage

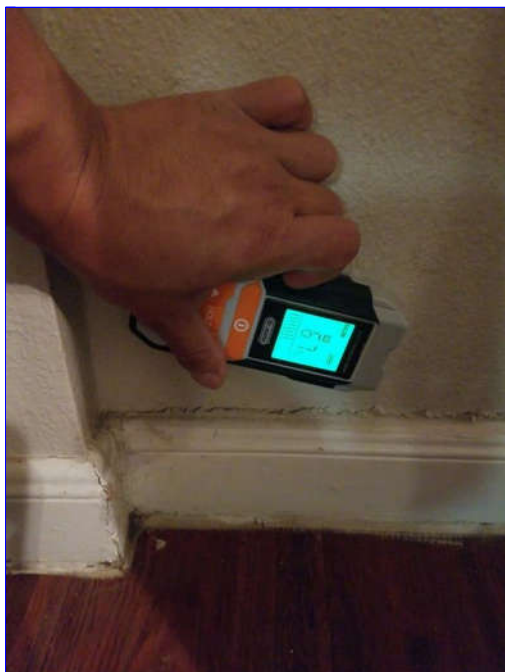
E. Item 62(Picture)

- An organic biological substance was/were observed to be present on walls, ceiling or other surfaces. We did not inspect, test or determine if this growth is or is not a health hazard. The underlying cause is moisture or dampness. I recommend you contact a licensed mold inspector for investigation or correction if needed. This is a potential safety hazard and should be investigated further.
- The wall(s) in various locations was/were observed to have the following defect(s): water damaged at the base boards and at the drywall. Excessive moisture at the wall was confirmed with a moisture meter. This condition appears to have been caused by water intrusion Sheetrock and insulation affected by moisture should be removed and replaced. Preventive measures for microbial hazards should be undertaken by a qualified, verified professional

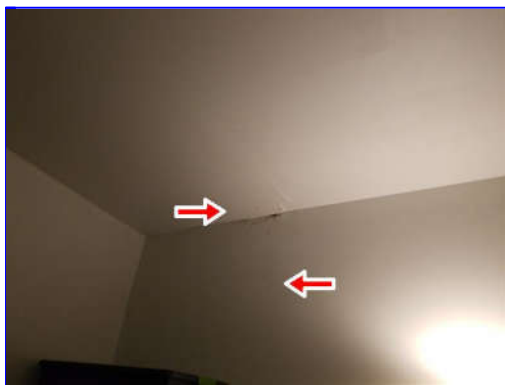
- Evidence of moisture intrusion was observed at the ceiling in various locations. The area could not be reached to test with a moisture meter. The source of water intrusion appears to originate at the exterior of the home Sheetrock and insulation affected by moisture should be removed and replaced. Preventive measures for microbial hazards should be undertaken by a qualified, verified professional
- An organic biological substance was/were observed to be present on walls, ceiling or other surfaces. We did not inspect, test or determine if this growth is or is not a health hazard. The underlying cause is moisture or dampness. I recommend you contact a licensed mold inspector for investigation or correction if needed. This is a potential safety hazard and should be investigated further.

F. Item 4(Picture) garage

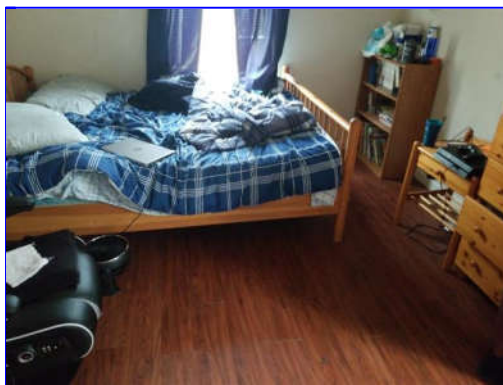
F. Item 9(Picture)

- The second level including both rear bedrooms was observed to be sloping toward the rear right corner of the house. This condition is likely related to foundation movement. Further evaluation and repairs should be undertaken.

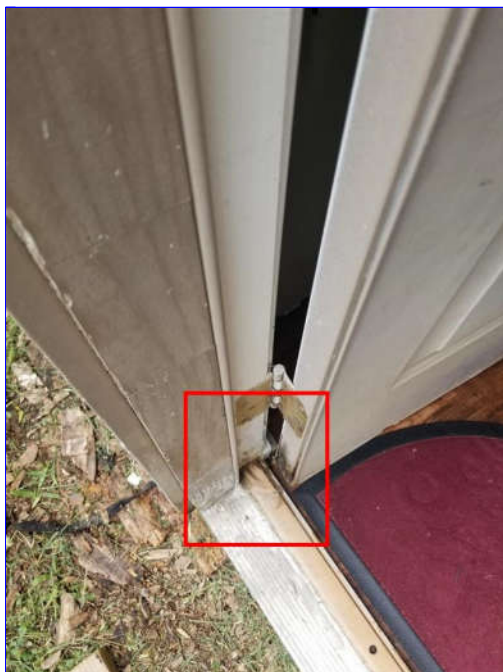
G. Item 1(Picture)

- The rear door was observed to have excess air gap, damaged weather stripping, door and frame are deteriorated at the bottom
- The door to the garage has damaged weather stripping

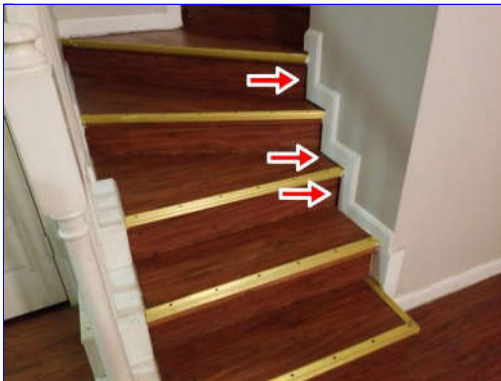
I. Item 1(Picture)

- Several steps are not properly cover along the risers and steps. They should be repaired or sealed.

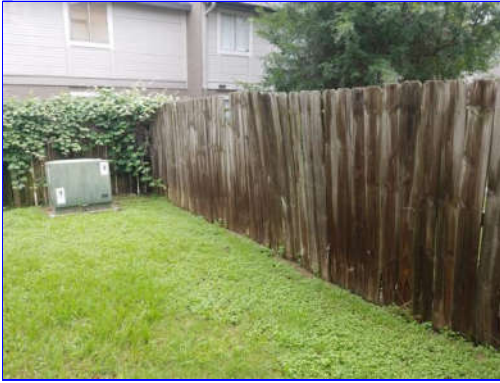
K. Item 1(Picture)

- The fence was observed to damaged. Repair or replacement should be made.

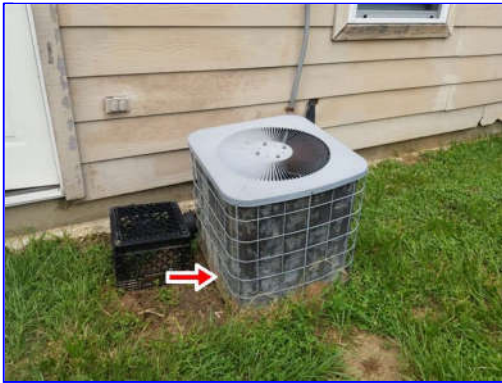
B. Item 10(Picture)

- Severe damage to the condensing unit fins was observed. This lessens the efficiency and may result in other conditions developing with the HVAC system. A qualified, verified, licensed HVAC technician should be consulted regarding repair or replacement.

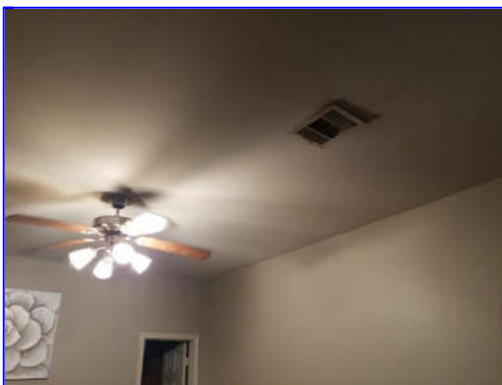
C. Item 1(Picture)

- Several supply registers were observed to be loose. They should be secured.

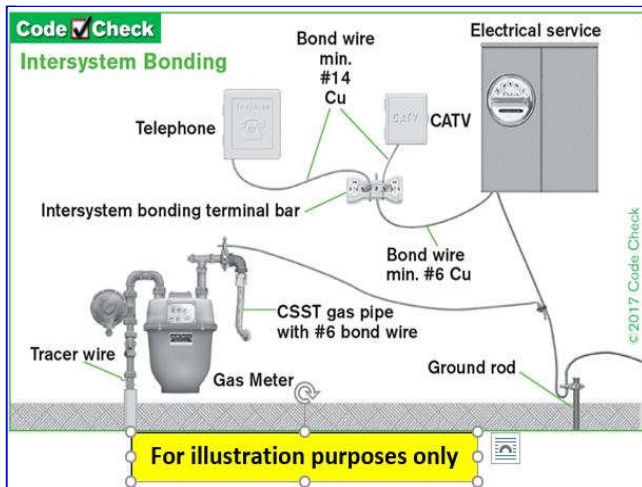
- Both gas meters were observed to not be bonded. Proper bonding should be metal to metal. Paint may have to be removed to ensure proper bonding. The utility company should be contacted regarding this condition.

E. Item 1(Picture) Gas meter bonding
