Date of Inspection: 7/30/2017 Time: 10:00 AM

PROPERTY INSPECTION REPORT

Concerning: 415 22nd St, 3C
Galveston TX, 77550
(Address or Other Identification of Inspected Property)

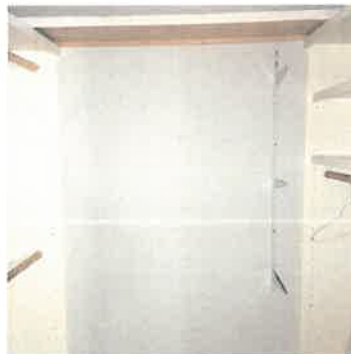
- The metal shelves installed in the closet was anchored to the wall using drywall screws with no drywall anchors. The vertical metal supports were not properly installed per the system/manufactures design. The system design is to use a main metal horizontal bracket that is anchored to the interior studs then the vertical brackets are then hung on the horizontal metal bracket. When checking for proper installation the left side pulled out of the wall. The installation appears unprofessional. I recommend proper repair to help prevent future issues once storing items on shelves.

Improperly installed metal shelving unit in closet

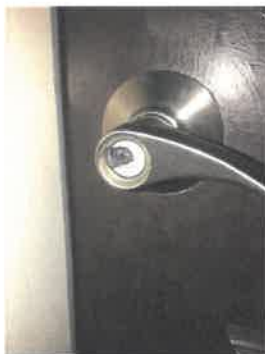
- The front door lock on the door knob/handle appears to have been drilled out. This lock will need to be replaced. I recommend replacing the door knob or replace the lock mechanism by a locksmith.
- The front entry door shows light through missing/damaged weather stripping. The weatherstripping is the stick on type which is prone to failure. The door does not appear to sit plumb within the frame. I recommend repair to help prevent air infiltration. I recommend further evaluation for repair options prior to option ending by a qualified contractor.
- The bedroom closet entry door did not latch. I recommend correcting for proper operation.

Damaged front door lock

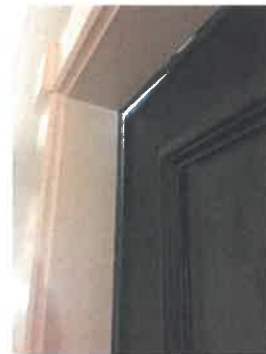
Front door weatherstripping issue

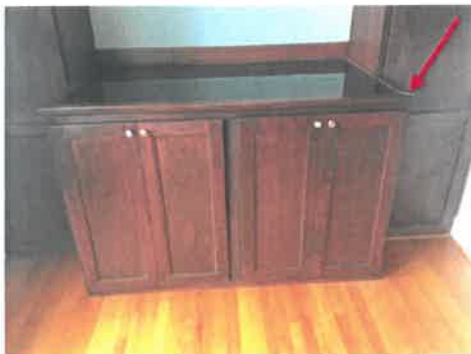
- The laundry cabinets do not appear to have been professionally installed. The doors are spaced too far apart and do not overlap. The right side cabinet joint is slightly loose. I recommend better securing to help prevent damage.

Unprofessional installation

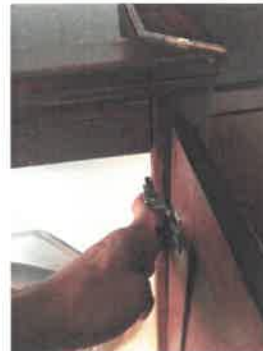
Loose joint

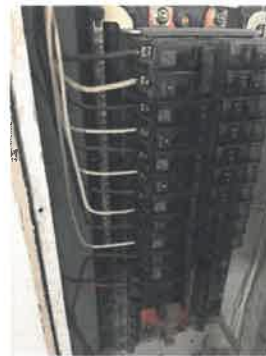
- White wire which is associated with the "neutral" wire was found to be installed on a hot breaker. This is considered unsafe due to no labeling or correct color coding. This wire is intended to be a hot wire with incorrect color coding. I recommend installing black electrical tape at both ends of this circuit to change the color for proper and safe identification.

Neutral wiring as hot

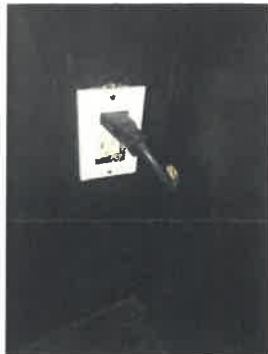
- The power cord for the washing machine was found to be routed through the cabinet. This type of cord is not approved to be installed through cabinets and walls. I recommend further evaluation to relocate the receptacle to be behind the washing machine.

Washing machine power cord is routed through the cabinet

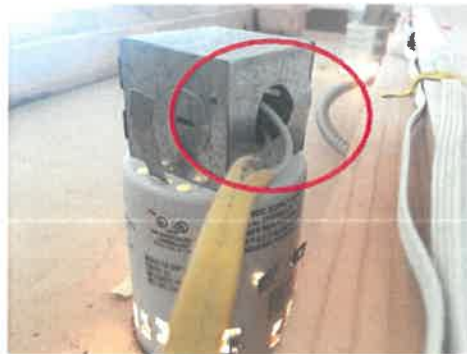
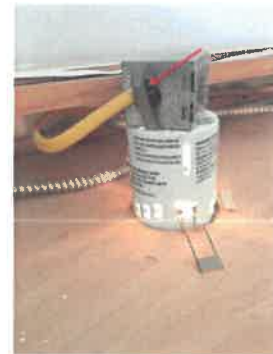
- The electrical wiring installed at the recessed lights above the washer and dryer area is missing the wiring protection when entering a metal housing. This is considered a safety issue and should be corrected by a licensed electrician.

Missing wiring protection

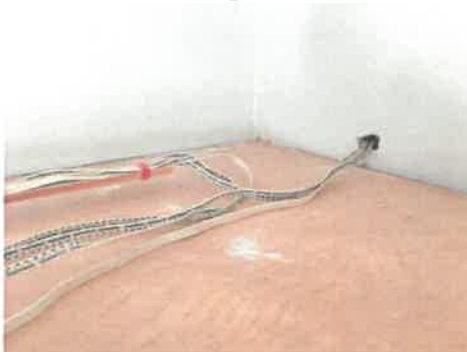
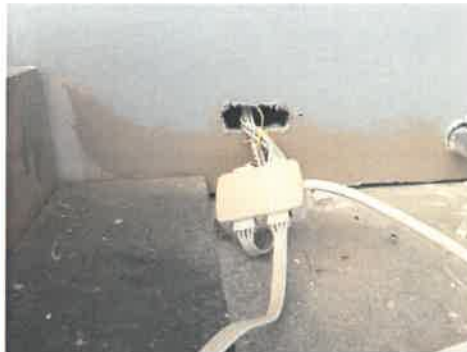
- The wiring for the LED lights was found to be routed through the wall between the kitchen and the laundry area. This is considered unprofessional and should have been routed through a protective conduit. I recommend repair by a licensed electrician.

LED wire routing through the wall

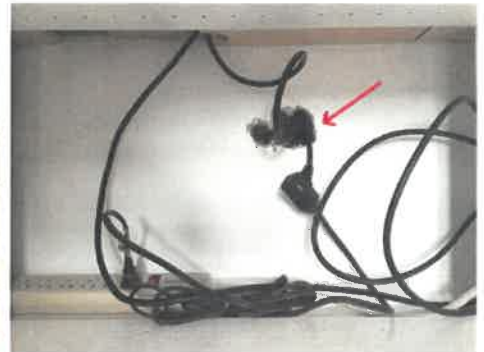
- The power cord for the TV was found to be routed through the wall. The cord is plugged into an extension cord that is plugged into the receptacle that is partially covered by the bench. This type of cord is not approved to be installed through walls and is recommended to be replaced by a licensed electrician. This is considered a potential safety hazard.

Electrical wiring from the TV is routed through the wall

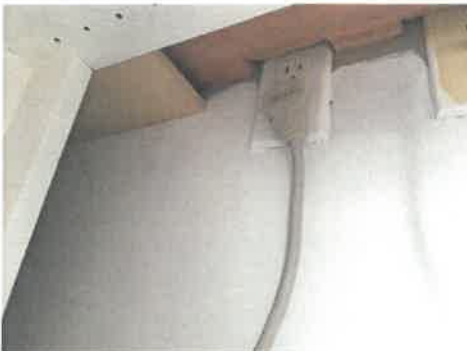
- The receptacle installed behind the base cabinet/bench under the living room TV area was partially covered. This may make access/repairs very difficult. I recommend further evaluation by a licensed electrician to relocate the receptacle.

Blocked receptacle behind bench

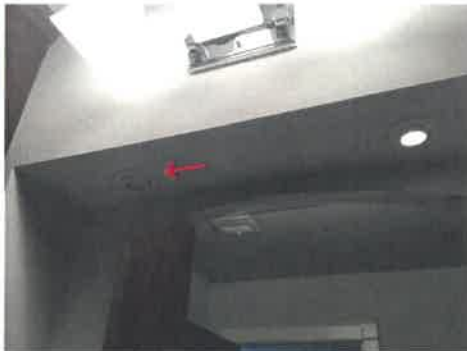
- The recessed light fixture installed in the bathroom just above the medicine cabinet/mirror was not operational on the left side. I recommend replacing the lightbulb and function testing. If this does not correct the issue I recommend further review and troubleshooting by a licensed electrician.

Inoperative bathroom light bulb

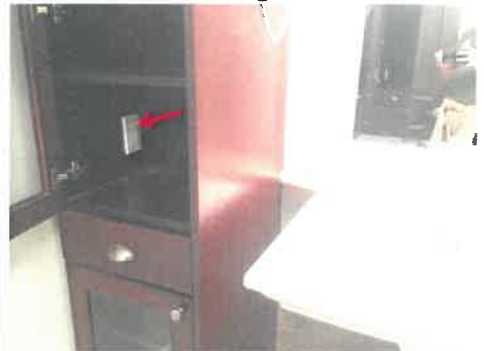
- The bathroom receptacle was found to be installed inside of the cabinet left of the sink. This is not considered very accessible or very usable. I recommend a licensed electrician relocate the receptacle or install a second one. I do not recommend storing items on the same level as the receptacle in the cabinet.

Bathroom receptacle

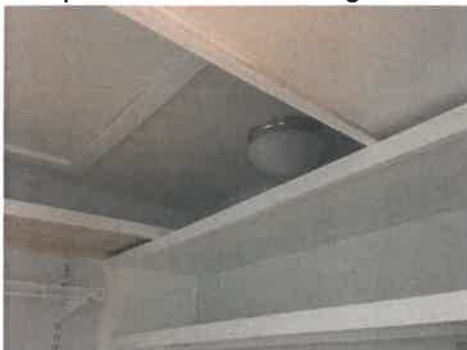
- The bedroom closet light fixtures were not operational at the time of the inspection. I believe the bulbs to be burnt out. I recommend replacing the bulbs and further function testing. If function testing after bulb replacement does not correct the issue, I recommend further evaluation for troubleshooting and repair options by a licensed electrician prior to your option period ending.

Bedroom closet lights inoperative

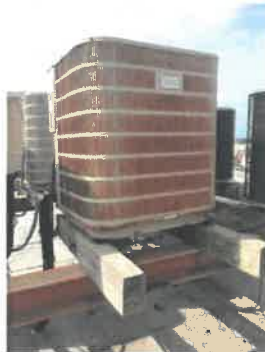
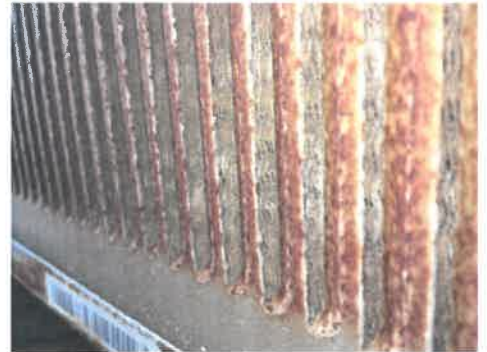
- The condensing unit(s) installed at the exterior appear to have dirty/damaged/corroded coils and may need to be cleaned and serviced. I recommend repair/service by a licensed HVAC contractor.
- The condensing unit and disconnect were not labeled very well. I recommend better labeling so servicing will be easier to locate equipment.
- The HVAC system was not operational at the time of the inspection. I recommend further evaluation and repair by a licensed HVAC contractor.

Dirty condensing coils

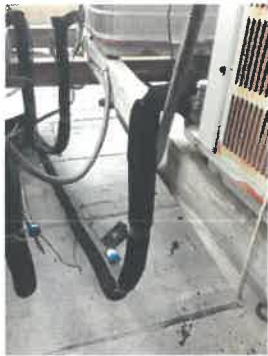
Refrigerant piping hanging with no support

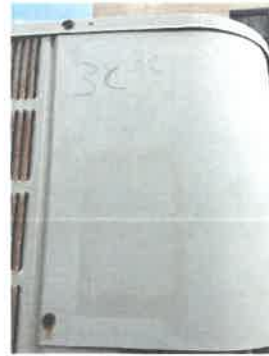
Poor labeling and missing data plate

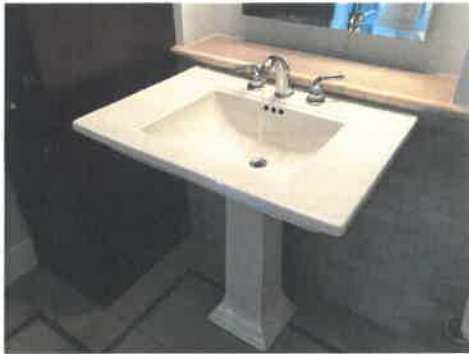
Comments:
 • The bathroom pedestal sink was slightly loose at the wall/base. I recommend repair as a loose connection now may get worse over time. I recommend further evaluation by a licensed plumber.

Loose pedestal sink (slightly)

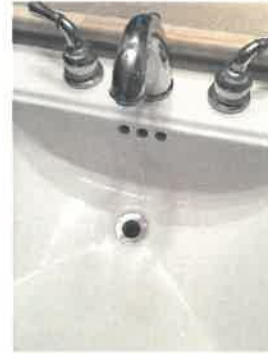
Missing pop up drain stopper

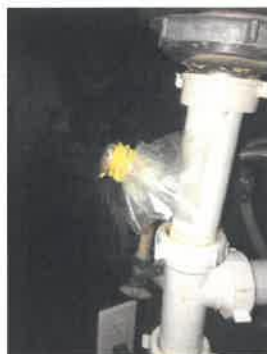
Comments:
 • The left side drain at the kitchen sink still has the connection for the dishwasher hose attachment. The drain has what appears to be a plastic bag secured with a rubber band. While this was not leaking at the time of the inspection there is a good chance it eventually will. I recommend a licensed plumber replace the pipe for one without the connection.
 • The drain stopper was not installed at the bathroom sink. I recommend installing for ease of use to fill the sink. I recommend repair by a licensed plumber.

Unprofessional repair at kitchen sink drain
