PROPERTY INSPECTION REPORT

243 Capriccio Lane
Montgomery, TX 77316

Report Number: 042519-Yazbak

By: John Nobles, Lic #6907 04/25/2019
(Name and License Number of Inspector) (Date)

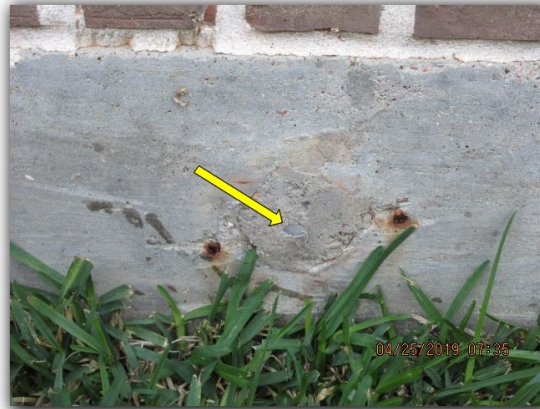
- Exposed post tension cable ends were noted along the perimeter beam of the foundation. The cable ends should be properly cleaned and sealed to reduce the risk of corrosion.

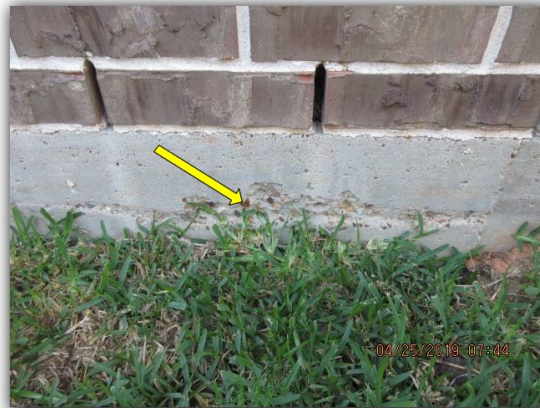
- Surface deterioration (known as spalling) was observed along the perimeter beam of the foundation. This condition is common and does not usually represent a structural concern. The spalling areas should be considered for repairs to prevent the exposed aggregate from becoming loose and falling out.

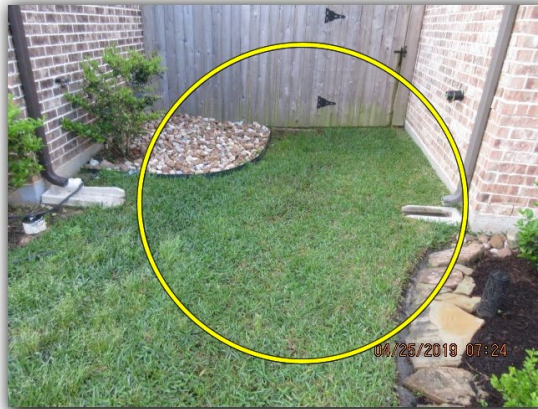
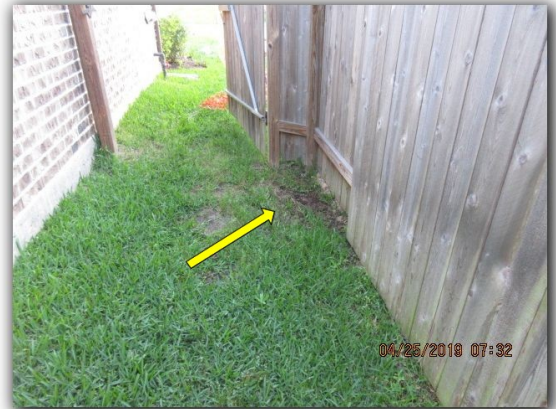
- Previous standing water was noted along the final grading/yard (Right Side of House, Left Side of House). This condition requires further investigation and repairs undertaken as necessary to ensure proper water drainage to the street and prevent water pooling.

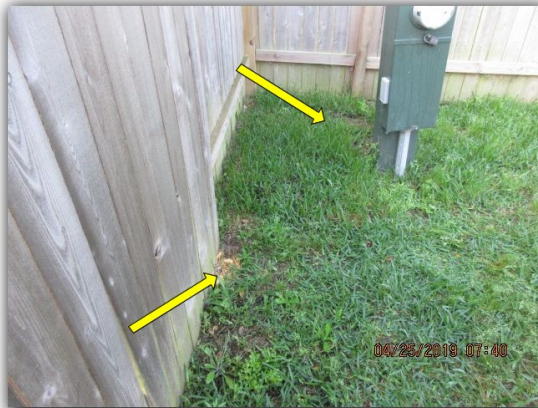
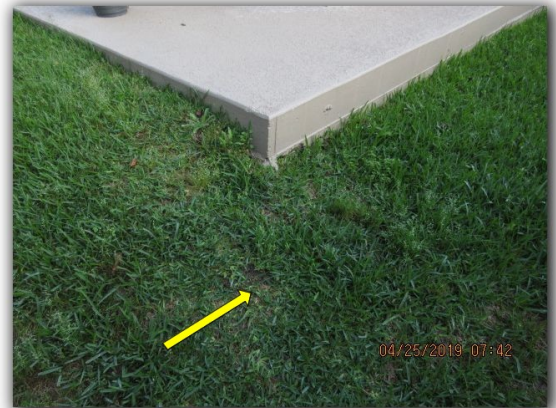
- Given the slope design of the finished grading, the protection from soil erosion appeared to be marginal at the time of inspection (Back Yard). The builder should be consulted to further evaluate this condition and remedies available for correction if needed.

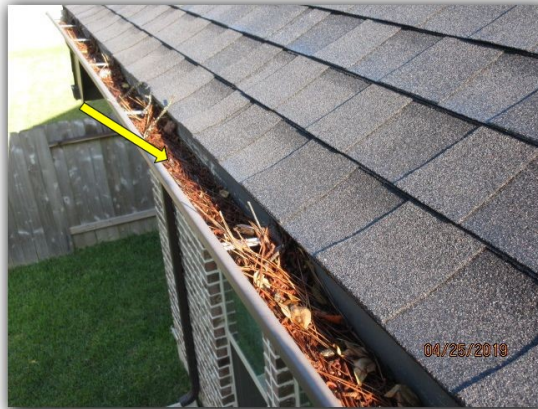
- Some of the gutters require cleaning. This should be part of a regular maintenance program.

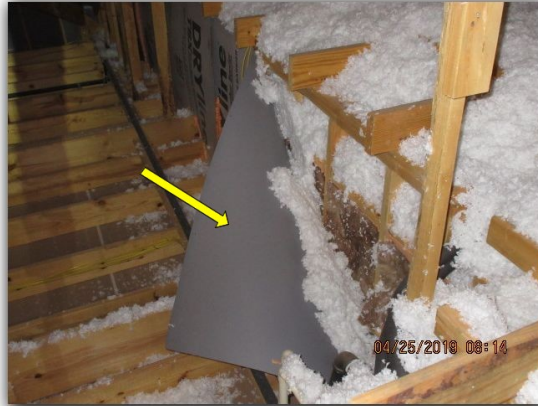
- Some of the thermo-ply type sheathing along the some of the walls appeared to be loose and/or damaged (Attic Area). These conditions should be further investigated and repairs undertaken as necessary.

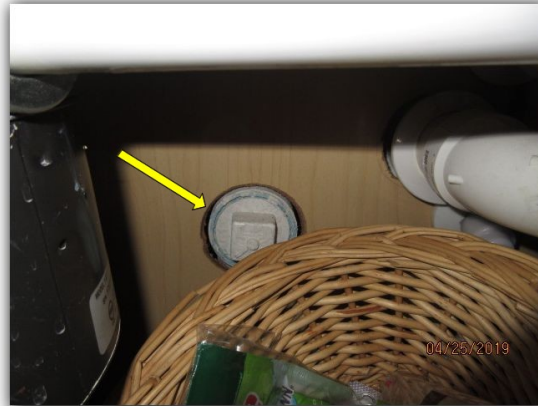
- The interior wall openings around the plumbing stub-outs should be sealed properly below all sinks. Sealing the openings will reduce the risk of drafts from within the walls and insect activity.

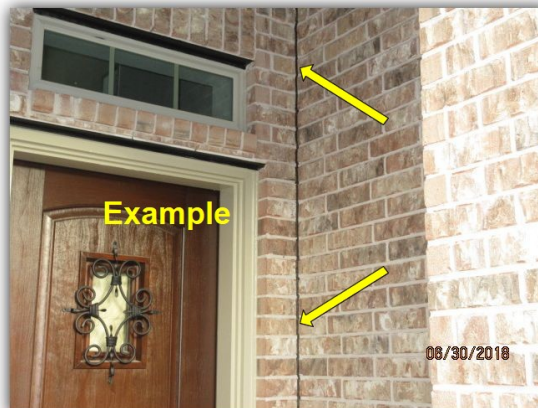
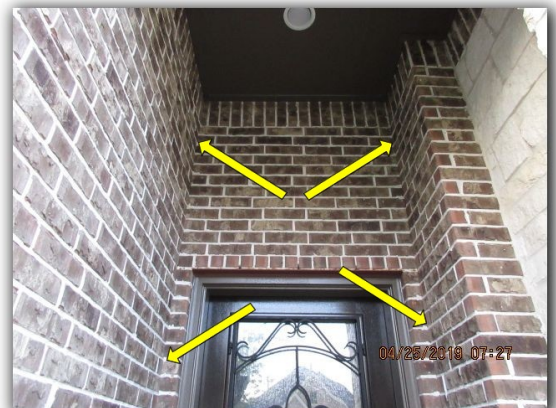
- Vegetation contact was observed along some of the exterior walls. Vegetation growth should be properly maintained to provide adequate clearance from the exterior walls of the house. This will allow adequate visibility for preventive maintenance inspections and reduce the risk damage along the exterior sidings.
- The caulking was noted missing or not installed along some or all the vertical inside brick corner junctions (Front Side of House). As preventative measures, these vertical junctions/joints should be properly sealed to reduce the risk of moisture penetration and insect activity. Under current building standards/ practices, exterior walls shall provide the building with a weather-resistant exterior wall envelope (**IRC 703**). The builder should be consulted to confirm that this was not overlooked on the building plans.

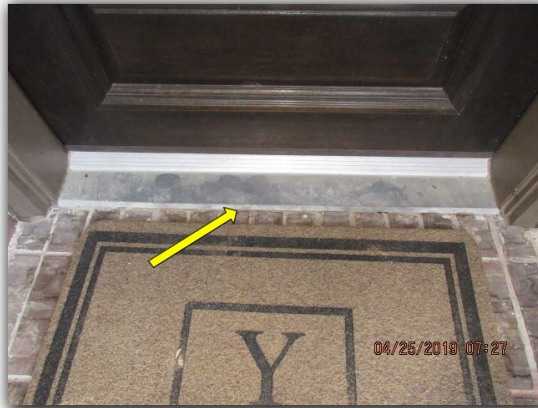
- As preventative measures, the threshold and step junctions along all exterior entry doors should be properly sealed to reduce the risk of water penetration and insect activity (Front Entry, Rear Entry).
(See Exhibit Below)

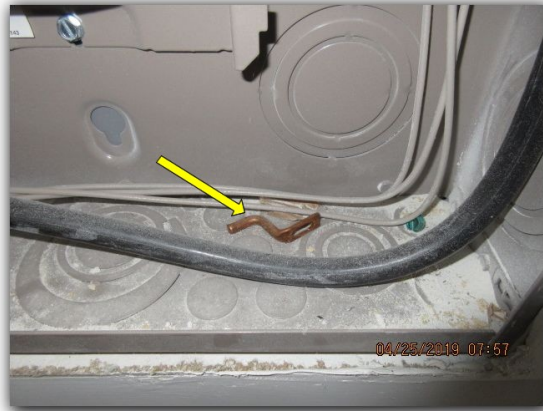
- The copper bond brackets inside the panel box were not attached or secured to the bus-bar at the time of inspection.

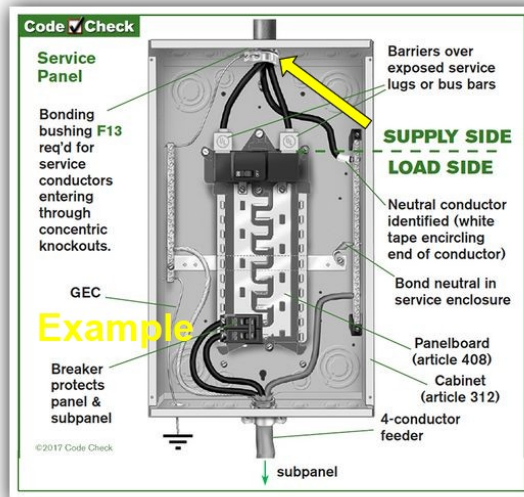
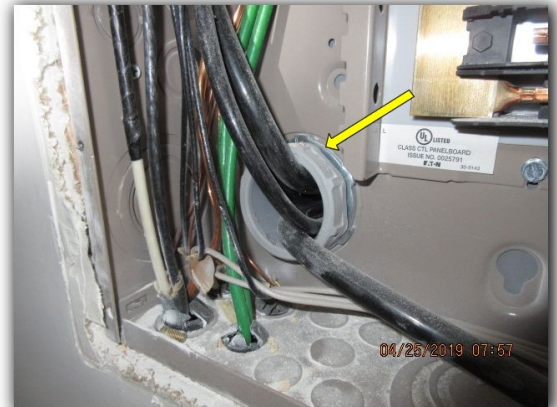
- The metal bushing where the service conductors enter through the box is not bonded. Current building standards require bonding metal bushings where the service conductors enter through concentric knockouts.

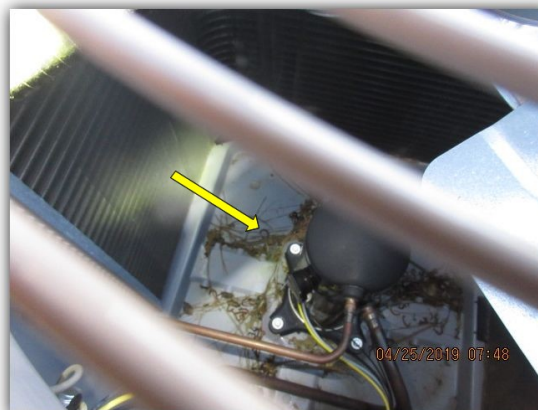
- The condenser/compressor unit of the air conditioning system appeared to be dirty and requires cleaning.

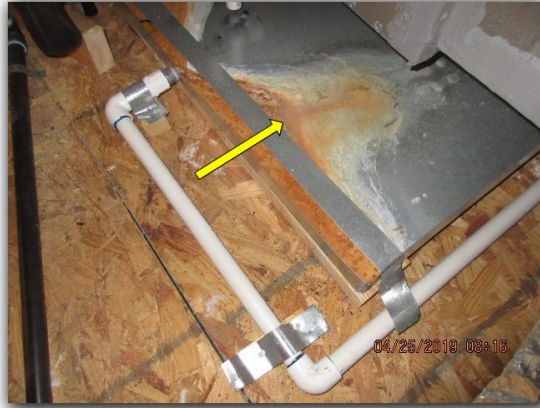
- Rust/damage was noted along the safety catch pan below the evaporator cabinet in the attic area. This condition requires further investigation and repairs undertaken as necessary to reduce the risk of water damage to the structure.
- Evidence of previous water accumulation and corrosion was noted in the auxiliary/safety catch pan under the evaporator unit. This condition is indicative of a clogged primary drain line or improper gravity flow from the primary drain line. This condition requires further investigation and repairs undertaken as necessary.

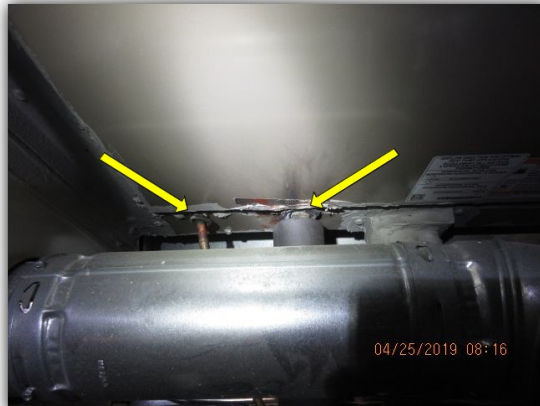
- The openings in the evaporator coil cabinet where the refrigerant/drain lines enter/terminate should be sealed properly to reduce the risk of air leaks.

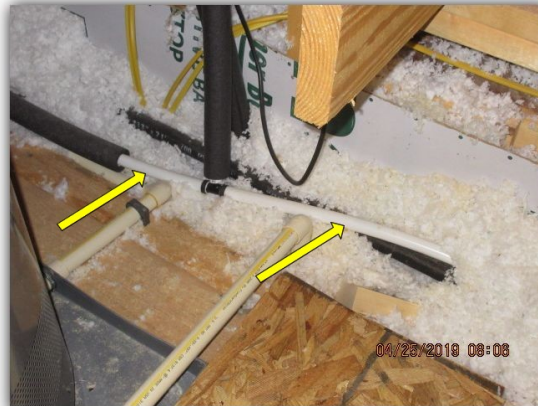
- All exposed water supply pipes in the attic area should be properly insulated to provide adequate protection during freezing conditions. It is recommended that this condition be considered for correction.

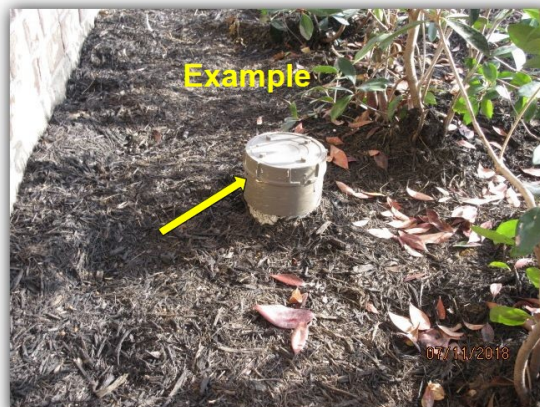
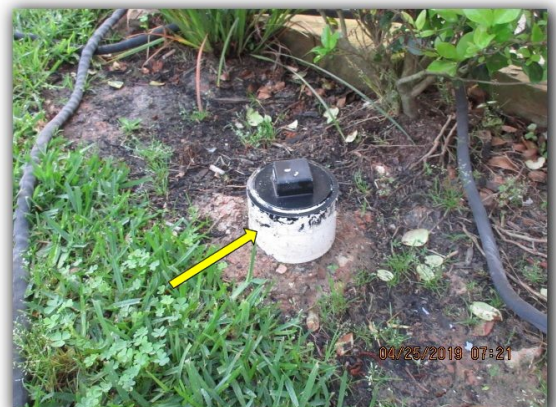
- Some of the PVC clean-outs are not painted. As preventative measures, all exterior PVC pipes should be properly painted to reduce the risk of degradation from the sun's ultra violet rays.

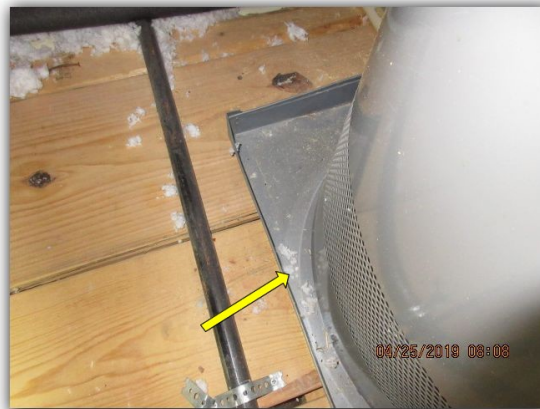
- The safety drain pan installed below the water heater contains debris. The pan should be emptied and cleaned as to provide adequate drainage in the event of a leak.

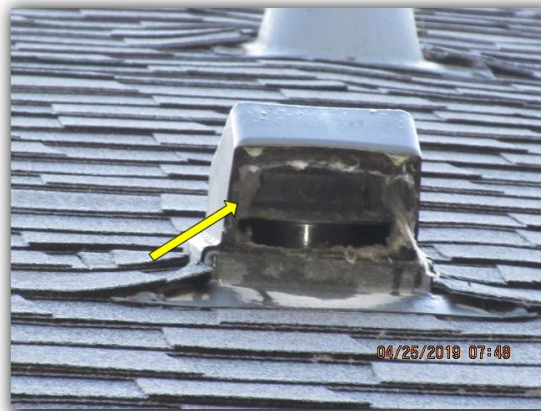
- Clean lint from dryer exhaust duct and exhaust vent opening. This should be part of a regular maintenance program as to prevent potential fire hazards. The design of the dryer duct to this house terminates vertically above the roof line through a vent jack. This type of configuration requires frequent cleaning as preventative measures to reduce the risk of clogs in the duct and prevent potential fire hazards.

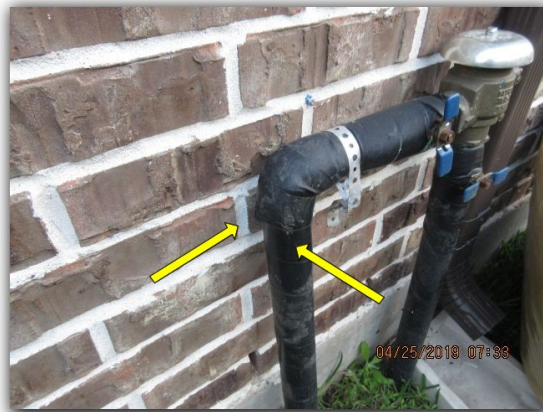
- Un-level sprinkler heads were noted (Various zones). These conditions require further investigation and repairs undertaken as necessary to ensure adequate spray coverage for the entire sprinkler system.
- Piping assembly for the shut off valve and vacuum breaker device is not properly supported along the exterior wall. This condition requires further investigation and repairs undertaken as to reduce the risk of damage to the shut off assembly.

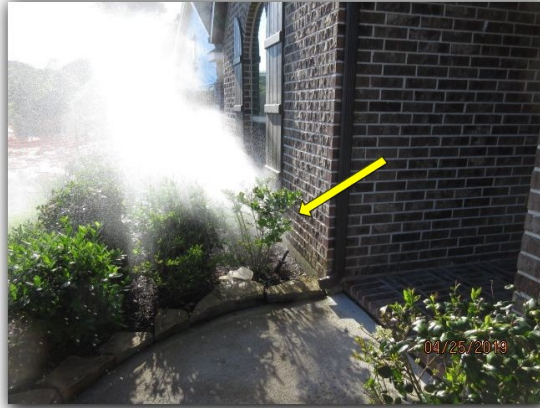
- The water spray from some of the sprinkler heads should be re-directed away from the structure and/or any fencing, decks, etc., to decrease the possibility of damage (Zones 1, 3, 4).
