Hedderman Stucco

Prepared For: David and Beverly Walsh
Address: 614 Asbury B Houston, TX 77007
Produced By: Phillip Lawlis
Date: October 31, 2018

At your request, a visual and probing moisture stucco inspection of the house located at 614 Asbury B, Houston, Texas, was made by Mr. Phillip Lawlis, TREC #9309, EDI Inspector #TX-172. **The visual inspection was performed on October 31 and the probing inspection was delayed due to rain until November 2.**

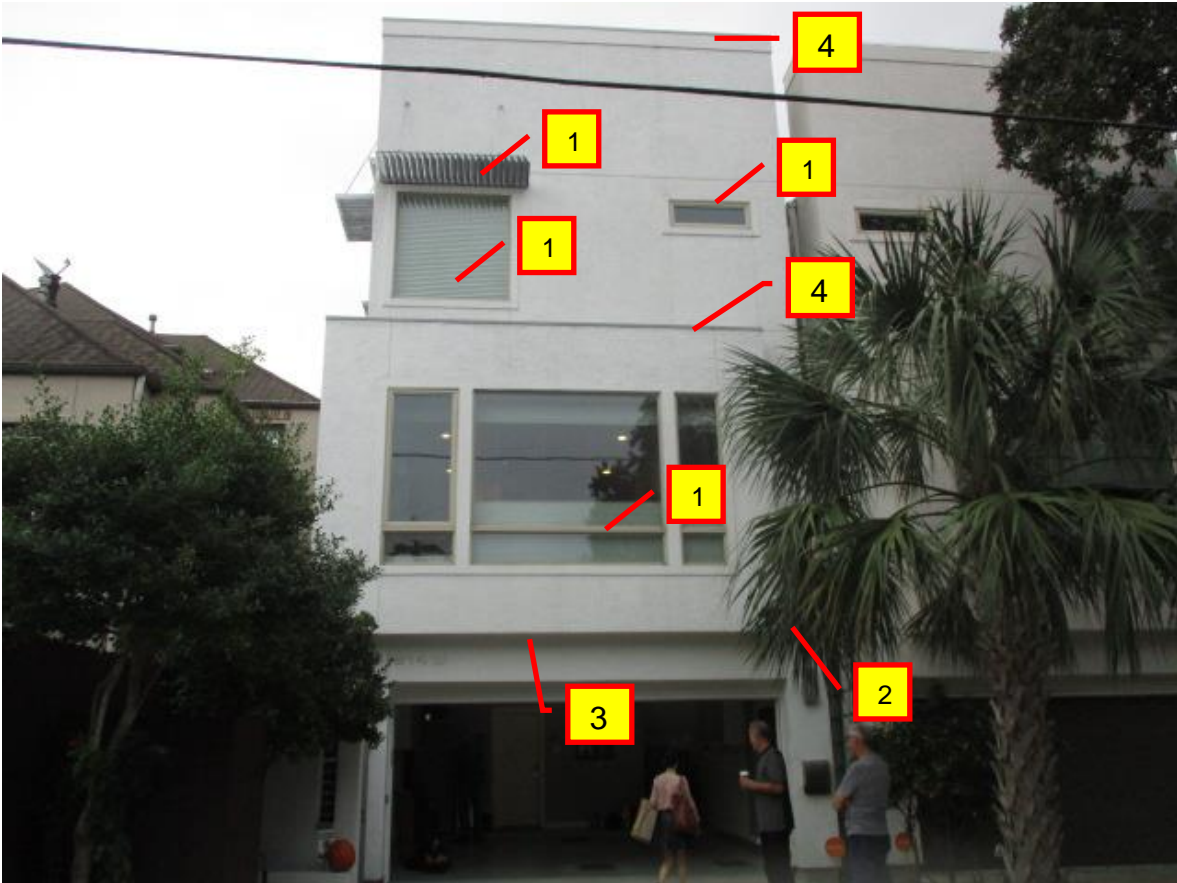
West Elevation (front)

#	Description of Visual Observations
1	Sealant missing, separated and/or inadequately applied
2	Rust at bottom corner indicating moisture
3	Relief drainage plane not present where stucco meets siding – joint has been sealed
4	Cap Flashing Present

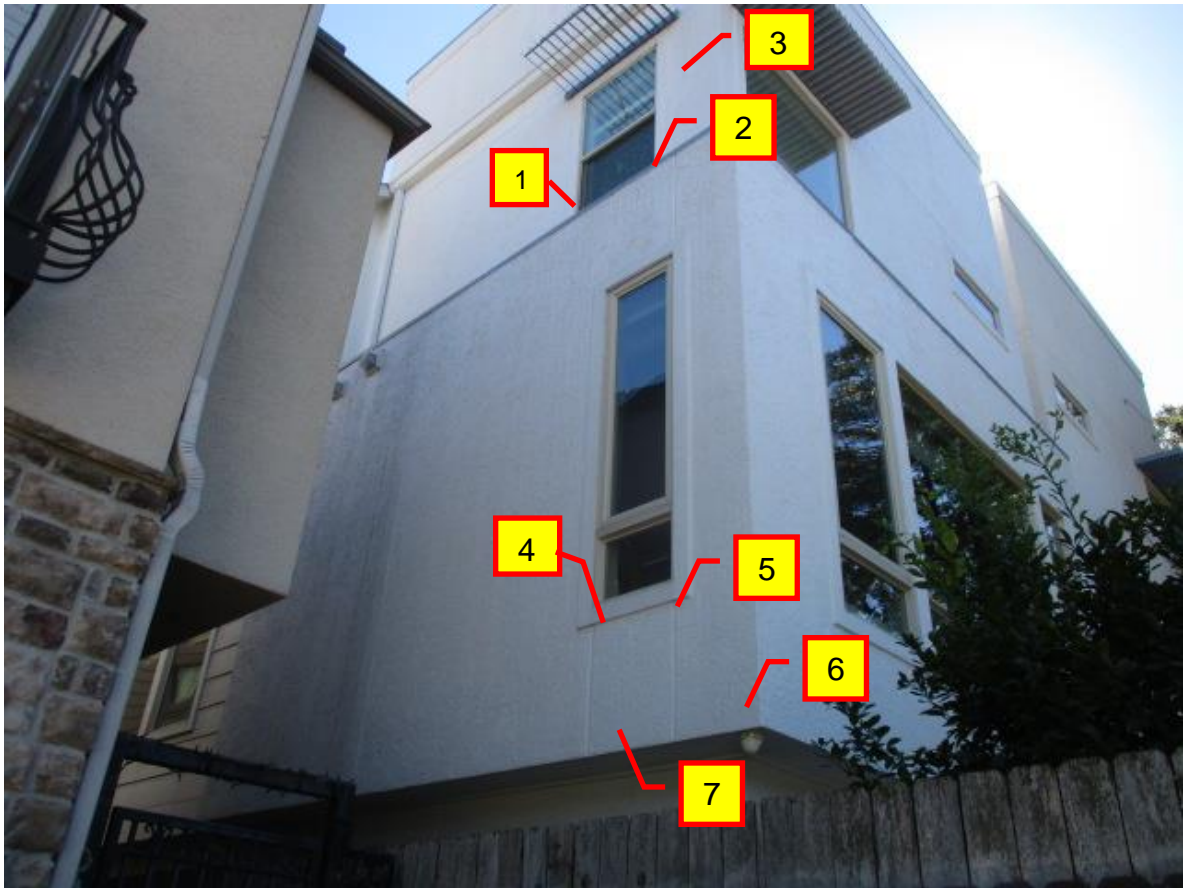
North Elevation

Probing area #	Moisture Reading	Substrate Integrity
#1	12.4 Low	Firm
#2	11.7 Low	Firm
#3	10.9 Low	Firm
#4	30.0 Low	Firm
#5	31.8 Low	Firm
#6	No Reading	Deteriorated
#7	40.0 High	Soft

Substrate damage was found on this house and further framing damage may be present beyond the substrate. It is recommended that all areas noted not to have **“Firm” substrate (Including Semi-soft, Soft, or Deteriorated)** be opened up to verify the extent of any damage. It is also recommended that the condition be repaired accordingly. It is noted that core sampling of the areas that were noted in the report is recommended to evaluate damage prior to removal of any large sections of stucco. Consult a qualified waterproofing contractor to perform a core sample and/or to repair the damage where applicable. Refer to elevation photos for locations.

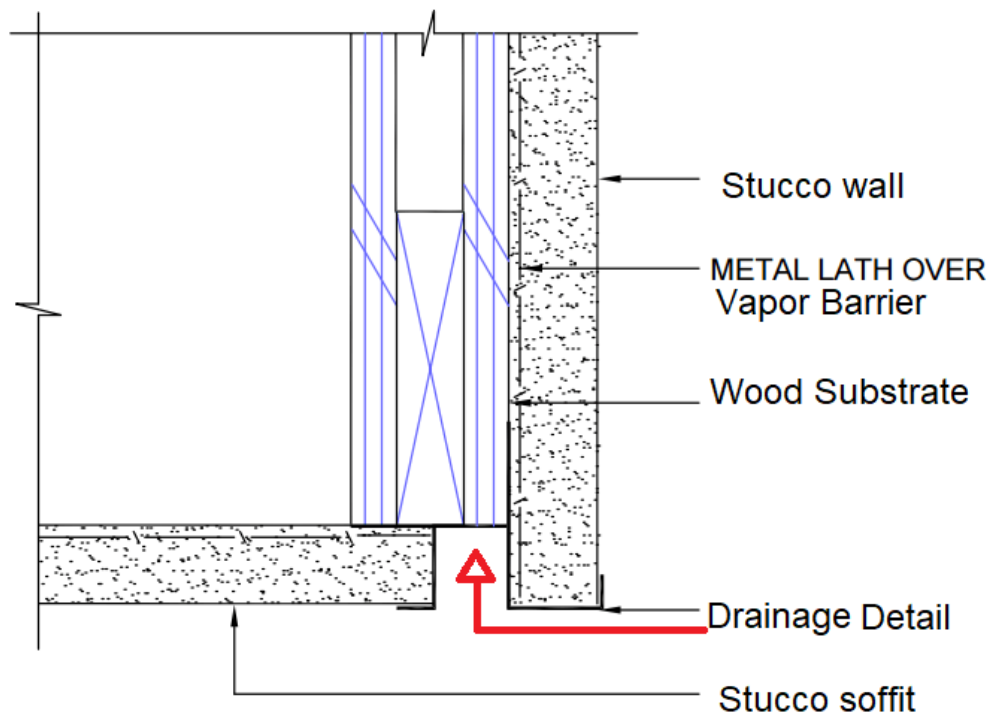
Overhanging Wall

The stucco veneer at the overhanging areas did not have a provision for a drainage relief plane to allow moisture a path to exit the stucco wall, as shown in the detail below. It is noted that there was staining in this area that may be an issue from not having this newer detail. Damage was found at the bottom edge of the stucco and this detail should be added when repairs to the area are made.
