# Hedderman Stucco

**Prepared For:** David and Beverley Walsh  
**Address:** 614 Asbury B Houston, TX 77007  
**Produced By:** Phillip Lawlis  
**Date:** October 31, 2018 and November 2, 2018

At your request, a visual and probing moisture stucco inspection of the house located at 614 Asbury B, Houston, Texas, was made by Mr. Phillip Lawlis, TREC #9309, EDI Inspector #TX-172. The visual inspection was performed on October 31 and the probing inspection was delayed due to rain until November 2.

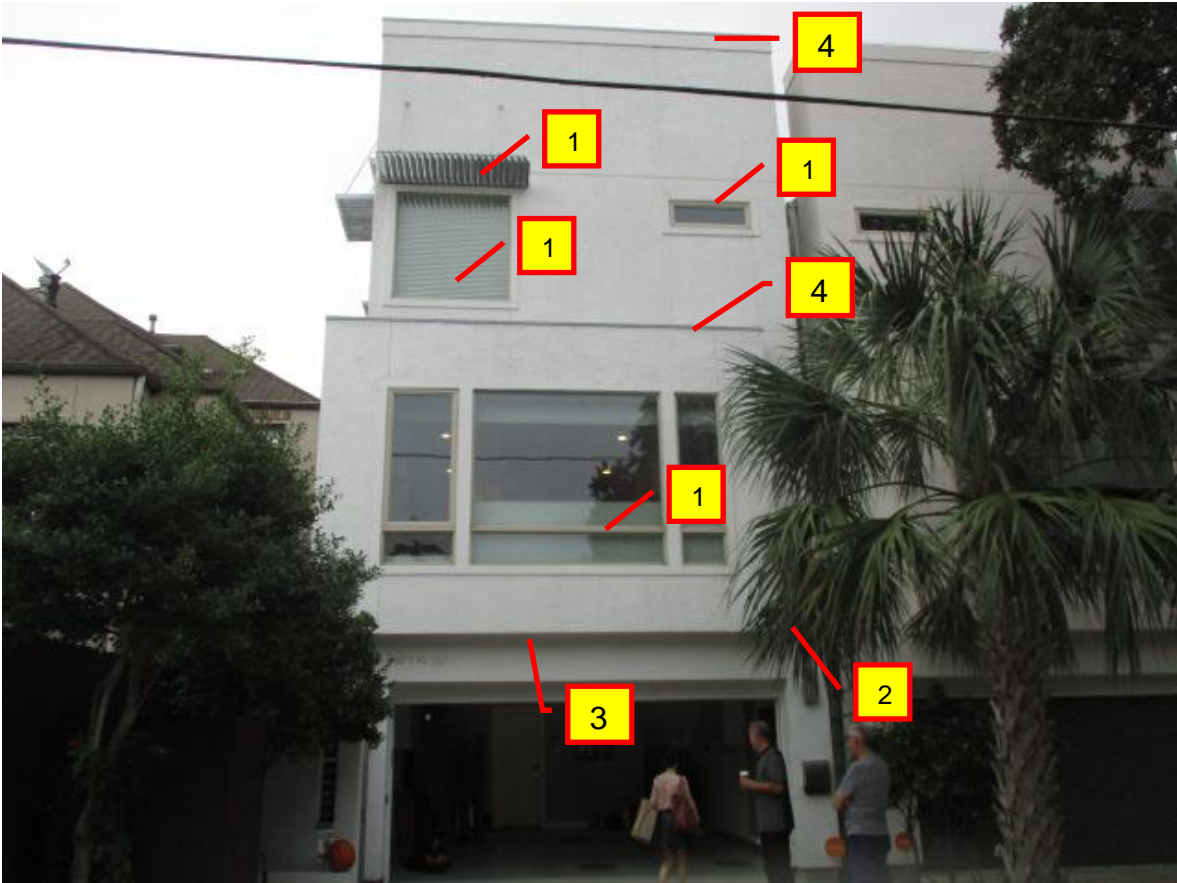
**West Elevation (front)**

#	Description of Visual Observations
1	Sealant missing, separated and/or inadequately applied
2	Rust at bottom corner indicating moisture
3	Relief drainage plane not present where stucco meets siding – joint has been sealed
4	Cap Flashing Present

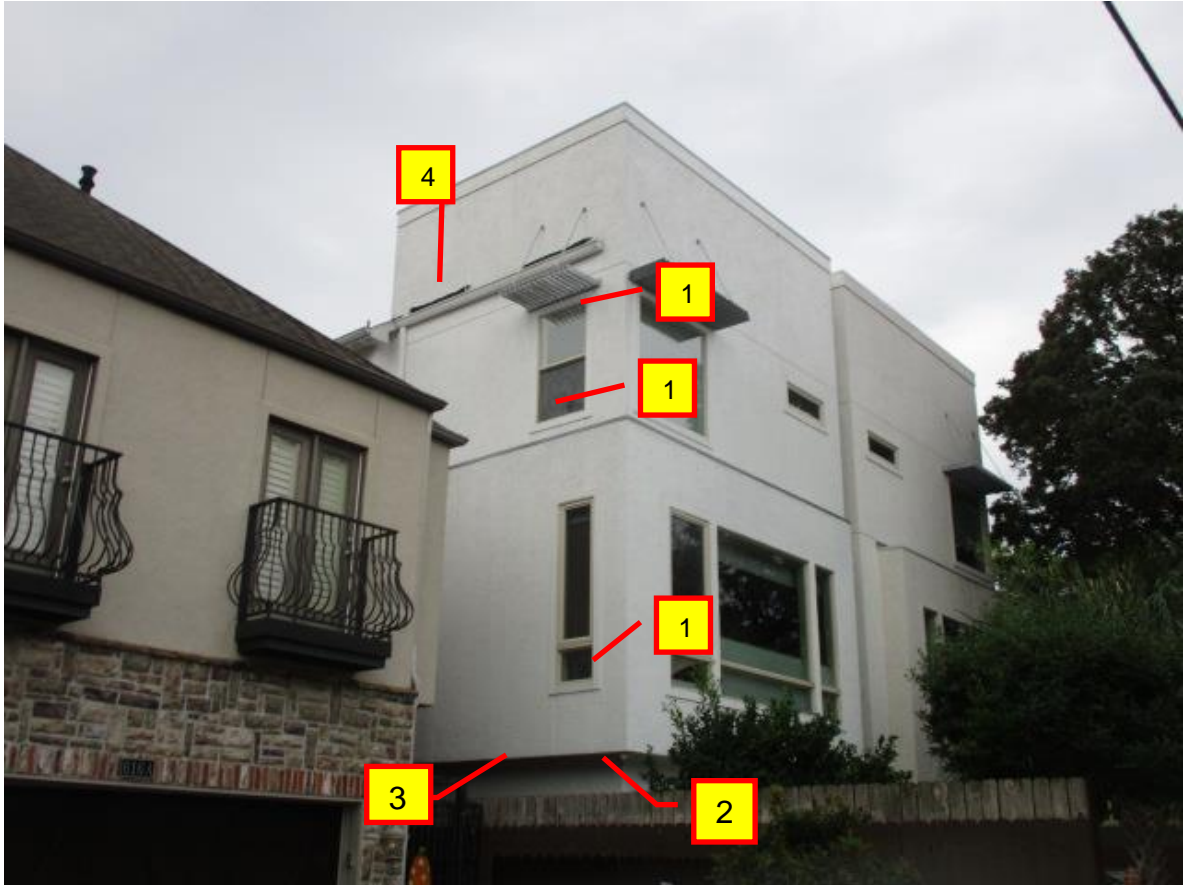
North Elevation

#	Description of Visual Observations
1	Sealant missing, separated and/or inadequately applied
2	Rust at bottom indicating moisture
3	Relief drainage plane not present where stucco meets siding – joint has been sealed
4	Upper scupper sealants not visible – recommend sealing as needed

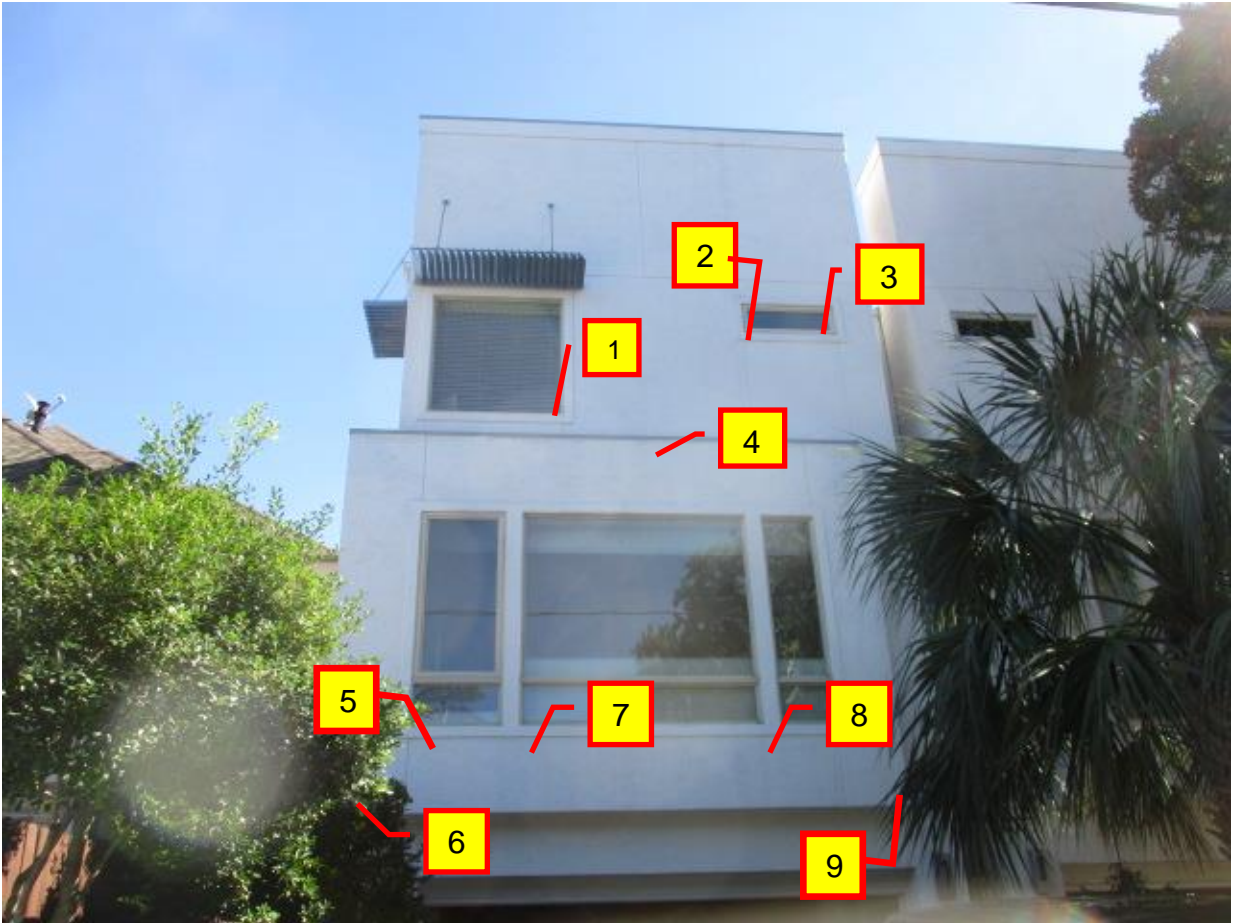
**West Elevation**

Probing area #	Moisture Reading	Substrate Integrity
#1	12.7 Low	Firm
#2	16.5 Elevated	Firm
#3	13.1 Low	Firm
#4	10.3 Low	Firm
#5	40.0 High = Wet	Soft
#6	No Reading	Deteriorated
#7	9.8 Low	Firm
#8	29.9 High	Soft
#9	No Reading	Deteriorated

Substrate damage was found on this house and further framing damage may be present beyond the substrate. It is recommended that all areas noted not to have **“Firm” substrate (Including Semi-soft, Soft, or Deteriorated)** be opened up to verify the extent of any damage. It is also recommended that the condition be repaired accordingly. It is noted that core sampling of the areas that were noted in the report is recommended to evaluate damage prior to removal of any large sections of stucco. Consult a qualified waterproofing contractor to perform a core sample and/or to repair the damage where applicable. Refer to elevation photos for locations.

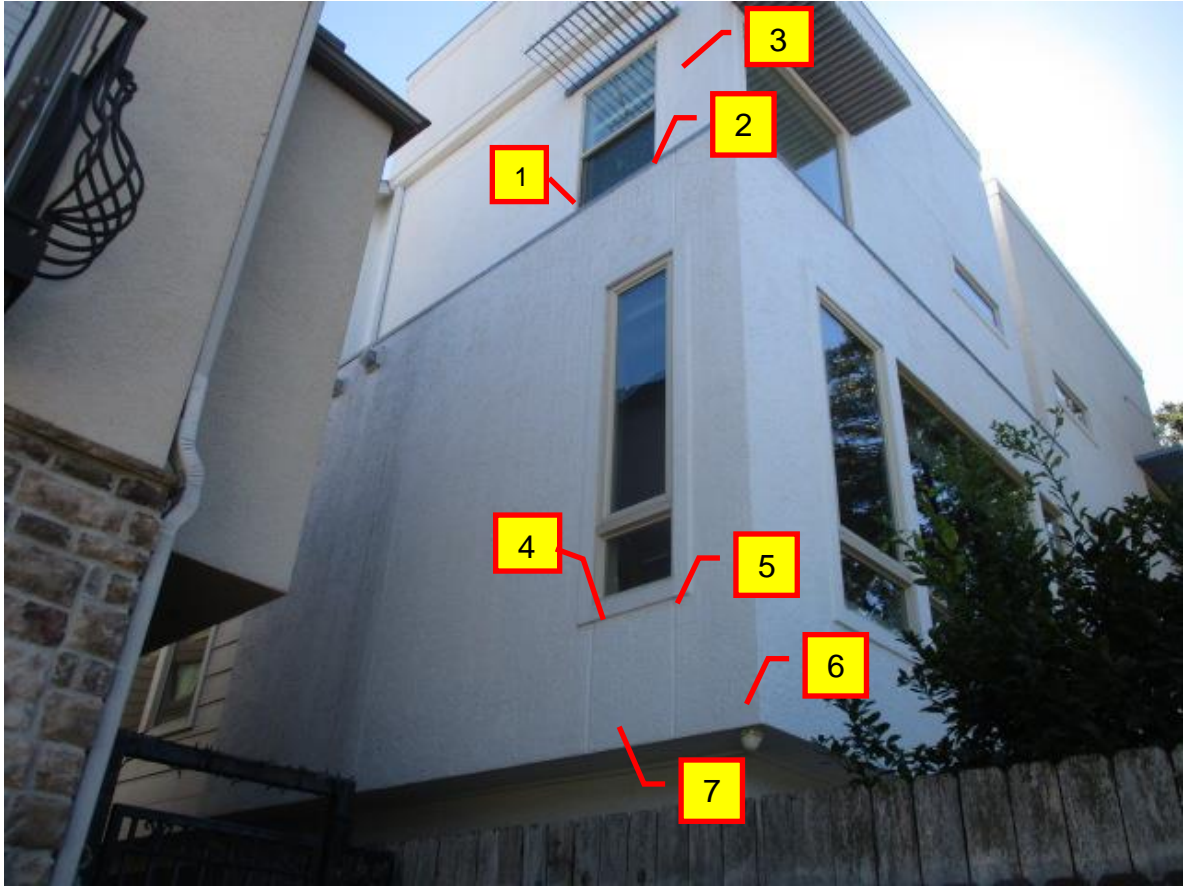
North Elevation

Probing area #	Moisture Reading	Substrate Integrity
#1	12.4 Low	Firm
#2	11.7 Low	Firm
#3	10.9 Low	Firm
#4	30.0 Low	Firm
#5	31.8 Low	Firm
#6	No Reading	Deteriorated
#7	40.0 High	Soft

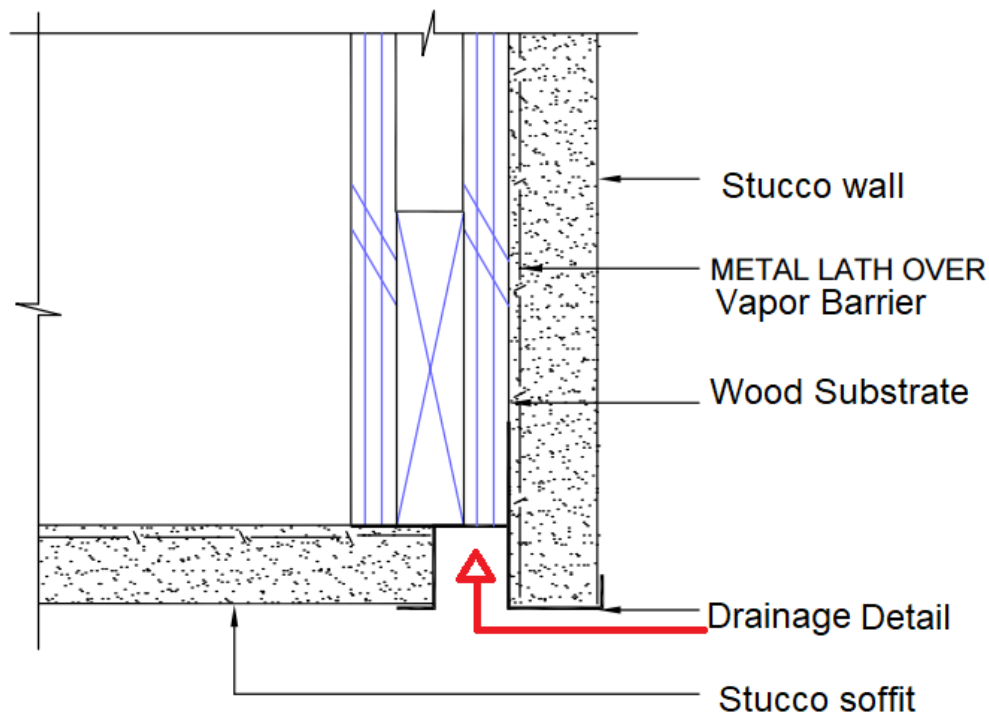
**Overhanging Wall**

The stucco veneer at the overhanging areas did not have a provision for a drainage relief plane to allow moisture a path to exit the stucco wall, as shown in the detail below. It is noted that there was staining in this area that may be an issue from not having this newer detail. Damage was found at the bottom edge of the stucco and this detail should be added when repairs to the area are made.
