PROPERTY INSPECTION REPORT

Concerning: **614 Asbury Unit B, Houston, Texas 77007**

By: **Scott Gillis # 22819**

October 31, 2018

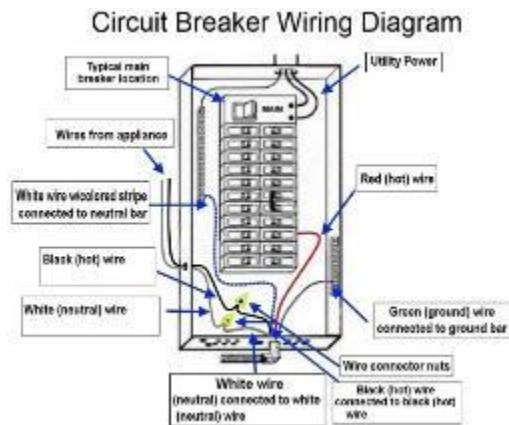
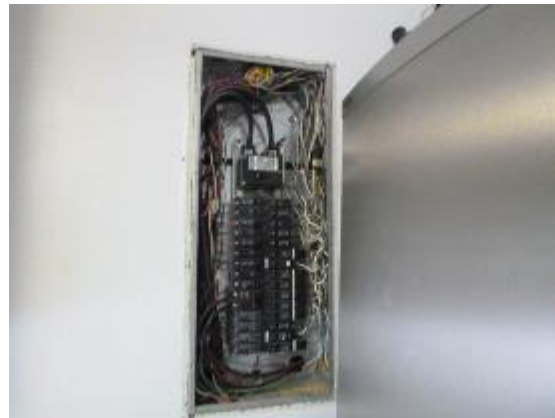
The breaker panel was not located in a readily accessible area, and did not allow proper access to the equipment. A three-foot working space needs to be provided and maintained in front of the equipment.

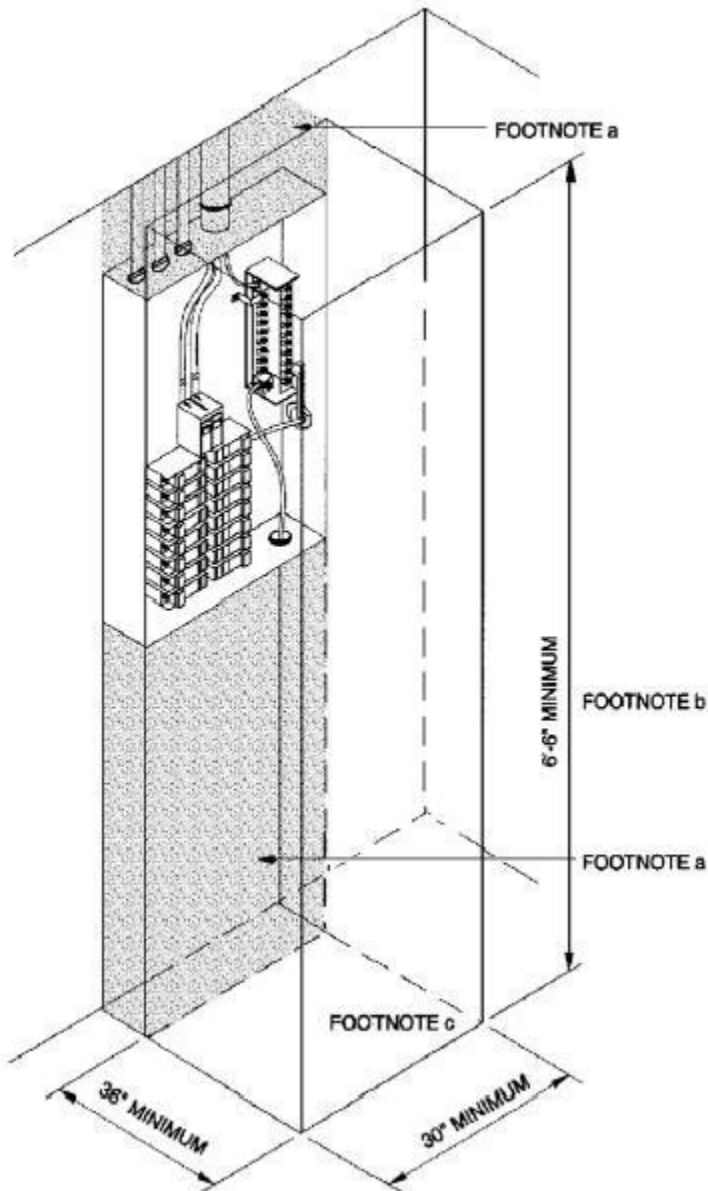
FIGURE E3305.1^{a, b, c, d, e}
WORKING SPACE AND CLEARANCES

E3305.1 Working space and clearances. IRC 2006

Sufficient access and working space shall be provided and maintained around all electrical equipment to permit ready and safe operation and maintenance of such equipment in accordance with this section and Figure E3305.1.

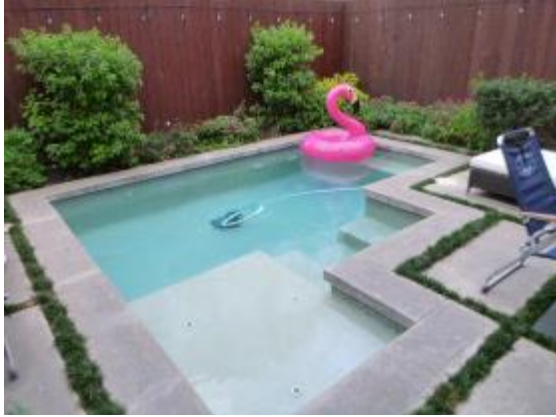
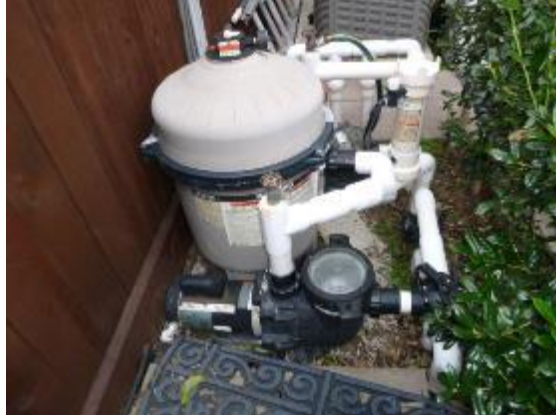
The surface of the pool was worn, and the pool may need to be re-plastered at this time. Have a service company provide a cost estimate to resurface the pool.

Further investigation is recommended.

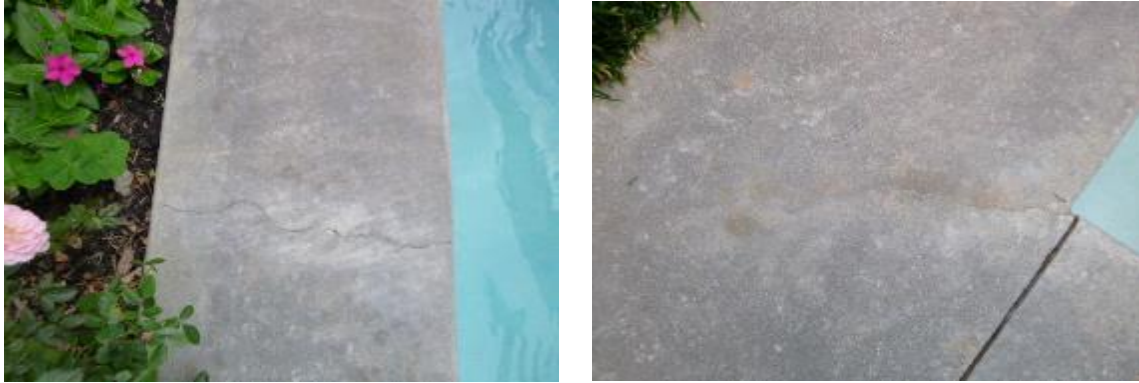
The coping for the pool was concrete slab that is cracked every few feet. The cracks are not separating and there is no unevenness of the surface at this time. It is recommended that a pool service company evaluate the concrete coping and provide an estimate for any necessary repairs.

Further investigation is recommended.

Obtain Cost Estimate

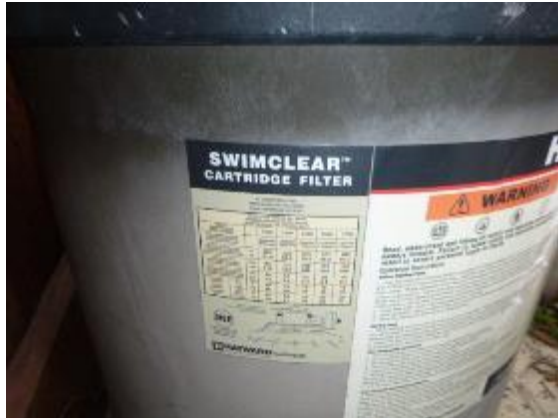
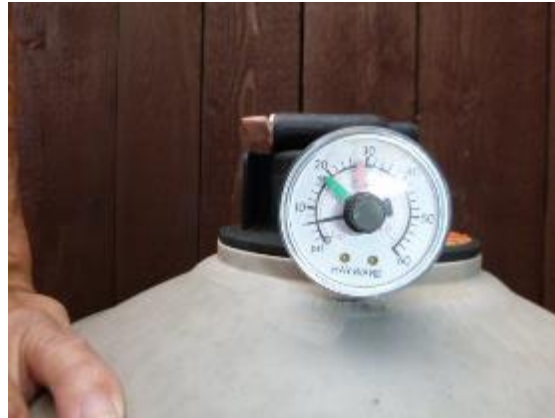
The pool filter was a cartridge filter that was functional at the time of the inspection, and showed an operating pressure of 7 psi. This is a lower than normal pressure reading and may indicate a problem with the equipment. Have a pool service company make an assessment of this condition and recommend any necessary repair.

Obtain Cost Estimate

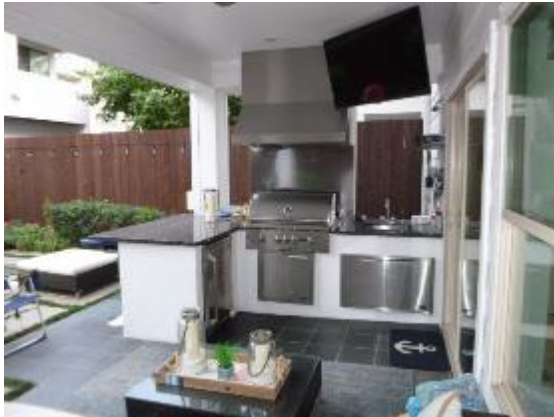
The summer kitchen was functional at the time of the inspection except for the rear burner on the gas grill that would only ignite when lit with a match. The vent hood, sink and small fridge were all operational as well as the ceiling fan and overhead lighting.

Have a service company evaluate the gas grill and provide cost estimate for any necessary repairs.

Obtain Cost Estimate
