HEDDERMAN ENGINEERING, INC.

REF: CONDITION OF PROPERTY SURVEY

At your request, a visual survey of the house located at 614 Asbury, Unit B, Houston, Texas, was made by Mr. Dennis Polk and Mr. Scott Gillis.

614 Asbury, Unit B

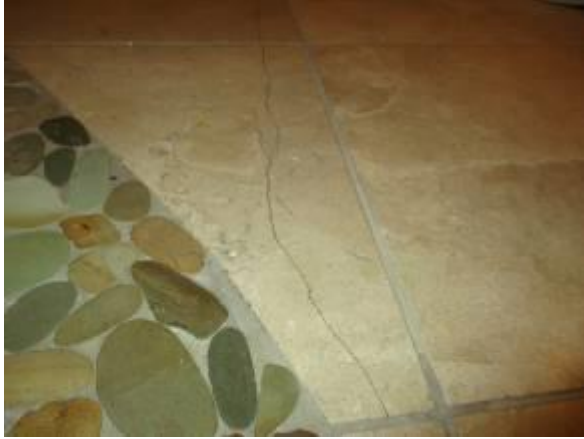
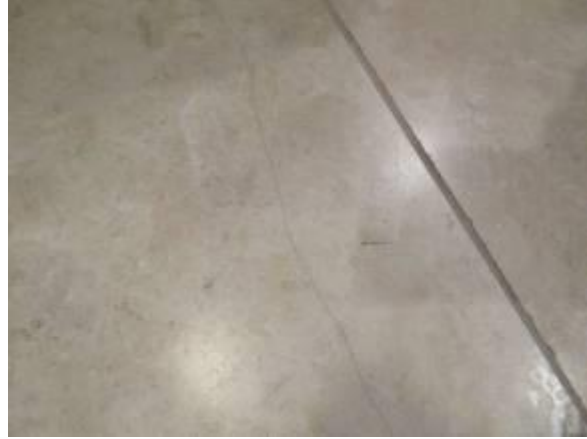
* Some separations and differential movement of materials due to differential foundation movement were observed, including the following:

- “Ghost” doors, where the door swings shut by itself were observed at the downstairs bathroom and third floor bathroom.
- The floor tile was cracked at the foyer, den, downstairs bathroom, and third floor bathroom.

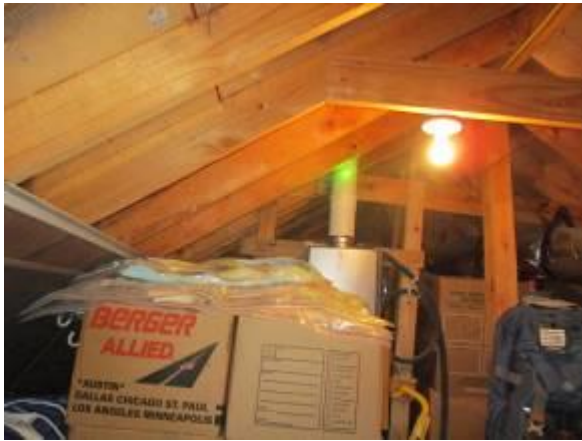
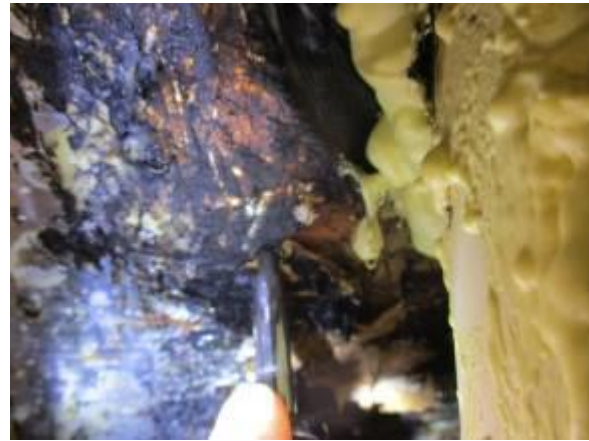
After observing the interior of the structure, evidences of roof leaks were visible in the attic, where the roof decking was rotted and active dripping was observed at the time of inspection. It is recommended that a roofing contractor be contacted to find the source of the leaks, and to make any needed repairs.

Rotted roof decking at the water heater vent pipe

Obtain Cost Estimate

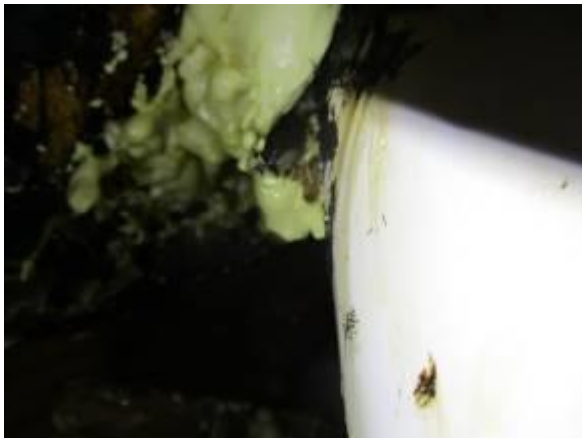
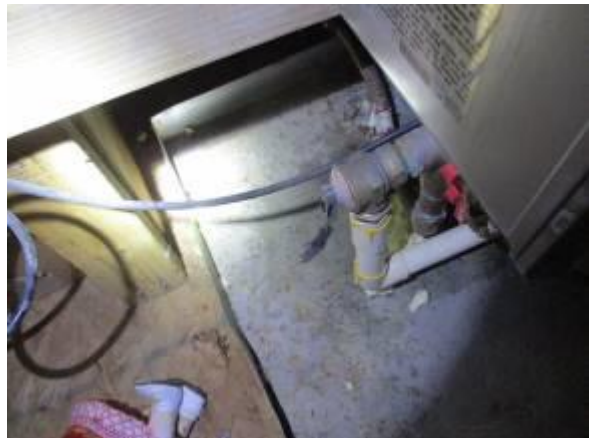
Active dripping at the roof jack/Standing water in the water heater pan

A repair attempt was made at the water heater vent pipe previously. However, the vent pipe was actively leaking at the time of inspection.

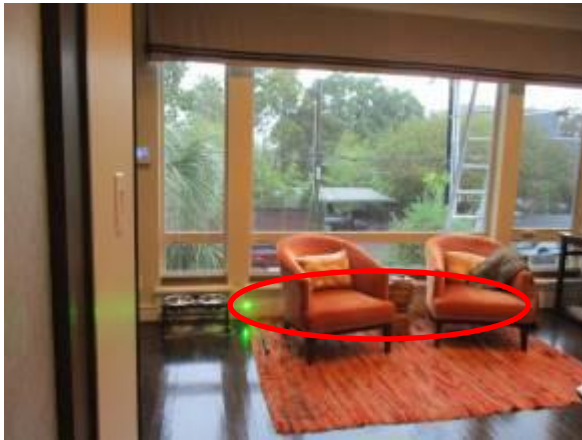
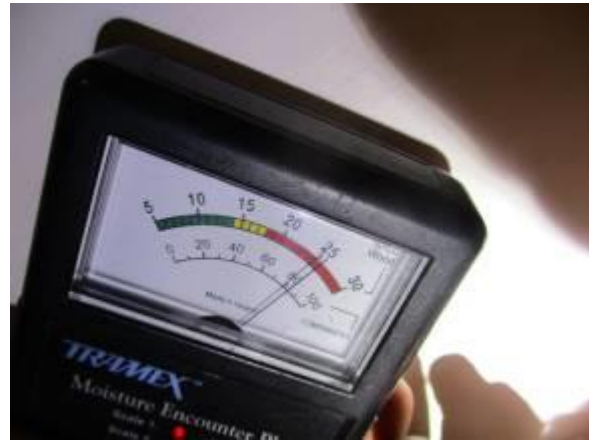
Locations included: breakfast room center window

Our moisture meter showed a higher than normal reading.

The source of the water penetration could not be determined with certainty but appears to be a lack of proper sealing around the window(s). It is recommended that the cause of the water penetration be determined, and the necessary repairs made to stop the water penetration and repair any secondary damages.

Obtain Cost Estimate

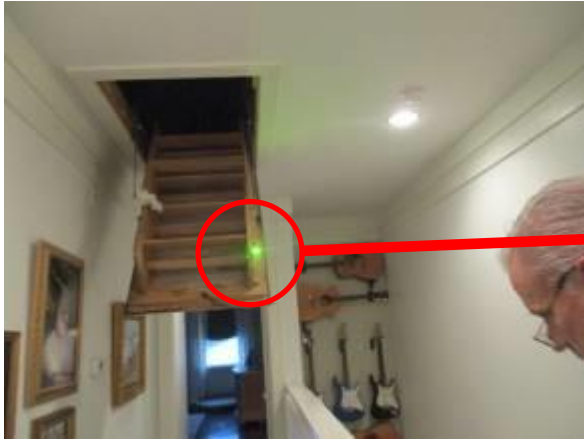
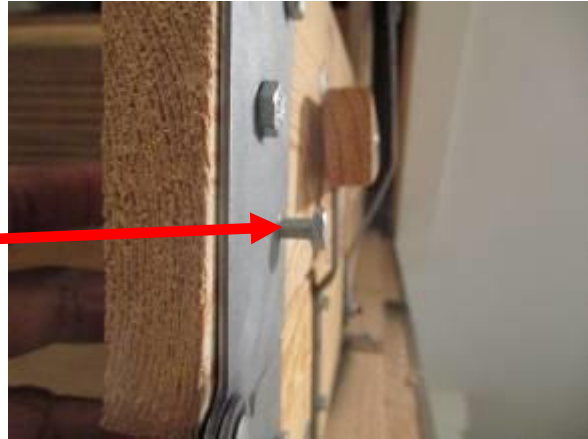
Some of the ladder hardware was loose and needs to be secured for safety purposes.

Obtain Cost Estimate

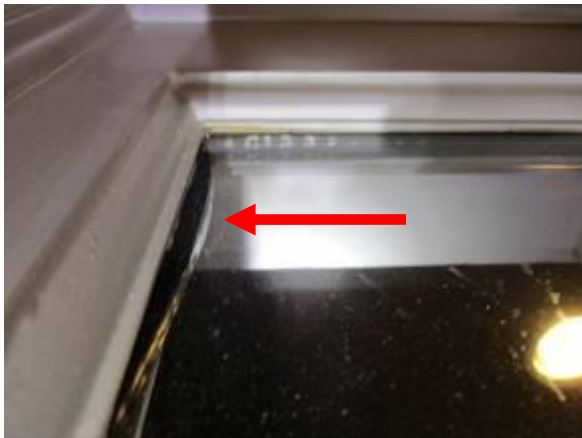
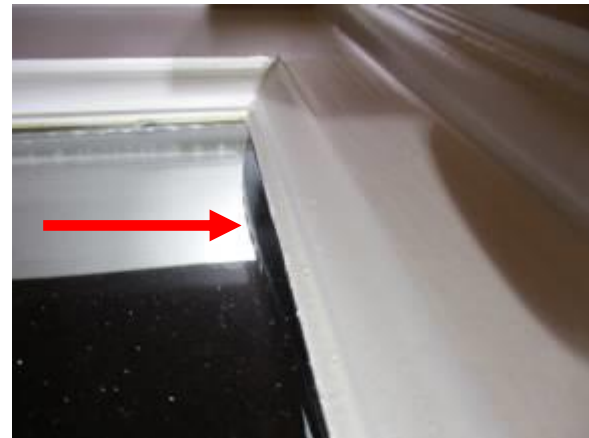
Locations included: front entry

We observed window panes in the exterior door where the seal around the perimeter of the window pane has moved out of its original position (squiggly). Further investigation with a window specialist is recommended to determine if the seal has been compromised and the extent of any needed repairs/replacement.

Obtain Cost Estimate

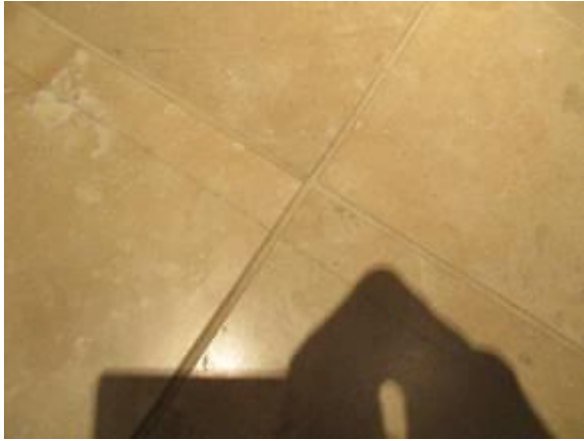
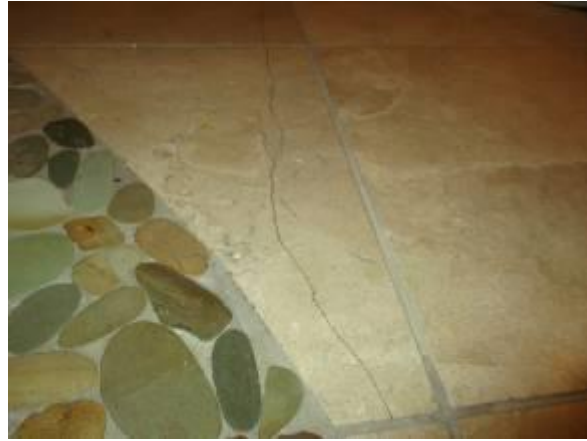
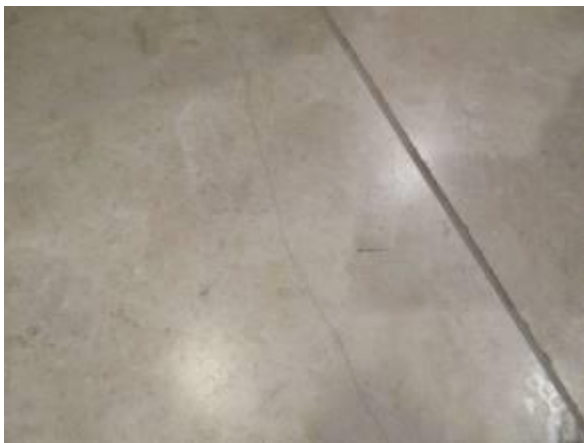
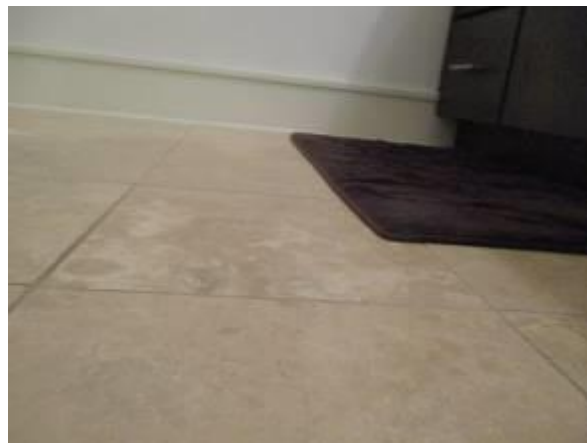
Locations included: foyer, den, downstairs bathroom, and third floor bathroom

Floor tiles were cracked and it is recommended they be replaced.

Obtain Cost Estimate

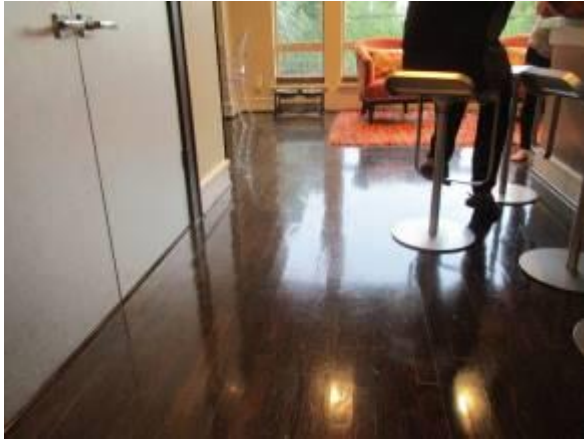
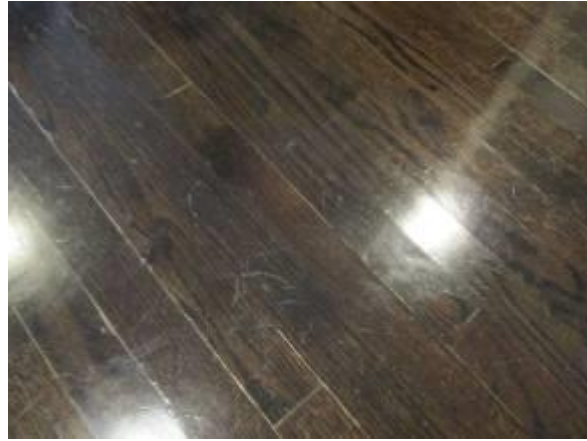
Locations included: second floor

The wood floor was observed to be buckled slightly, with the edges of the boards curling downwards into a “cupping” effect. This condition is typically caused when the wood floors have excessive moisture in the wood and are stained and sealed before the moisture can escape. When the wood dries, the wood shrinks, causing the edges of the boards to curl downward, leaving an uneven surface. Further investigation with a wood floor specialist and/or a service company is recommended to determine the source of the moisture, and to make any needed repairs.

Obtain Cost Estimate

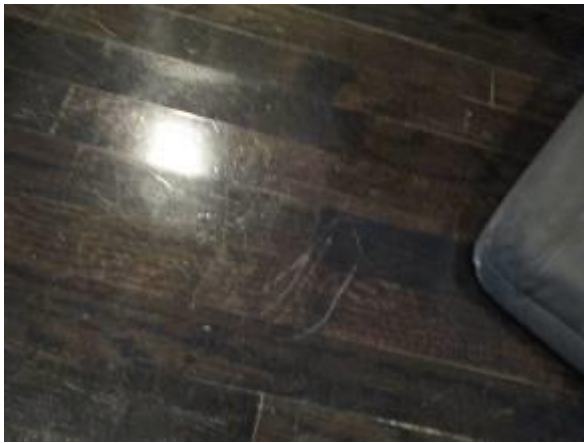
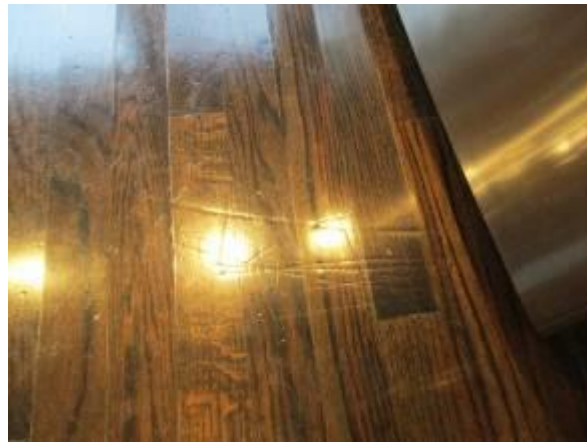
Locations included: second floor

The wood floor was damaged with excessive scratches in the floor. Further investigation with a wood floor specialist is recommended to provide a cost estimate for repairs to the floor.

Obtain Cost Estimate

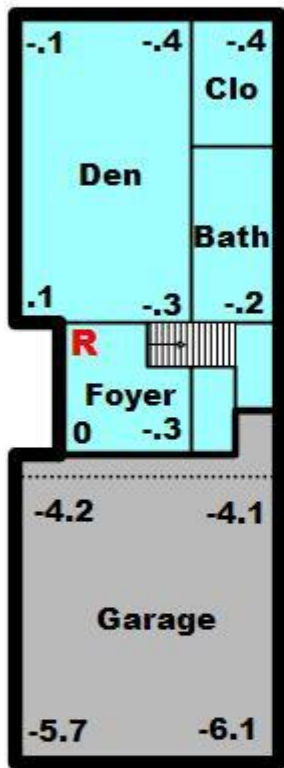
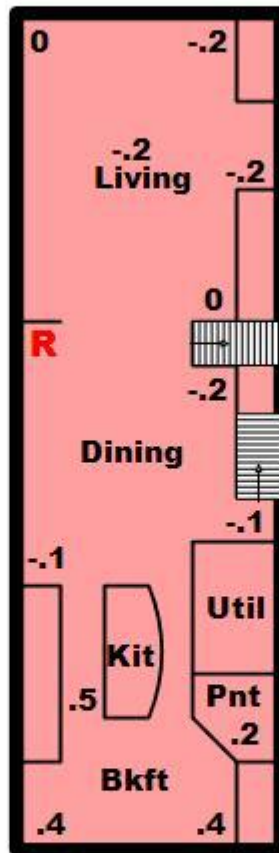
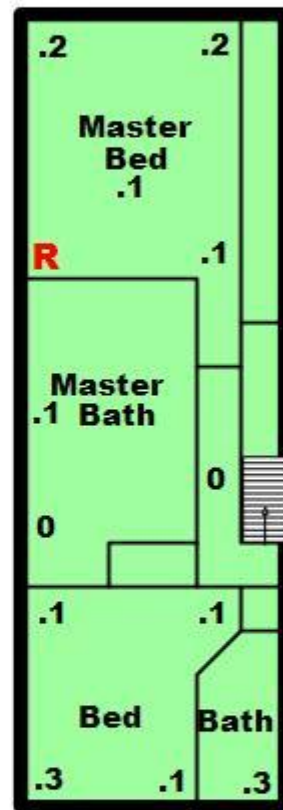
**Elevation Readings
614 Asbury, Unit B**

The floors were checked with an electronic level and were observed to be sloping generally southeast. The difference in elevation between the high point and low point was 0.5 inch. The high point was located at the den, and the low point was located at the southeast section of the house and at the downstairs bathroom. The unlevelness takes place over a horizontal distance of approximately 20-25 feet.
