Lone Star Stucco, LLC

Moisture Assessment Report

614 Asbury St # B

3/3/2021

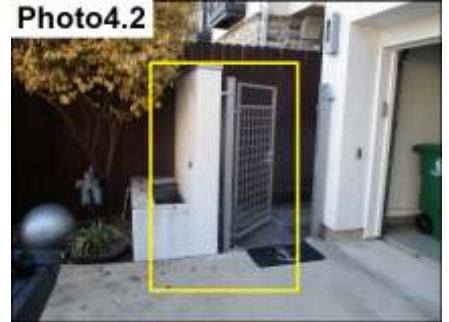
Photo4.2

CMU Entry Wall/ Positive Detail

Grid Location	Item Description	Moisture Readings	Substrate Condition	Observations
Yellow Box	CMU Entry Wall			The entry wall noted is constructed of a concrete masonry unit wall. The inspector states that this is a positive detail. Please refer to photos #4.2 and #4.3 for more detail.

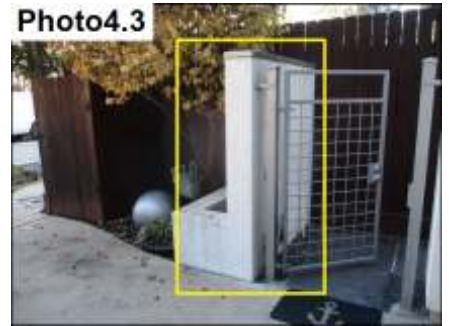
Photo4.3

CMU Entry Wall/ Positive Detail

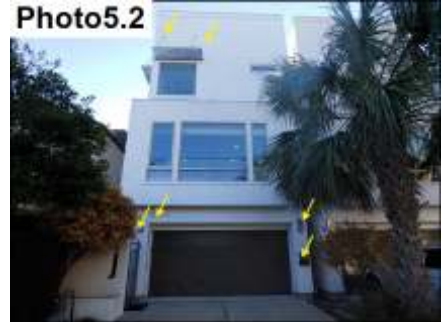
Photo5.2

Penetration Sealants/ Seal

Grid Location	Item Description	Moisture Readings	Substrate Condition	Observations
Yellow Arrows	Penetration Sealants			The penetration sealants are aged. The inspector suggests having a qualified stucco waterproofing contractor seal this area with NP1 or low modulus sealant in an effort to prevent moisture intrusion. These types of sealants are of high quality and compatible with stucco and other termination points. Please refer to photos #5.2, #5.3, #5.4, #5.5, #5.6, #6.1, #6.2, #6.3, #6.4, #6.5 and #6.6 for more detail.

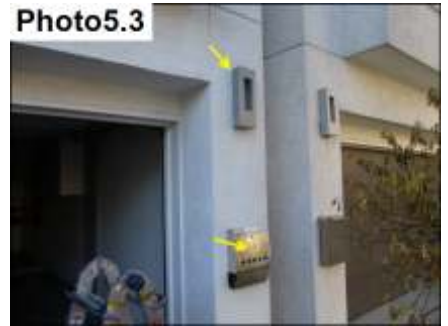
Photo5.3

Penetration Sealants/ Seal

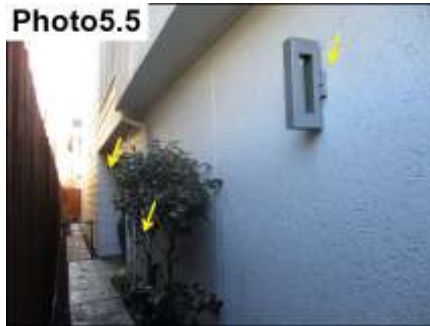
Photo5.5

Penetration Sealants/ Seal

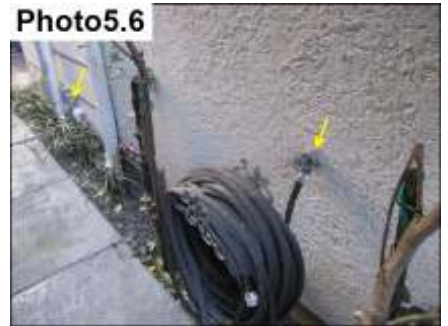
Photo5.6

Penetration Sealants/ Seal

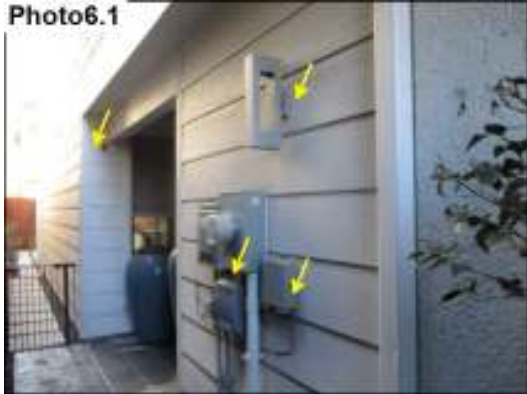
Photo6.1

- The penetration sealants are aged. The inspector suggests having a qualified stucco waterproofing contractor seal this area with NP1 or low modulus sealant in an effort to prevent moisture intrusion. These types of sealants are of high quality and compatible with stucco and other termination points. Please refer to photos #5.2, #5.3, #5.4, #5.5, #5.6, #6.1, #6.2, #6.3, #6.4, #6.5 and #6.6 for more detail.

Penetration Sealants/ Seal

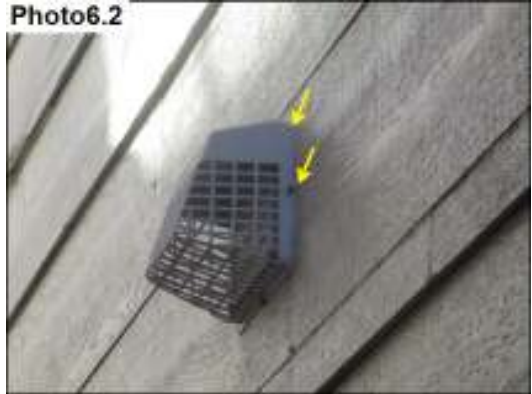
Photo6.2

Penetration Sealants/ Seal

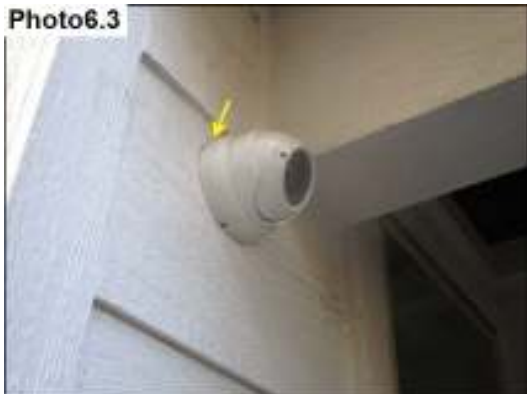
Photo6.3

Penetration Sealants/ Seal

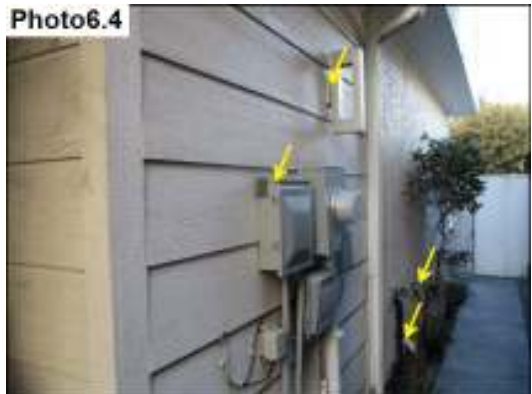
Photo6.4

Penetration Sealants/ Seal

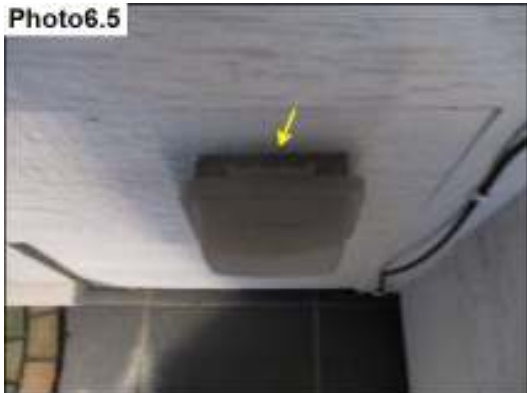
Photo6.5

Penetration Sealants/ Seal

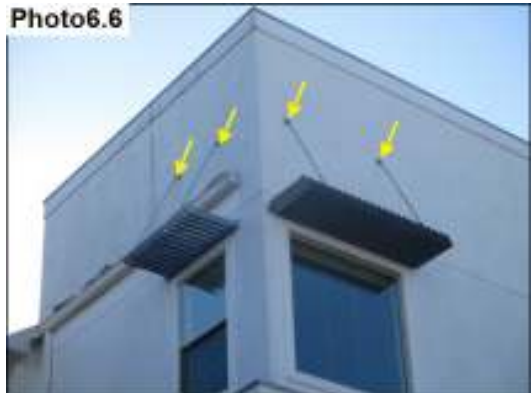
Photo6.6

Penetration Sealants/ Seal

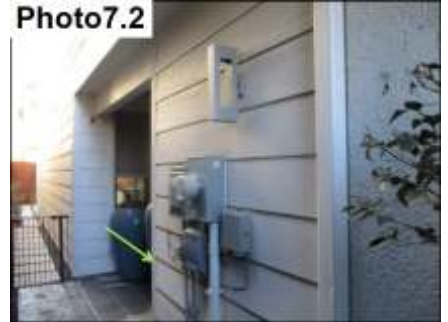
Photo7.2

Door Trim & Miter / Seal

Grid Location	Item Description	Moisture Readings	Substrate Condition	Observations
Green Arrows	Door Trim Sealants			The door trim sealants are separated or aged. The inspector suggests having a qualified stucco waterproofing contractor seal this area with NP1 or low modulus sealant in an effort to prevent moisture intrusion. These types of sealants are of high quality and compatible with stucco and other termination points. Please refer to photos #7.2, #7.3, #7.4, #7.5 and #7.6 for more detail.

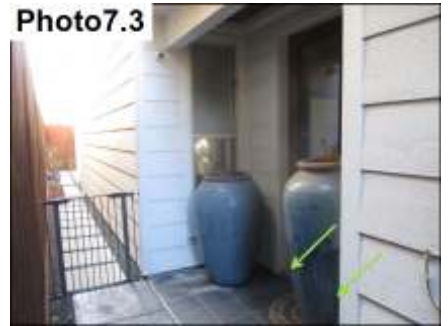
Photo7.3

Door Trim & Miter / Seal

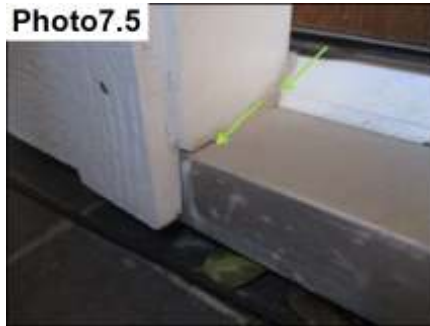
Photo7.5

Door Trim & Miter / Seal

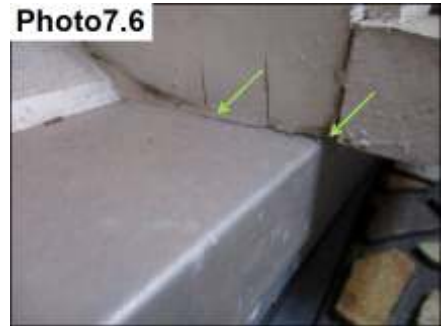
Photo7.6

Door Trim & Miter / Seal

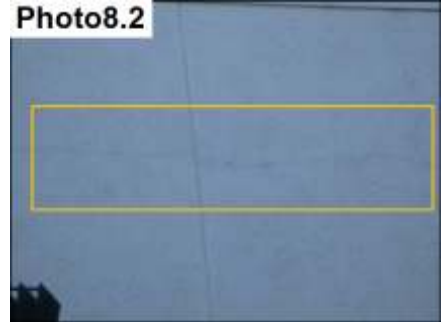
Photo8.2

- Cracks are noted in this location. The inspector suggests to have a qualified stucco waterproofing contractor seal and paint these cracks in an effort to prevent moisture intrusion. Please refer to photos #8.2 and #8.3 for more detail.

Cracks/ Seal And Paint

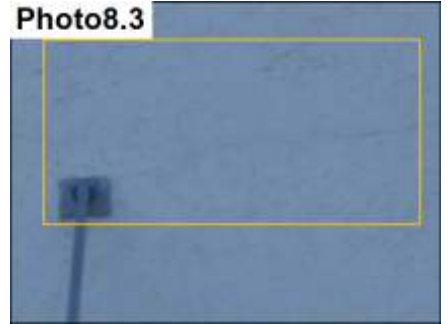
Photo8.3

Cracks/ Seal And Paint

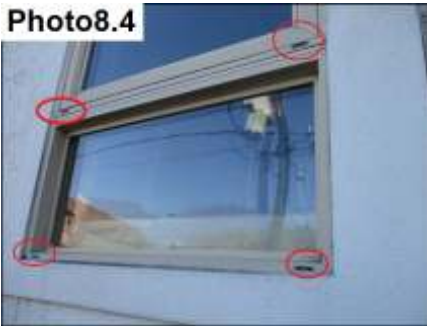
Photo8.4

- The window weep louvered doors are missing from this location. The inspector suggests installing doors where needed to let moisture properly evacuate the system and prevent moisture intrusion. Please refer to photos #8.4 #8.5 and #8.6 for more detail.

Missing Window Weep Louvered Door/ Install Door

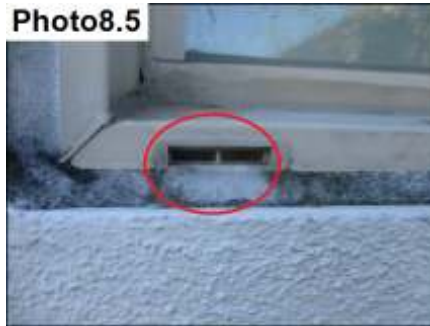
Photo8.5

Missing Window Weep Louvered Door/ Install Door

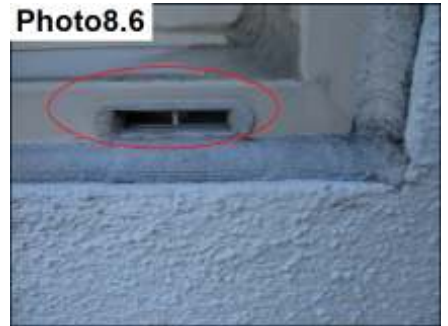
Photo8.6

Missing Window Weep Louvered Door/ Install Door

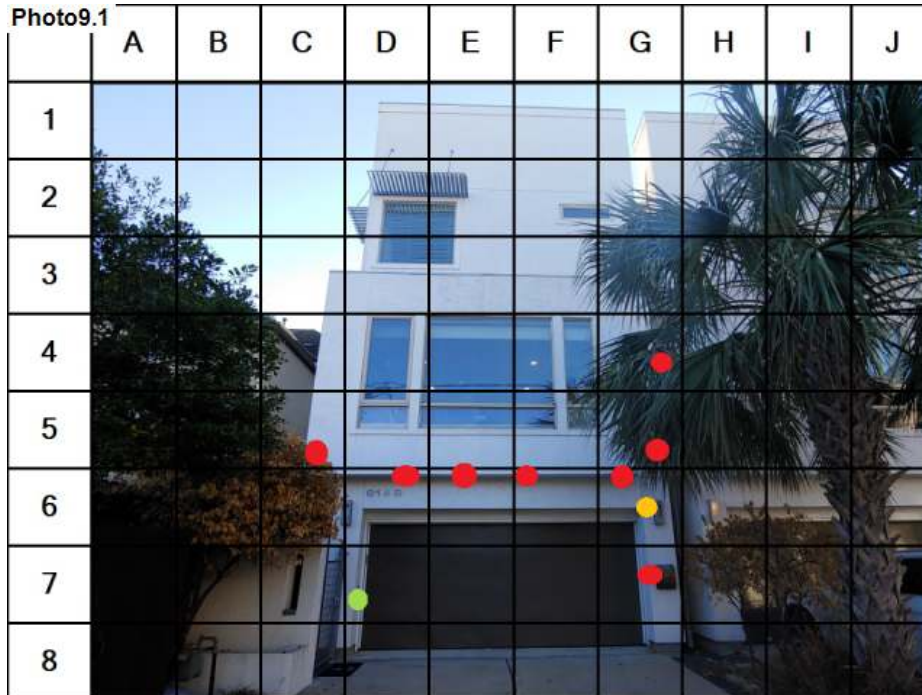
Grid Location	Item Description	Moisture Readings	Substrate Condition	Observations
D7	Corner Wall	18%	Firm	A moisture probe was made at the corner wall. The substrate was firm with no damage noted at this time.
G7	Right Wall Below Bottom Wall		None	A moisture probe was made at the right wall below the bottom of the bumpout. No substrate was noted in this location. The inspector suggests modifying this area as needed.
G6 Orange Dot	Bottom Bumpout	29%	Semi-Firm	A moisture probe was made at the bottom of the bumpout. An elevated moisture reading was noted with a semi-firm substrate.
G6	Bottom Bumpout Below Windows	28%	Semi - Firm	A moisture probe was made at the bottom of the bumpout. An elevated moisture reading was noted with a semi-firm substrate.
G5	Corner Wall Above G6	27%	Firm	A moisture probe was made at the corner wall below the metal cap. The substrate was firm with no damage noted at this time.

G4	Corner Wall Above G5	25%	Firm	A moisture probe was made at the corner wall below the metal cap. The substrate was firm with no damage noted at this time.
C5	Corner Wall Below Metal Cap	20%	Firm	A moisture probe was made at the corner wall below the metal cap. The substrate was firm with no damage noted at this time.
D6	Bottom Wall Below The Windows	29%	Semi-Firm	A moisture probe was made at the bottom of the bumpout below the windows. An elevated moisture reading was noted with a semi-firm substrate.
E6	Bottom Wall Below The Windows	28%	Semi-Firm	A moisture probe was made at the bottom of the bumpout below the windows. An elevated moisture reading was noted with a semi-firm substrate.
F6	Bottom Wall Below The Windows	30%	Semi-Firm	A moisture probe was made at the bottom of the bumpout below the windows. An elevated moisture reading was noted with a semi-firm substrate.

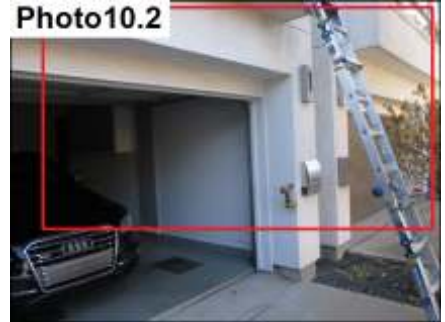
Photo10.2

Confirmed Substrate Damage/
Repair And Add Relief

Grid Location	Item Description	Moisture Readings	Substrate Condition	Observations
Red Box	Confirmed Substrate Damage			Confirmed substrate damage is noted at the right wall below the bottom wall with missing relief below the undersized metal flashing.. The inspector suggests having a qualified stucco waterproofing contractor further assess and repair this area as needed and to install a proper relief above in an effort to allow proper moisture evacuation. Please refer to photos #10.2, #10.3, #10.4 and #10.5 for more detail.

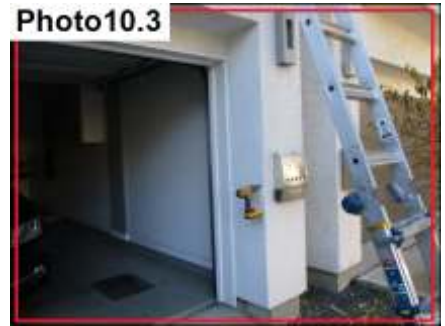
Photo10.3

Confirmed Substrate Damage/
Repair And Add Relief

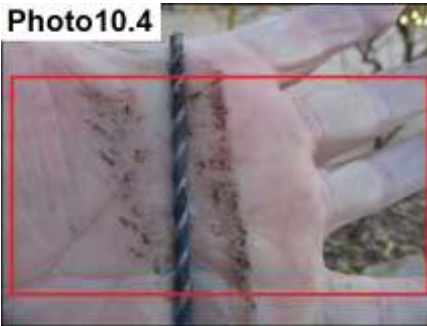
Photo10.4

Confirmed Substrate Damage/
Repair And Add Relief

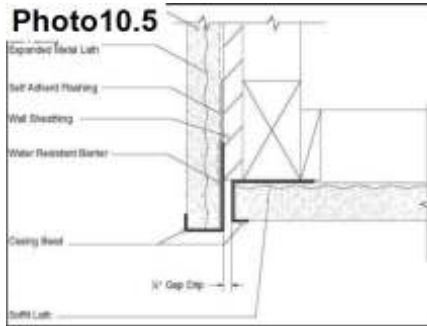
Photo10.5

Proper Relief Detail

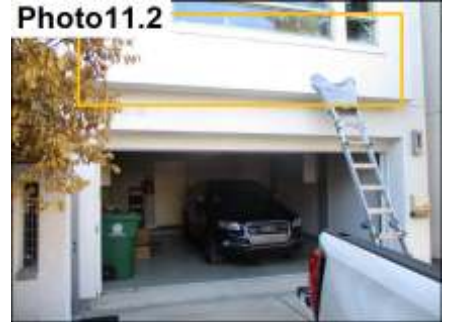
Photo11.2

Semi-Soft Substrate Below Bank Of Windows

Grid Location	Item Description	Moisture Readings	Substrate Condition	Observations
Oranage Box	Semi-Firm Substrate Below Bank of Windows			Elevated moisture and semi-firm substrate is noted below the bank of windows where the cement fiber panel has been sealed over. The inspector suggests having a qualified stucco waterproofing contractor further assess, core sample and rework or modify this area as needed in an effort to allow proper moisture evacuation. Please note that this area was previously repaired but inspector believes the window is failing allowing additional moisture intrusion. Please refer to photos #11.2, #11.3, #11.4, #11.5 and #11.6 for more detail.

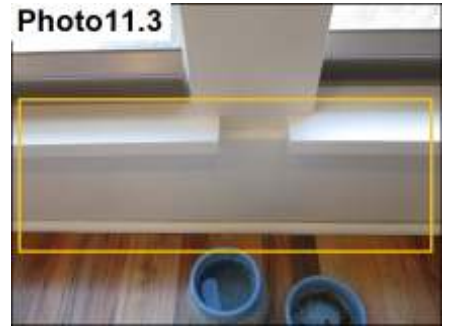
Photo11.3

Semi-Soft Substrate Below Bank Of Windows

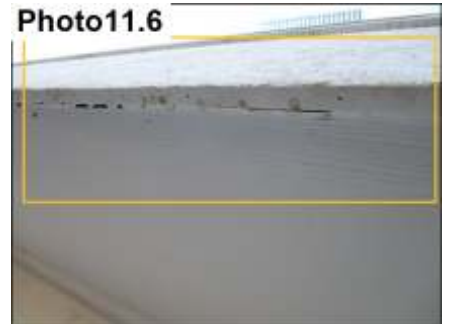
Photo11.6

Semi-Soft Substrate Below Bank Of Windows

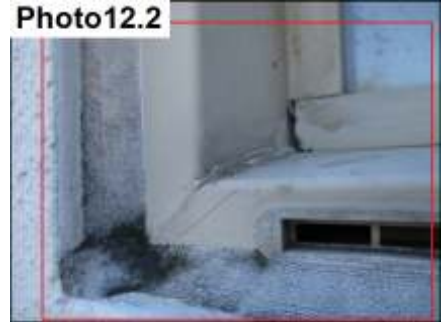
Photo12.2

Windows / Wet Glaze & Seal

Grid Location	Item Description	Moisture Readings	Substrate Condition	Observations
Red Box	Bank of Windows			The window and window miter sealants are aged and separated. The inspector suggests having a qualified stucco waterproofing contractor to assess and wet glaze then seal this area with NP1 or low modulus sealant in an effort to prevent moisture intrusion. Additionally, it is recommended to have a representative of the window manufacture assess the left window for defects or improper flashing during initial construction. Please refer to photos # 12.2, #12.3, #12.4, #12.5 and #12.6 for more detail.

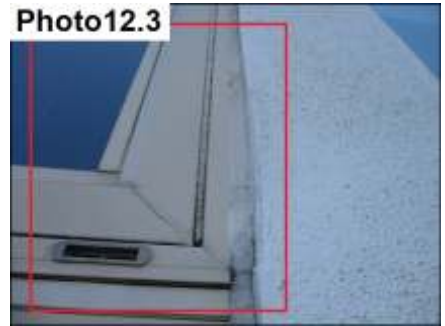
Photo12.3

Windows / Wet Glaze & Seal

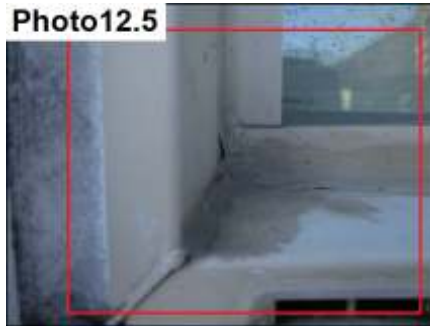
Photo12.5

Windows / Wet Glaze & Seal

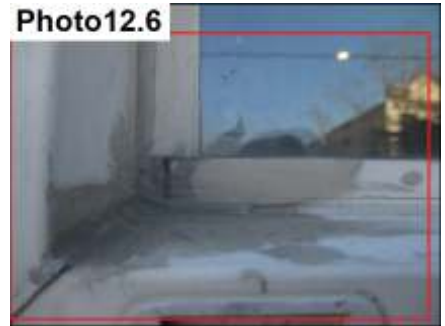
Photo12.6

Windows / Wet Glaze & Seal

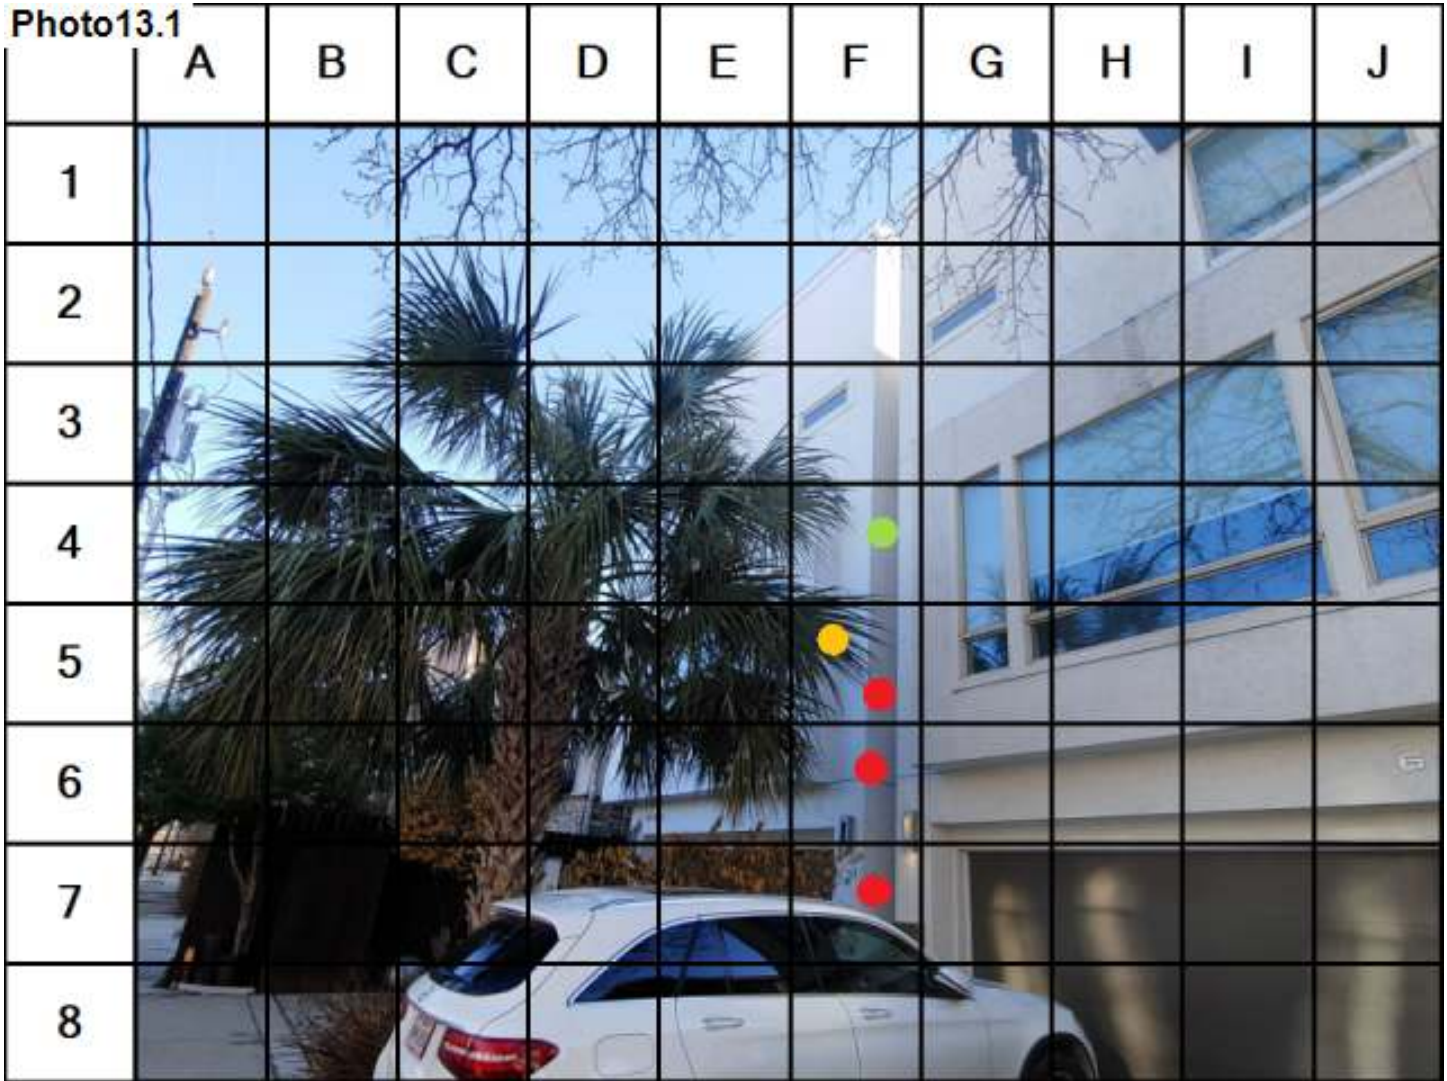
Photo13.1

Grid Location	Item Description	Moisture Readings	Substrate Condition	Observations
F7	Corner Wall	23%	Firm	A moisture probe was made at the corner wall. An elevated moisture reading was noted with a firm substrate.
F6	Corner Wall	22%	Firm	A moisture probe was made at the corner wall. An elevated moisture reading was noted with a firm substrate.
F5	Corner Wall	24%	Firm	A moisture probe was made at the corner wall. An elevated moisture reading was noted with a firm substrate.
F5/ Orange Dot	Inside Corner Wall	20%	Firm	A moisture probe was made at the inside corner wall. An elevated moisture reading was noted with a firm substrate.
F4	Corner Wall	18%	Firm	A moisture probe was made at the corner wall. The substrate was firm with no damage noted at this time.

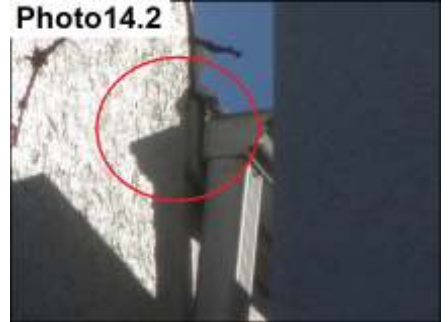
Photo14.2

Roof Diverter Flashing Sealants/
Seal

Grid Location	Item Description	Moisture Readings	Substrate Condition	Observations
Red Circle	Roof Diverter Flashing Sealants			The roof diverter flashing sealants are aged or separated. The inspector suggests having a qualified stucco waterproofing contractor seal this area with NP1 or low modulus sealant in an effort to prevent moisture intrusion. These types of sealants are of high quality and compatible with stucco and other termination points. Please refer to photos #14.2 and #14.3 for more detail.

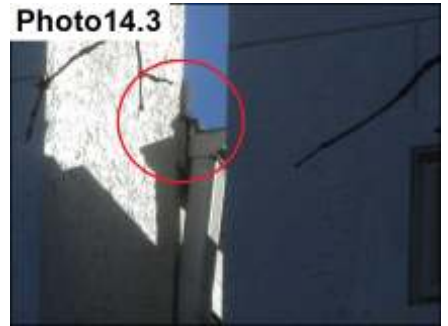
Photo14.3

Roof Diverter Flashing Sealants/
Seal

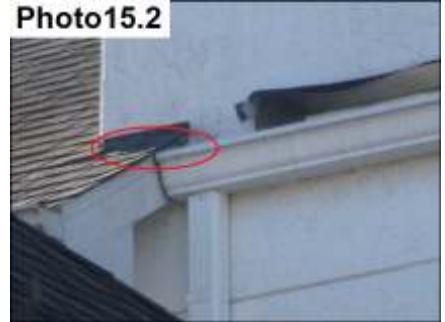
Photo15.2

- The roof diverter flashing sealants are separated or missing. The inspector suggests to have a qualified waterproofing contractor seal this area as needed in an effort to prevent moisture intrusion. Please refer to photos #15.2 and #15.3 for more detail.

Roof Diverter Flashing Sealants/s Seal

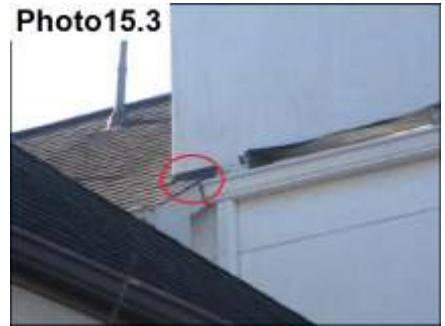
Photo15.3

Roof Diverter Flashing Sealants/s Seal

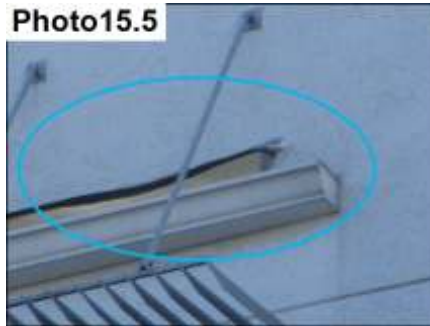
Photo15.5

- The scupper sealants are aged. The inspector suggests having a qualified stucco waterproofing contractor seal this area with NP1 or low modulus sealant in an effort to prevent moisture intrusion. These types of sealants are of high quality and compatible with stucco and other termination points. Please refer to photos #15.4 and #15.5 for more detail.

Scupper Flashing Sealants/s Seal

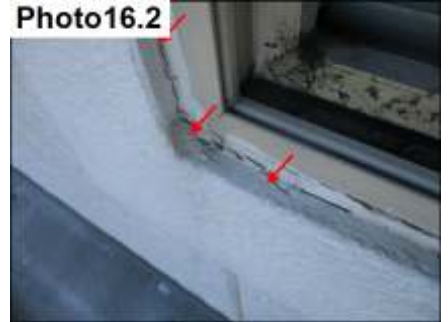
Photo16.2

Window Sealants/ Seal

Grid Location	Item Description	Moisture Readings	Substrate Condition	Observations
Red Arrows	Window Sealants			The window sealants are aged or separated. The inspector suggests having a qualified stucco waterproofing contractor seal this area with NP1 or low modulus sealant in an effort to prevent moisture intrusion. These types of sealants are of high quality and compatible with stucco and other termination points. Please refer to photos #16.2, #16.3, #16.4, #16.5 and #16.6 for more detail.

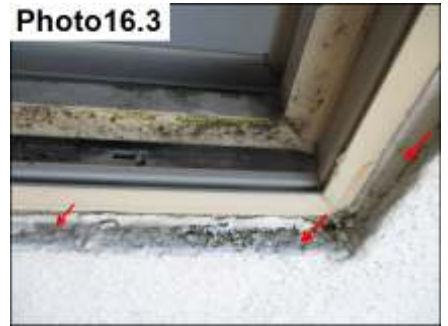
Photo16.3

Window Sealants/ Seal

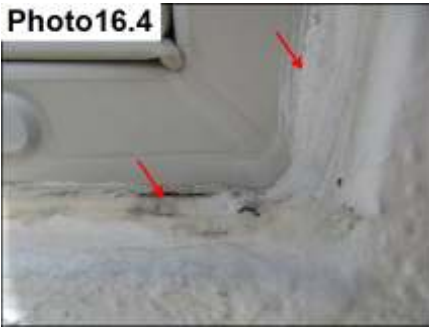
Photo16.4

Window Sealants/ Seal

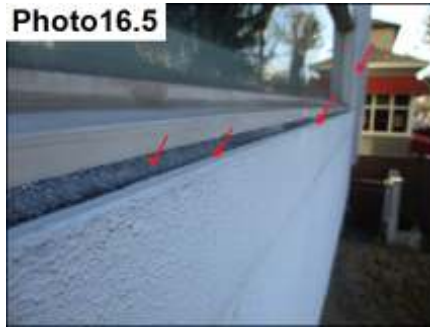
Photo16.5

Window Sealants/ Seal

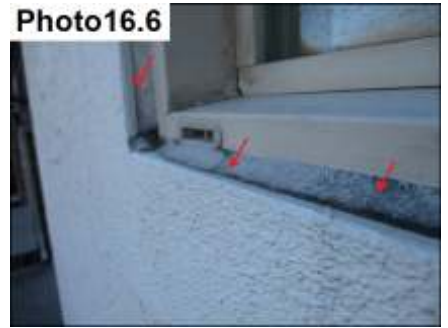
Photo16.6

Window Sealants/ Seal

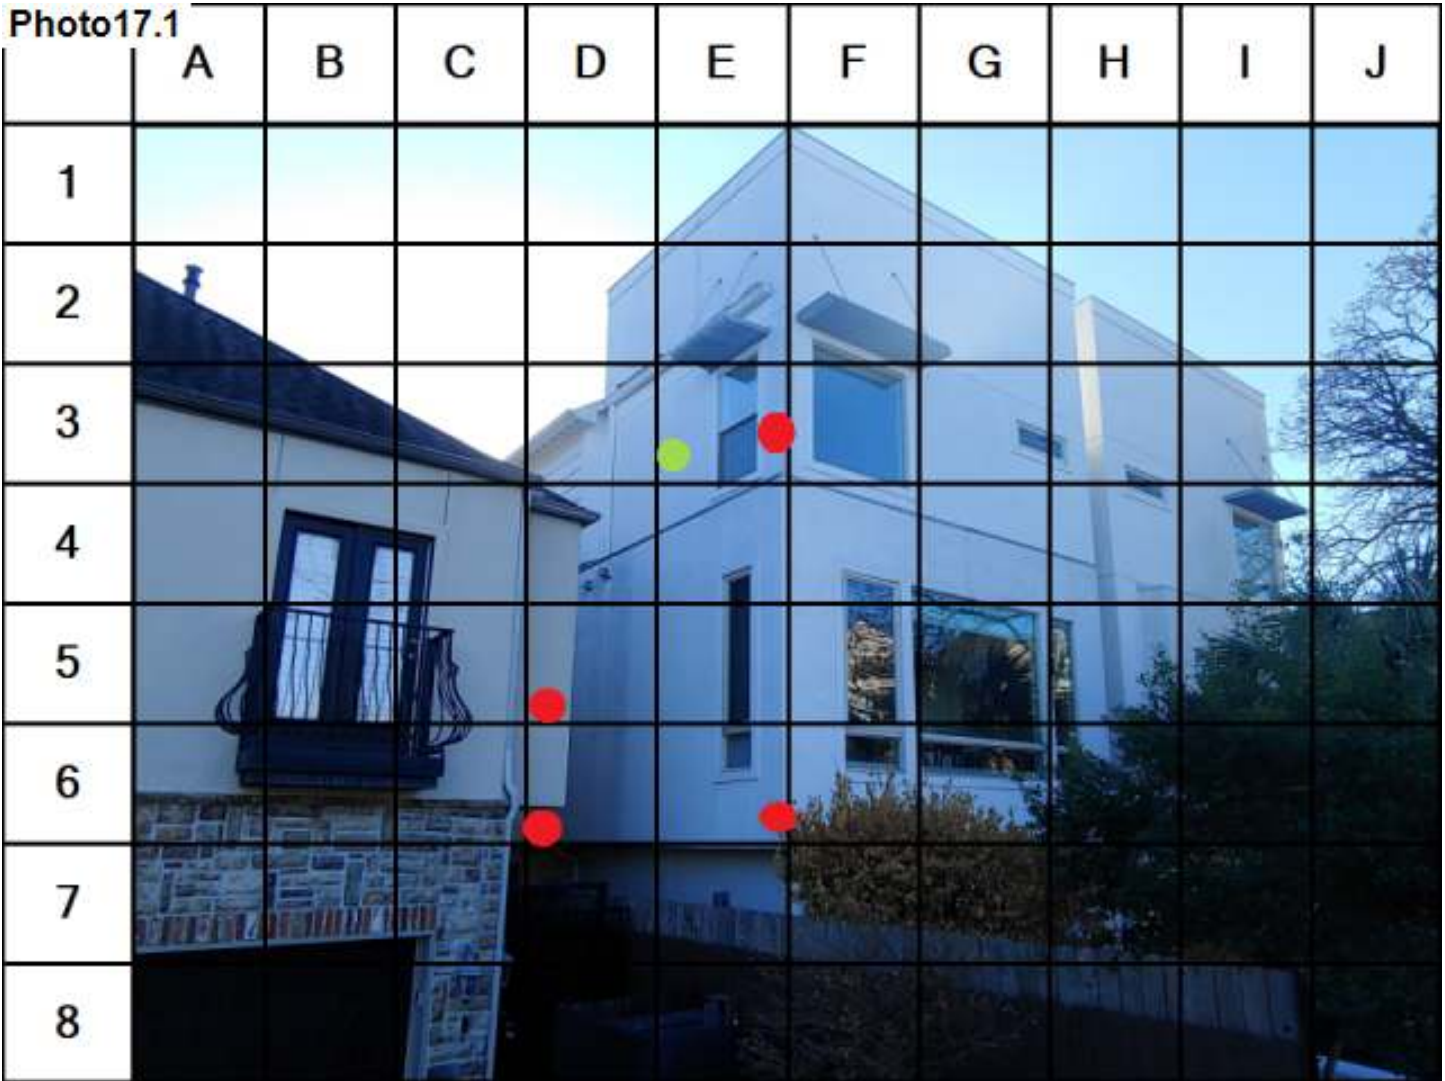
Photo17.1

Grid Location	Item Description	Moisture Readings	Substrate Condition	Observations
D7	Bottom Corner Wall		None	A moisture probe was made at the bottom wall. No substrate was noted in this location. The inspector suggests to modify this area as needed.
D6	Above Probe E6	27%	Semi-Soft	A moisture probe was made above probe D7. An elevated moisture reading was noted with a semi-soft substrate. The inspector suggests to modify this area as needed.
E5	Corner Wall Metal Cap	22%	Firm	A moisture probe was made at the corner wall below the parapet. An elevated moisture reading was noted with a firm substrate.
E3	Corner Wall Below Parapet	22%	Firm	A moisture probe was made at the wall below the scupper. An elevated moisture reading was noted with a firm substrate.
E3	Wall Below Metal Cap	18%	Firm	A moisture probe was made at the wall below the metal cap. An elevated moisture reading was noted with a firm substrate.

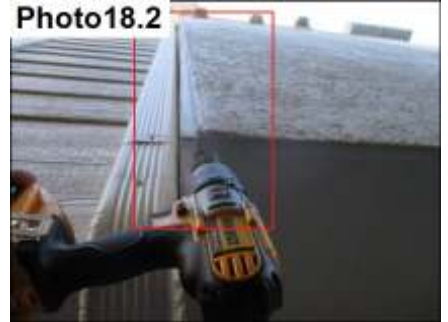
Photo18.2

Substrate Damage Noted / Repair

Grid Location	Item Description	Moisture Readings	Substrate Condition	Observations
Red Box	Bottom Wall			Confirmed substrate and potential frame damage is noted at the left wall below the sizable gap at the metal cap and stucco termination. The inspector suggests having a qualified stucco waterproofing contractor further assess and repair this area as needed. Please refer to photos #18.2, #18.3 for more detail.

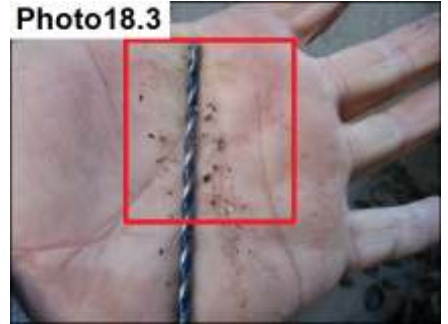
Photo18.3

Substrate Damage

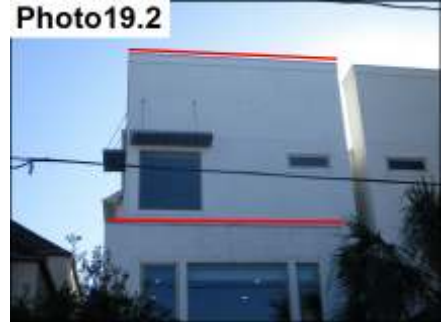
Photo19.2

Under-Sized Metal Cap And Parapet Cap/ Replace Cap

Grid Location	Item Description	Moisture Readings	Substrate Condition	Observations
Red Lines	Under-Sized Metal Cap And Parapet Cap			The metal cap and parapet cap are under-sized at the face of the stucco termination creating lift during weather events allowing moisture to penetrate the system. The inspector suggests having a qualified stucco waterproofing contractor replace the caps with a of a three inch cap in an effort to prevent moisture intrusion. Please refer to photos #19.2, #19.3, #19.4, #19.5, #19.6, #20.1, #20.2, #20.3 and #20.4 for more detail.

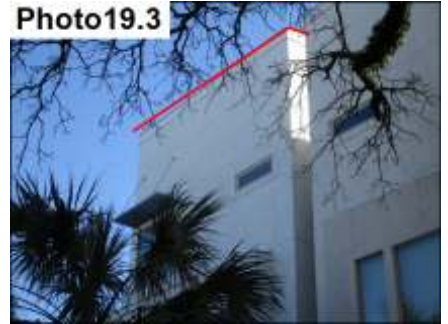
Photo19.3

Under-Sized Metal Cap And Parapet Cap/ Replace Cap

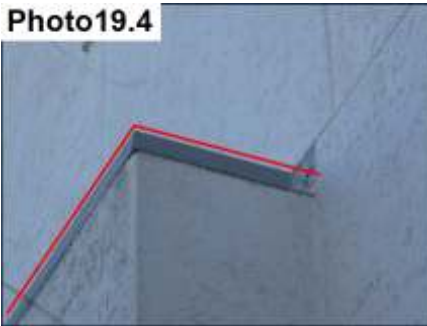
Photo19.4

Under-Sized Metal Cap And Parapet Cap/ Replace Cap

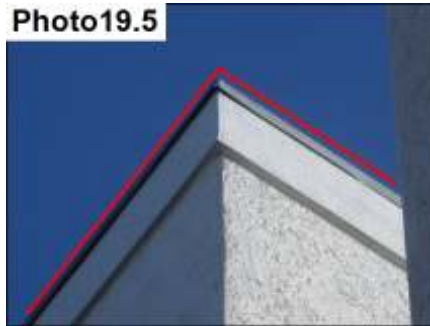
Photo19.5

Under-Sized Metal Cap And Parapet Cap/ Replace Cap

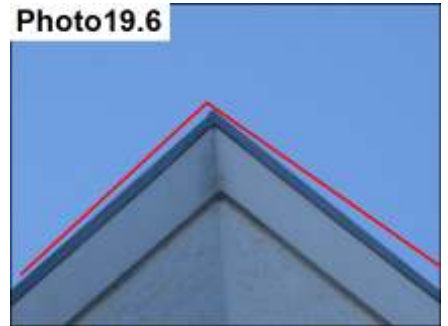
Photo19.6

Under-Sized Metal Cap And Parapet Cap/ Replace Cap

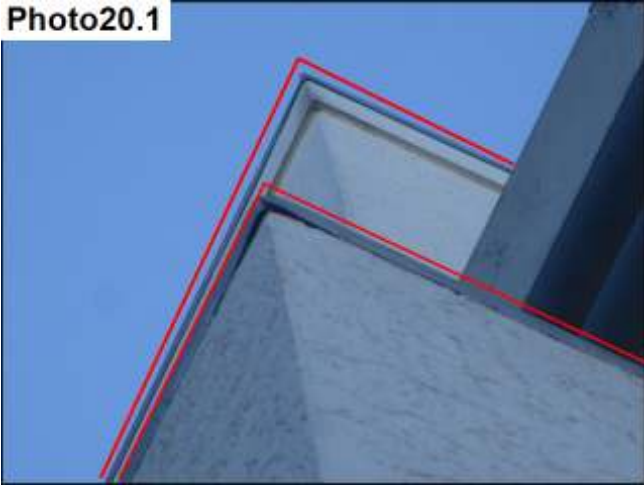
Photo20.1

- The metal cap and parapet cap are under-sized at the face of the stucco termination creating lift during weather events allowing moisture to penetrate the system. The inspector suggests having a qualified stucco waterproofing contractor replace the caps with a of a three inch cap in an effort to prevent moisture intrusion. Please refer to photos #19.2, #19.3, #19.4, #19.5, #19.6, #20.1, #20.2, #20.3 and #20.4 for more detail.

Under-Sized Metal Cap And Parapet Cap/ Replace Cap

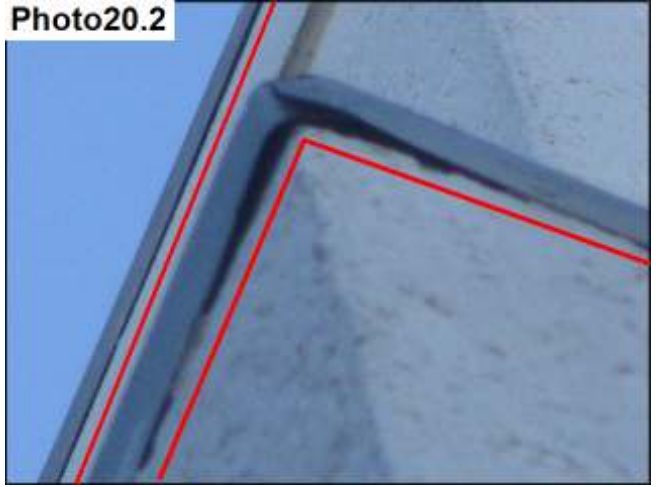
Photo20.2

Under-Sized Metal Cap And Parapet Cap/ Replace Cap

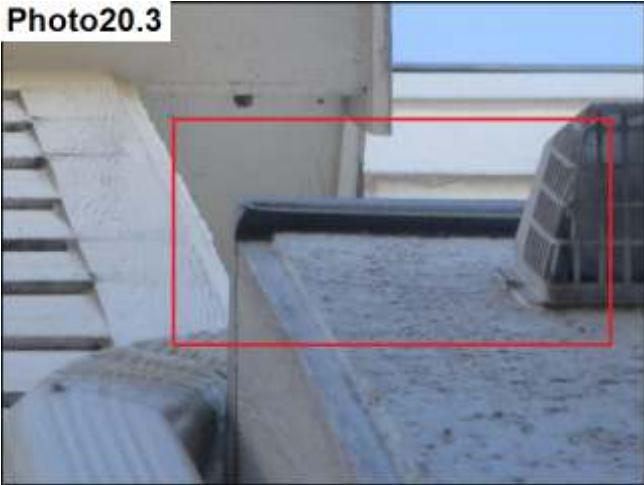
Photo20.3

Under-Sized Metal Cap And Parapet Cap/ Replace Cap

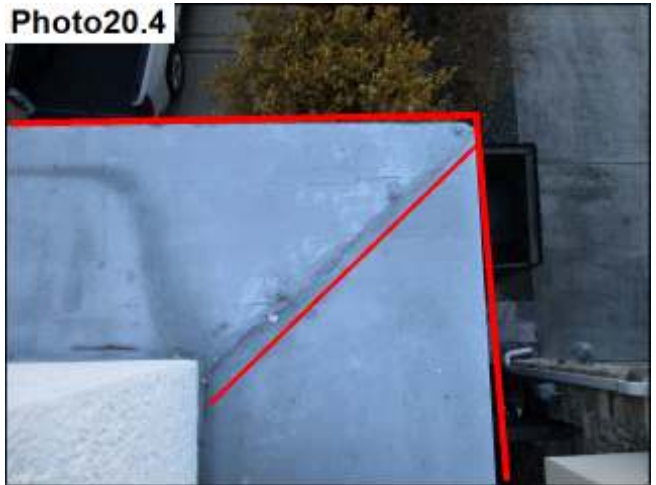
Photo20.4

Under-Sized Metal Cap And Parapet Cap/ Replace Cap
