Property Inspection Report

PROPERTY INSPECTION REPORT

Concerning: 9010 St. Laurent Ln., Houston, TX 77044
(Address or Other Identification of Inspected Property)

By: Larry Fleming, Lic #4860 08/16/2019
(Name and License Number of Inspector) (Date)

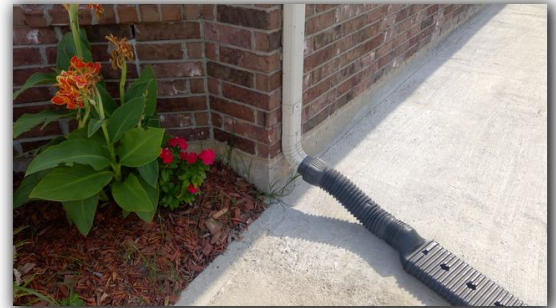
- Shovel Cracks observed at slab brick ledge corners at multiple locations

Would recommend that a licensed and / or qualified contractor be consulted to make any further recommendations and / or repairs

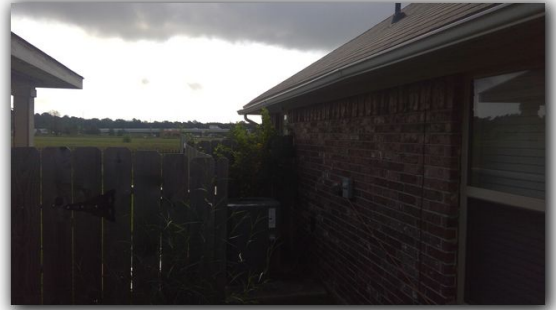
Gutters / downspouts observed to be damaged / dented at one or more locations.

Would recommend that a licensed and / or qualified contractor be consulted to make any further recommendations and / or repairs

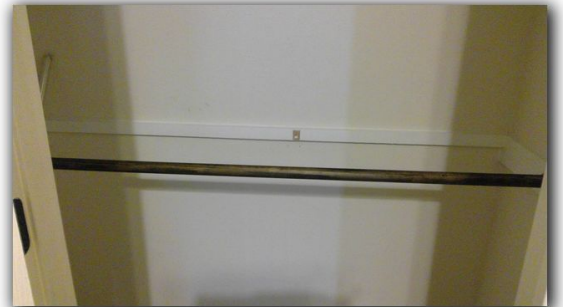
- Braces for closet shelving / rods appeared to be removed and not replaced at the time of the inspection.

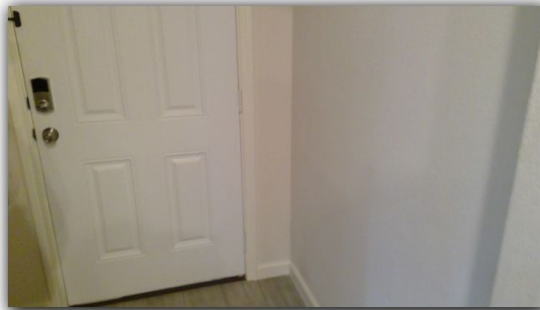
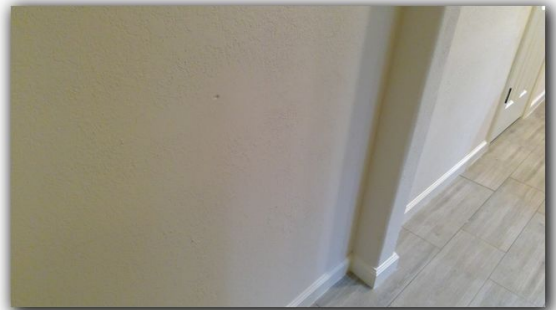
Sheetrock damage observed behind doorknobs at one or more locations where it appears the sheetrock has been damaged by the doorknob.

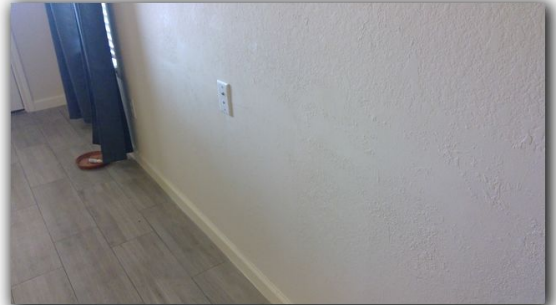
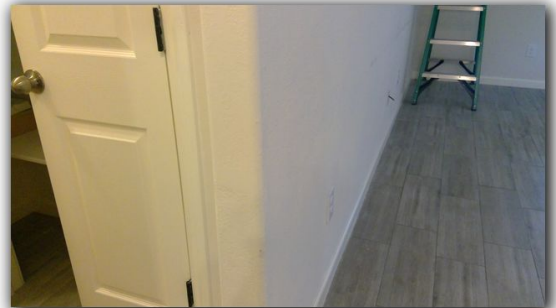
Evidence of previous repairs observed in interior walls at one or more locations. It appeared to the inspector that the sheetrock repair was due to previous flooding of the house. The sheetrock repairs did not appear to be performed in a usual and customary building practice manner. Seams were very noticeable.

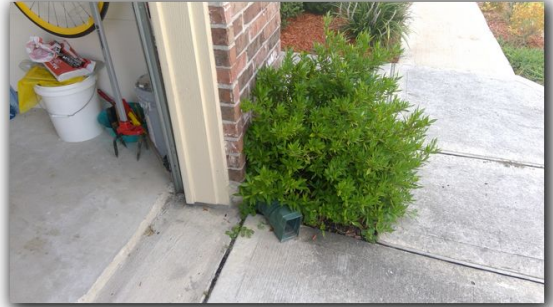
Heavy vegetation needs to be trimmed from touching exterior walls

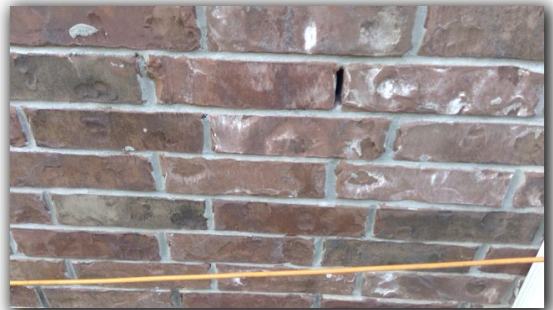
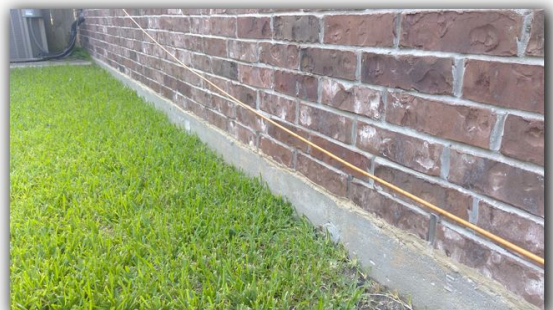
Weep holes had been closed at some locations and other mortar was removed higher up with what appeared to be an attempt at weepholes or drying out of the walls due to previous flooding of the house. The removed mortar should be patched and the lower weepholes need to be opened to properly maintain the moisture barrier drainage system in the exterior wall system.

Would recommend that a licensed and / or qualified contractor be consulted to make any further recommendations and / or repairs.

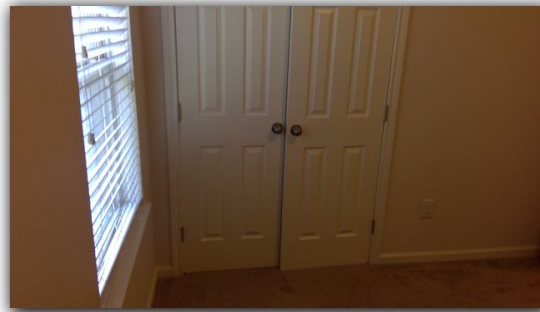
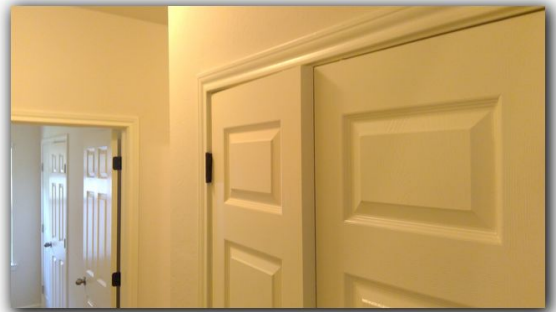
Interior doors rub, stick or hit frames at multiple locations.

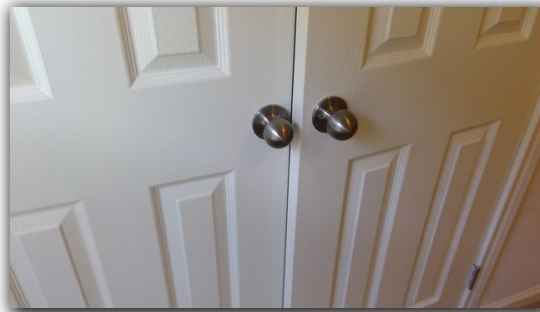
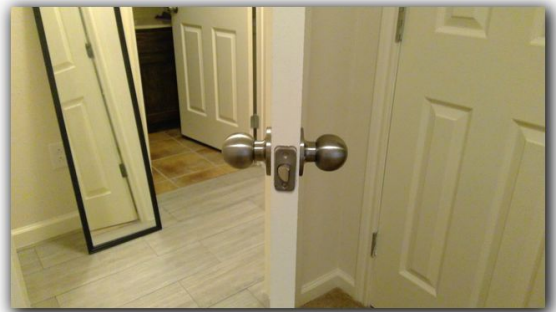
Deficient Hardware observed at one or more interior door locations

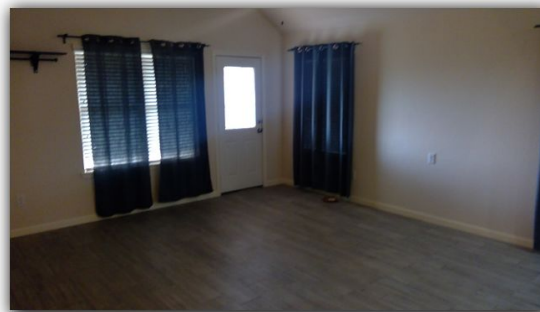
Double cylinder locks requiring the use of a key to open pose safety consideration

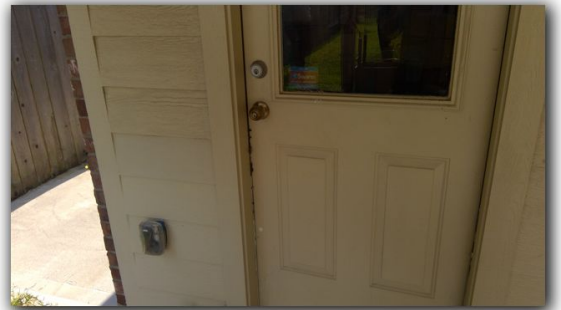
Damaged weather stripping observed at one or more exterior door locations

Would recommend that a licensed and / or qualified contractor be consulted to make any further recommendations and / or repairs

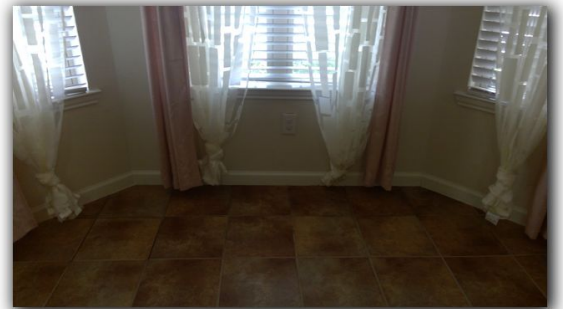
Outlet/Switches loose at multiple locations.

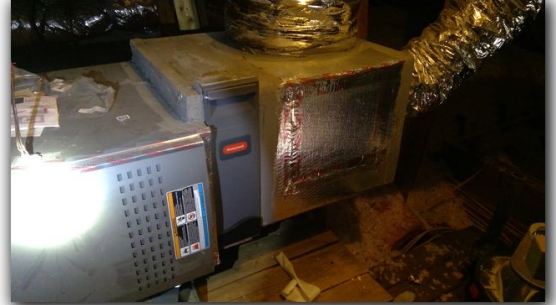
HVAC duct system does not conform to current code regarding proper sealing / mastic

Would recommend that a licensed and / or qualified contractor be consulted to make any further recommendations and / or repair

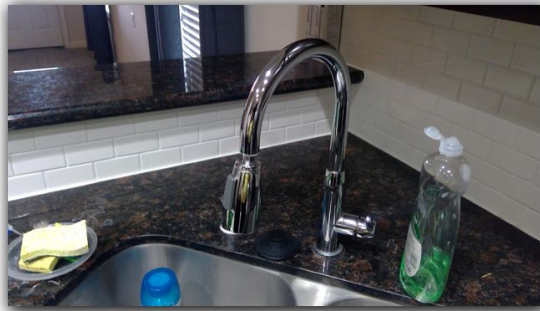
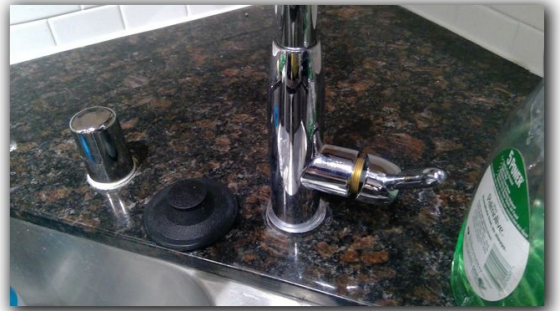
- Part appears to be missing from faucet handle at kitchen sink

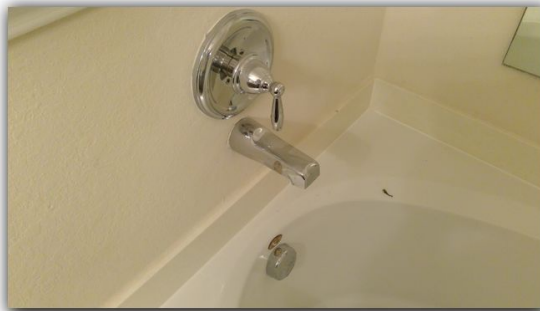
- Caulking or grout missing or damaged / cracks observed at one or more shower / tub enclosure locations. See tub spout at master bathtub..

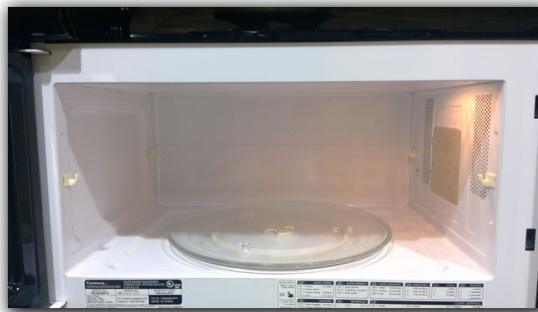
Metal rack(s) missing from interior of microwave.

Would recommend that a licensed and / or qualified contractor be consulted to make any further recommendations and / or repair
