Total Home Inspection

Property Inspection Report

1722 Stacy Falls, Houston, TX 77008
Inspection prepared for: Michael Round
Real Estate Agent: Chris Cuchapin - Texas Top Realty

Date of Inspection: 10/25/2018 Time: 9:30 AM
Age of Home: 2005 Size: 2387
Weather: 72 light rain and rain during the previous week.
Order ID: 764

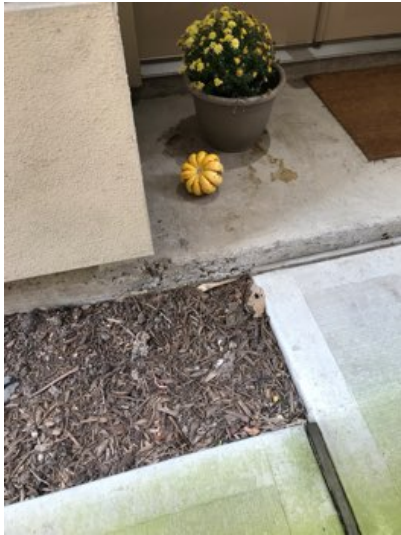
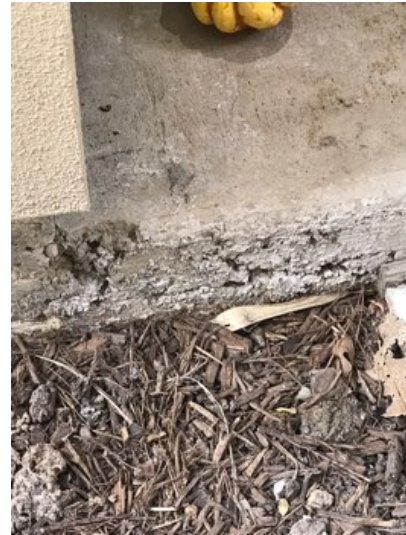
There were areas of concrete that had a honey comb pattern due to original pour. These areas may be sealed with mortar.

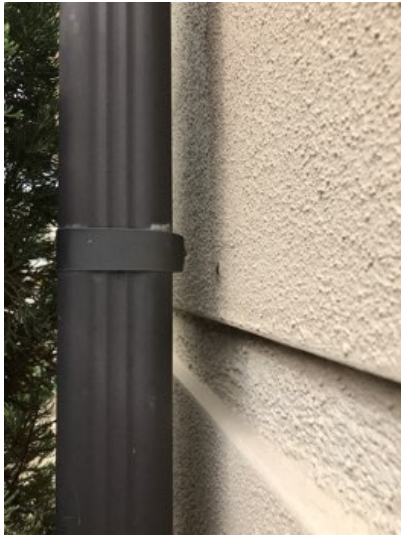
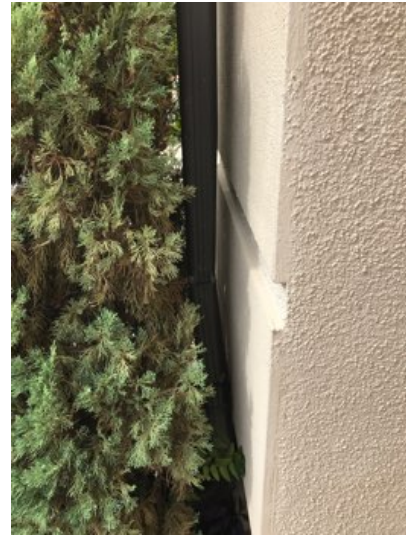
The left front gutter was loose from the wall and needs to be re-aligned.

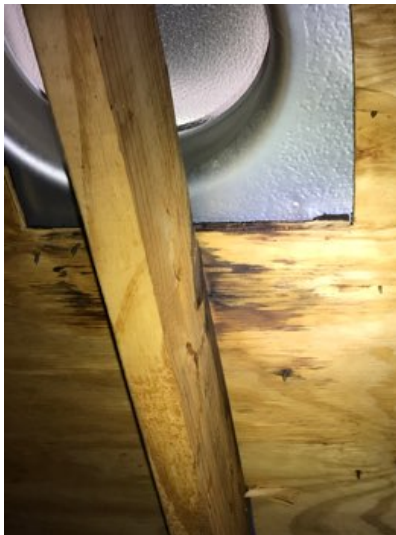
Roof deck was stained at the attic vent. Moisture was not detected at the time of the inspection.

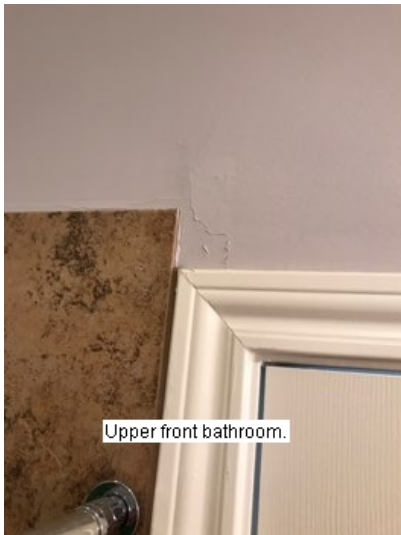
Upper front bathroom.

Several repaired cracks were noted in drywall in random areas of the home.

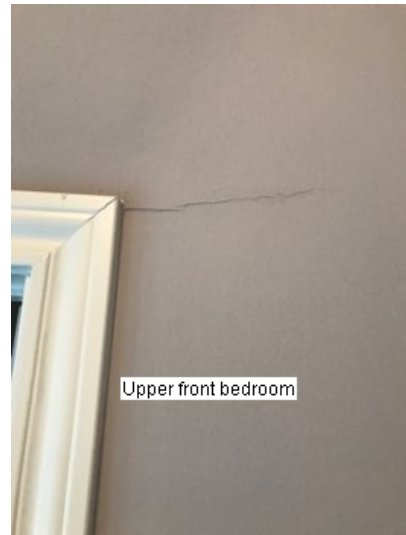
Upper front bedroom

Several repaired cracks were noted in drywall in random areas of the home.

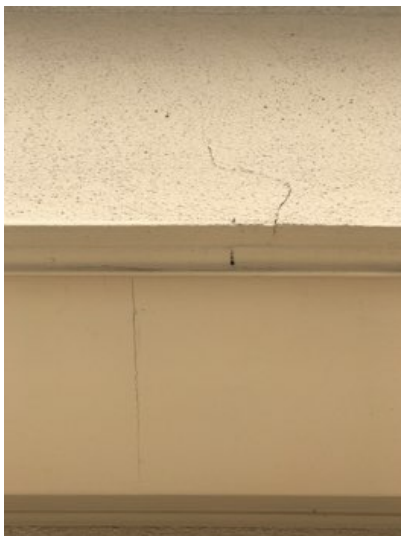
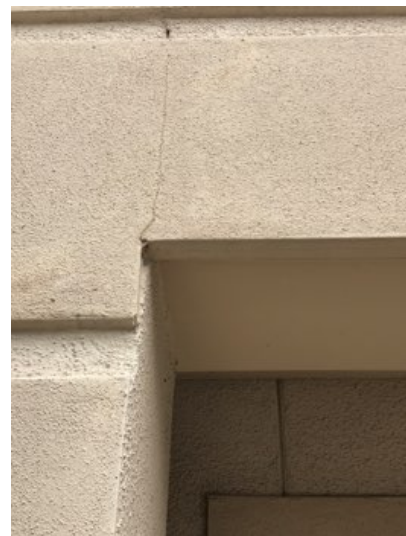
Stress cracking was noted above the garage door opening and to the left.

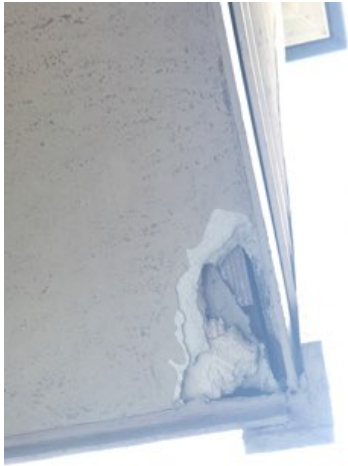
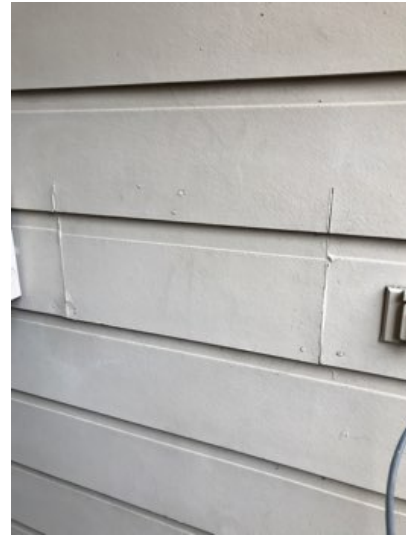
The soffit was damaged on the right rear lower level.

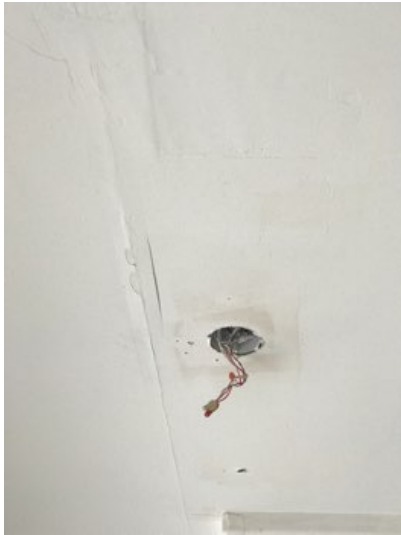
The garage ceiling has sustained damage and has repairs.

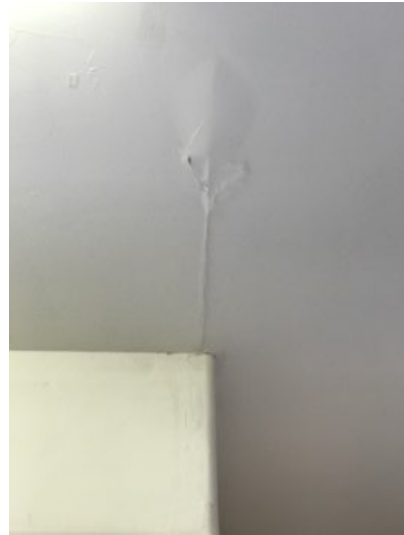
The garage ceiling has sustained damage and has repairs.

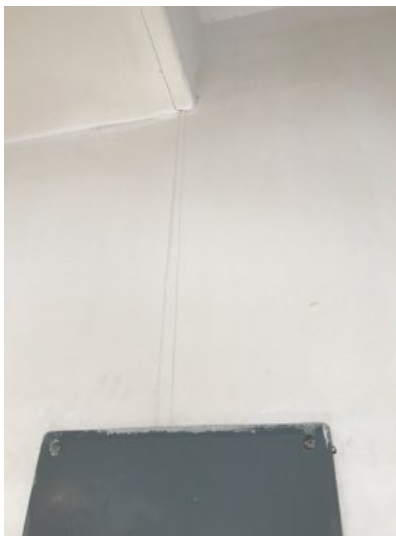
The garage ceiling has sustained damage and has repairs.

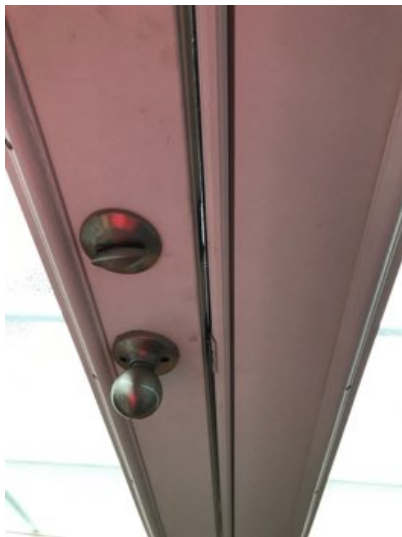
Balcony door weatherstrip do not seal properly and need adjustment or replacement.

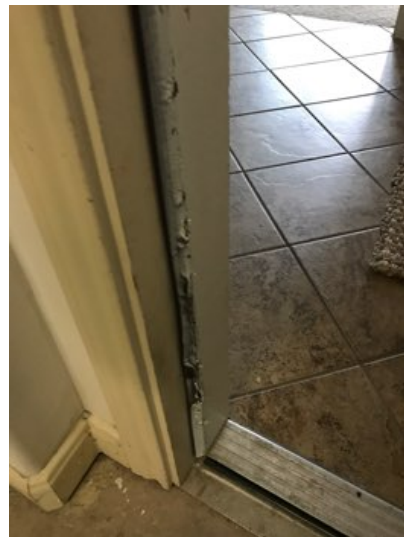
The garage pedestrian door has a damaged weather strip.

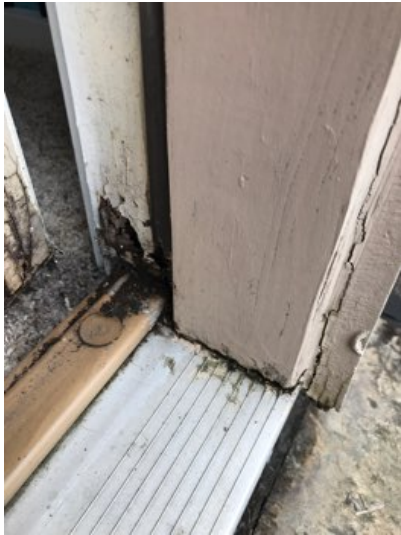
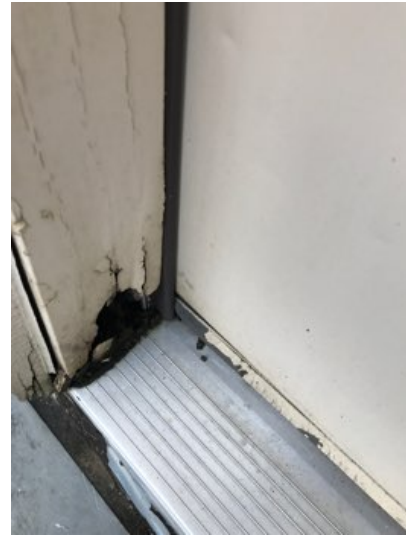
Deterioration of door and frame and adjacent wood trim noted at the third floor balcony. Framing and flooring in this area contained an high level of moisture ad detected with and FLIR camera. Doors and frame should be replaced and door saddle should be installed over proper flashing.

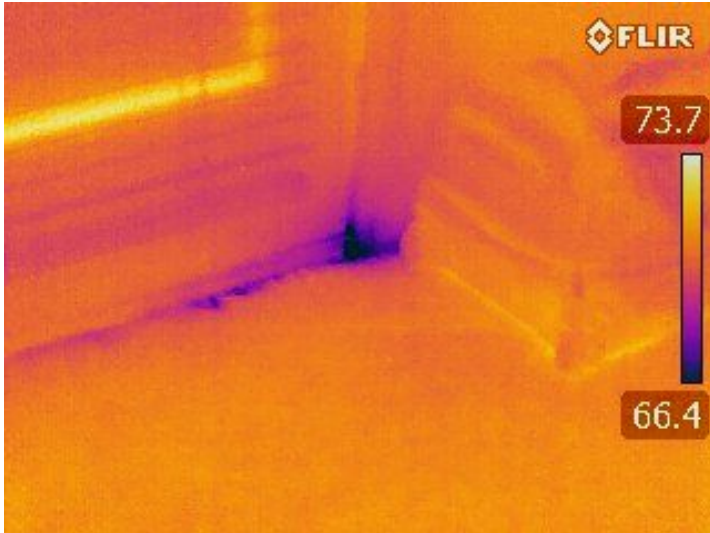
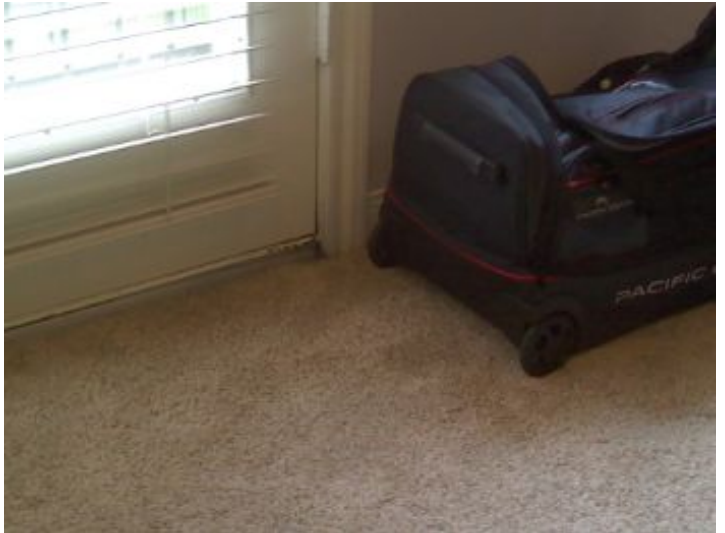
Deterioration of door and frame and adjacent wood trim noted at the third floor balcony. Framing and flooring in this area contained an high level of moisture ad detected with and FLIR camera. Doors and frame should be replaced and door saddle should be installed over proper flashing.

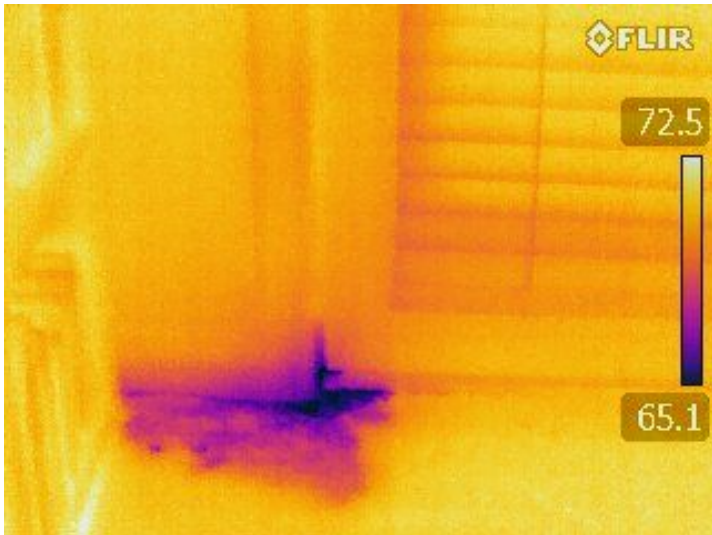
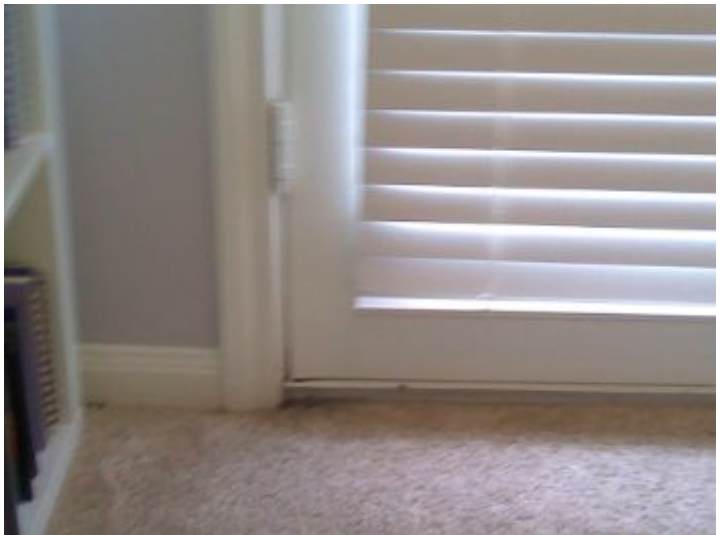
Deterioration of door and frame and adjacent wood trim noted at the third floor balcony. Framing and flooring in this area contained an high level of moisture ad detected with and FLIR camera. Doors and frame should be replaced and door saddle should be installed over proper flashing.

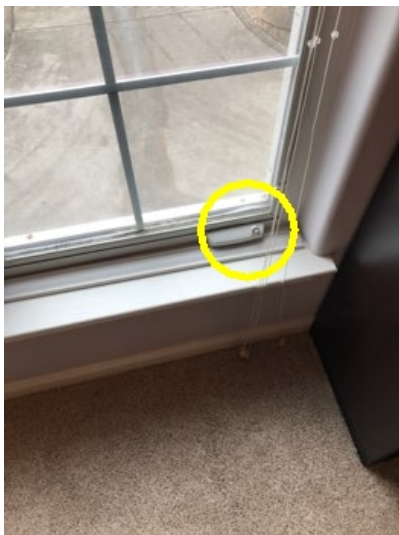
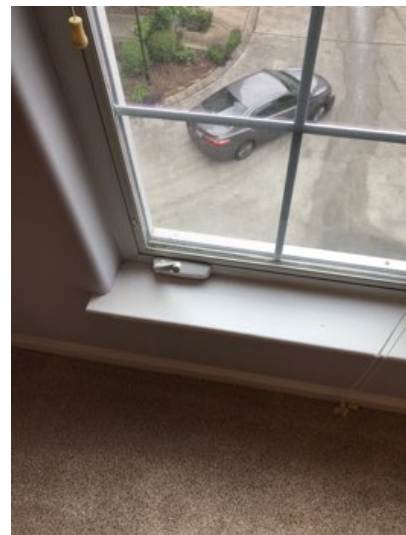
The right side front bedroom window is missing its hand crank.

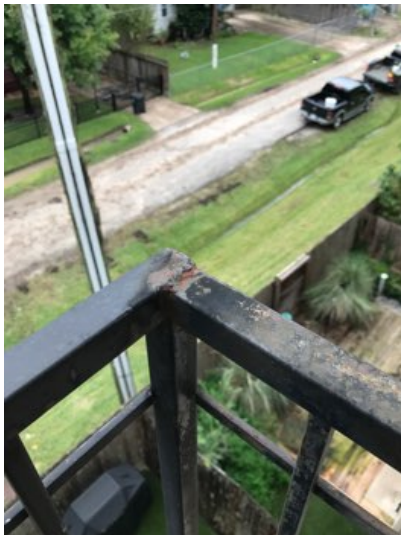
Balcony hand rails were showing signs of rust were noted and indicate rails should be refinished to arrest oxidation.

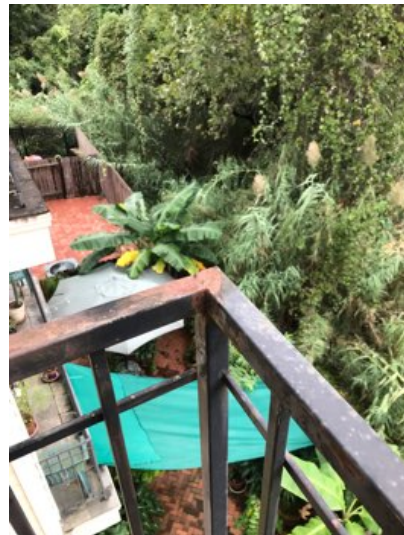
Balcony hand rails were showing signs of rust were noted and indicate rails should be refinished to arrest oxidation.

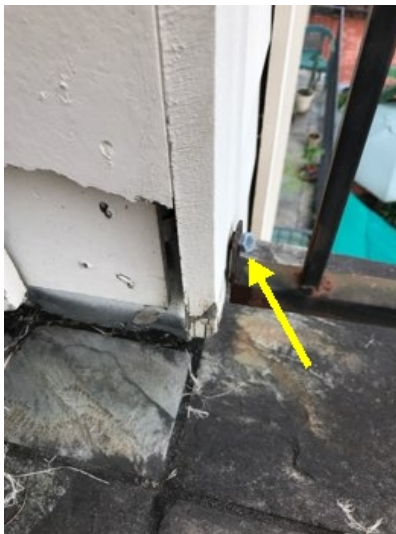
Damaged siding was noted at the upper level balcony.

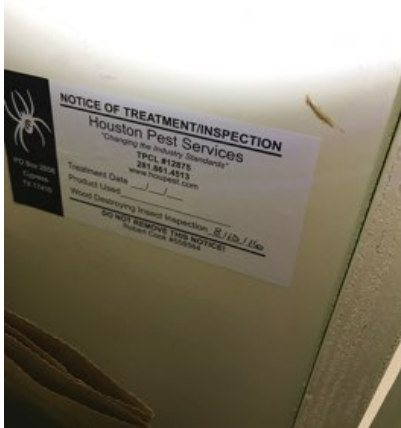
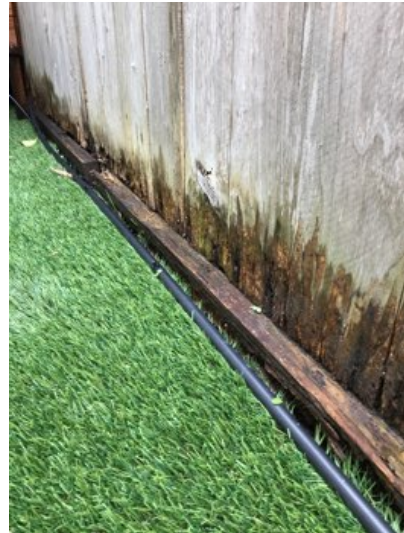
- A sticker for termite treatment dated 8 2016 was noted at the kitchen sink counter.
- **Rear fence has sustained termite damage.**

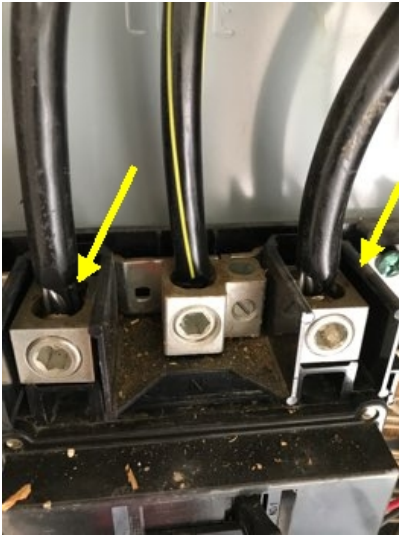
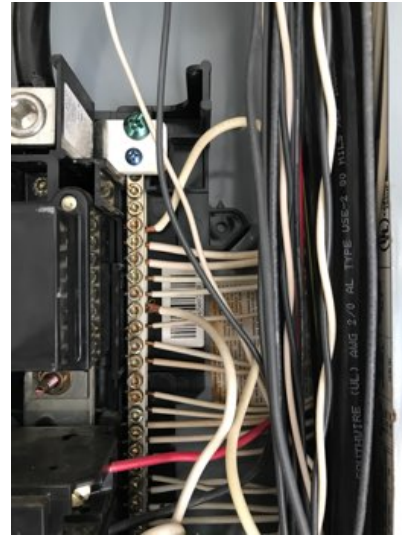
It did not appear that there were anti-oxidants used on the aluminum wire connections.

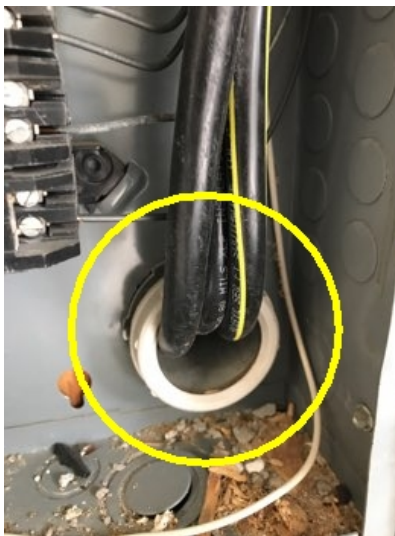
There was no bonding jumper on the service raceway coming from the electric meter box. This raceway coming into the service panel through a concentric knock out should have a bonding bushing or other bonding device.

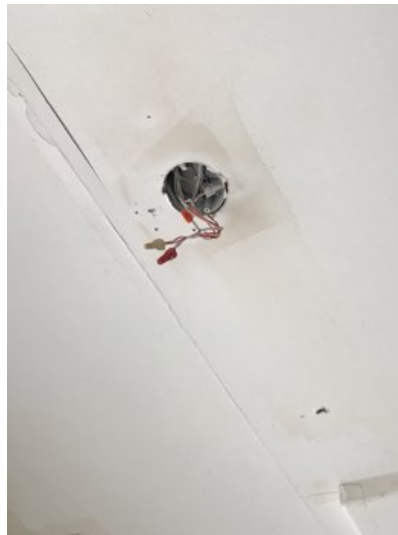
Exposed wiring was noted in the garage ceiling.

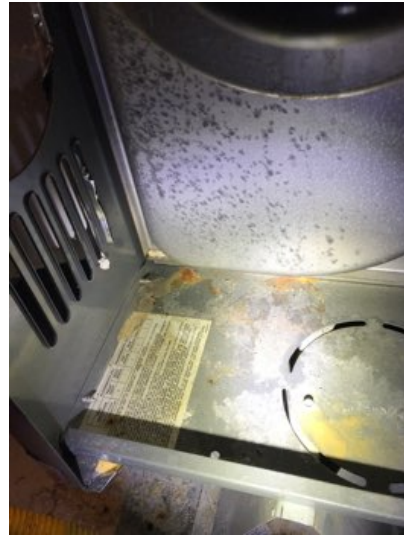
Furnace contained minor rust and is likely from rain water leaking through the furnace flue.

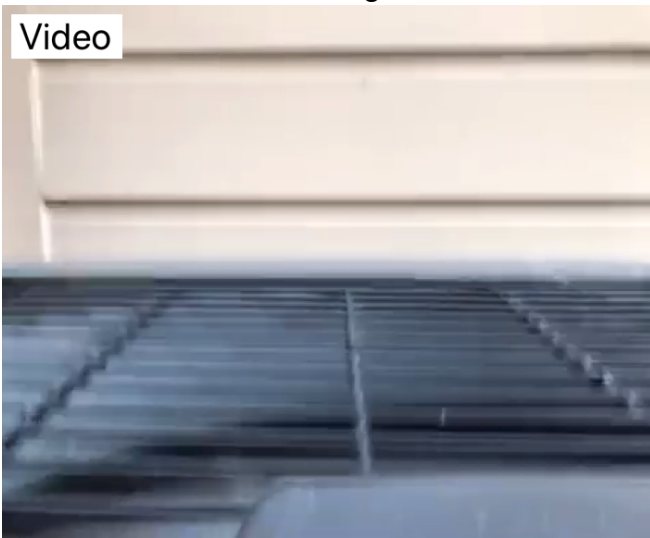
Vibration was noted at the condensing unit.

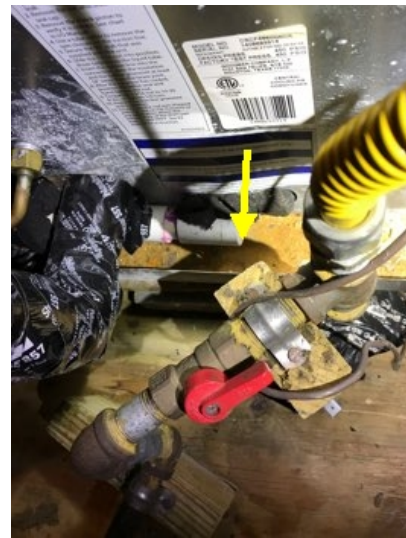
Evidence of water stains and rust in secondary evaporator drain pan. Suspect this could be from typical condensation, however, this could be a sign of improper drainage of the main drain line. Recommend that unit be evaluated and serviced by an HVAC professional.

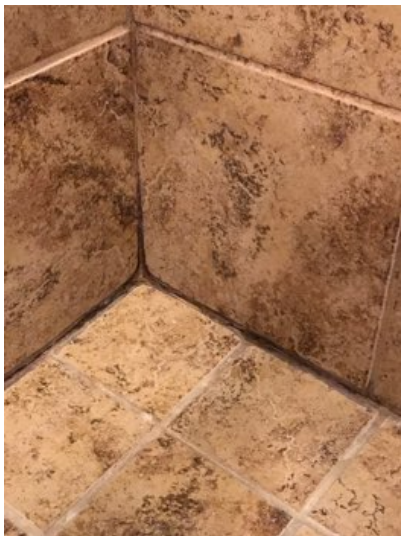
Caulking joints in the master shower should be improved.

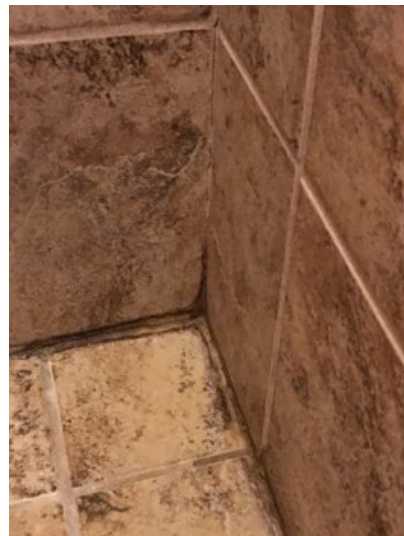
Caulking joints in the master shower should be improved.

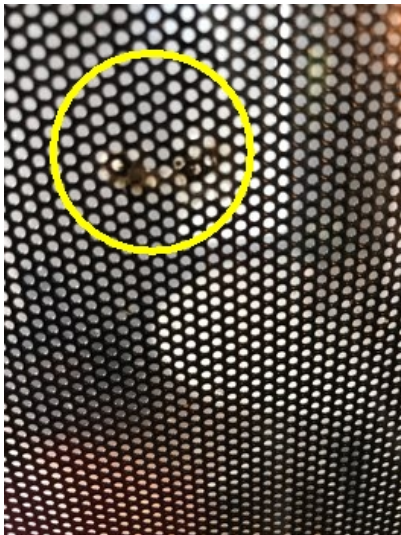
Damage was noted on the front door display glass.
