Inspection Report

Property Address: 20 Back Bay Galveston Tx 77551

On The Ball Home Inspection

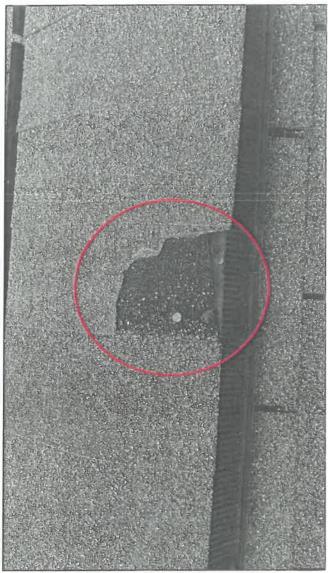
C. Item 10(Picture)

(4) Broken and missing shingles. Recommend a roofer evaluate and repair,

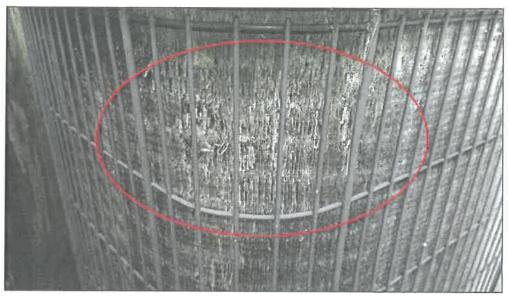
B. Item 4(Picture)

(3) Outside A/C unit did not operate on day of inspection

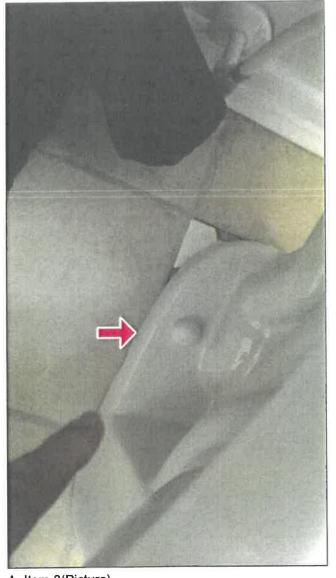
A. Item 3(Picture)

(2) Toilets in both bathrooms are loose. Recommend tightening.

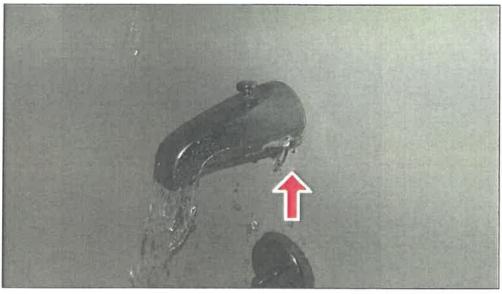
A. Item 7(Picture)

(5) Hall bathroom faucet has a hole on the back side that leaks water. Recommend repair or replace.

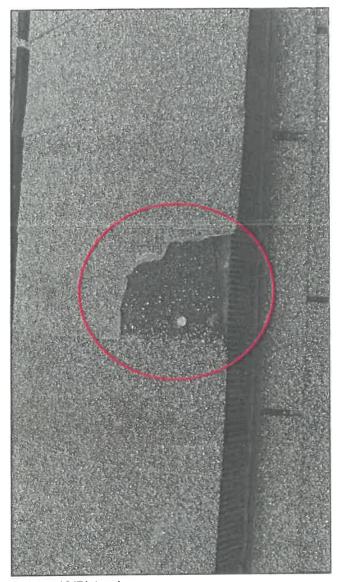
C. Item 10(Picture)

(4) Broken and missing shingles. Recommend a roofer evaluate and repair.

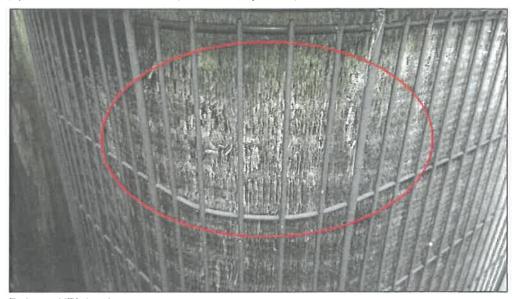
B. Item 4(Picture)

(3) Outside A/C unit did not operate on day of inspection

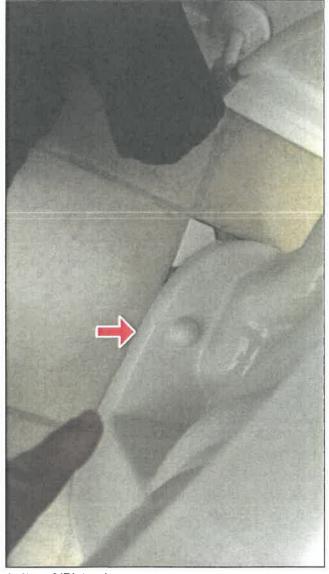
A. Item 3(Picture)

(2) Toilets in both bathrooms are loose. Recommend tightening.

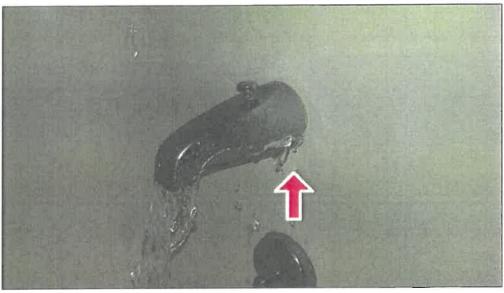
A. Item 7(Picture)

(5) Hall bathroom faucet has a hole on the back side that leaks water. Recommend repair or replace.
