PROPERTY INSPECTION REPORT

Concerning: 18 Fair Light Court, The Woodlands, TX 77382
(Address or Other Identification of Inspected Property)

By: Scott Weible, Lic #10293 04/19/2018
(Name and License Number of Inspector) (Date)

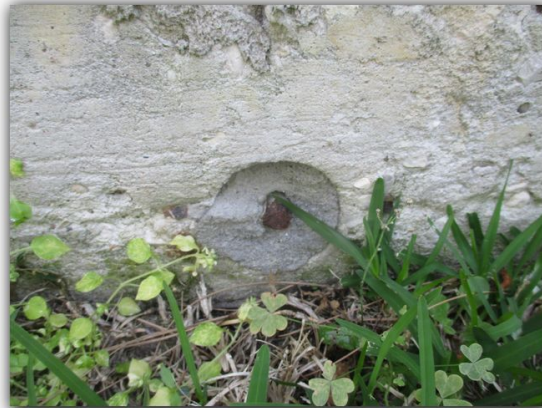
The ends of some of the post tension cables are exposed at the edge of the foundation. Recommend sealing by a qualified post tension contractor to reduce water penetration, corrosion, and failure of the cable retainer.

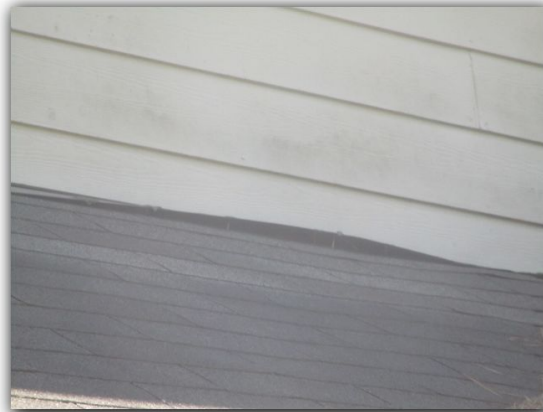
The flashing where the lower level roof meets the upper level wall at the back of the house is uplifted. Recommend re-attaching and sealing.

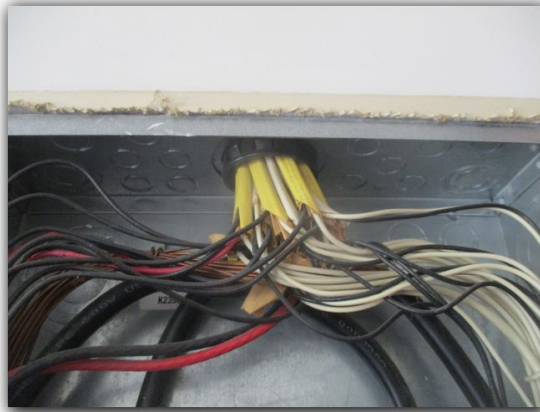
All of the electrical wires enter the top of the panel through one hole with none of the cables secured to the panel. Each cable is required to be secured to the panel to provide a firestop in the wall of the panel. Recommend further evaluation and repair by a licensed electrician.

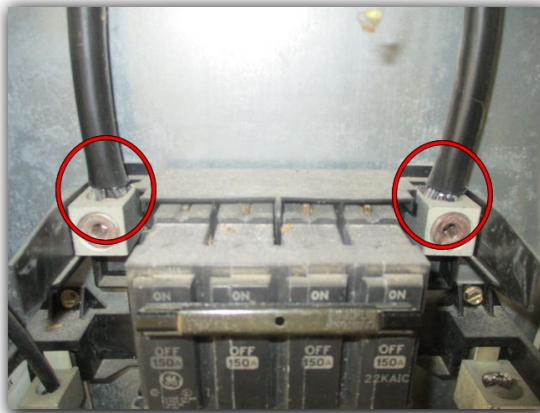
There is no antioxidant paste on the aluminum service entrance wires where they connect to the main breaker and the neutral bus.

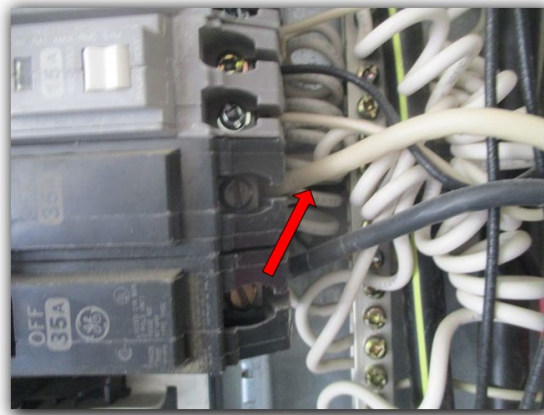
There is a white wire used as a hot conductor connected to the breaker for the A/C system. Normally the white wires are neutral. When used as a hot conductor, the white wires

should be color coded.

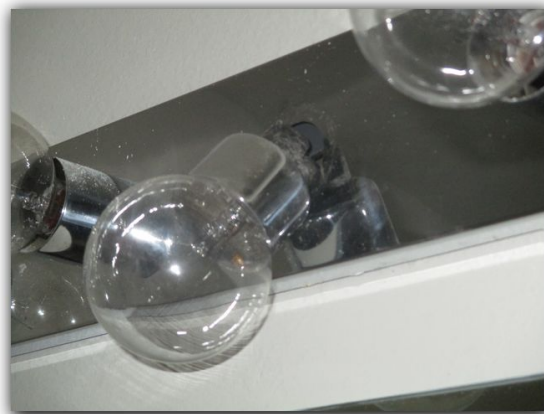
The light fixture above the sinks in the upstairs hall bathroom is broken. Additionally, one of the bulbs is hanging by the wires.

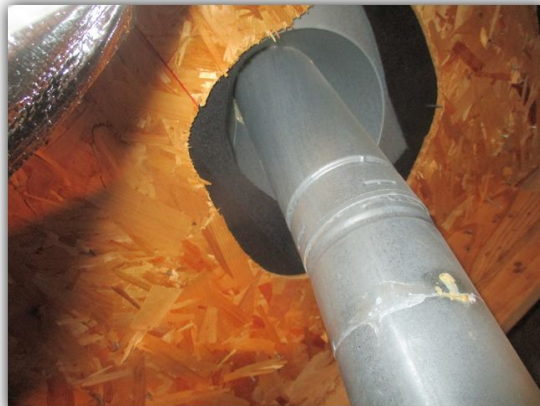
The vent for the heating system is too close to the roofing materials in the roof deck. Recommend a minimum 1 inch clearance to combustible materials.

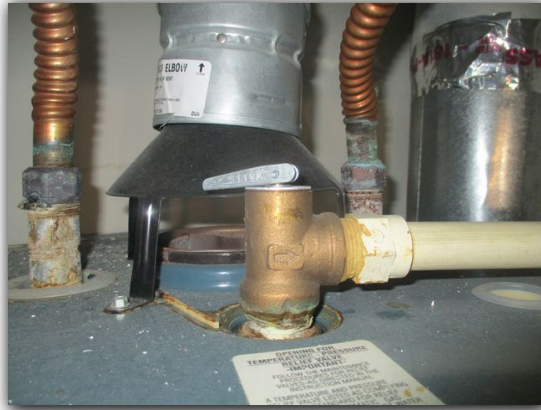
The temperature / pressure relief valve for the water heater is stuck. Recommend replacement of the valve by a licensed plumber.

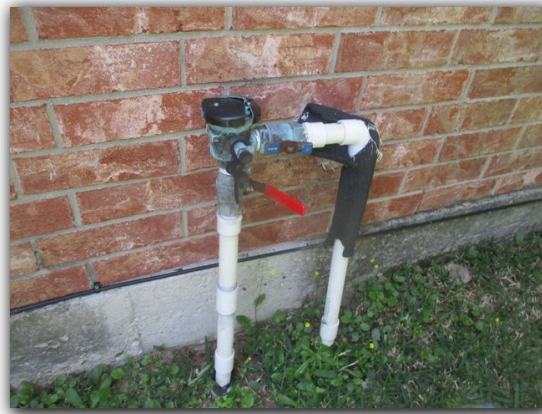
The anti-siphon valve for the sprinkler system has froze and broke. As a result, the sprinkler system could not be tested.

Recommend insulating the anti-siphon valve to reduce the possibility of freezing.
