1st Rate Inspections Property Inspection Report

1706 W 5th St, Freeport, TX 77541 Inspection prepared for: Debbie Martinez Real Estate Agent: Moon Kim - Lifestyles Realty, Inc.

Date of Inspection: 5/21/2021 Time: 9:30 AM Age of Home: 1942 Size: 800 Order ID: 18361

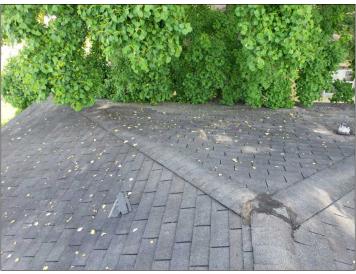
-Tree limbs should be kept trimmed at least 5' from roof to help prevent damage to the roof during windy conditions.

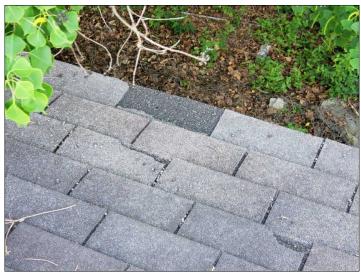
-There are damaged or missing shingles on the roof, recommend repairs or replacement of damaged shingles.

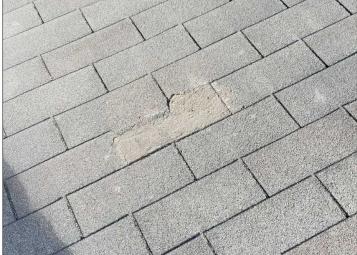
-Signs of improper previous repairs were noted on the roof. Recommend a roofing professional verify the integrity of the repair.

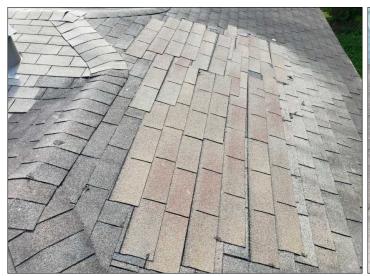
-Signs of improper previous repairs were noted on the roof. Recommend a roofing professional verify the integrity of the repair.

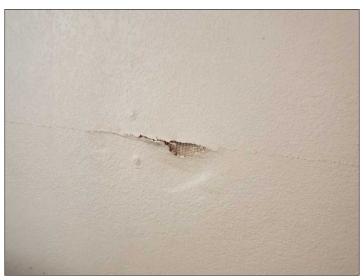
-There is damage to the drywall, recommend repairs as needed. Mainly at - living room
