RESIDENTIAL INSPECTION REPORT

10335 Dyer Glen
Houston TX 77070

PROPERTY INSPECTION REPORT

Concerning: 10335 Dyer Glen, Houston TX 77070

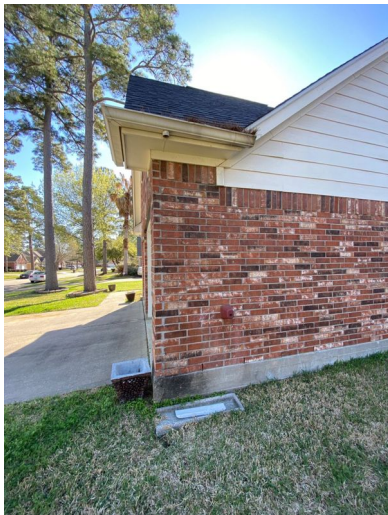
Right Side

3: Gutters & Downspouts: Missing Downspout

Evaluate and remedy as needed.

Recommendation: Recommended DIY Project

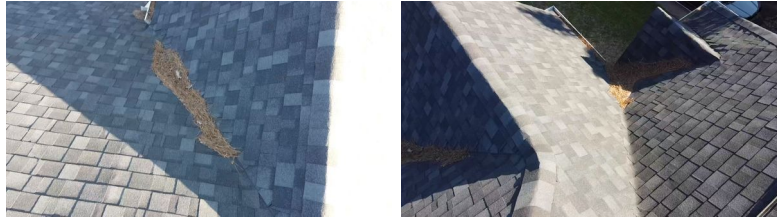
Debris was present on roof surface. The condition of the roof covering underneath could not be determined. Removal of debris and evaluation of the roofing materials underneath is recommended.

Recommendation: Contact a qualified professional.

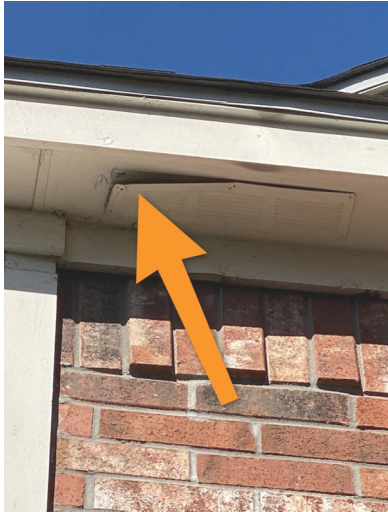
Left Side

2: Venting: Damaged Soffit Vent Screens

One or more soffit vent screens were damaged at the time of inspection. Evaluation and remediation by a qualified professional is recommended.

Recommendation: Contact a qualified roofing professional.

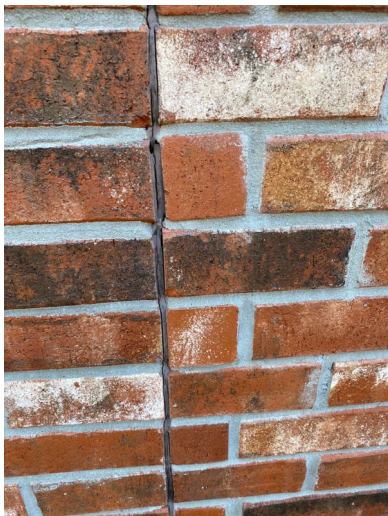
Sealant in the expansion joints is missing or has deteriorated. Remedy as needed.

Recommendation: Contact a qualified masonry professional.

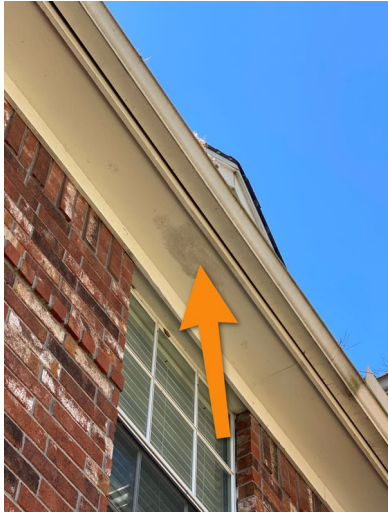
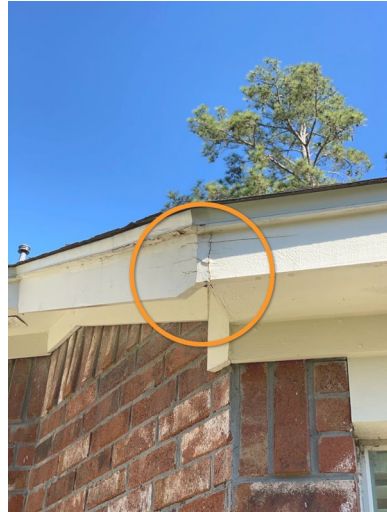
2: Exterior- Fascia/Soffit/Eaves: Damaged Boards

One or more boards on the fascia, soffit, and/or eaves were damaged. Evaluation and remediation by a qualified professional is recommended.

Recommendation: Contact a qualified professional.

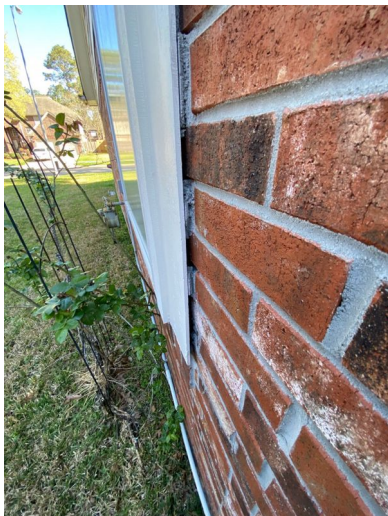
Right Side

3: Exterior- Caulking: Deteriorated/Missing

Caulking around siding or trim was deteriorated or missing.

Recommendation: Contact a qualified professional.

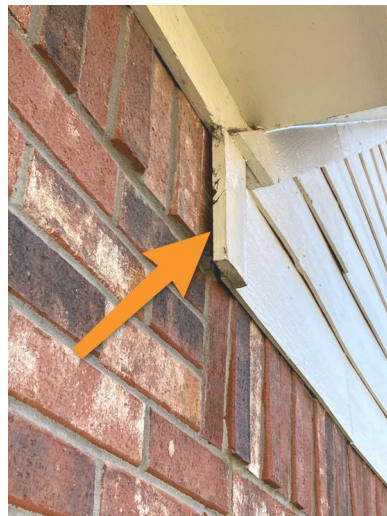
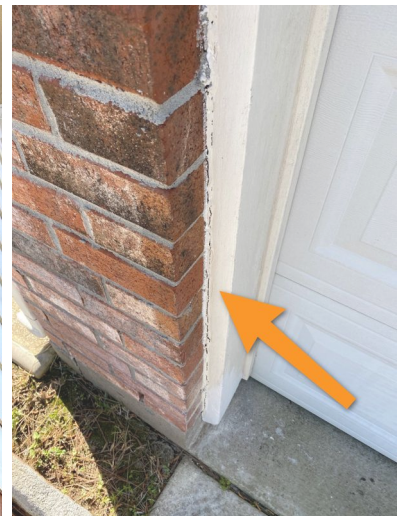
Front

4: Exterior- Caulking: Deteriorated/Missing Around Window Frames

Caulking around window frames was missing or deteriorated. Caulking around window frames is an important barrier to moisture and air intrusion. Most exterior sealants have a lifespan of 5 to 8 years and should be regularly maintained with that lifespan in mind. Evaluate and remedy as needed.

Recommendation: Contact a qualified professional.

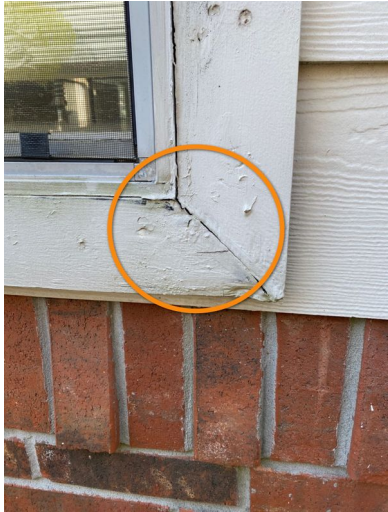
5: Exterior: Trim missing, loose, or damaged

Sections of exterior trim were either missing, loose, or damaged. Remedy as needed.

Recommendation: Contact a qualified professional.

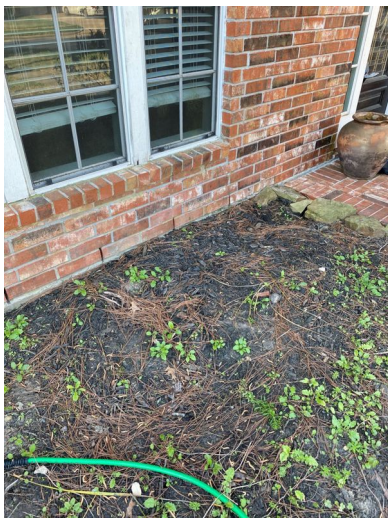
Front

6: Exterior: High Soil

A high soil level was observed. The foundation should have at least 4 inches of exposure. Remedy as needed.

Recommendation: Contact a qualified landscaping contractor

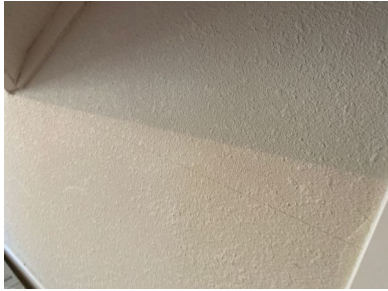
2nd Floor

7: Interior: Hairline Cracks on Drywall

Hairline cracks were observed on the interior drywall. Hairline cracks may be related to the following:

Recommendation: Recommend monitoring.

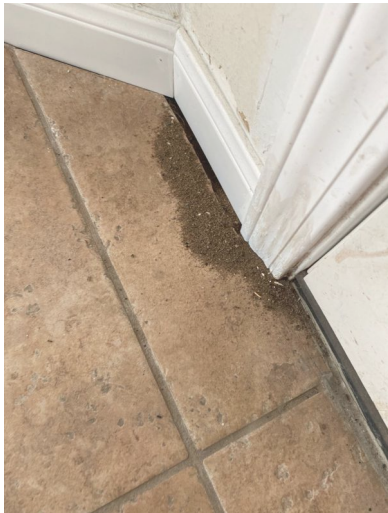
Dining Room Rear door

There was evidence of wood destroying insects (WDI) in one or more areas. The extent of damage inside walls (if any) is not visible. Further evaluation by a pest control company is recommended.

Recommendation: Contact a qualified pest control specialist.

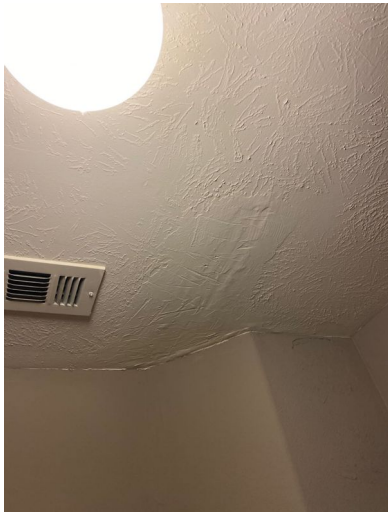
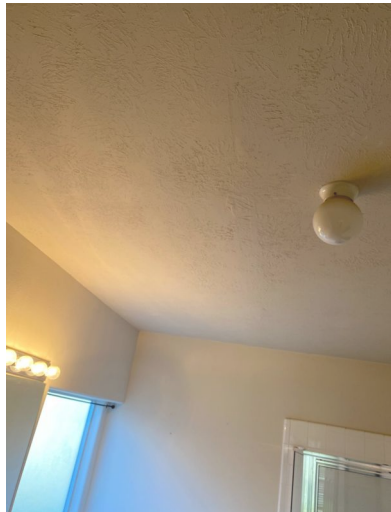
Patched ceiling areas were observed at the time of inspection. Obtaining all previous work documentation is recommended.

Recommendation: Contact a qualified professional.

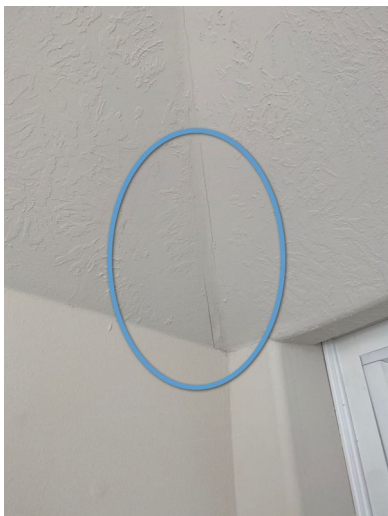
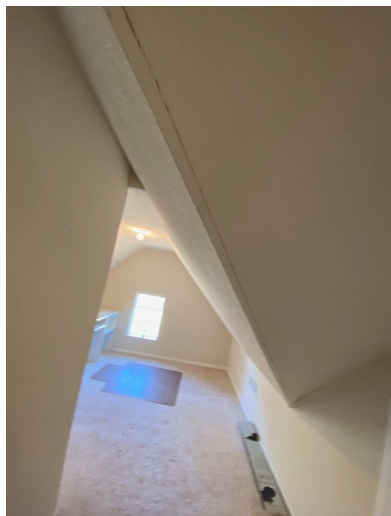
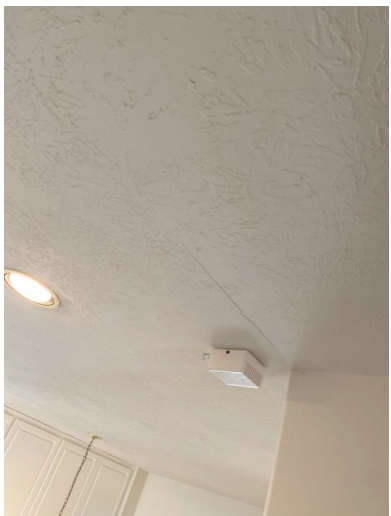
2: Ceiling: Texture Cracks

Texturing cracks were observed in vaulted ceiling joints and appear cosmetic in nature. These are not typically caused by structural defects.

Recommendation: Contact a handyman or DIY project

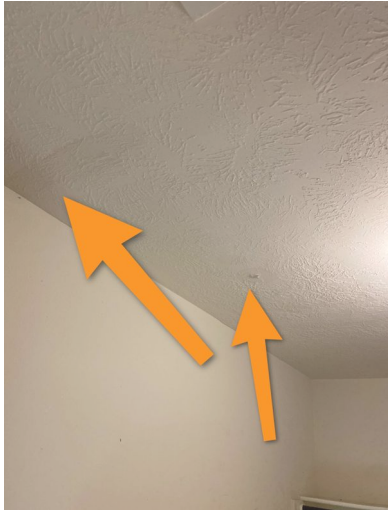
Primary Closet

3: Ceiling: Evidence of Previous Moisture Contact

Wall structure showed signs of previous water intrusion. Tested negative for moisture at the time of the inspection. Evaluate and remedy as needed.

Recommendation: Contact a qualified professional.

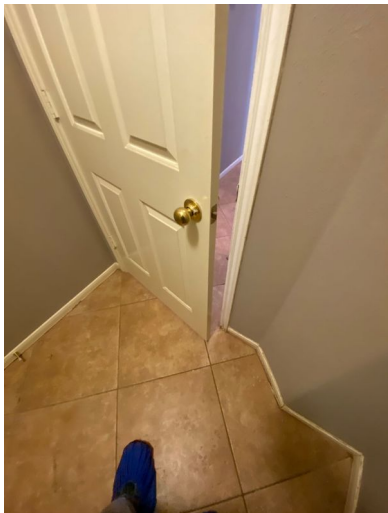
Laundry Area

Door did not latch properly. Handyman repair of latch and/or strike plate is recommended.

Recommendation: Contact a qualified handyman.

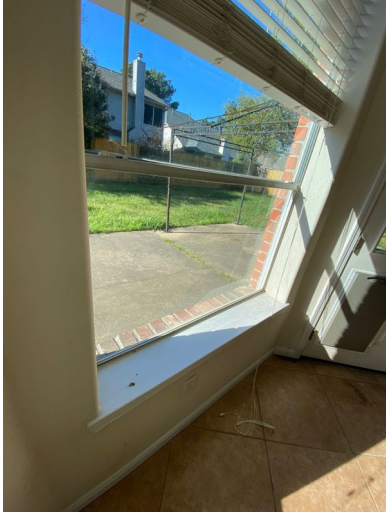
1: Missing/Damaged Screen(s)

One or more windows are missing a screen or had a damaged screen. Replacement of screens is recommended.

Recommendation: Contact a qualified window repair/installation contractor.

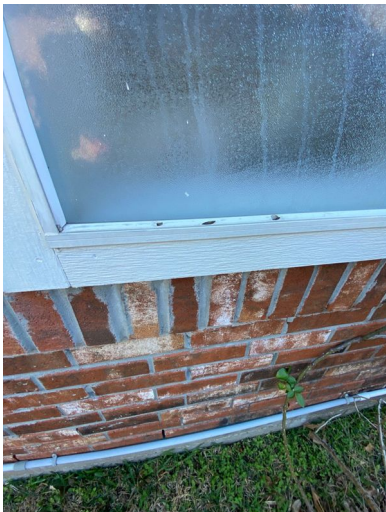
Right Side

2: Plastic trim is damaged/missing

Plastic trim around windows is either damaged or missing. Remedy as needed.

Recommendation: Contact a qualified window repair/installation contractor.

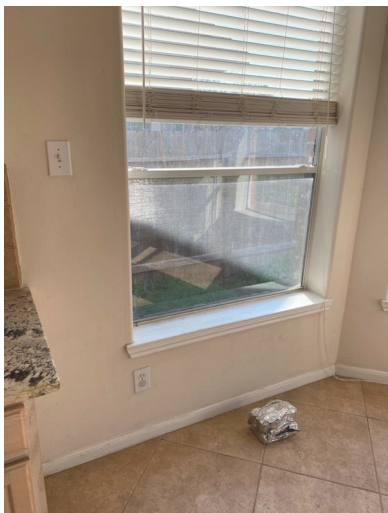
Breakfast Area

3: Window will not stay open

The window will not stay open. Evaluation and remediation by a window professional is recommended.

Recommendation: Contact a qualified window repair/installation contractor.

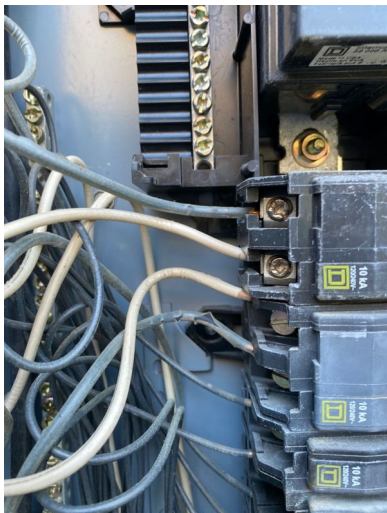
White wires connected to breakers are not marked with black or red electrical tape to indicate that they are "hot". Remedy as needed.

Recommendation: Contact a qualified electrical contractor.

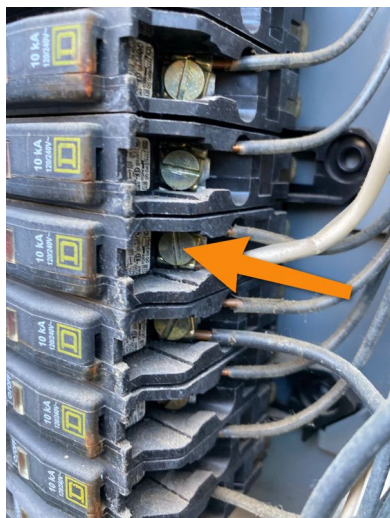
Two or more wires are attached to a single breaker. Most terminals are not designed for two wires, and is a poor installation practice. Further evaluation by a licensed electrician is recommended.

Recommendation: Contact a qualified electrical contractor.

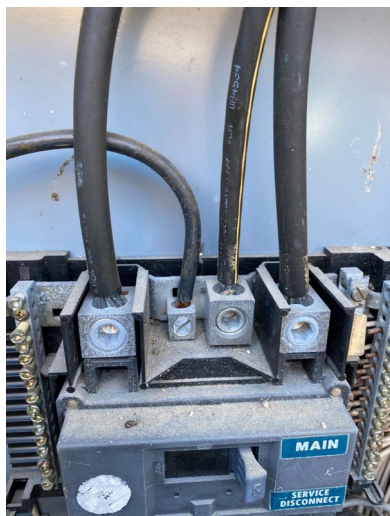
4: No Antioxidant Paste

Antioxidant paste was not present at service conductor connection to main (aluminum) lugs in the distribution panel. Paste is recommended to prevent oxidation. Remedy as needed.

Recommendation: Contact a qualified professional.

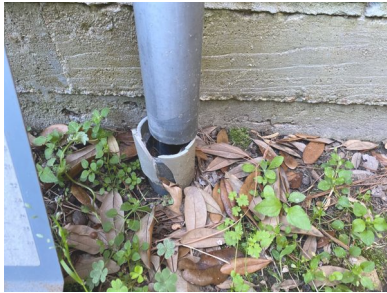
5: Gap in Conduit

a licensed electrician is recommended.

Recommendation: Contact your local utility company

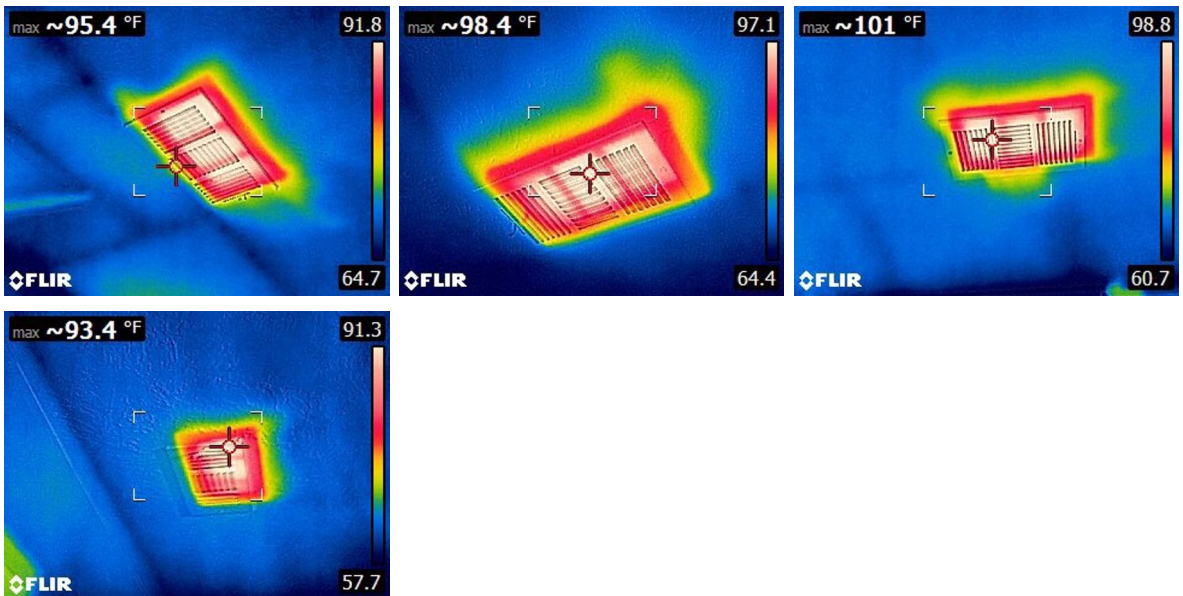
1: Functionality: Inadequate heat

The temperature rise was lower than expected during normal operation. Evaluation and remediation by a licensed HVAC contractor is recommended.

Recommendation: Contact a qualified HVAC professional.

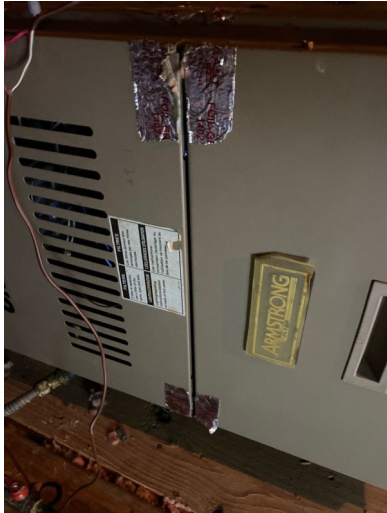
Air handler cabinet sealant was missing, loose, and/or deteriorated. Remedy as needed.

Recommendation: Contact a qualified professional.

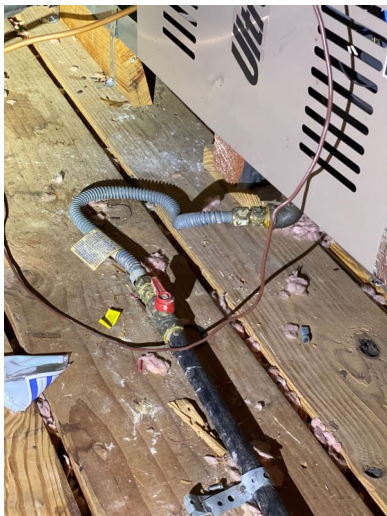
4: Gas piping: Missing Sediment Trap (Drip Leg)

Sediment traps are installed to help prevent sediment in the gas piping from getting into the gas valve or burner area of an appliance and causing problems. Remedy as needed.

Recommendation: Contact a qualified professional.

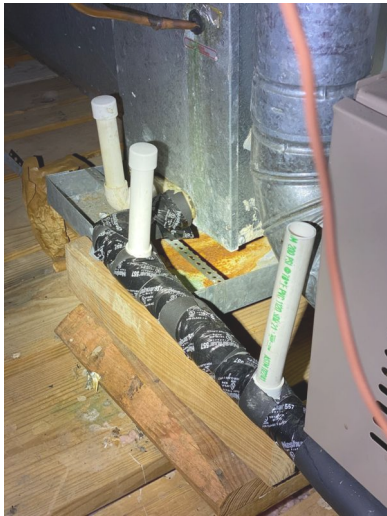
1: Condensate system: Rusted Emergency pan

The emergency overflow pan is rusted. Further evaluation by an HVAC professional is recommended.

Recommendation: Contact a qualified HVAC professional.

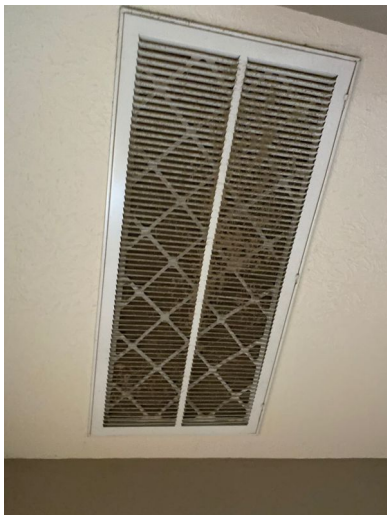
1st Floor

1: Filter: Requires Replacement

The furnace filter may have been beyond its expected lifespan. Replacement is recommended.

Recommendation: Recommended DIY Project

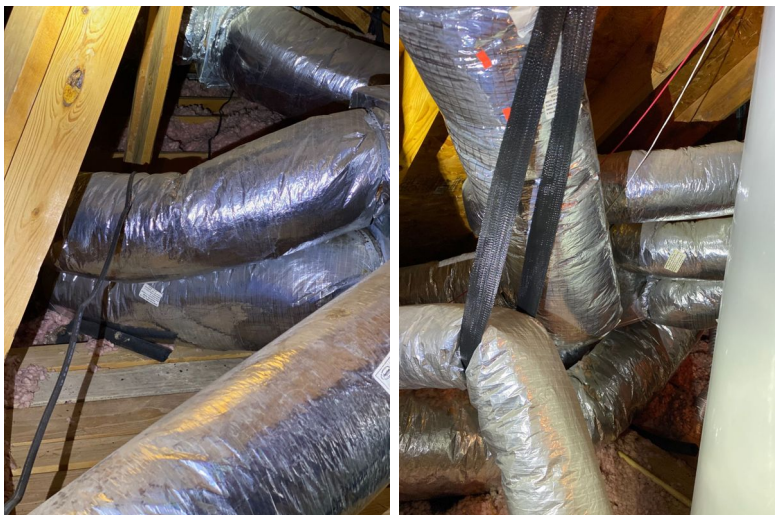
2: Ducts: Ducts resting on each other.

Ducts were resting on each other. This can result in condensation forming between the two sections of ductwork. Remedy as needed.

Recommendation: Contact a qualified professional.

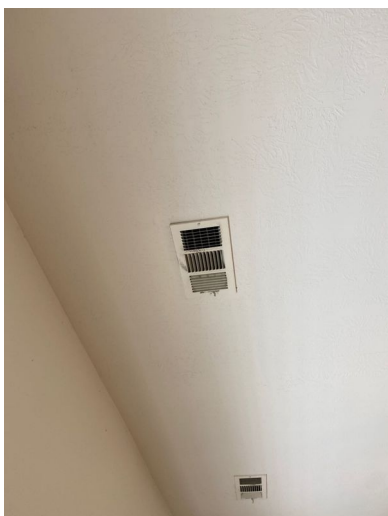
Primary Bedroom

3: Visible substance observed on Supply Register

A dark substance was observed on an air supply register in the home. Servicing and cleaning of the system by a qualified HVAC contractor is recommended, as this can be a result of excessive water vapor/humidity in the conditioned air.

Recommendation: Contact a qualified HVAC professional.

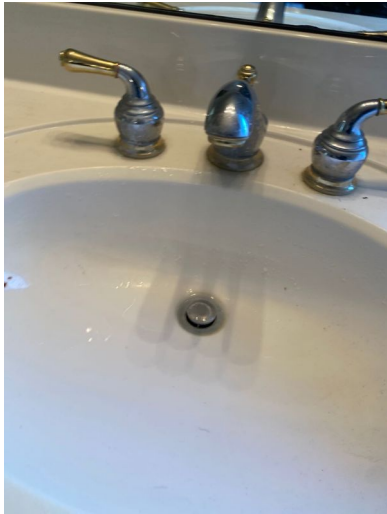
Primary Bathroom

1: Fixtures: Aerators or Screens Damaged

Recommendation: Contact a qualified plumbing contractor.

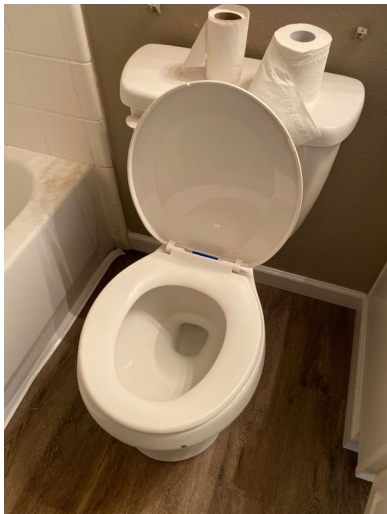
2nd Floor Hall Bathroom

2: Toilet: Not securely Mounted to Floor

Evaluate and remedy as needed.

Recommendation: Contact a qualified professional.

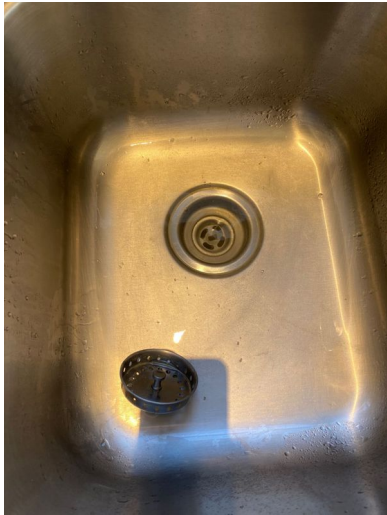
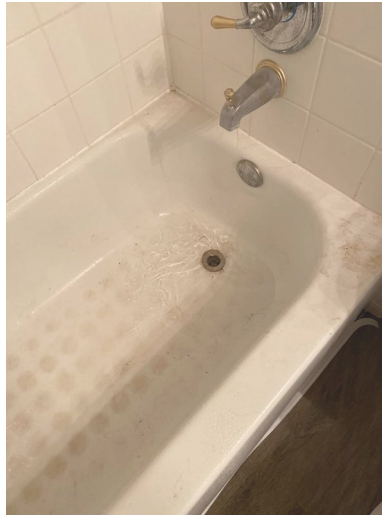
Poor/slow drainage was observed at time of inspection. Evaluation and/or remediation by a licensed plumber is recommended.

Recommendation: Contact a qualified plumbing contractor.

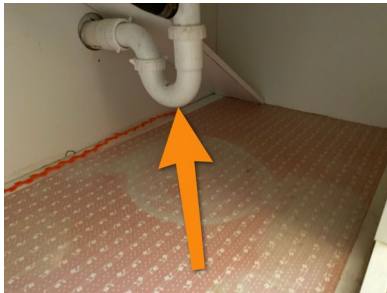
2nd Floor Hall Bathroom

3: Drain piping: Leaks

Leaking was observed at time of inspection. Evaluation and/or remediation by a licensed plumber is recommended.

Recommendation: Contact a qualified plumbing contractor.

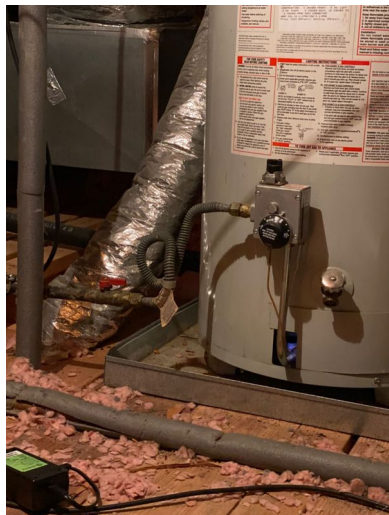
2: Gas Water Heater: Missing Sediment Trap (Drip Leg)

Sediment traps are installed to help prevent sediment in the gas piping from getting into the gas valve or burner area of an appliance and causing problems. Remedy as needed.

Recommendation: Contact a qualified professional.

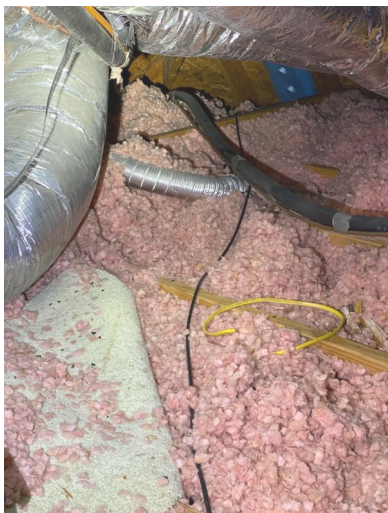
The exhaust fan(s) vented to the eave soffits in the attic. Newer building standards recommend exhaust fans discharge through the roof.

Recommendation: Contact a qualified professional.
