Enclosed is the report of the visual inspection that was conducted on the structural foundation of the residence located at 4415 Sarong Street, Houston, Texas, by Mr. Denis G. Hanys, PE. This inspection was conducted for you on the date of November 16, 2020.

**FOUNDATION INSPECTION REPORT**  
**REPORT NO. 20-53**

The residence inspected was located at 4415 Sarong Street, Houston, Texas. The Client for this inspection was Mr. & Mrs. Michael Gross. The residence was not occupied.

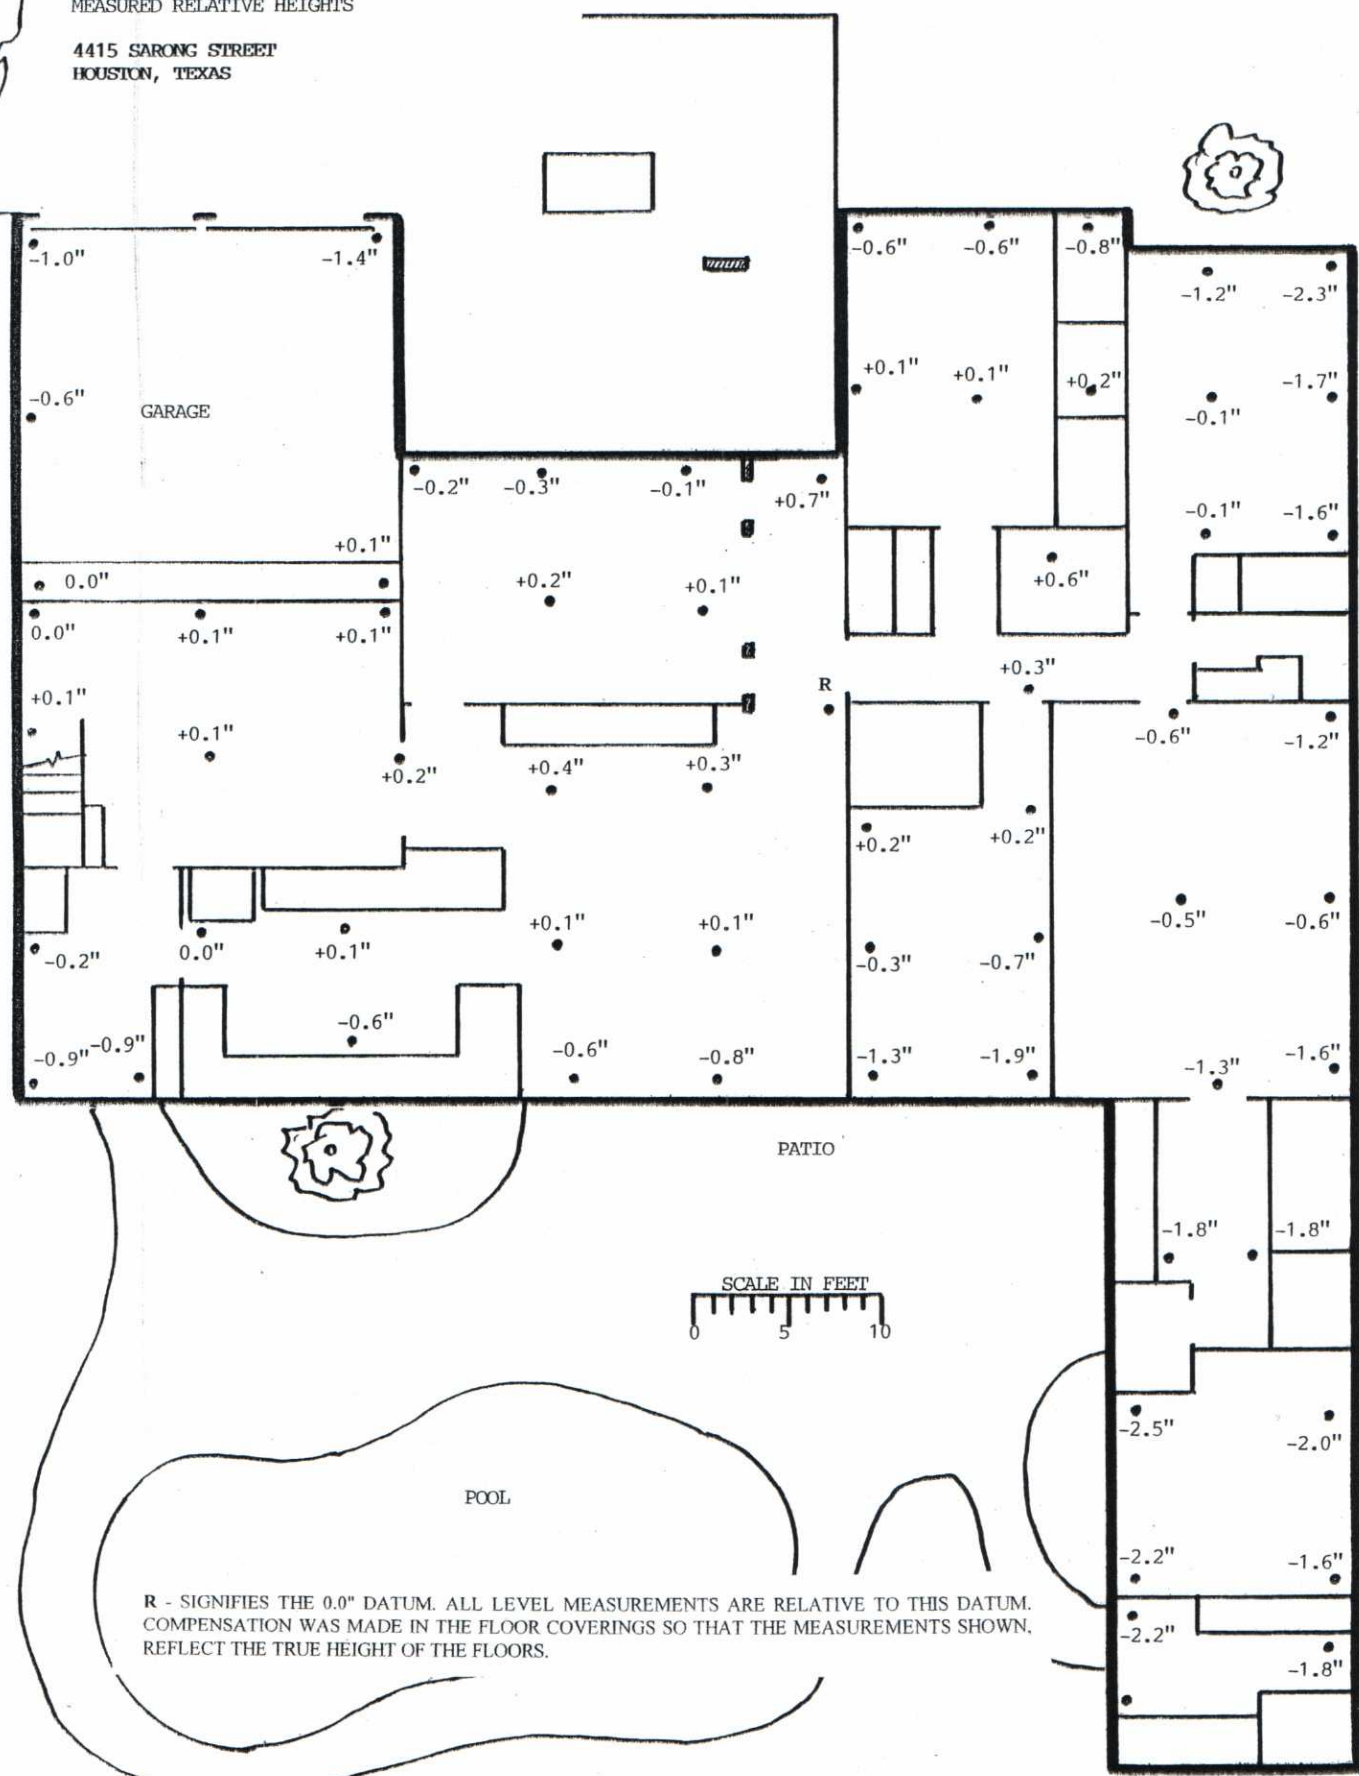
RESIDENCE OUTLINE SHOWING MEASURED RELATIVE HEIGHTS

Inspection of the foundation of this residence failed to reveal the existence of a severely deflected condition or evidence indicating that major foundation instabilities were present. Counters, sills, etc. were observed to be in a reasonably level condition. Deviations from level were observed at isolated locations in the floor. These deviations were measured using an electronic level manometer and the results have been superimposed upon the resident outline sketch. Compensation was made in the floor coverings so that the measurements shown should reflect the true height of the floors. From this sketch, it can be seen that the interior floors tend to be higher in relative elevation in the center portion and lowest at the northeast corner. Although, slope is present in the interior floors, the doors and windows generally fit properly in their frames and doors opened and closed freely. Minor cracks were and repaired cracks were observed on walls, old separations were observed at the exterior corners, that do not appear to have worsened in magnitude, and very minor cracks were on the interior; however, it is our opinion that the magnitude of these cracks was not sufficient to be indicative that a severe foundation problem was present. The concrete in the visible portion of the foundation was observed to be free of significant honeycomb pockets, or exposed reinforcement steel, although, cracks were observed on the surface of the perimeter grade beams and on the surface of the garage slab, and on the surface of the tile floor coverings. It is important to understand, however, that cracking is a normal property of concrete, and is not necessarily indicative of a foundation functional failure.

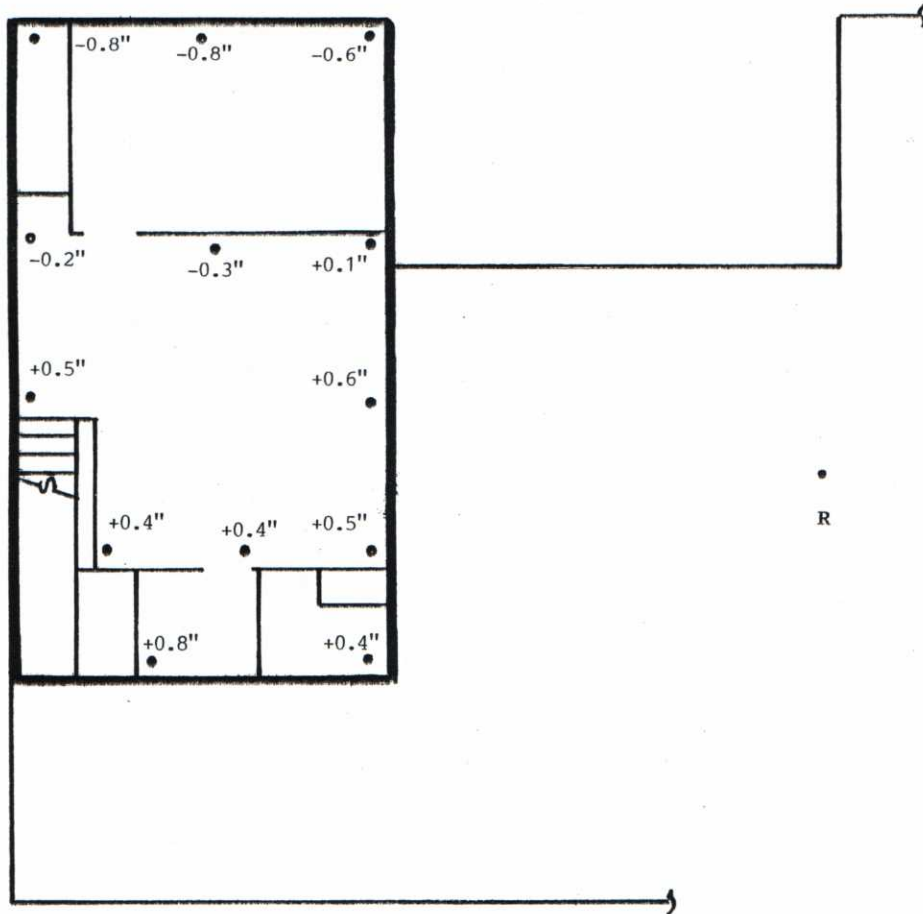
SECOND FLOOR

The relative heights of the second level floors were also measured, and this is shown on the second attached sketch. These measurements were taken to complement the measurements taken on the first level, and can be used to monitor the future performance of the second story floor support structure, if needed.
