# Home Inspection Report

4111 Avenue T, Galveston , TX 77551

Wednesday July 14, 2021

# PROPERTY INSPECTION REPORT

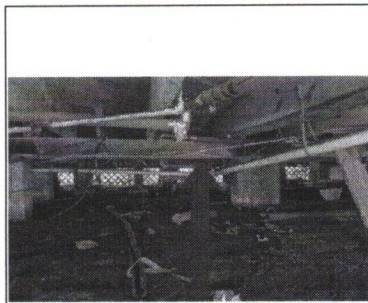
There is a visible slope in the beam near the middle of the home however there did not appear to be a foundation concern

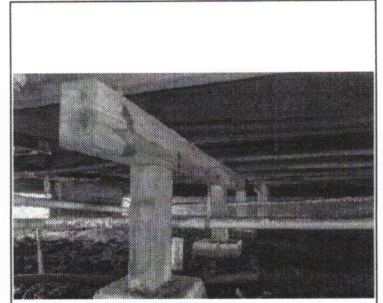
\*marked deficient due to the uneven or sloping areas of the foundation \*

Added foundation materials which appear to be causing the unevenness in the hallway

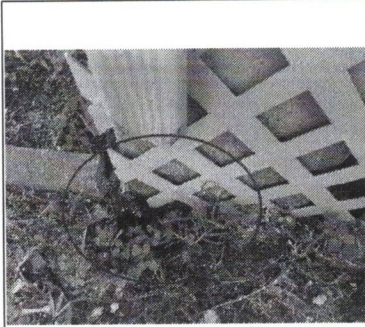
Comments: The downspouts at the northwest corner of the home and southwest corner are recommended to have an extension or splash guard to prevent erosion of the soil near a foundation pier. The northwest corner already has a 5-6" hole from draining stormwater right next to a foundation pier.

Northwest corner already has 5-6" hole from water draining

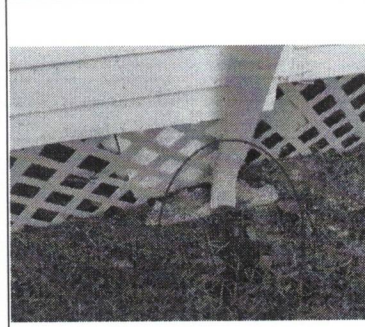
Recommend splash guard or extension on southwest corner

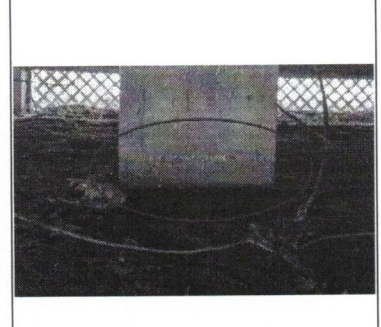
You can see the water level line on the pier and it was on all of the piers

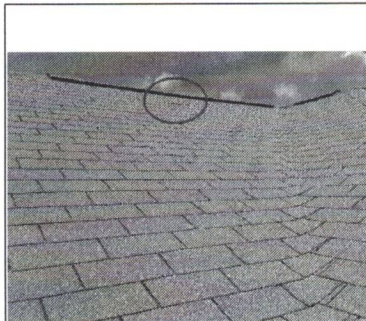
Southeast corner, minor lifted shingle

There was one raised nail lifting a shingle at the southeast ridge, recommend that the nail be secured so the shingle will sit flat.

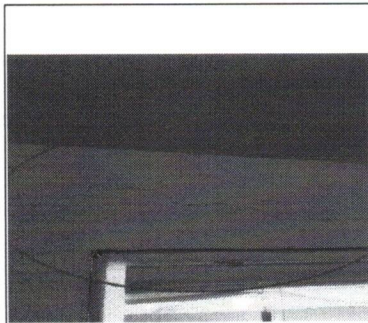
Possibly lead based paint in older doors and window frames

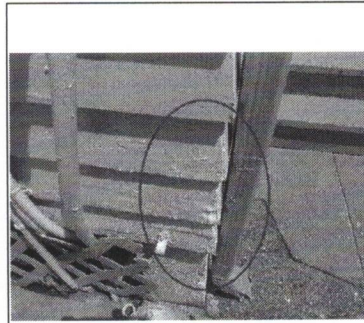
The southeast corner had deteriorating areas that were filled with caulking, recommend that it be repaired properly.

Southeast corner had deteriorating areas that were filled with caulking

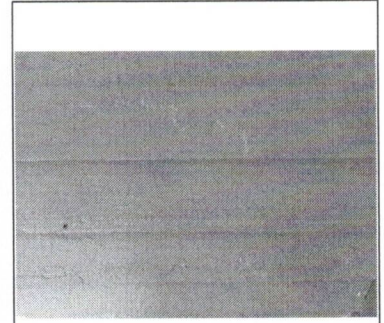
Typically when you see paint that wasn't scraped it indicates that there may be lead.

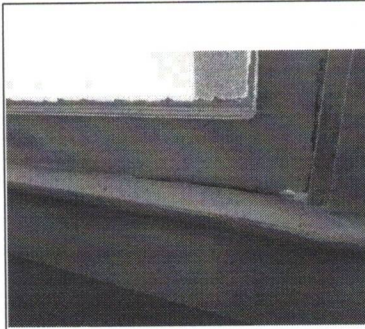
Window to the right of fireplace has gaps in the bottom

The window to the right of the fireplace however has gaps at the bottom which could be prone to leak in a wind driven rain, recommend that weather stripping be added at the bottom of the windowsill to cover the gap.

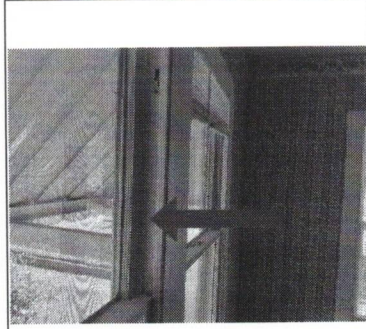
All of the windows functioned in the dining room along with the weights, pulleys and ropes with the exception of a broken rope and counterweight on the left window of the north wall. The window still functioned however it is recommended to be repaired.

Missing rope and counterweight

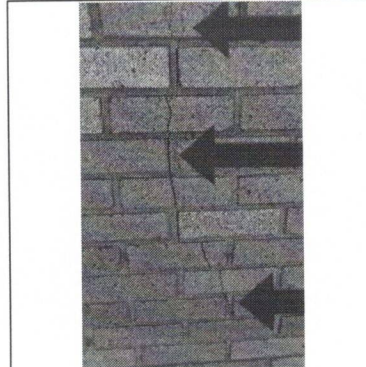
Cracks in exterior brick suggests minor movement

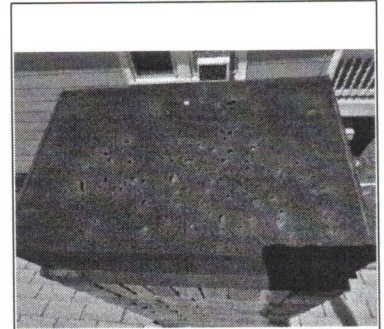
Cap needs replaced

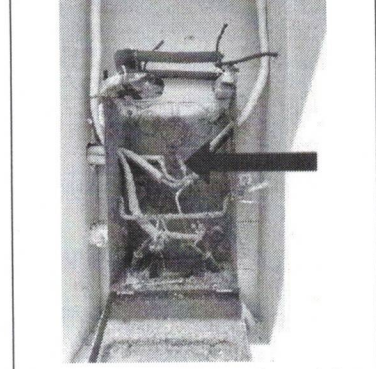
Old fuse box still has live wiring, is unsafe

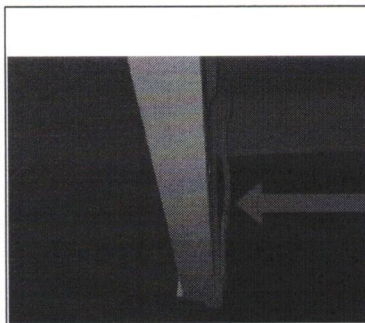
Recommend that wiring in east bedroom's closet be protected, possibly with conduit

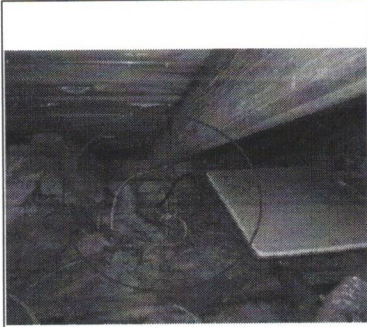
There were a bunch of spliced wires and loose wiring located in various areas throughout the attic and crawlspace that need to be addressed by a qualified electrician for repair.

Spliced wiring south side of attic

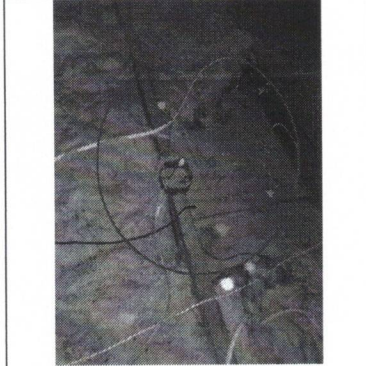
Open boxes and loose wiring

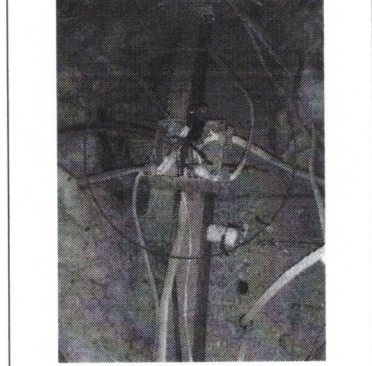
Open junction boxes in attic

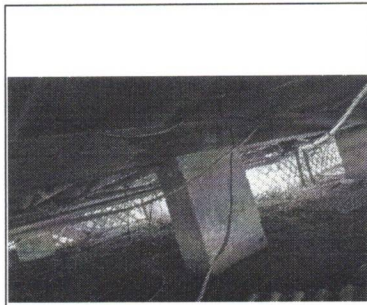
All kinds of loose wiring under the home

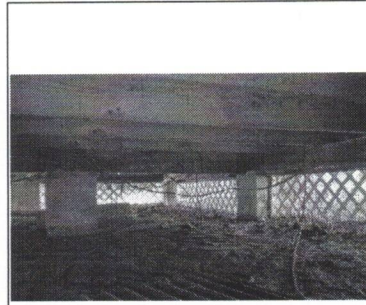
Loose wiring under the home

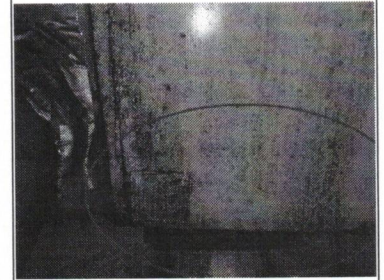
Interior is very old and heavily rusted

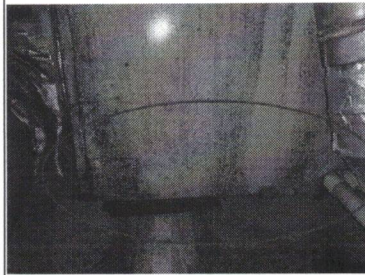
Very rusted

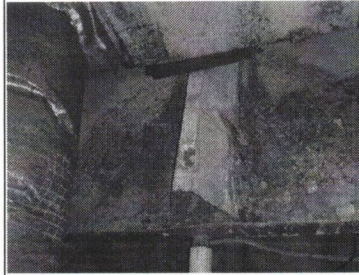
The safety pan is heavily rusted and in need of replacement. It is recommended that as a preventive maintenance to keep the primary condensate drain for the air conditioner clear that at minimum of a cup of bleach be poured down the clean out at the very least 3 to 4 times a year. The clean out is located near the interior units of the hvac system, the clean out will be a piece of PVC pipe which may or may not have a cap covering the PVC pipe. Remove the cap and pour bleach directly down the pipe and this will keep the drain line free of algae buildup. The exterior AC unit can also be sprayed off with a water hose to remove any excess salt buildup to help prolong its useful life.

Pan needs replaced

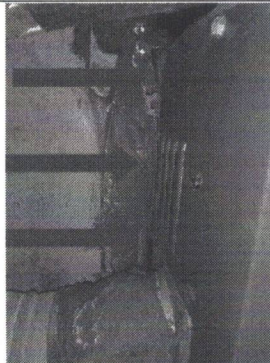
Leaking lots of air near furnace

were leaking air, recommend that this be repaired by a qualified hvac technician. As previously mentioned there was quite a bit of air leaking out near the plenum.

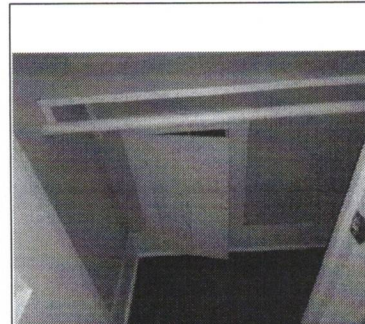
Access panel in west bedroom is allowing very humid air to enter

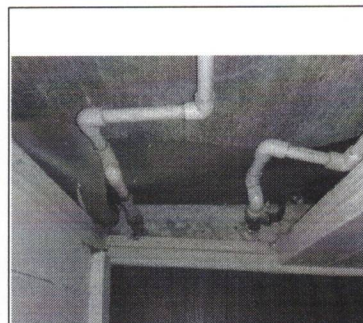
The water lines coming through the floor for the shower are not fully sealed which is allowing humid air into the closet

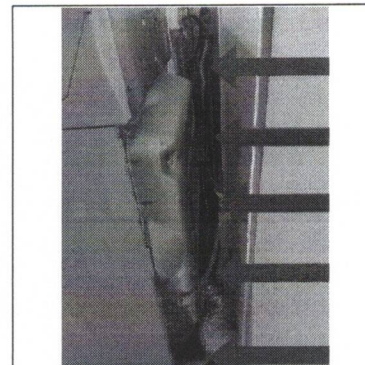
The flexible gas line connecting the dryer is approximately 8' long or longer and max allowable is only 6', recommend that a qualified plumber reconfigure the gas line connection.

Flexible gas line was 8' +in length when 6' is max allowable

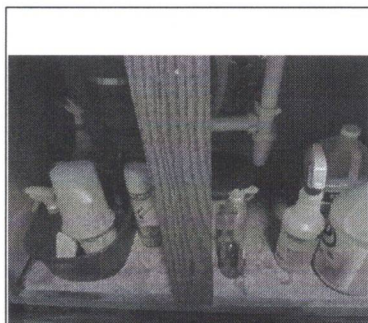
Kitchen vanity has been repaired likely from a leak

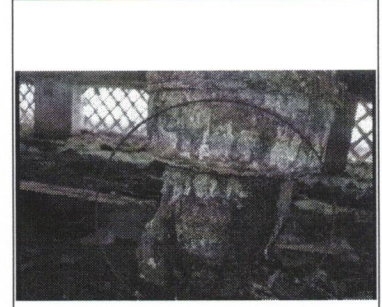
Cast iron under toilet leaks

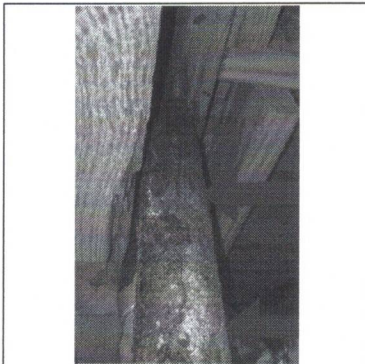
The sink drain line in bathroom is cast iron

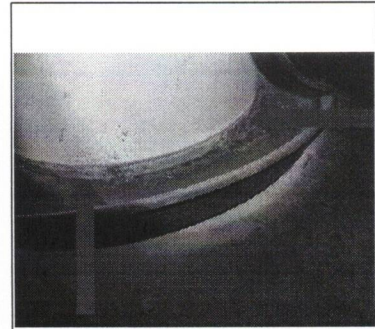
The bottom of the appliance appeared to be starting to rust out and may need to be replaced in the near future.

Appliance is starting to rust at the bottom

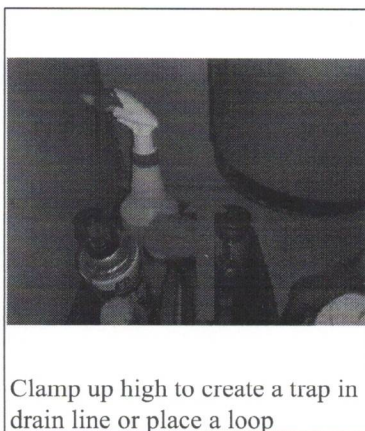
Comments: The dishwasher operated properly when run on the "normal" wash setting on the day of the inspection however the unit was missing the high loop or trap to prevent water from being syphoned back into the dishwasher from the sink. It is recommended that the drain line be clamped up higher than the disposal after it enters the cabinet through the wall to prevent any backflow.

Clamp up high to create a trap in drain line or place a loop

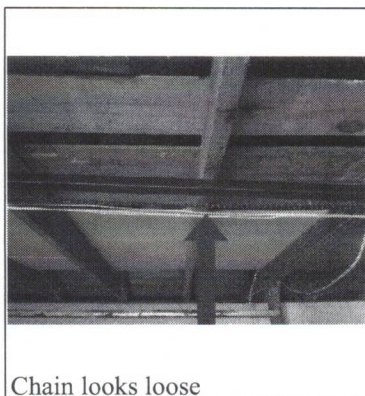
Chain looks loose

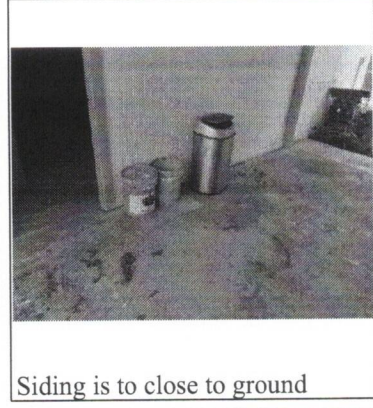
The ground contact between most of the wood exteriors siding needs to be broken, it is recommended to have at least two inches of clearance from the ground and siding to prevent premature wear due to moisture damage. There is minor moisture stains and or damage on all of the walls in the garage.

Siding is to close to ground
