PROPERTY INSPECTION REPORT

Concerning: 19822 Shallow Shaft, Richmond, TX
(Address or Other Identification of Inspected Property)

By: B. Fred Brock, Lic #246 04/21/2018
(Name and License Number of Inspector) (Date)

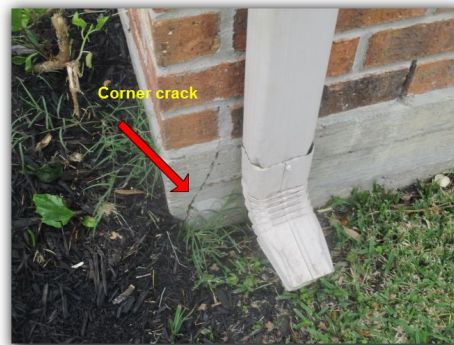
- Foundation corner fracture(s) existed which are generally the result of movement between the masonry walls (expanding) and the concrete foundation (shrinking). Although this condition did not appear to adversely affect the structure, sealing these cracks may be desired as they could provide hidden access for wood destroying insects. A Structural Pest Control licensee can be retained for more specific information. Please note that the corners should be examined periodically. If the fracturing worsens and the corner(s) break off then the brick veneer may lack proper support and repair would be needed.

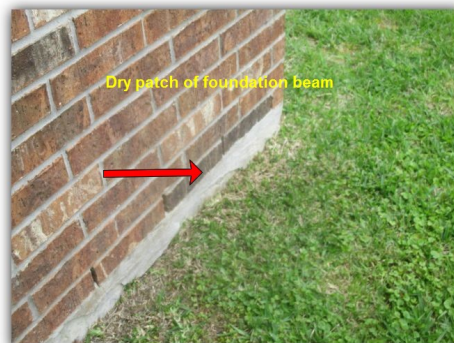
Note: The grade beam surface has had an application of dry patch sometimes called slab dressing applied typically to mask deficiencies in the finish. The application effectively conceals the beam surface from view and may conceal cracks, defects etc in the foundation as well as insect entry

- Corner spall detached at left rear location in need of repair in my opinion

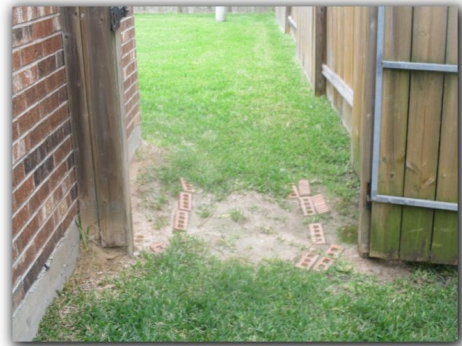
- There was evidence of impaired site drainage located in the right side yard below the side yard gate area. Corrective measures should be taken to ensure water will properly drain off the lot

Under accepted industry standards water should not stand for more than 24 hrs within 10 ft of the structure and for more than 48 hrs in drainage swales.

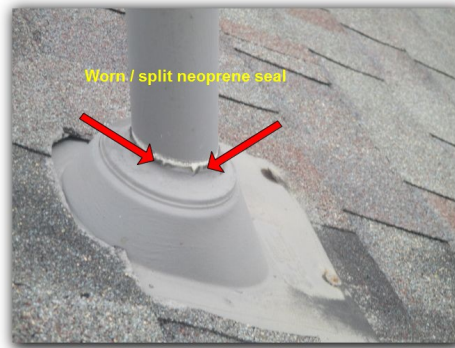
- The roof level plumbing vent stack flashings have rubber seals which over time have become deteriorated and may allow water intrusion. The seals should be checked and sealed or roof jacks replaced if necessary by a qualified roofing contractor

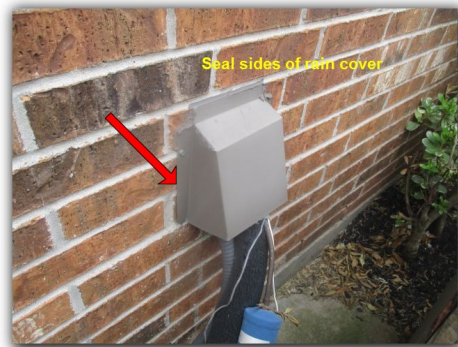
- There are openings and details in at the exterior veneer which are in need of sealants including but not limited to the sides of the HVAC rain cover lineset cover

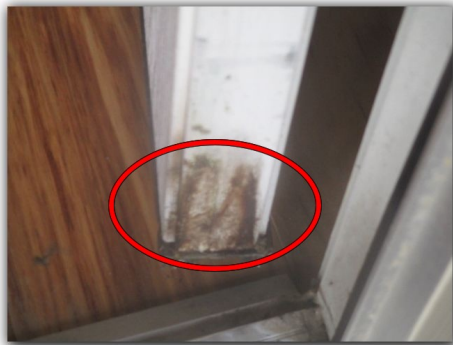
- The rear patio door has deterioration at the lower edge hinge side of door

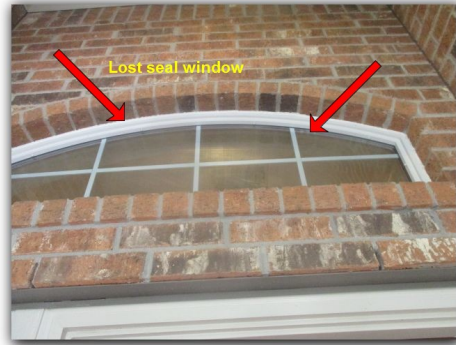
- Windows checked found with defective tension guides in the right front bed room . The tension rods allow the windows to stay in raised position. Repairs are needed at this time
- The insulated glass unit window located above the front entry door appears to have lost the seal, this has resulted in a film to develop between the panes of glass. The insulated glass windows no longer function as designed when they lose their seal and replacement may be necessary.

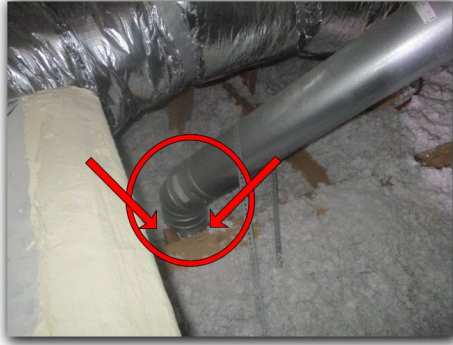
- The combusted gas vent lacks Mfg required clearance to the attic insulation . This deficiency may cause overheating damage to the vent system

- Secure loose strapping materials to vent as intended

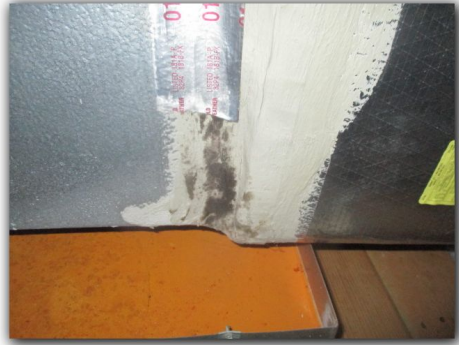
- The internal components of the evaporator coil are not readily accessible however there is evidence of excessive condensation staining and organic growth on the equipment housings. The cause and remedy should be determined by a qualified HVAC technician at this time

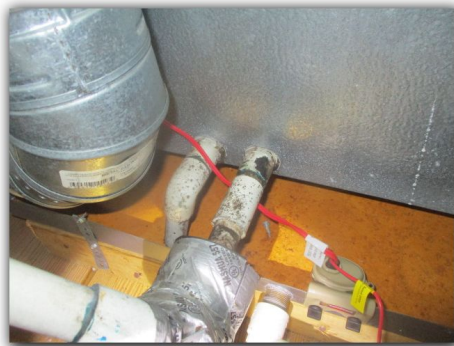
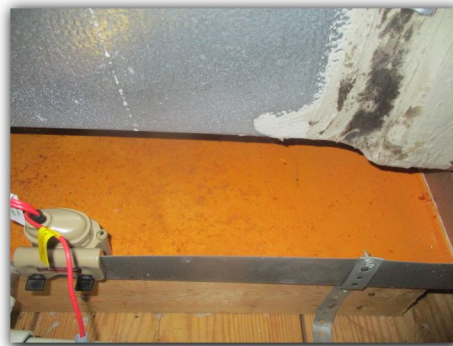
- Drain lines should be fully insulated
- The drain pan located below the coil has significant rust accumulation obstructing the pan surface in my opinion the pan should be replaced

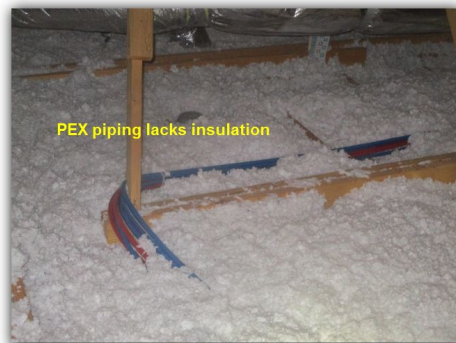
- There is PEX piping visible in the attic which lacks insulation.

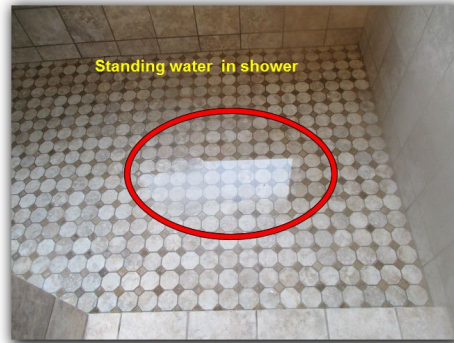
- Observed residual water standing at the rear of the shower enclosure after run test which did not drain off the floor in a timely manner. This may be caused by insufficient slope of the shower floor, Further evaluation by a qualified plumber is recommended

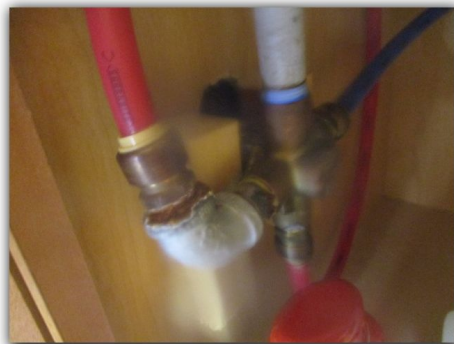
- Dissimilar metal piping connections lacking di-electric connections and corrosion at these connections existed at the water supply to personal hygiene sprayer. This device also lacks a back flow protection device to protect the potable water supply.

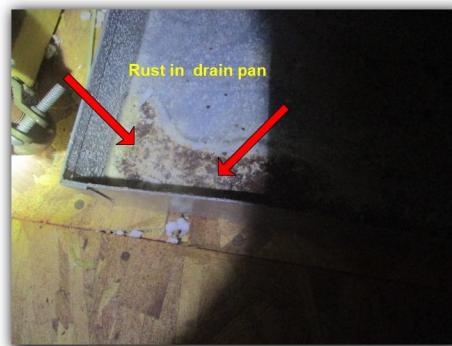
- The flue (vent pipe) has inadequate clearance from combustible materials(roofing) Double walled vent pipes should have at least 1-inch of clearance from combustible material.
- The drain pan located below the water heater some rust accumulation in my opinion the pan should be replaced
