PROPERTY INSPECTION REPORT

Concerning: 14827 Fall Creek Preserve Dr. Humble, Texas 77396

Inspection Date: 02/15/2018

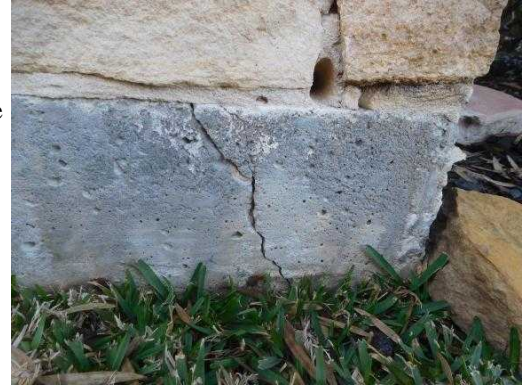
Cracks at the corners of the foundation are normal curing cracks and do not appear to indicate any type of structural failure (see photo).

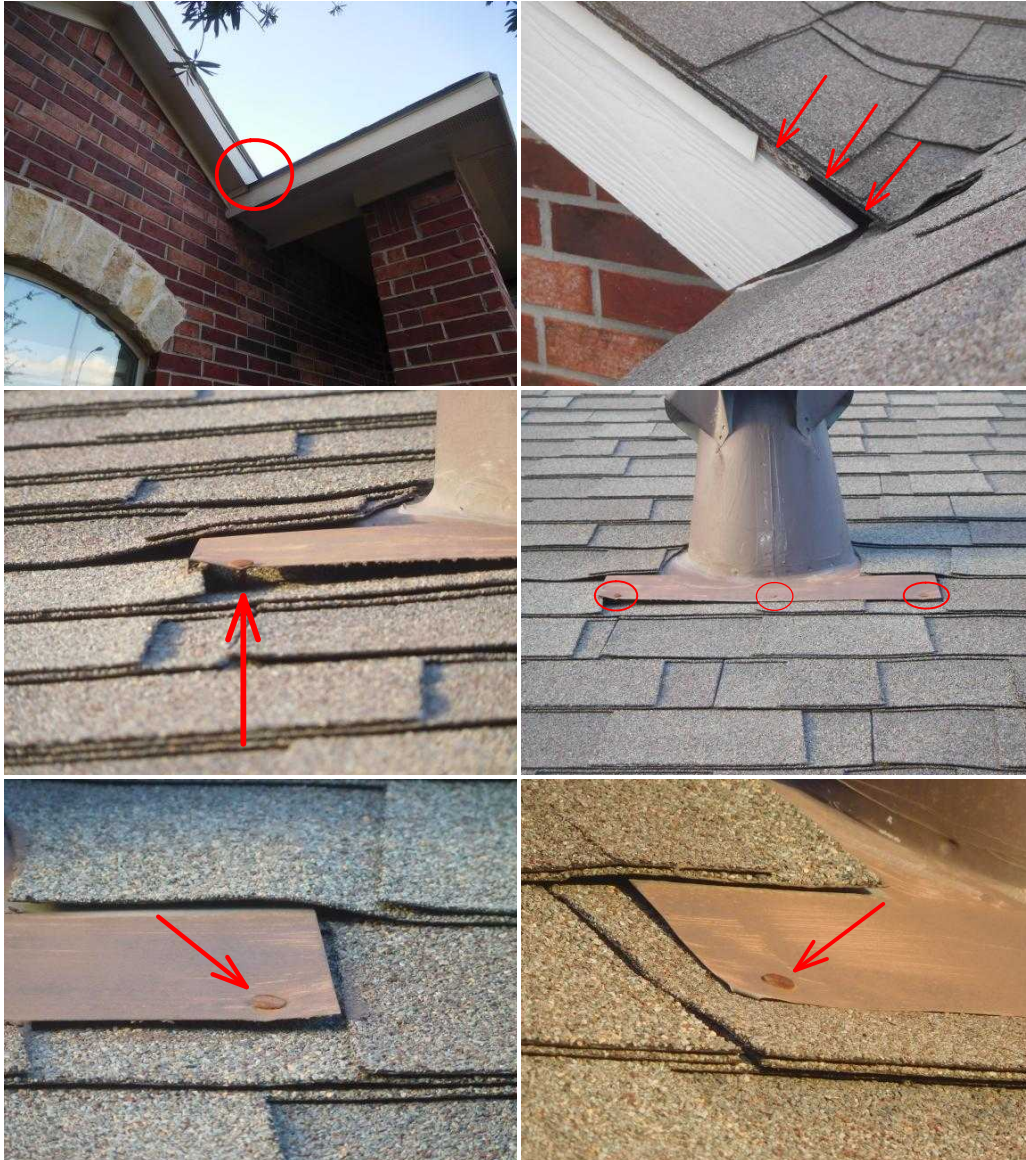
However, a section of drip edge flashing is missing at the roofline adjacent to the front entryway (see photos). Replace the missing drip edge flashing so that it covers the entire length of the fascia board.

A nail pop and partially raised apron flashing were noted at one of the vents at the (see photo). Properly reset the nail and seal as needed.

I recommend properly sealing over exposed roofing nail heads at the various roof penetration flashings and cap shingles as needed (see photos).

Water stains were noted on the metal exhaust vent for the furnace (see photo). No elevated moisture was noted in the drywall ceiling below at this time and no visible defects were noted at the weather cap and rain collar. Observe the vent and the area below to try and determine whether or not the vent penetration leaks during heavy rain. Service as needed.

A qualified roofing contractor is recommended to evaluate and estimate for repairs.

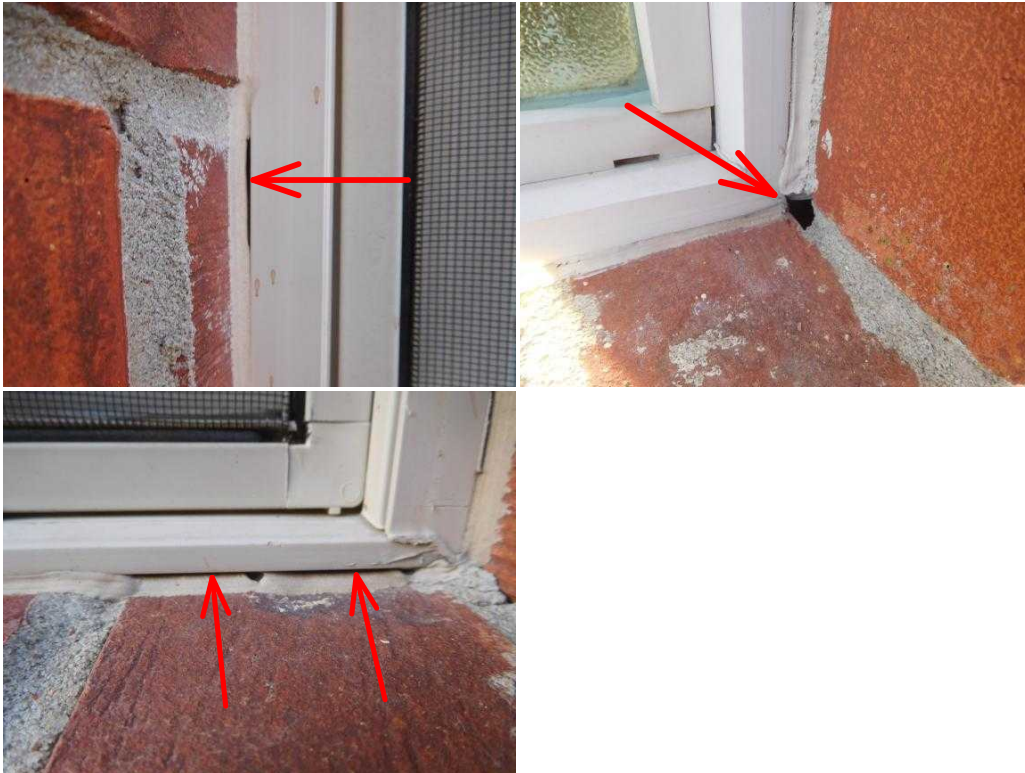
I recommend properly sealing any small gaps at the perimeter edges of the windows at the exterior side (see photos).

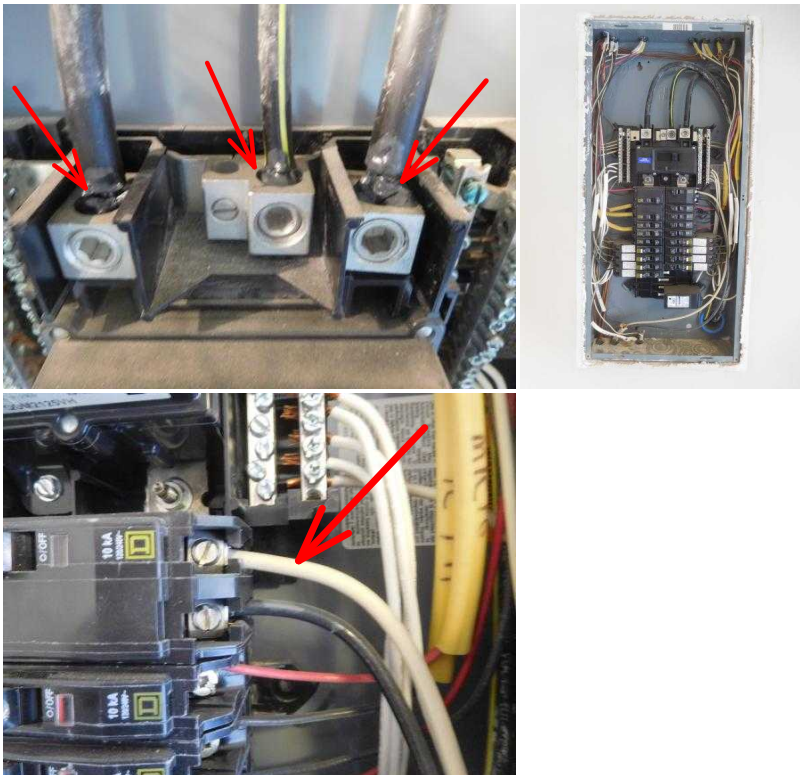
An anti-corrosive gel has been properly applied to the aluminum service cables where they connect at the main contact lugs (see photo).

The panel, breakers, and wiring appear to be in good condition at this time (see photo).

Label white neutral wire used as "hot" wire red or black to denote "hot" wire at breakers in panel box (see photo). The lack of proper labeling does not affect the conductivity of the wiring or safety for everyday use and is not considered a major deficiency.

All electrical repairs listed in report, or otherwise noted during repairs, should be made by a qualified licensed electrical contractor as per code and safety.

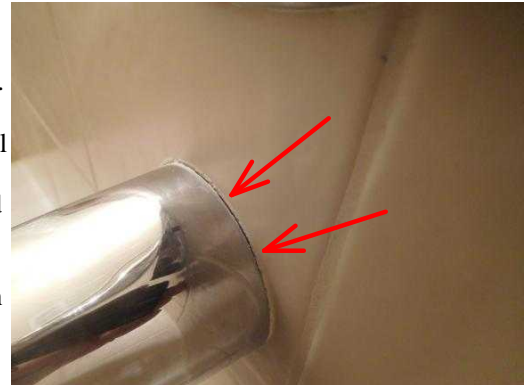
Ensure that all gaps at the escutcheons (where the plumbing penetrates the shower/tub enclosures) of the tub faucets, handles, and shower heads in the bathrooms are properly sealed (see photo).

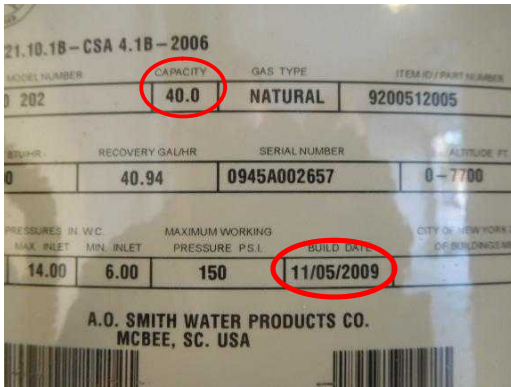
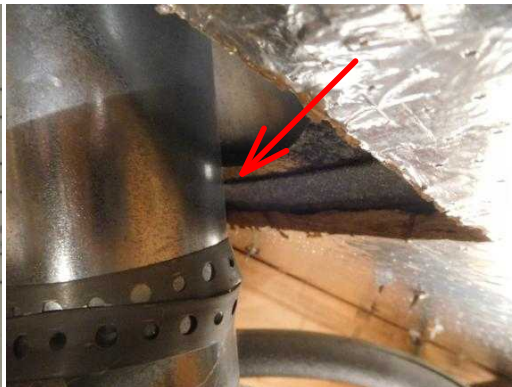
It was noted that the metal exhaust flue is in too close of proximity to shingles at the point where it penetrates the roof in the attic (see photo). This type 'B' metal vent needs to have a minimum of a 1 inch clearance to all combustible materials in order to operate safely. I recommend having a qualified contractor assess this condition and make the necessary correction.

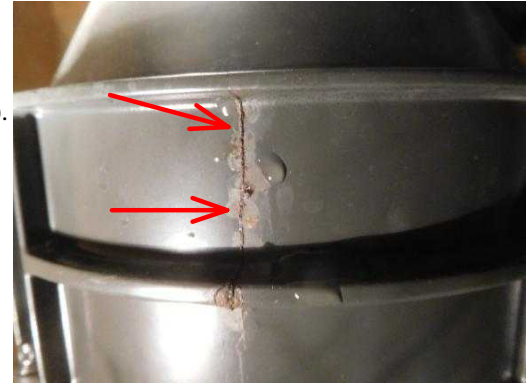
However, it was noted that the unit is cracked and leaks water (see photo). Replace.

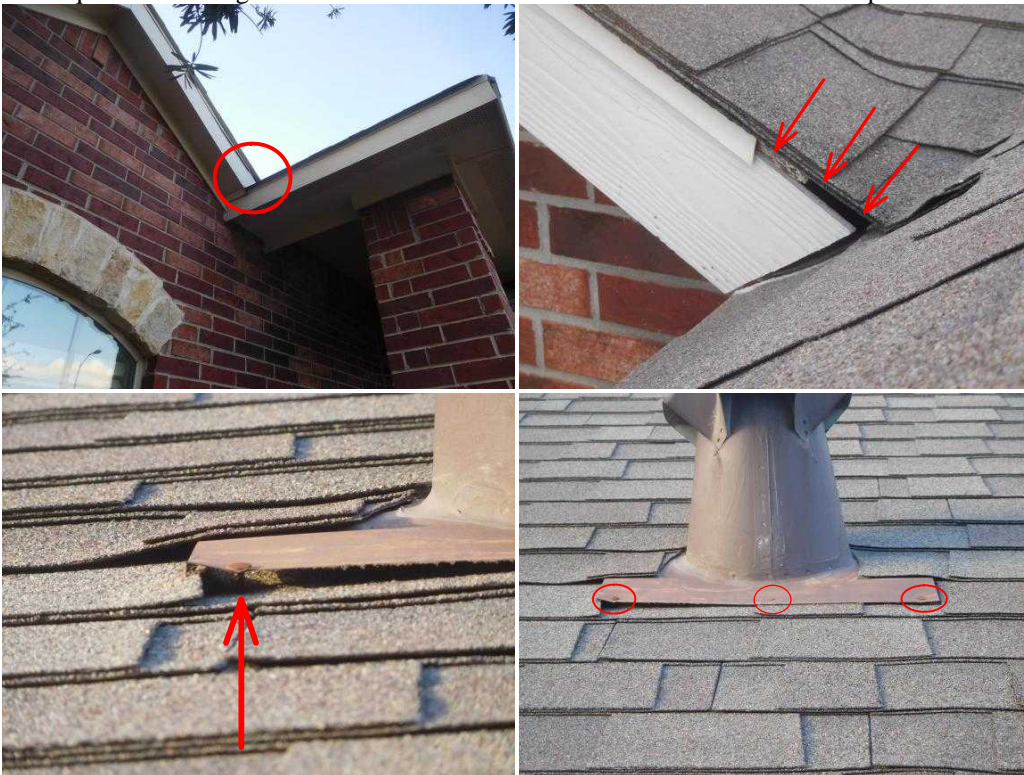
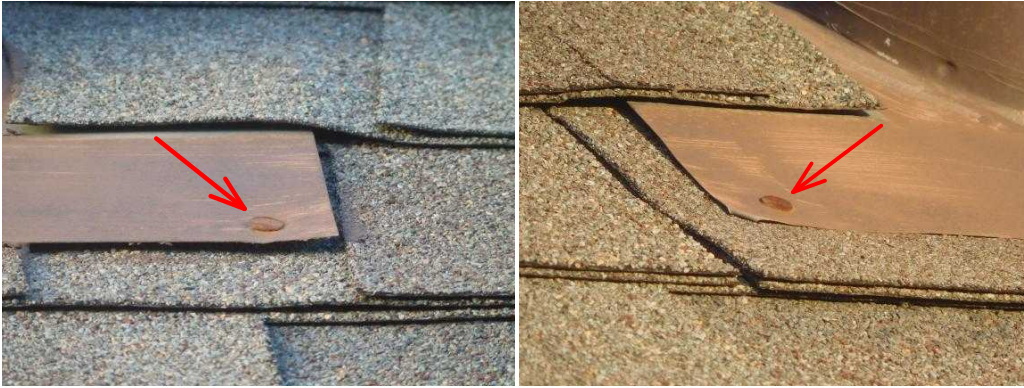
However, a section of drip edge flashing is missing at the roofline adjacent to the front entryway (see photos). Replace the missing drip edge flashing so that it covers the entire length of the fascia board.

A nail pop and partially raised apron flashing were noted at one of the vents at the (see photo). Properly reset the nail and seal as needed.

I recommend properly sealing over exposed roofing nail heads at the various roof penetration flashings and cap shingles as needed (see photos).

Water stains were noted on the metal exhaust vent for the furnace (see photo). No elevated moisture was noted in the drywall ceiling below at this time and no visible defects were noted at the weather cap and rain collar. Observe the vent and the area below to try and determine whether or not the vent penetration leaks during heavy rain. Service as needed.

A qualified roofing contractor is recommended to evaluate and estimate for repairs.

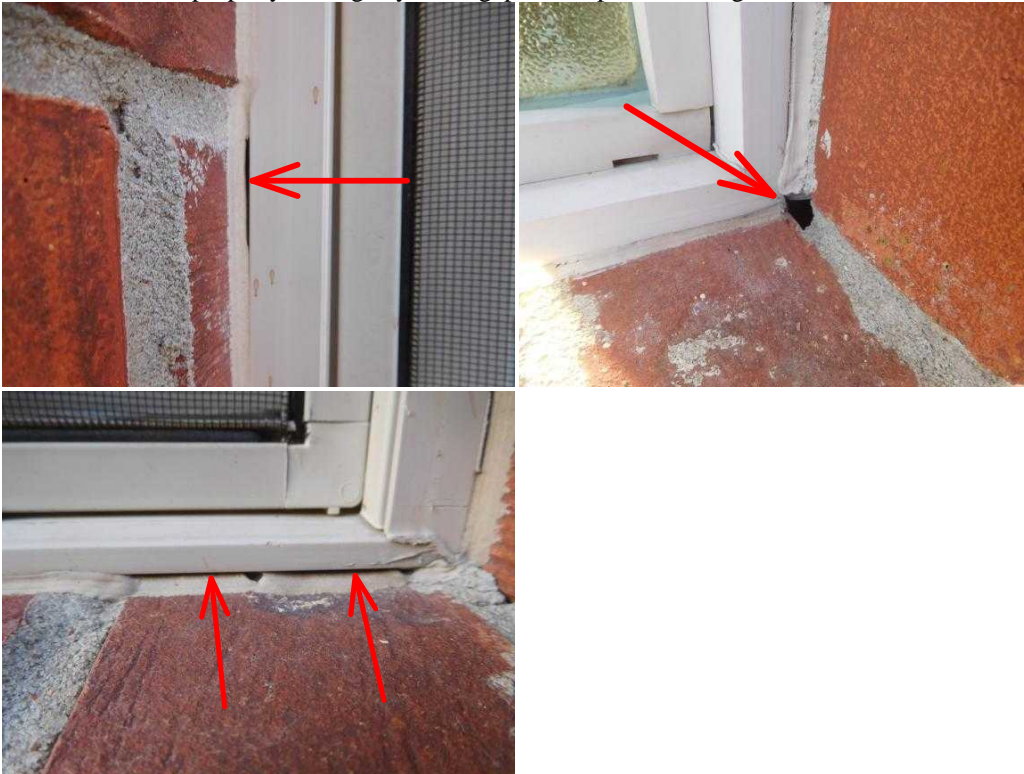
I recommend properly sealing any small gaps at the perimeter edges of the windows at the exterior side (see photos).

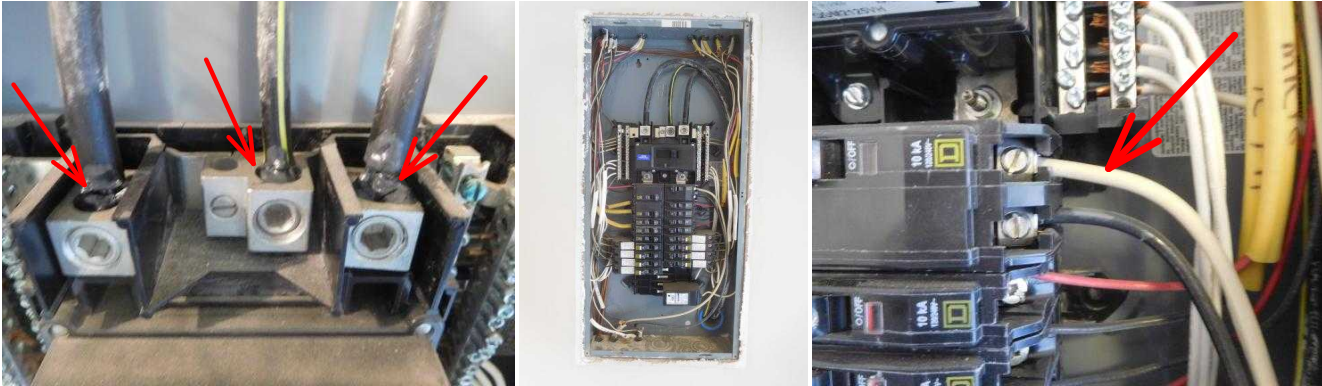
An anti-corrosive gel has been properly applied to the aluminum service cables where they connect at the main contact lugs (see

The panel, breakers, and wiring appear to be in good condition at this time (see photo).

Label white neutral wire used as "hot" wire red or black to denote "hot" wire at breakers in panel box (see photo). The lack of proper labeling does not affect the conductivity of the wiring or safety for everyday use and is not considered a major deficiency.

All electrical repairs listed in report, or otherwise noted during repairs, should be made by a qualified licensed electrical contractor as per code and safety.

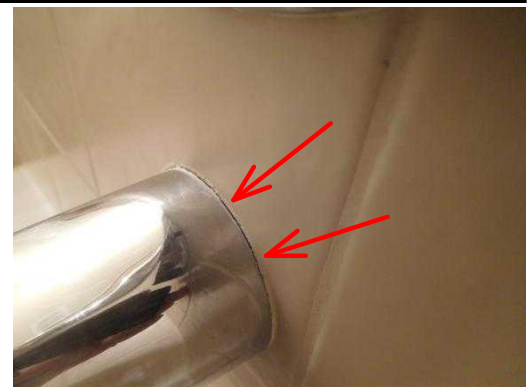
Ensure that all gaps at the escutcheons (where the plumbing penetrates the shower/tub enclosures) of the tub faucets, handles, and shower heads in the bathrooms are properly sealed (see photo).

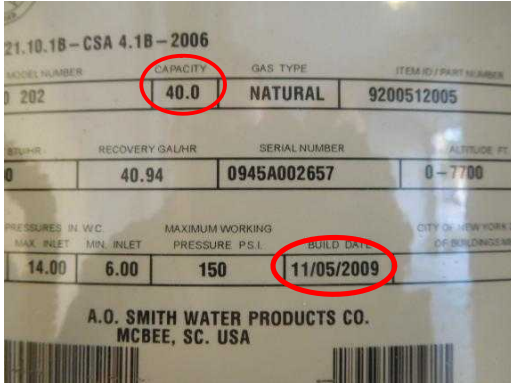
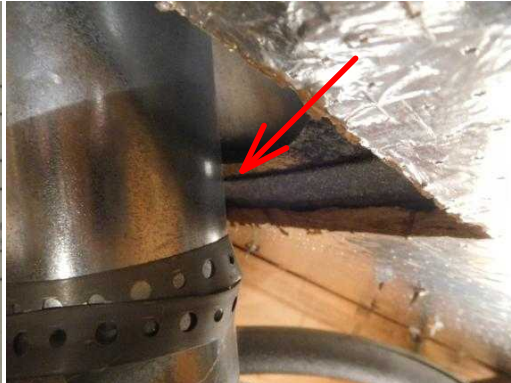
It was noted that the metal exhaust flue is in too close of proximity to shingles at the point where it penetrates the roof in the attic (see photo). This type 'B' metal vent needs to have a minimum of a 1 inch clearance to all combustible materials in order to operate safely. I recommend having a qualified contractor assess this condition and make the necessary correction.

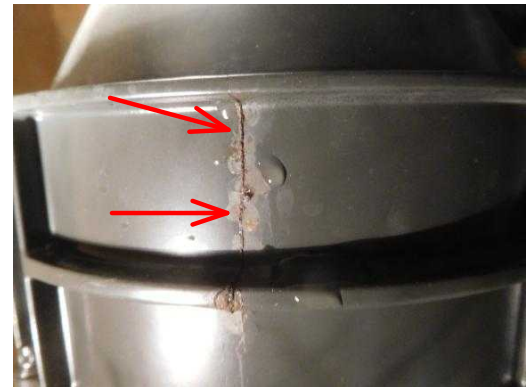
However, it was noted that the unit is cracked and leaks water (see photo). Replace.
