RESIDENTIAL INSPECTION REPORT

1727 Northshore Dr Missouri City TX 77459

06/11/2021 9:00 am (Date)

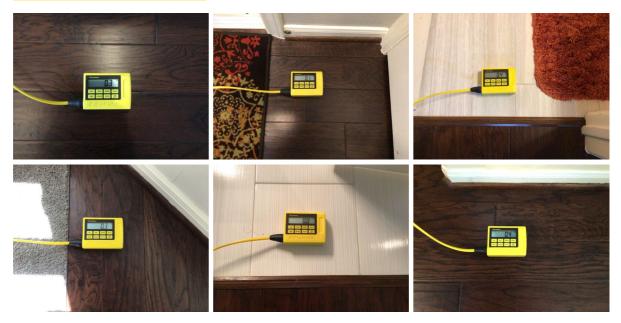
Foundation Inspected with Digital Level:

This foundation was measured with the use of an electronic digital measurement tool. Multiple elevation points were registered on the foundation throughout the property to determine if there were elevation variations that indicated excessive movement of the foundation. At the time of this inspection the measured areas did not indicate any variations that, in this inspector's OPINION, indicated any need for invasive repairs to the foundation.

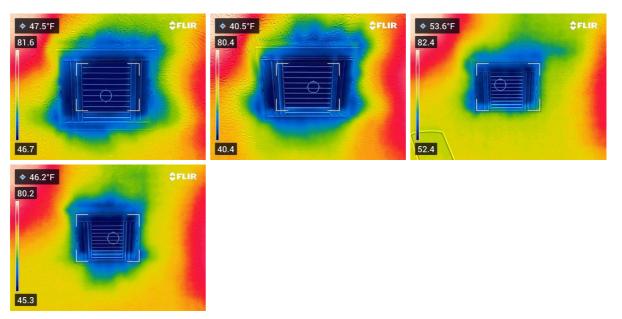
Temperature difference (delta) - First Floor: 18°

Temperature difference (delta) - Second Floor: 16° *No access to internal coils:* There was no removable panel cover to provide viewing access to the internal evaporator coils.
