Inspection Report

PROPERTY INSPECTION REPORT

1113 East Washington Avenue, Navasota, TX 77868

William Baldwin TREC 21825 10/22/2018

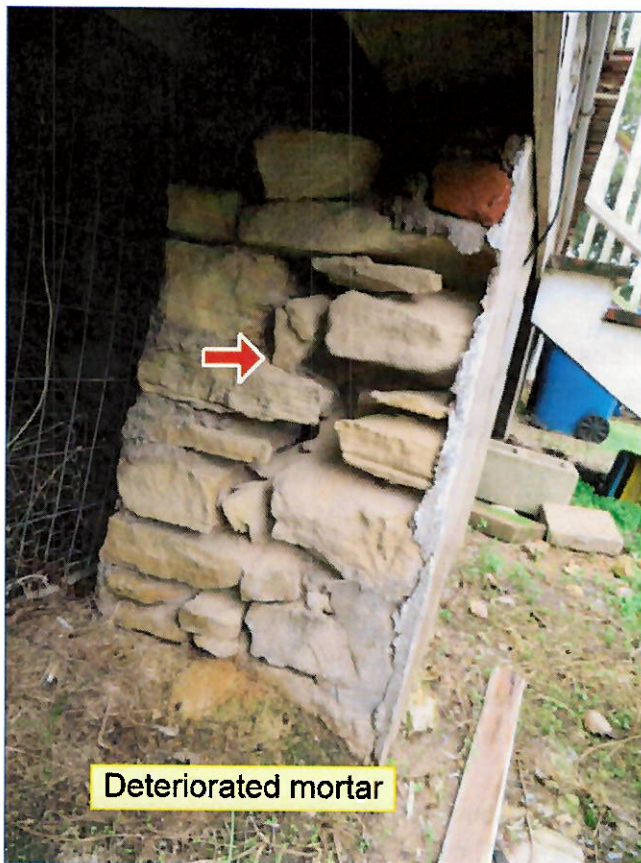
A. Item 1(Picture)

- The piers are the original stacked stones and also stacked concrete masonry blocks placed under the porches. The mortar between the stacked stones has deteriorated at all of the piers, which then allows the house to settle and become out of level. The upstairs floors are out of level, and the downstairs floors slope towards the center of the home.
- There are wide spans between the piers under the center of the home, which may be contributing to the sagging. An engineer is recommended to determine the best layout of piers and repairs that need to be made.
- Loose stones and step cracks throughout perimeter stone walls under bay window at North wall.
- Loose and missing stone at piers on NE corner.
- There are a couple of screw jacks that are rusted and appear to have been added as floors sagged.
