PROPERTY INSPECTION REPORT

Concerning: 5118 Bur Oak Dr, Pasadena TX 77505

By: John Landry - TREC #21080, TPCL #0698991

11/26/2019 9:00 am

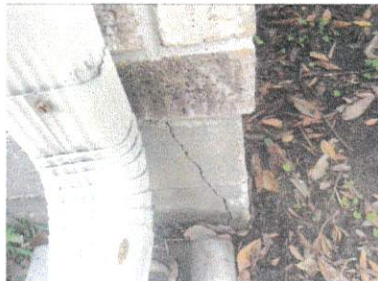
1: Slab: Shear Cracks

Note: Shear cracking ("corner pops") observed at foundation corners is not normally associated with structural movement or deficiencies.

Recommendation: Contact a handyman or DIY project

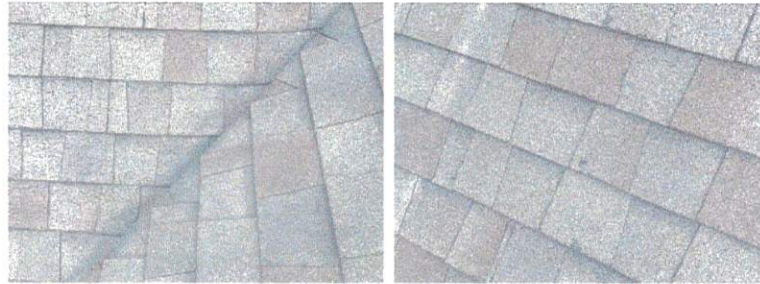
2: Roof covering overview - Repaired by IYARD
 - Recommendation

Roof covering has some wear and tear including some exposed fasteners, some granular loss, some potential impact marks, and some pitting of the shingles. If further evaluation is desired consult with a roofing contractor for any repair costs or replacement cost estimates.

Recommendation: Contact a qualified professional.

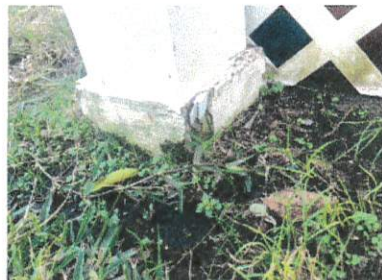
1: Exterior: Trim missing, loose, or damaged

Some damage observed at trim at base of rear porch posts

Sections of exterior trim were either missing, loose, or damaged. Remedy as needed.

Recommendation: Contact a qualified professional.

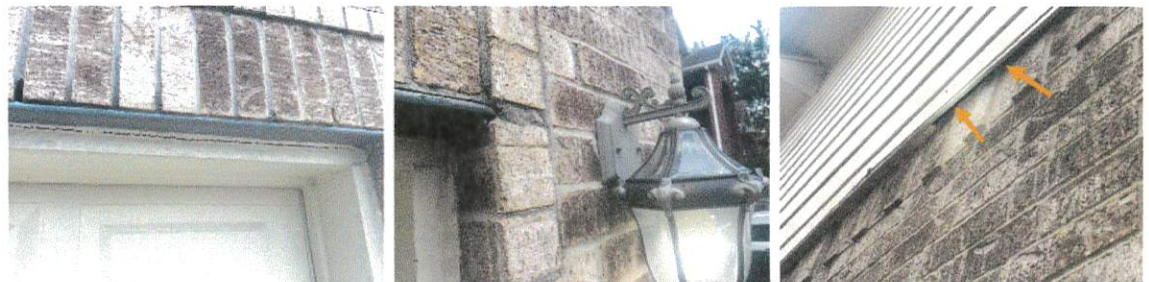
3: Exterior masonry, siding, and trim

For example, around exterior lights, gap above garage door, siding right side
Seal any gaps or openings in exterior masonry, siding, and trim to prevent any moisture intrusion.

Recommendation: Contact a qualified professional.

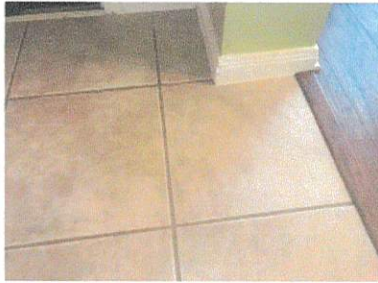
2: Flooring: Tiles Cracked/Chipped

For example, near front door
Floor tiles were cracked or chipped.

Recommendation: Contact a qualified professional.

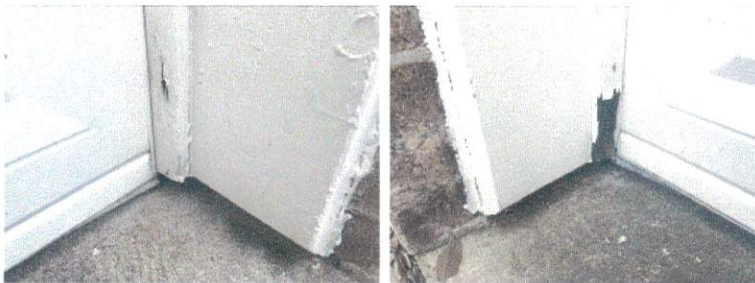
1: Door: Wood Rot at Base of Frame

Garage doors
Wood rot was observed at the base of a door frame. Remedy as needed.

Recommendation: Contact a qualified handyman.

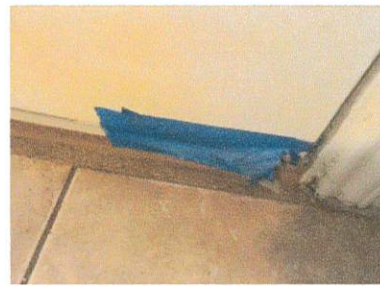
3: Door: Damaged

Rear door at base
Evaluated and remedy as needed

Recommendation: Contact a qualified door repair/installation contractor.

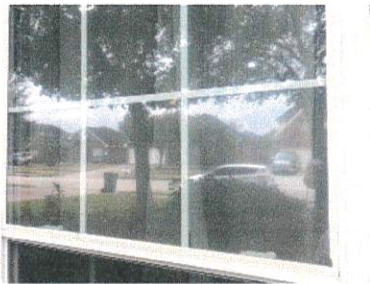
2: Low-e coating imperfections

For example, dining room window

The low-e coating inside the window showed signs of imperfections.

Note: This condition primarily affects window clarity. It can appear as streaks on the glass or as bronzed colored flecks and can (but not necessarily) be indicative of a failed seal.

Recommendation: Recommend monitoring.

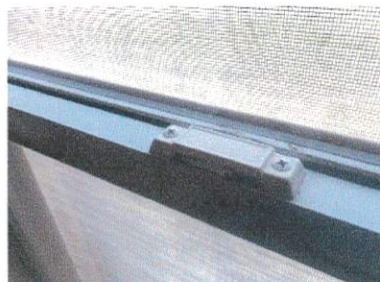
3: Hardware: Missing or Damaged

Latch broken middle window Master Bedroom

Window hardware was missing or damaged. Remedy as needed.

Recommendation: Contact a qualified window repair/installation contractor.

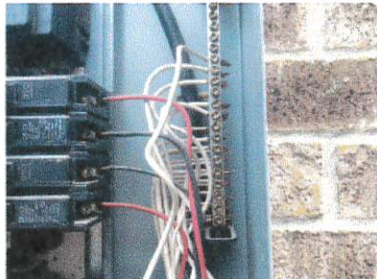
1: Double Lugged Neutral Wires

Double lugged neutral wires were on the neutral bus bar inside the distribution panel. One neutral wire per lug is recommended. Remedy as needed.

Recommendation: Contact a qualified electrical contractor.

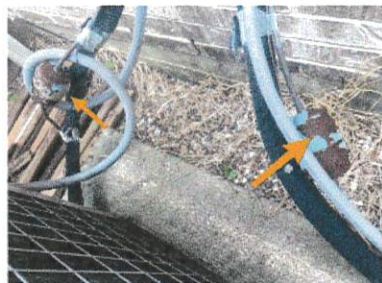
1: Condenser: Rusted Filter Drier

Both units

The filter drier was rusted. Evaluation and remediation by a licensed HVAC contractor is recommended.

Recommendation: Contact a qualified HVAC professional.

- both condensers/driers replaced by STAGNER A/C

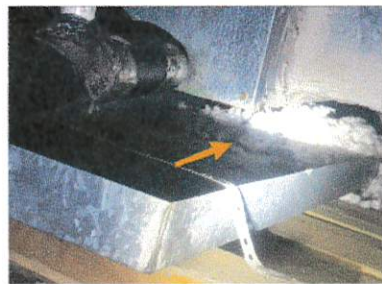
2: Condensate system: Debris in emergency pan

Debris was in the emergency overflow pan which will prevent proper drainage. Remedy as needed.

Recommendation: Contact a qualified HVAC professional.

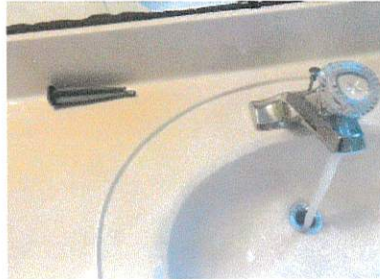
HALL BATHROOM SINK, MASTER BATHROOM BOWL SINKS, 2ND FLOOR BATHROOM SINK

Drain stops had issues that prevented them from working properly (holding water). Remedy as needed

Recommendation: Contact a qualified plumbing contractor. *repaired by owner*

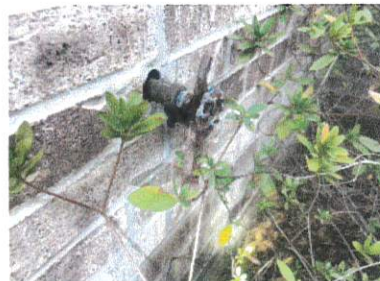
2: Fixtures: Dripping

Front hose bibb at left

A faucet was dripping. Evaluation and/or repair by a qualified handyman or licensed plumber is recommended. Fixtures:

Recommendation: Contact a qualified plumbing contractor.

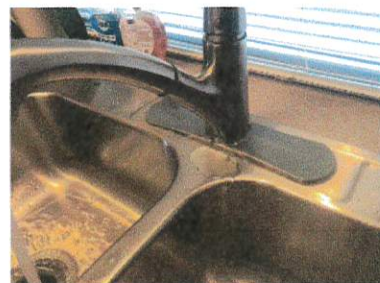
3: Fixtures: Stem Leaking

Kitchen

The faucet stem leaked when operated. Remedy as needed.

- sink faucet replaced by owner

Recommendation: Contact a qualified plumbing contractor.

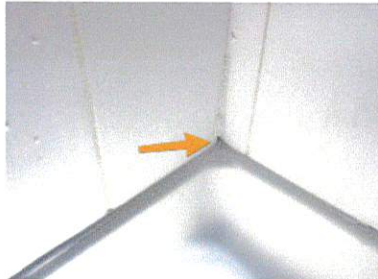
5: Shower: Missing/Deteriorated Caulking or Grout

Master Bathroom

Recommendation: Contact a qualified professional.

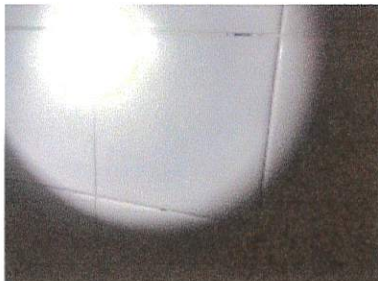
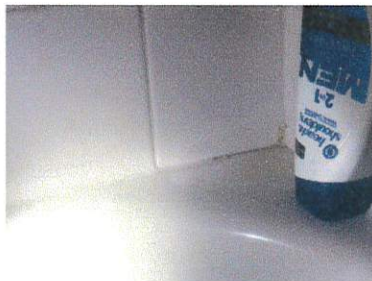
7: Tub: some Caulk/grout Deteriorated/Missing

2nd Floor Bathroom

Deteriorated or missing caulk/grout was present at tub. Remedy as needed to maintain an optimal moisture barrier.

Recommendation: Contact a handyman or DIY project
