PROPERTY INSPECTION REPORT

Concerning: 9114 Kirkstone Spring, TX. 77379

Inspected By: Rod Scarborough TREC License # 7189 September 28, 2020

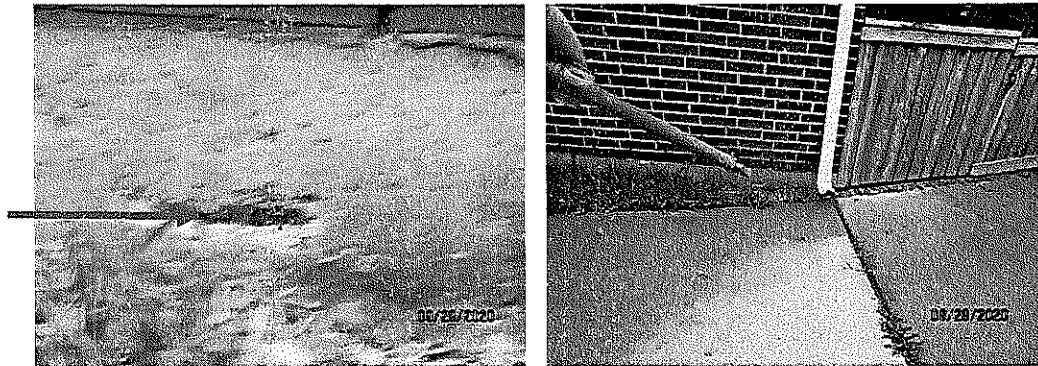
Exposed rebar was observed on the right side of the structure. Recommend sealing and monitored on a continual basis.

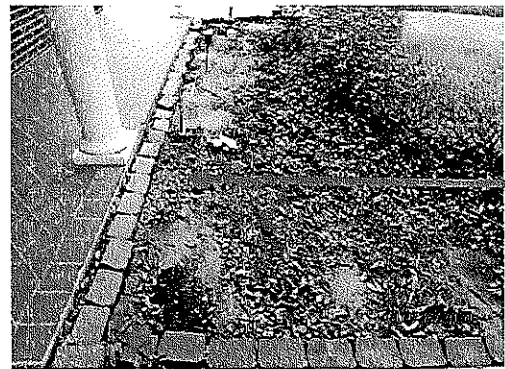
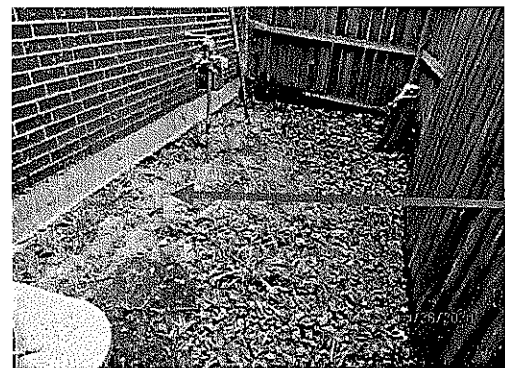
☒ Grading and drainage around the structure does not appear to be functioning as intended in all areas. Signs of erosion/damage & flat/improperly sloped areas were observed on the front, back & left sides of the structure. These conditions may be conducive to ponding which may have an adverse effect on the foundation/structure. It is recommended that the drainage improvements be made in these areas or that sub-surface drainage be installed to allow the water to flow freely away from the structure & to the street as required. After the drainage improvements have been made it is recommended that the drainage around the structure should be monitored during/after heavy rains & if ponding water is observed then additional drainage improvements should be performed.

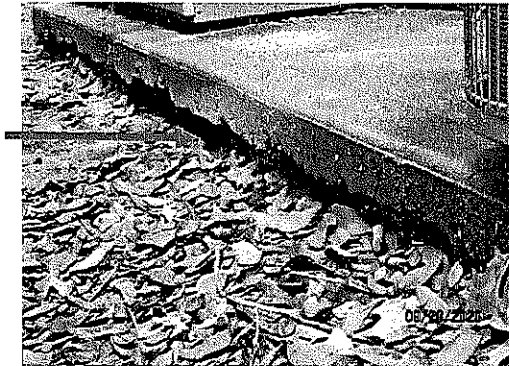
☒ The grading under the AC condenser pad is being washed away, recommend backfilling to prevent further washout & sinking of the AC pad.

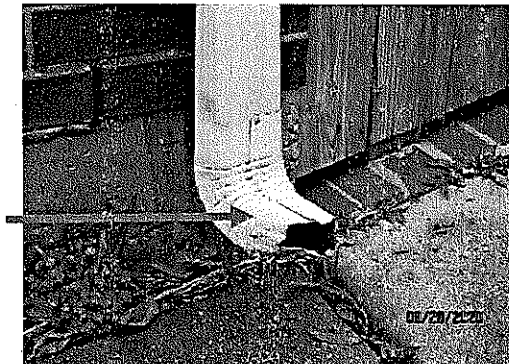
Damaged gutter down spout was observed on the right side of the structure. Recommend repair/replacing.

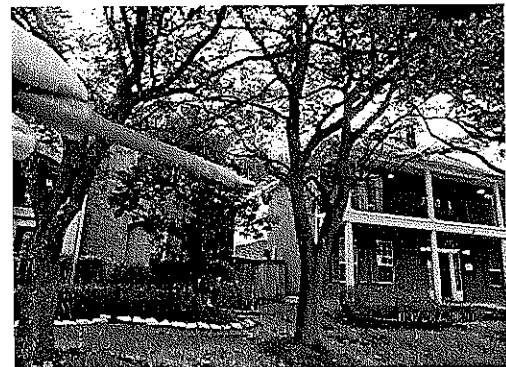
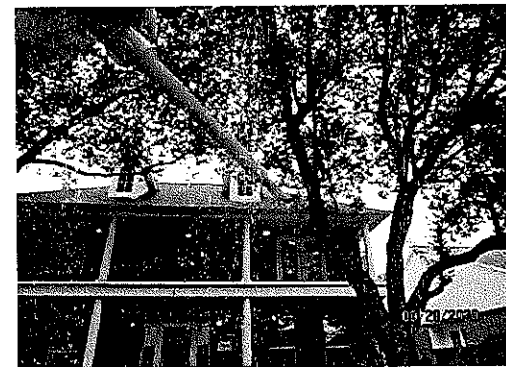
What appeared to be damaged/missing shingles were observed on the front, left & back sides of the roof. Recommend repair/replacement.

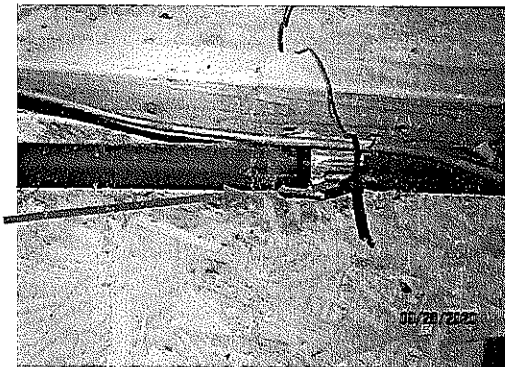
Existing/previous moisture penetration/staining was observed in the attic decking by the upstairs HVAC equipment. A moisture reading was performed in & moisture was detected at the time of the inspection.

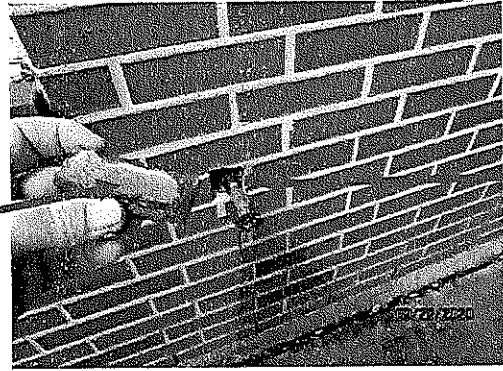
Missing/damaged brick was observed around the hose bib on the back side of the structure. Recommend repair/sealing.

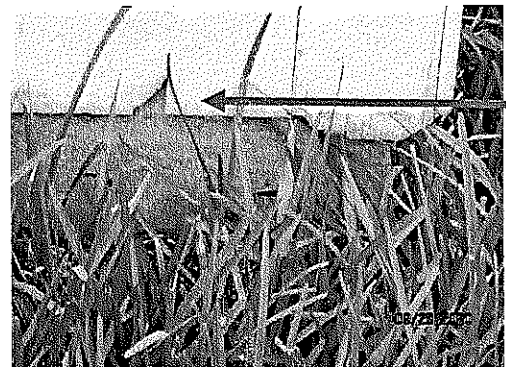
Minor damage to the siding/trim was observed in some areas around structure.

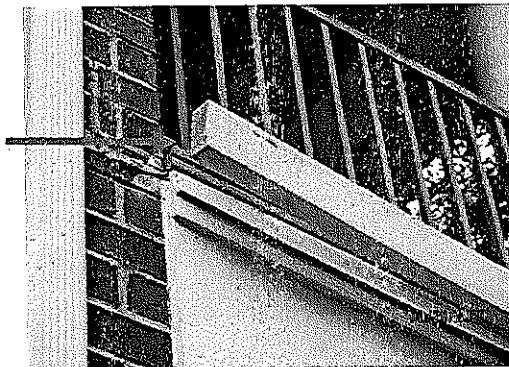
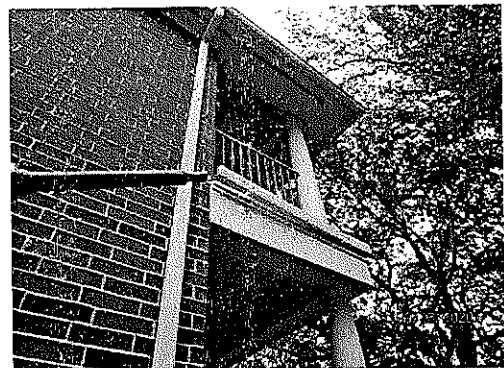
→ The trim board to the left side of the balcony is not properly secured. Recommend securing.

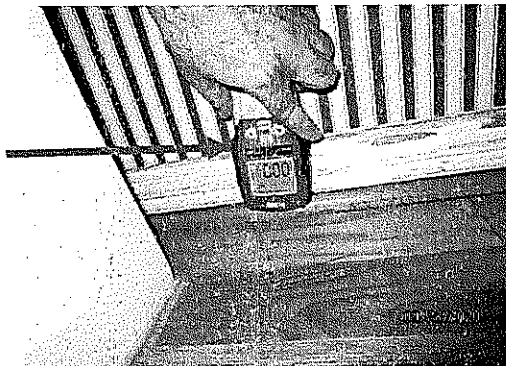
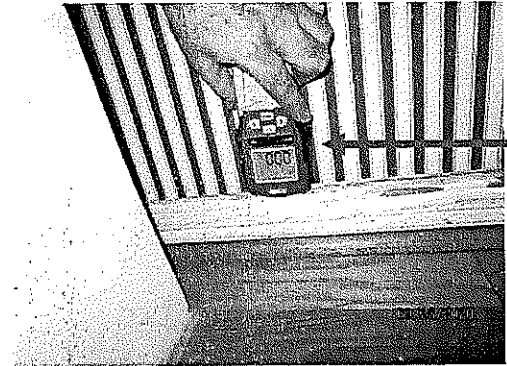
Existing/previous moisture penetration was observed but may not be limited to the base of the wall in the half bath on the interior of the structure. A moisture reading was performed & no moisture was detected at the time of the inspection.

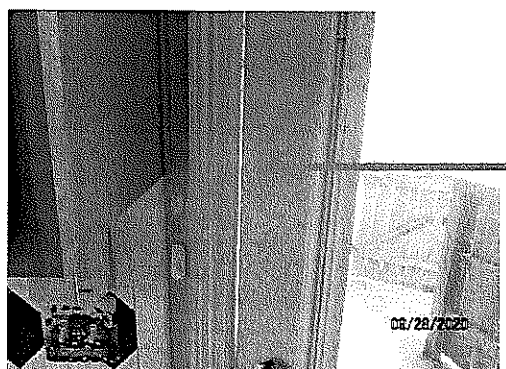
The glazing at the front door is broken. Recommend replacing.

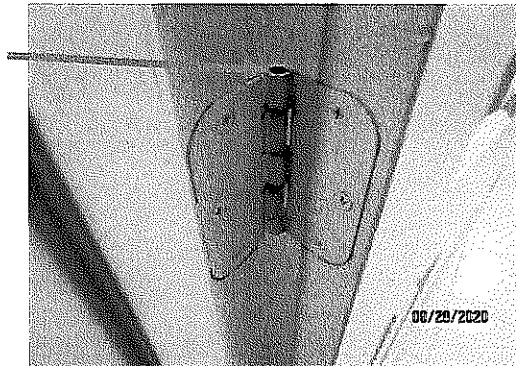
Door leading into the hall bathroom is missing a hinge pin at the middle hinge. Recommend replacing.

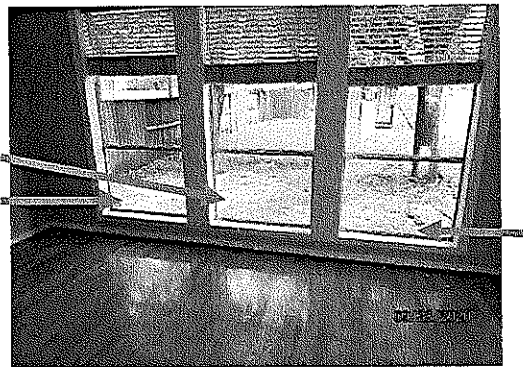
Unable to determine the presence of safety/tempered glass at the windows in the main living area due to not being able to located the tempered/safety glass etching. Safety/tempered glass is required by today's standards.

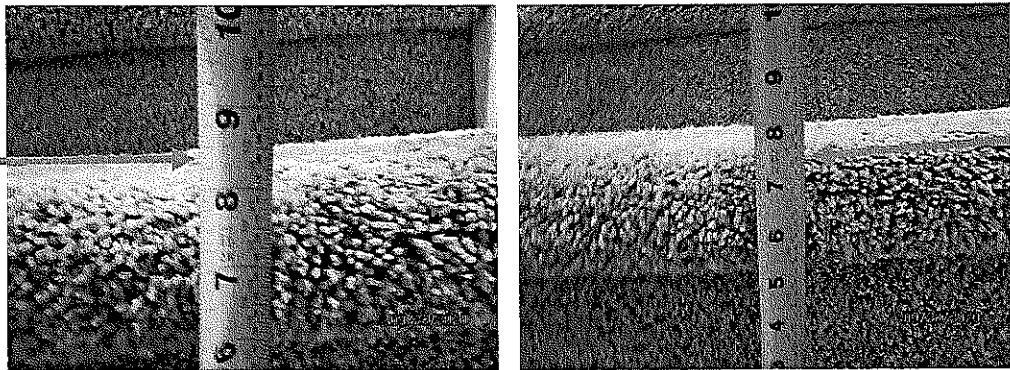
The stair riser heights do not meet current building standards of a maximum of 7 3/4" with a variance of 3/8". The riser heights varied from approx. 7 3/4" - 8 1/2".

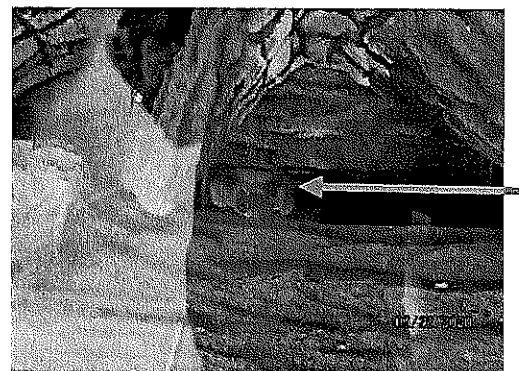
The fireplace could not be lit under normal conditions. The gas valve was closed & the pilot was out upon arrival to the inspection. The pilot was lit & multiple attempts were made to light the fireplace however the fireplace would not light under normal conditions. Recommend further evaluation/repair.

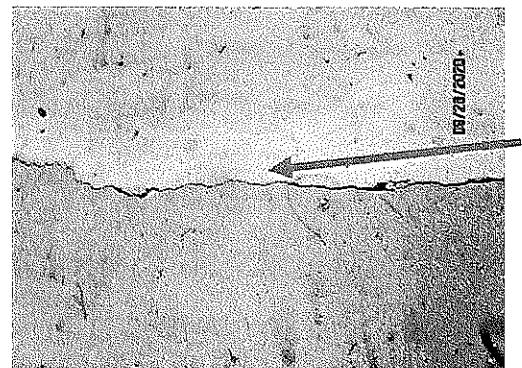
Cracking was observed in the driveway. Recommend repair.

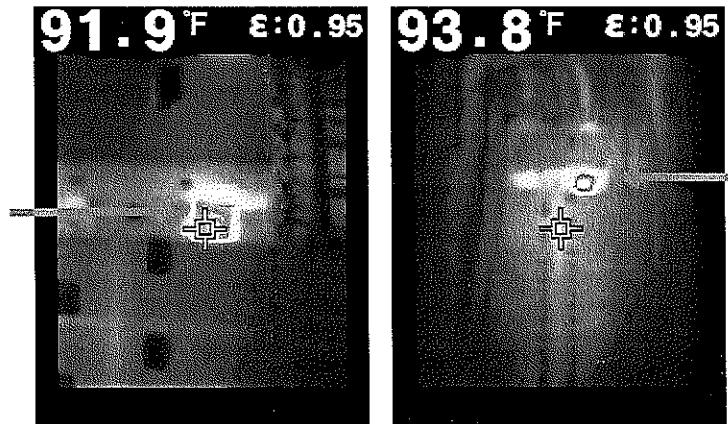
The 40 Amp breaker at the top right side of the bus showed signs of potential overheating. Recommend further evaluation/repair.

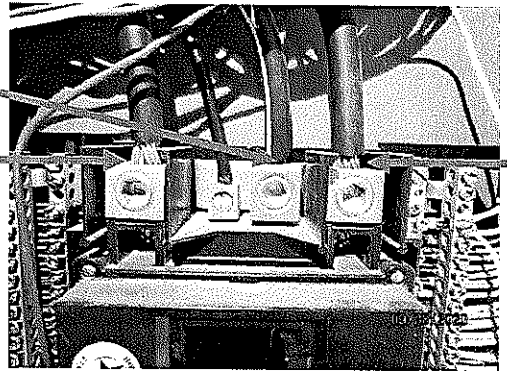
All "hot" wires on breakers should be red or black. Any other color wire should be painted or taped black to indicate that it is "hot". One or more white (neutral) wires are being used as hot wires without being properly marked.

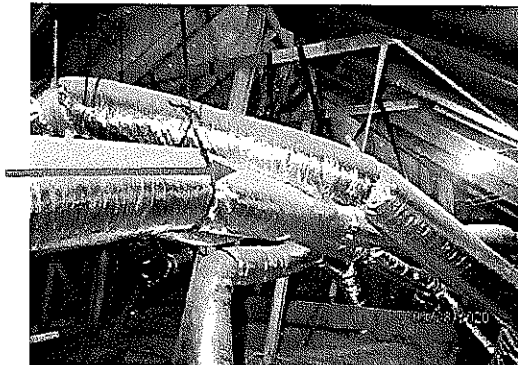
The flex duct was observed to be in direct contact with other pieces of duct in some areas of the attic. Recommend adding insulation between the ducts or rerouting ducts should be considered to prevent condensation between the ducts.

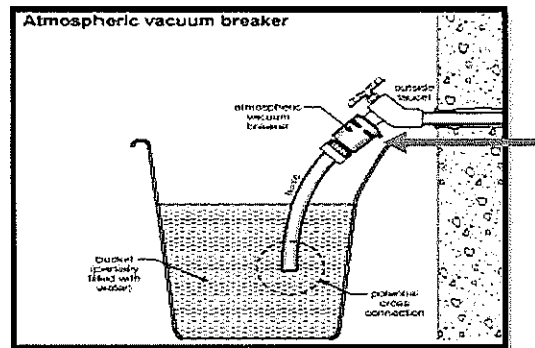
Back flow preventers are not installed on all hose bibs. Recommend installing to prevent water from backing up into the water system.

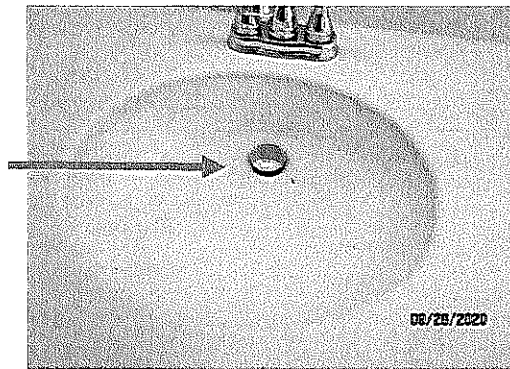
The left side master bath sink is slow to drain.

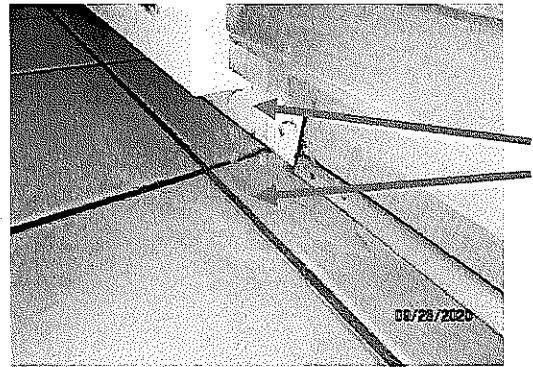
An attempt to run the dishwasher through a complete normal cycle was made however the dishwasher had to be shut off without completing the cycle due to the dishwasher door seal is damaged & is leaking water all over the floor. The dishwasher was shut off & the cycle was not completed. Recommend repair as required.

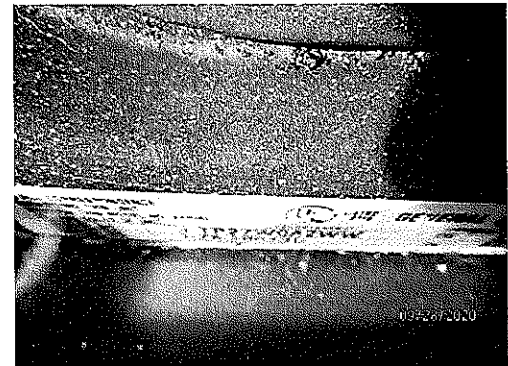
The ovens were turned on to 350 degrees and allowed to cycle through the preheat function, a temperature reading was performed and read 325 degrees at the top oven & 330 degrees at the bottom, a variance of 25 degrees is considered acceptable. Recommend recalibrating the oven to the correct temperature as required.

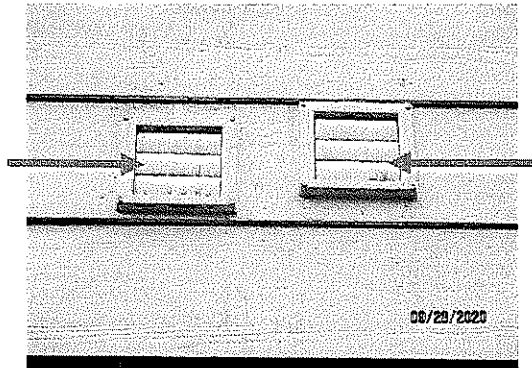
The utility room & downstairs half bath exhaust vents do not appear to be properly terminated to the exterior as noted by the lack of movement at the exterior exhaust flaps on the right side of the structure.
