## PROPERTY INSPECTION REPORT

Concerning: 1717 Church Street, Galveston, TX 77550  
(Address or Other Identification of Inspected Property)

By: Danny Marlow Lic.#: 23187 05/19/2021  
(Name and License Number of Inspector) (Date)

**Inspection No. 521350-715**

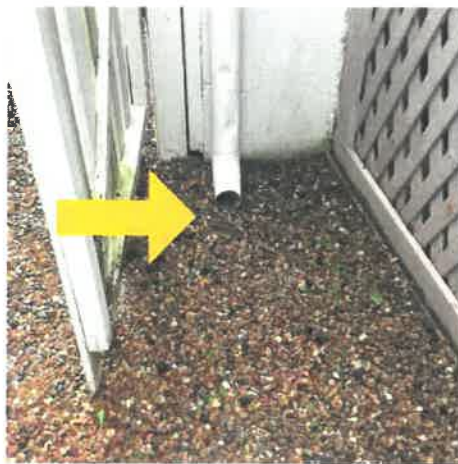
- Downspouts improperly discharging water against foundation. Redirect and extend all downspouts away from foundation for proper drainage.

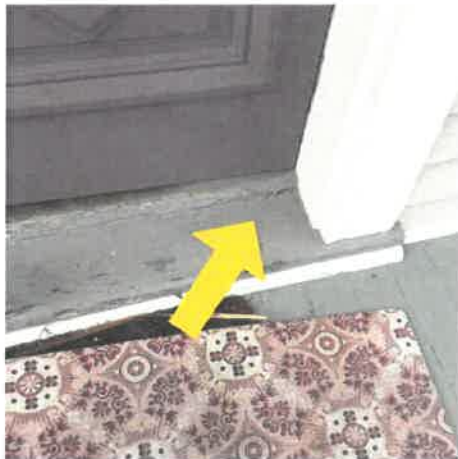
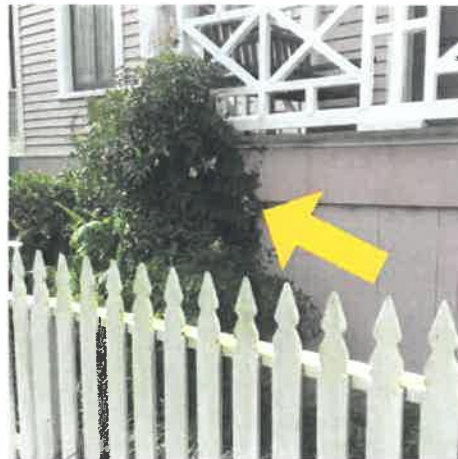
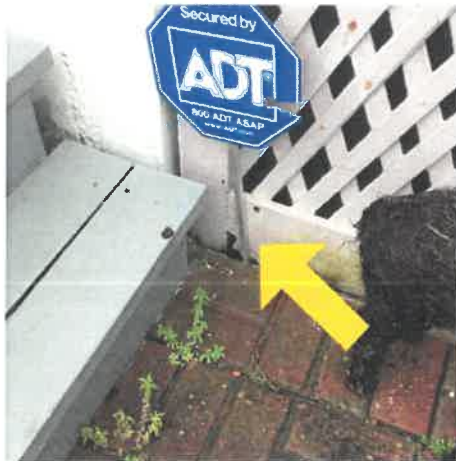
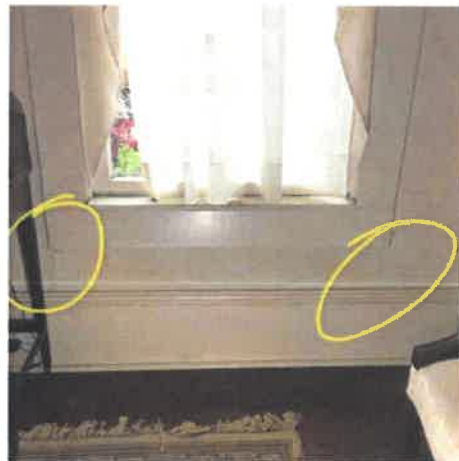
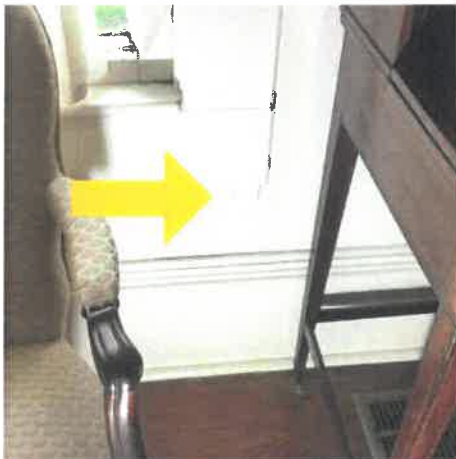
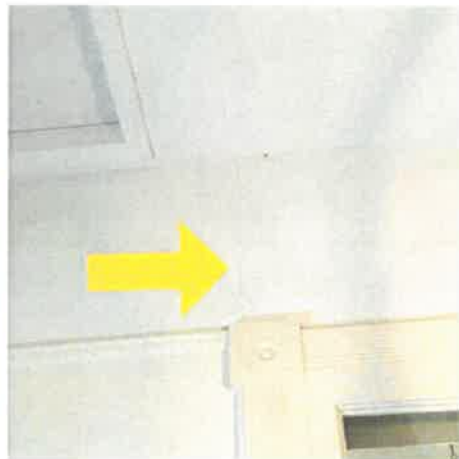
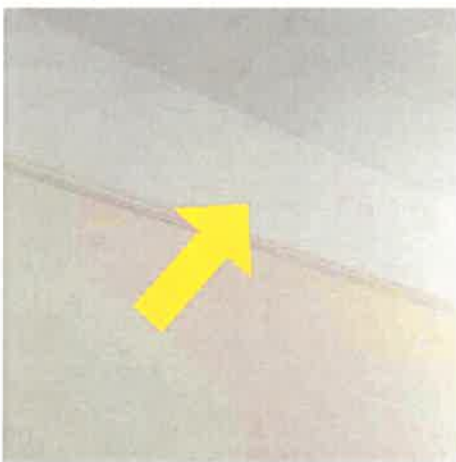
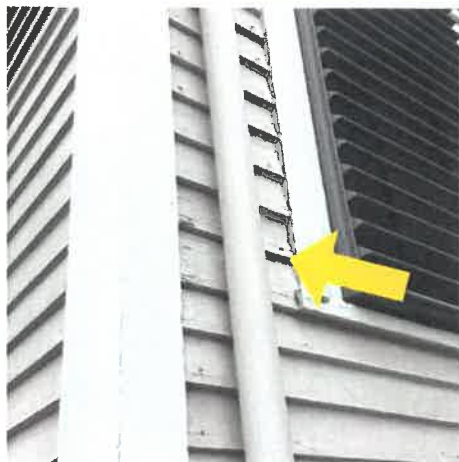
- Wood siding with wood trim (exterior). Drywall with wood trim (interior).
- There were various areas where minor stress cracks were noted (typically associated with settlement).
- There was minor wood rot/deterioration noted miscellaneous areas of trim and siding. Recommend repairs as needed to prevent further deterioration and damages.
- Vines growing on exterior walls should be trimmed or maintained so as not to interfere with siding etc. Vines are intrusive by nature and will increase vulnerability of water intrusion into the structure materials.

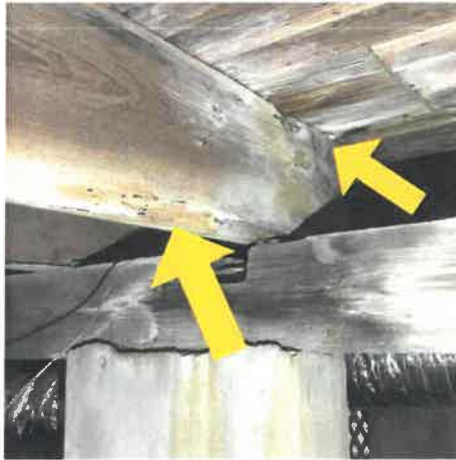
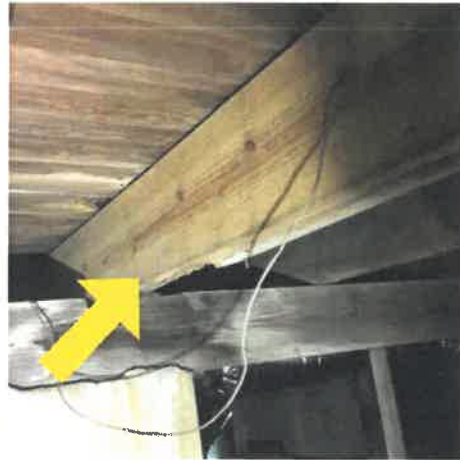
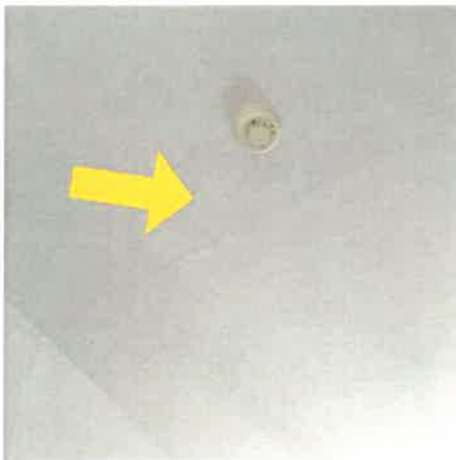
- There was rot/deterioration noted at one floor joist at middle left side of the home (repairs appeared to have been made). Recommend having qualified contractor evaluate.
- There was a minor stress crack noted at hallway ceiling (typically associated with settlement).

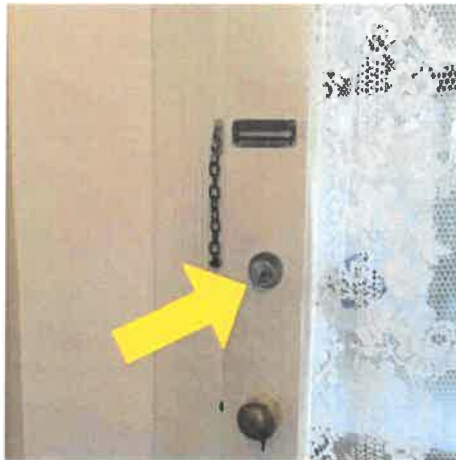
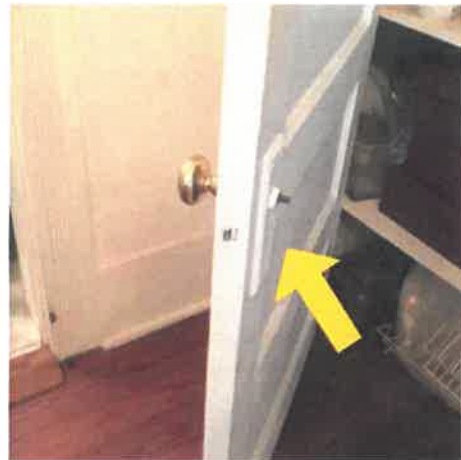
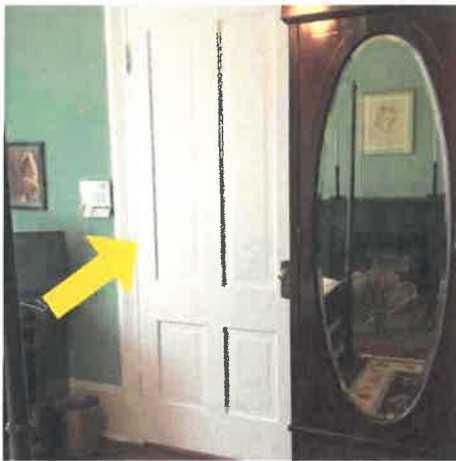
- All doors were functioning properly at time of inspection.
- There was a missing door knob noted at closet in dining area.
- Middle back door was noted to be dragging on the door frame when closed. Recommend repairs/adjustments for proper operation.
- Middle back door was noted as having a deadbolt that requires a key for exit. Recommend installing deadbolt with thumb latch for emergency egress.
- Front right bedroom door was not staying in the open position when opened. Recommend repairs/adjustments for proper operation.

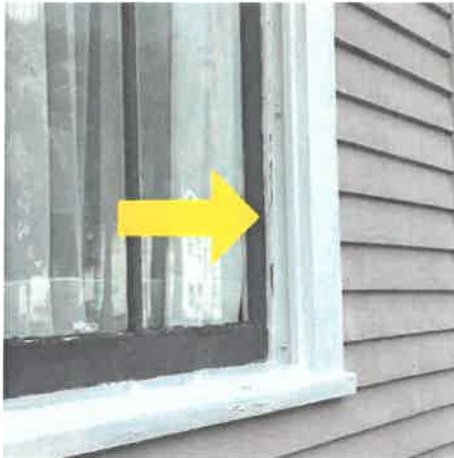
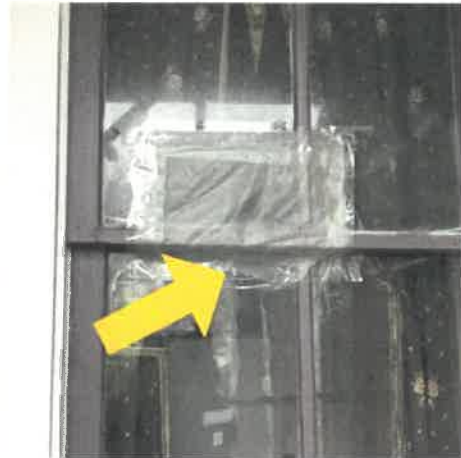
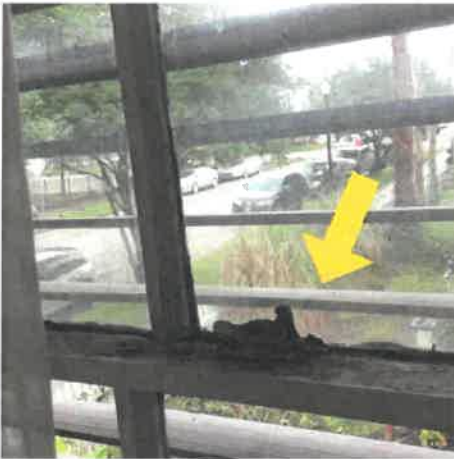
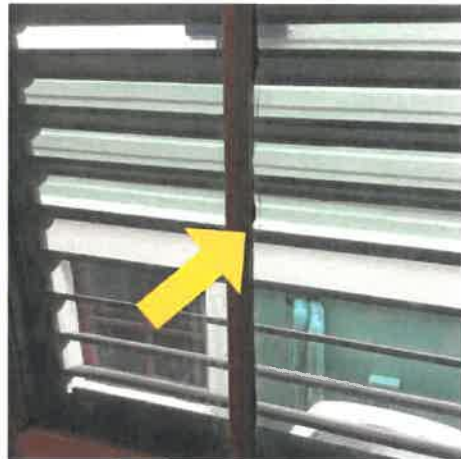
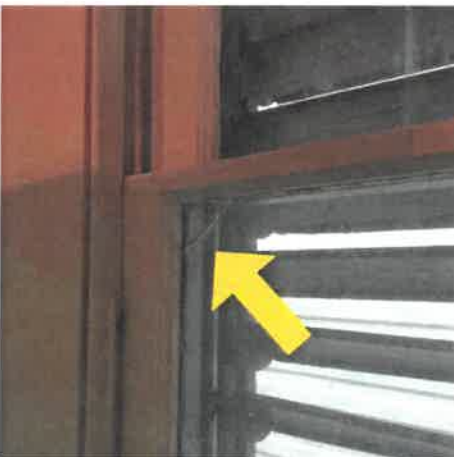
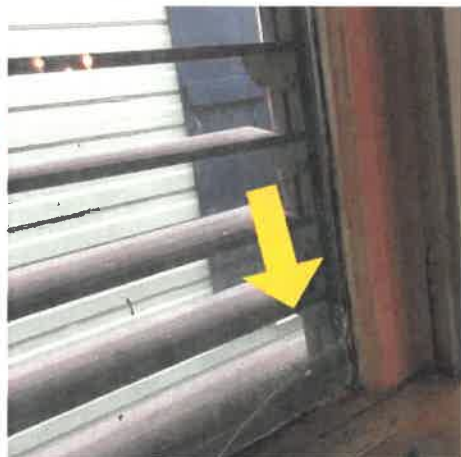
- Windows are old and in various states of repair (damaged locking hardware, broken glass, damaged opening hardware). Recommend having qualified contractor evaluate the extent of damages and repair or replace as needed for proper operation and emergency egress.
- Sealant is deteriorated and cracked around the exterior of multiple windows. Recommend removing old sealant and re-sealing to prevent water and/or pest penetration.

*Windows repaired May 24, 2021*

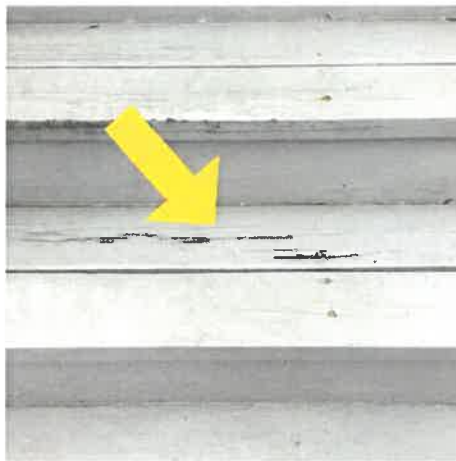
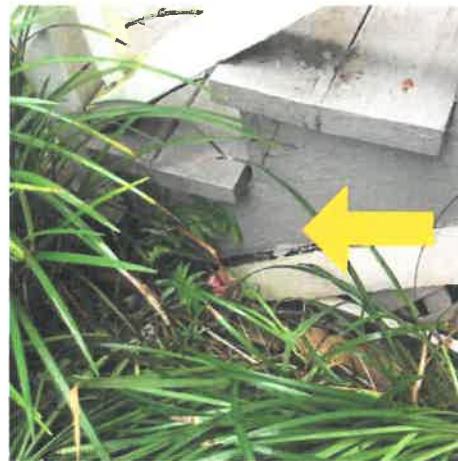
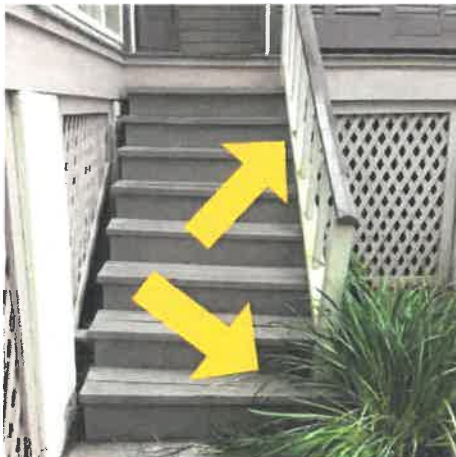
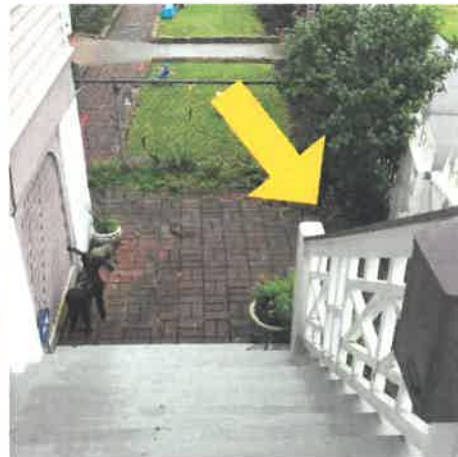
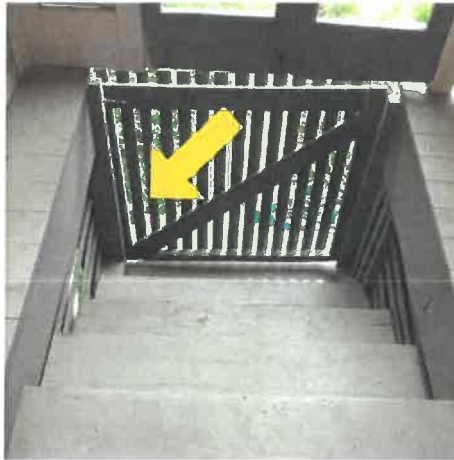
- Stairways are missing the required graspable type handrails. Recommend installing graspable type handrails for safety.
- Handrails should be at least 1 1/2 inches out from the wall so that you can get your hand around it, and the part that you grab should be roughly 1 1/2 inches across the top surface.
- Side stairway was noted to be leaning/uneven and was showing wood rot/deterioration. Recommend having qualified contractor evaluate and repair as needed for safety.
- There was wood rot noted at various stairway steps. Recommend repairs or replacements as needed.

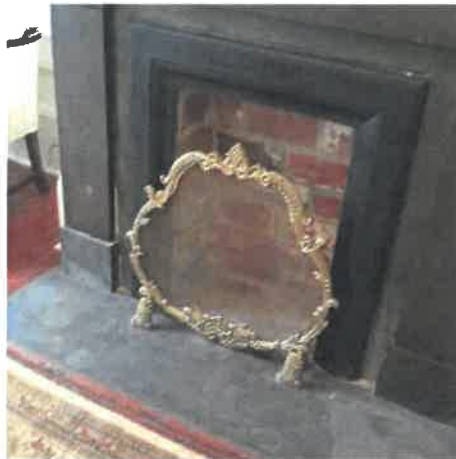
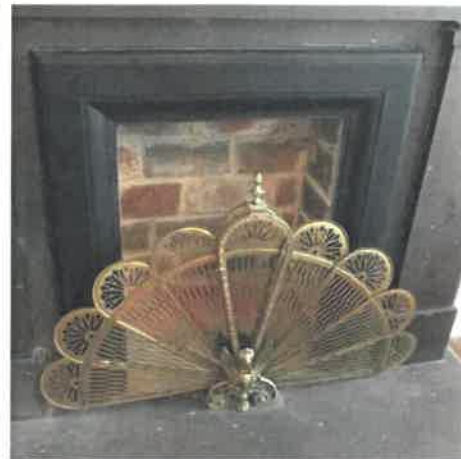
- Fireplaces were noted as being abandoned/closed up and chimneys removed.

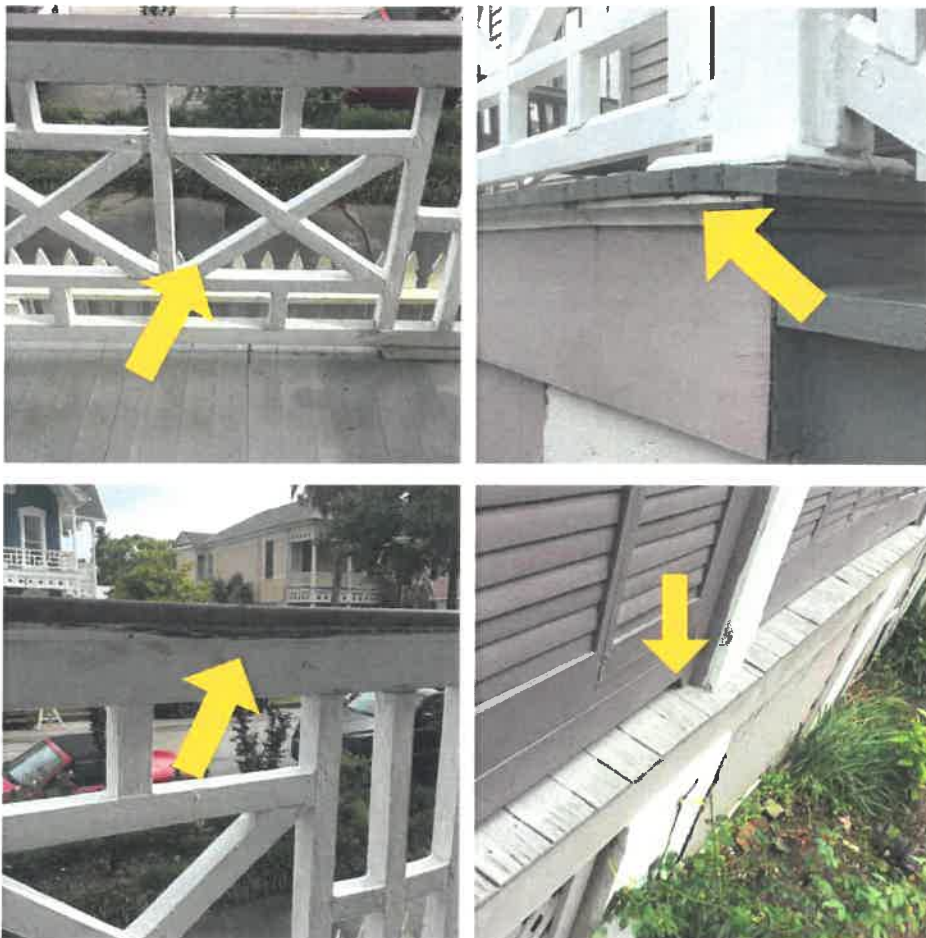
- There were miscellaneous areas where deterioration/damages were noted. Recommend having qualified contractor evaluate the extent of damage and repair as needed to prevent further deterioration and damages.
- Exercise caution,railings pose potential safety hazard due to detailing(a safety hazard for small children).
- Balusters on guardrails should be vertical and spaced no more than 4inches apart for safety.
- There were miscellaneous deck boards showing age and wear. Recommend monitoring and repairs as needed.

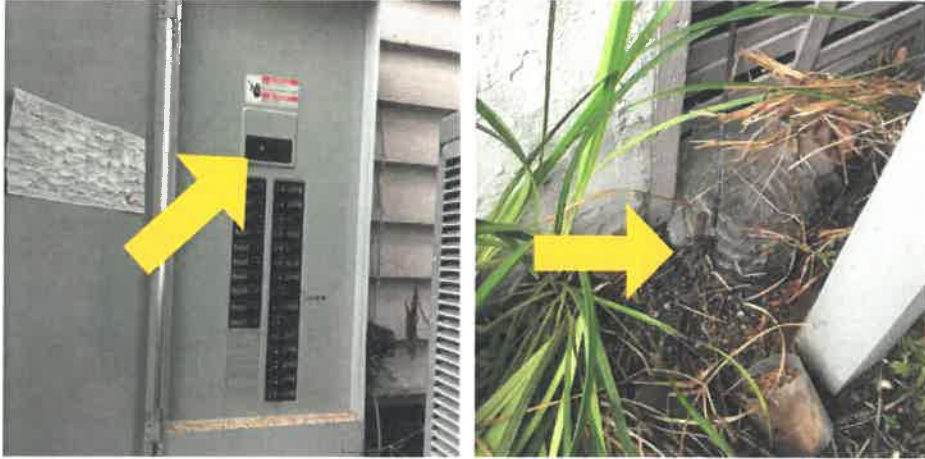
- 120/240 volt, 200 amp service.
- Grounding is through grounding rod to earth.
- Main disconnect is located in service panel on back exterior of the home.
- Ground connection was noted as being loose. Recommend securing ground connection for proper grounding and safety.

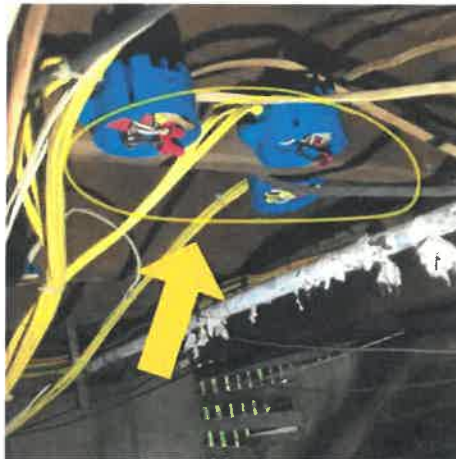
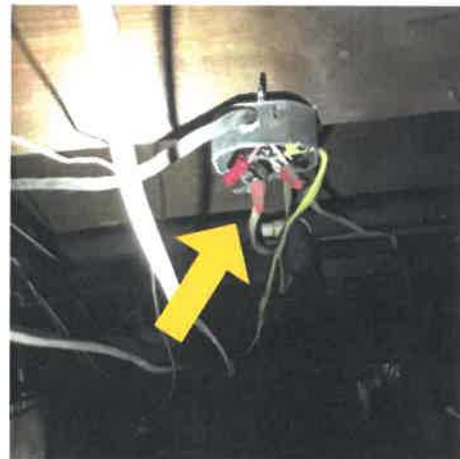
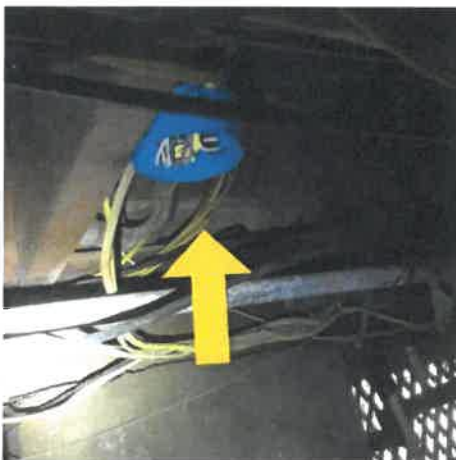
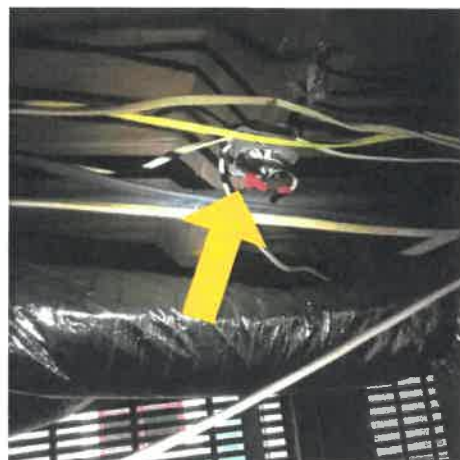
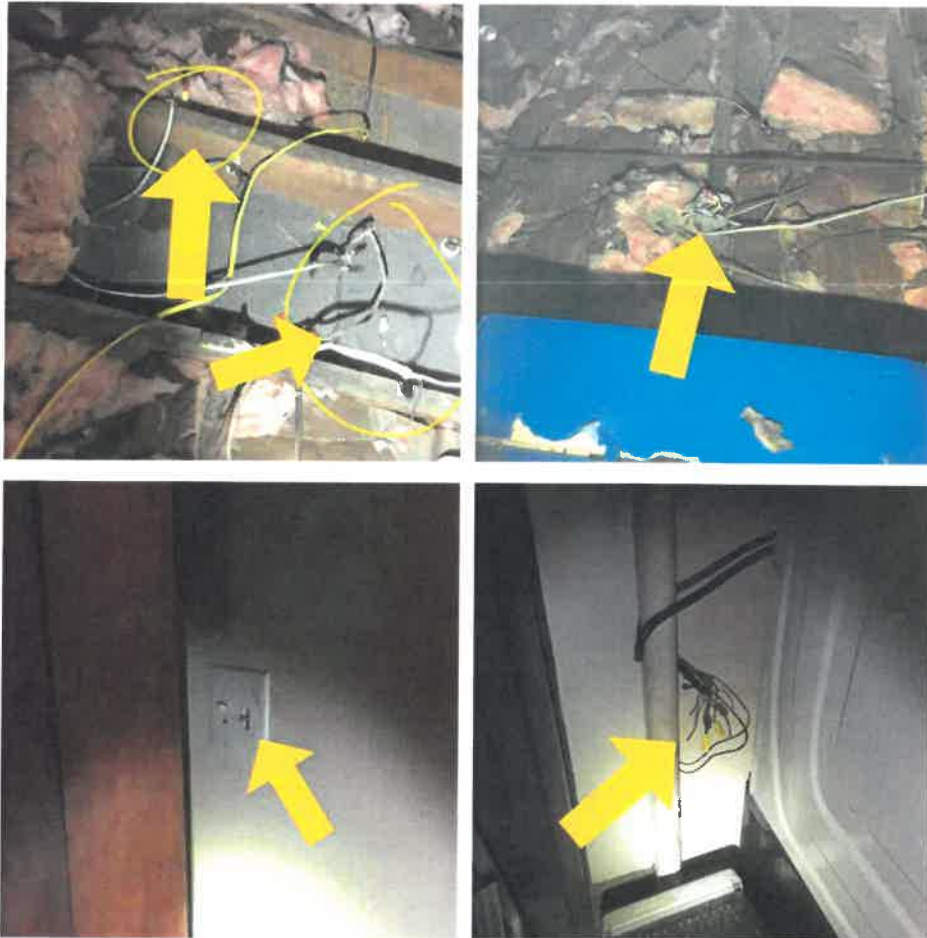
- All wiring appears to be copper and in good condition.
- Smoke detectors were not found in all required areas. Smoke detectors are required in all sleeping rooms in areas just outside of sleeping rooms and in living area of each floor. Recommend installing smoke detectors in all required areas for safety.

- There were miscellaneous open junction boxes noted under the home and in the attic.
- There were open wire splices noted in attic. Wire splices should be made in a closed junction box.

- There were unterminated wires noted on back deck at washing machine.
- There were multiple receptacles that were noted to be having an open ground when tested. Recommend having licensed electrician evaluate electrical issues and repair as needed for proper operation and safety.

- There were two light switch knobs that were missing at the time of the inspection. Recommend repairs for proper operation.
- Multiple receptacles are not GFCI protected in required areas. Receptacles in wet areas, outside and in garage are required to be GFCI protected to reduce the risk of electrical shock(kitchen, bathrooms & garage). Recommend installing GFCI Receptacles as required for safety.

- There was a damaged/loose receptacle noted in garage. Recommend repairs as needed for proper operation and safety.

*See  
A+B  
B-d  
attached  
with to become  
pursuant to  
the bid.*

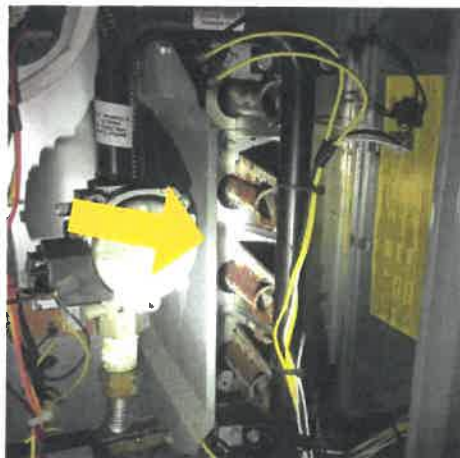
- Forced air furnace(manufactured in (manufactured in 2008).
- Natural gas energy source and was working as designed at time of inspection
- There was rusting noted at burners. Recommend having licensed HVAC technician evaluate and repair as needed for proper operation.

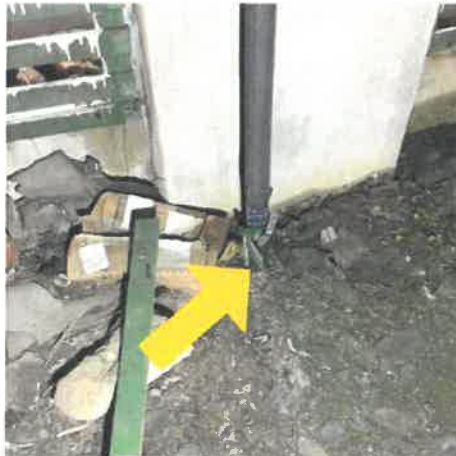
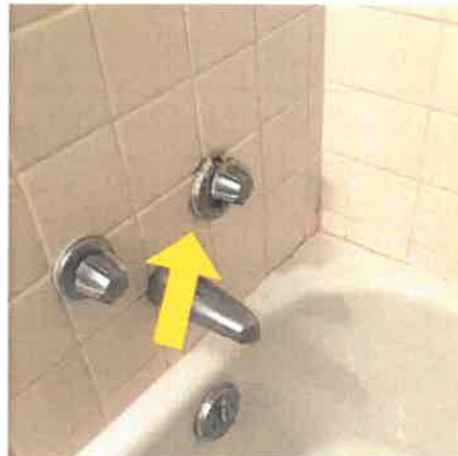
- Water meter is located in back yard at alley
- Main water cut off is located under home in crawlspace
- Static water pressure was 60 psi. at time of inspection. Normal water pressures should be between 40 and 80 psi.
- There was damaged trim noted at faucet in bathtub

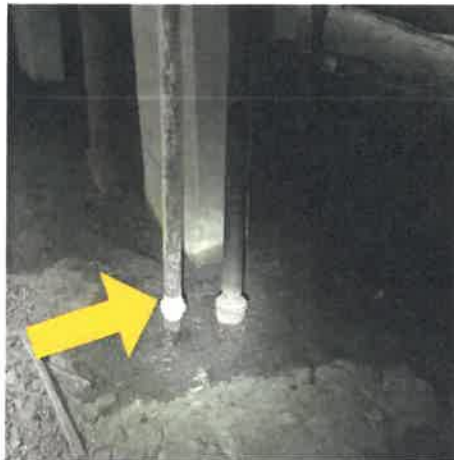
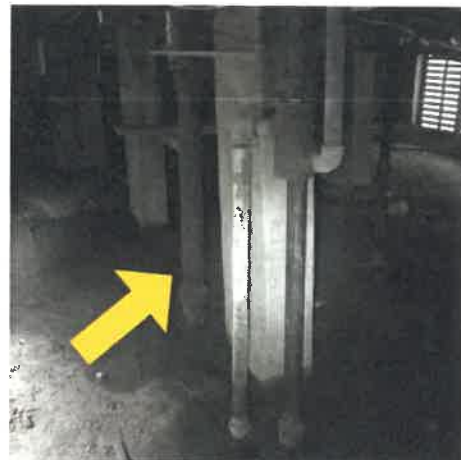
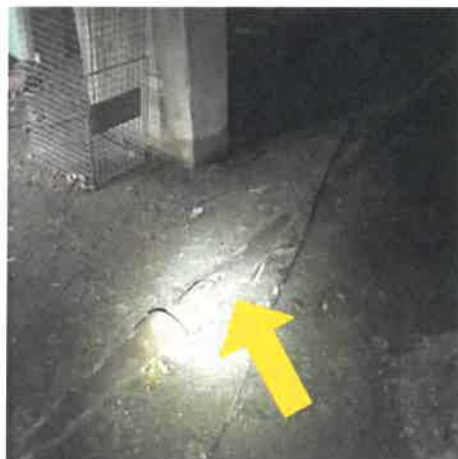
- There were old cast iron drain lines noted under home, some were noted to be showing moderate to heavy deterioration. Recommend having licensed plumber evaluate and repair or replace as needed for proper drainage

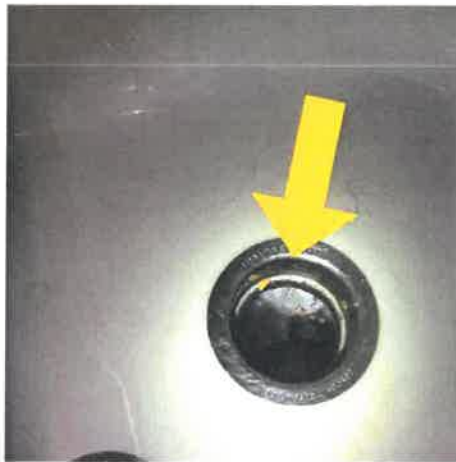
- Food waste disposer was operating as designed at the time of inspection.
- Splash guard for disposal was missing at time of inspection. Recommend replacing with a new splash guard to prevent food being thrown out of top of disposal.

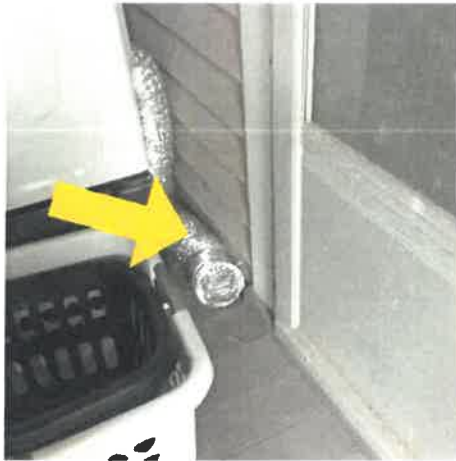
- Dryer vent pipe terminates onto back deck. Recommend having exhaust ran to exterior of home.

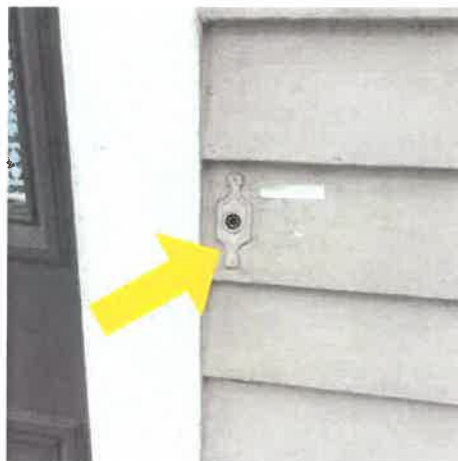
- Door chimes/bell inoperative at time of inspection.

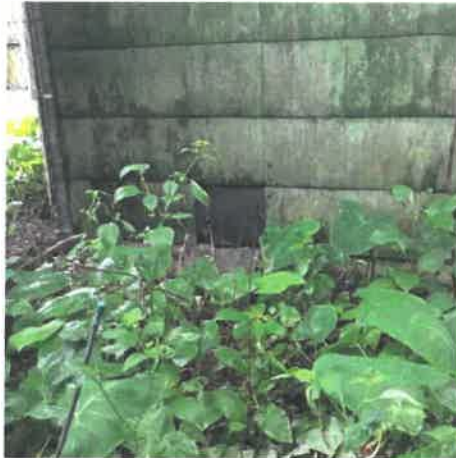
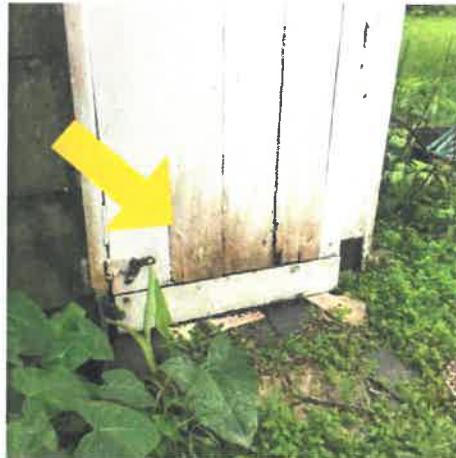
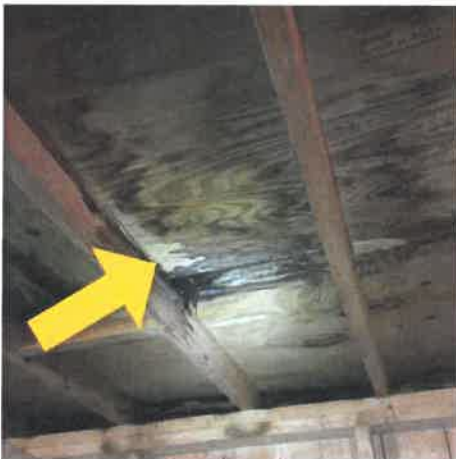
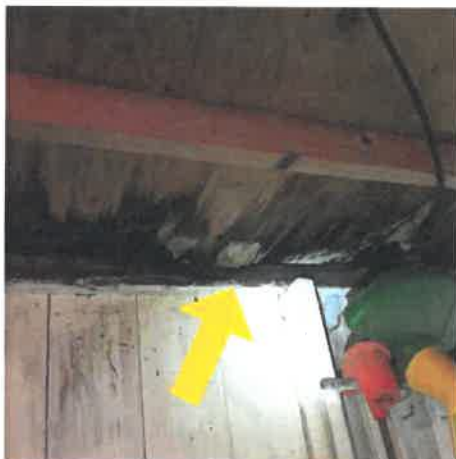
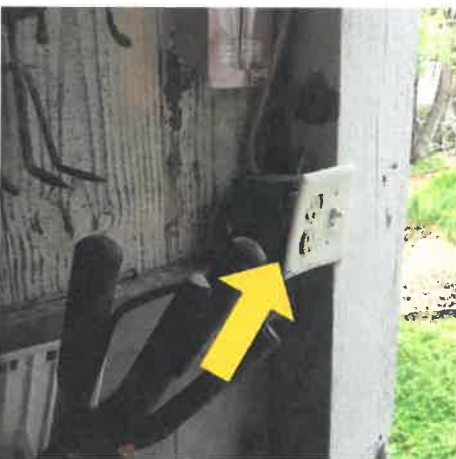
- Asbestos siding.
- There was damaged siding noted at front of garage. Recommend repairs as needed to prevent further deterioration and damages.
- There was wood rot noted at entry doors. Recommend repairs as needed to prevent further deterioration and damages.
- There were moisture related damages noted at sheathing in garage( there was moisture present at time of inspection).
