1st Rate Inspections

Property Inspection Report

10511 Windriver Dr, Houston, TX 77070

Date of Inspection: 6/12/2019 Time: 8:30 AM

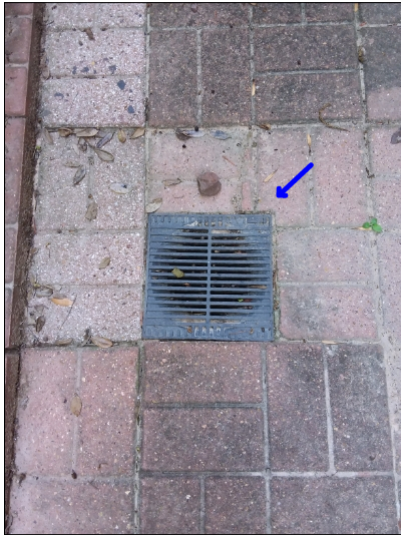
-Surface drains have been noted on the property. We can not determine the condition of drains that are below grade level. Mainly at -right

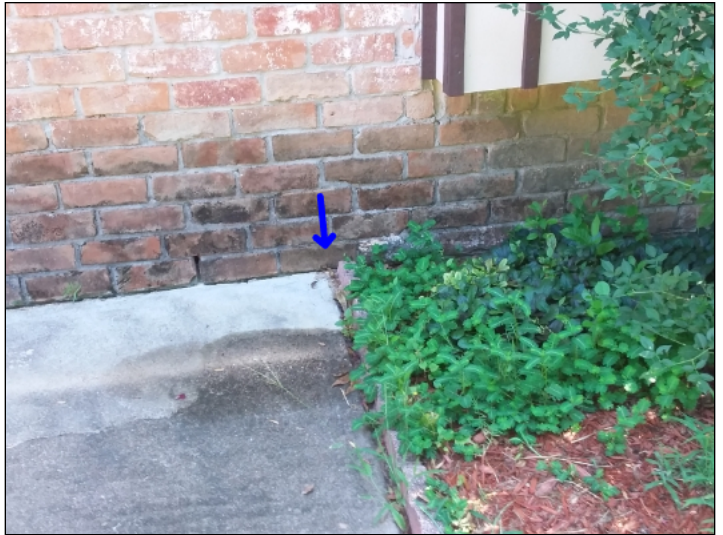
B.2. -The soil or rock level around the home is higher than recommended or in contact with the siding materials. Recommend lowering the soil line to help prevent water penetration and/or damage to the structure. Mainly at -rear

-The soil or rock level around the home is higher than recommended or in contact with the siding materials. Recommend lowering the soil line to help prevent water penetration and/or damage to the structure. Mainly at -rear

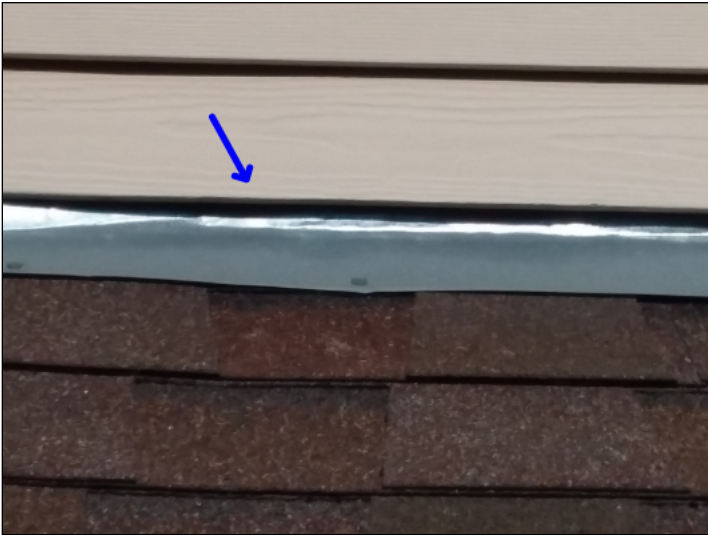
C.2. -Recommend painting all unpainted vents and flashings to help prevent damage due to UV rays or rust.

-Recommend painting all unpainted vents and flashings to help prevent damage due to UV rays or rust.

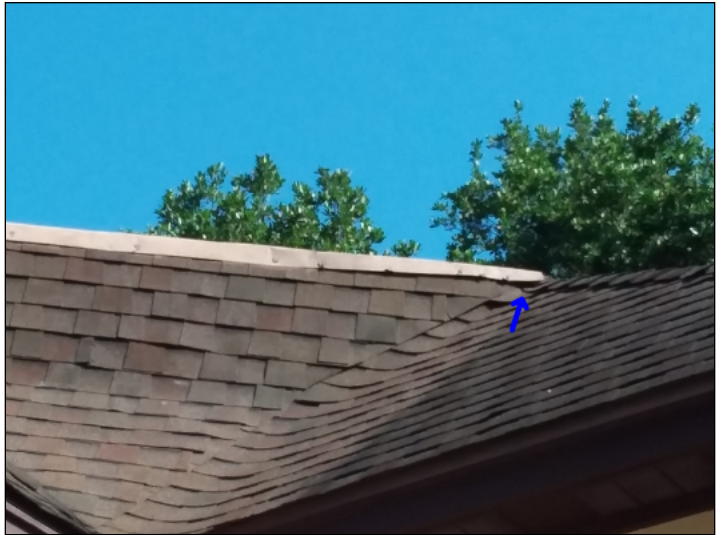
C.3. -The roof flashing is lifted. Recommend securing all loose or lifted flashings and sealing nails to help prevent water penetration. Mainly at -rear

-The roof flashing is lifted. Recommend securing all loose or lifted flashings and sealing nails to help prevent water penetration. Mainly at - rear

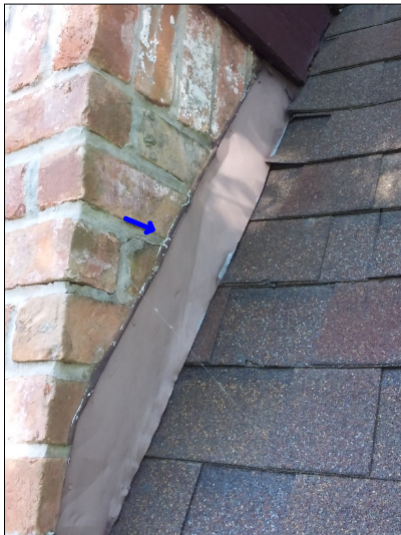
C.4. -The flashing needs to be sealed. Recommend repairs to help prevent water penetration. Mainly at -front

-The flashing needs to be sealed. Recommend repairs to help prevent water penetration. Mainly at -front

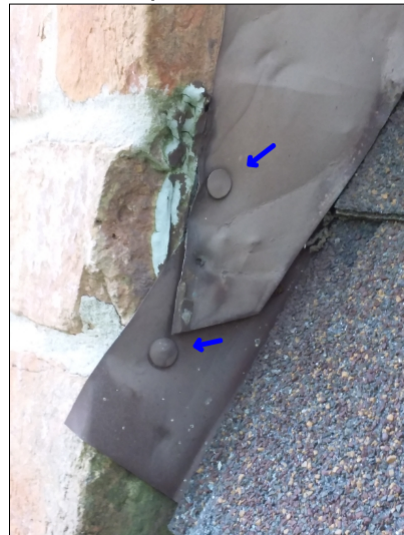
-All exposed nails and fasteners on roof should be sealed at all penetrations, ridges and roof to wall connections.

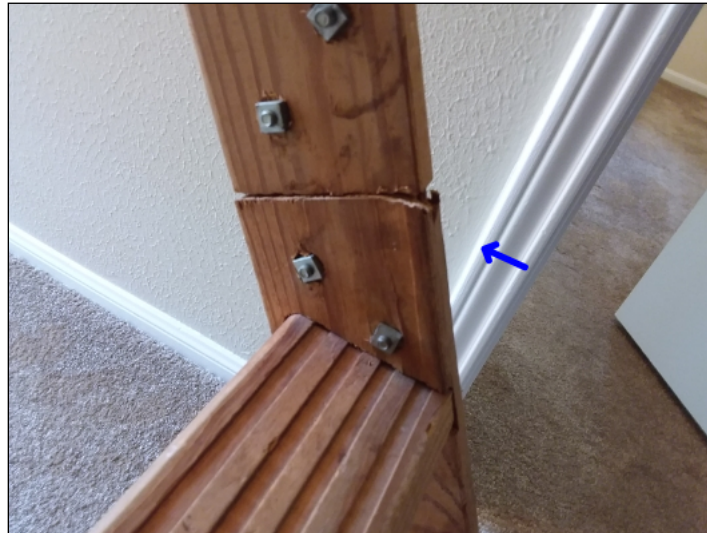
-Attic stairway is damaged, recommend repair or replacement to help prevent injury.

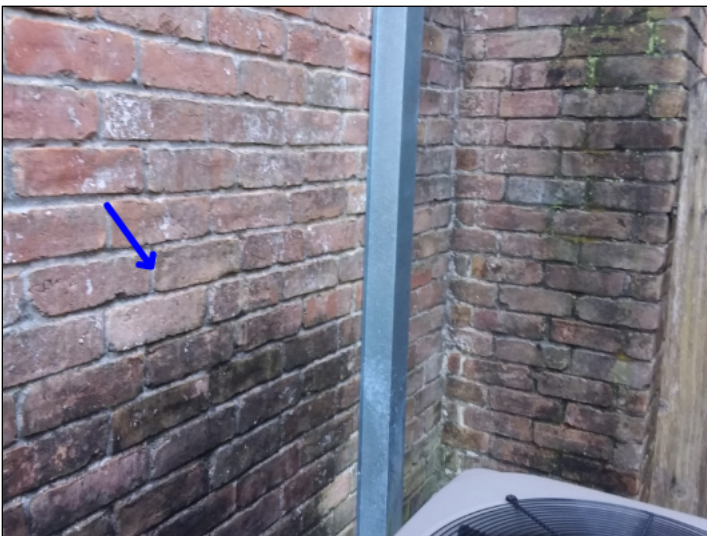
-There are signs of growth on exterior siding, recommend cleaning.

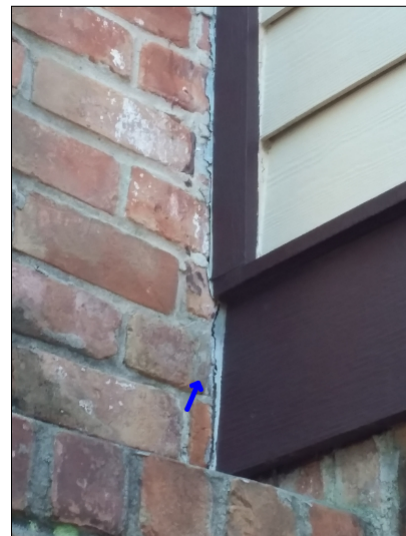
-Recommend sealing between the trim and brickwork to help prevent water penetration. Mainly at -right

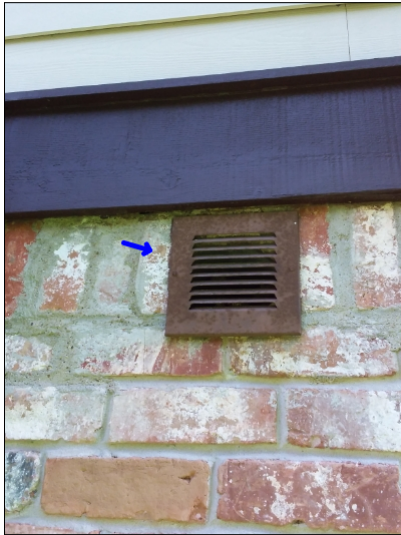
-Seal all vents at wall connection to help prevent water penetration into walls.

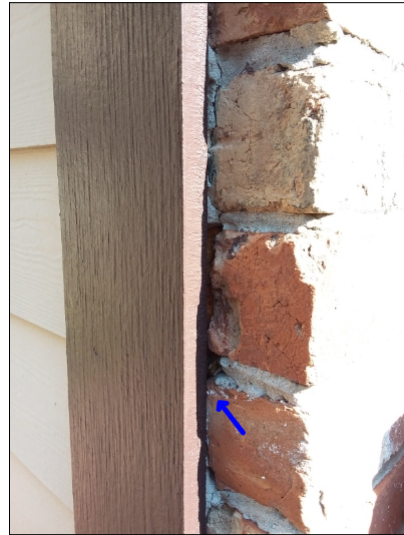
-Recommend sealing between the trim and brickwork to help prevent water penetration. Mainly at -rear/left

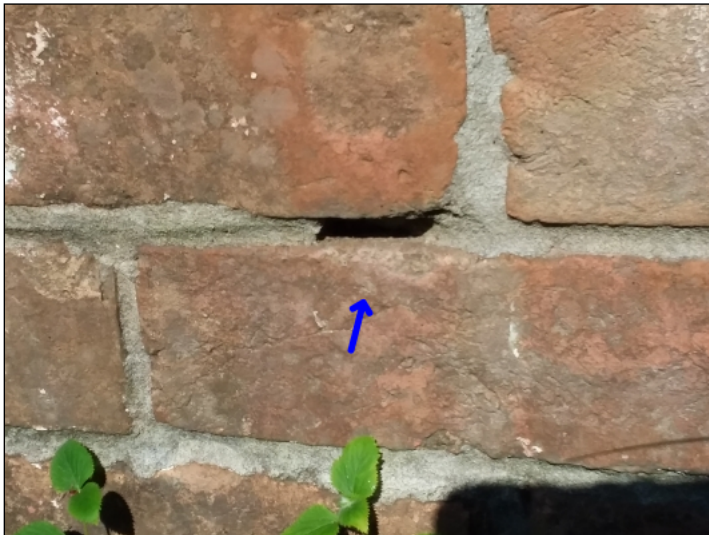
-Seal all gaps and holes in brick or siding to help prevent moisture intrusion. Mainly at -left

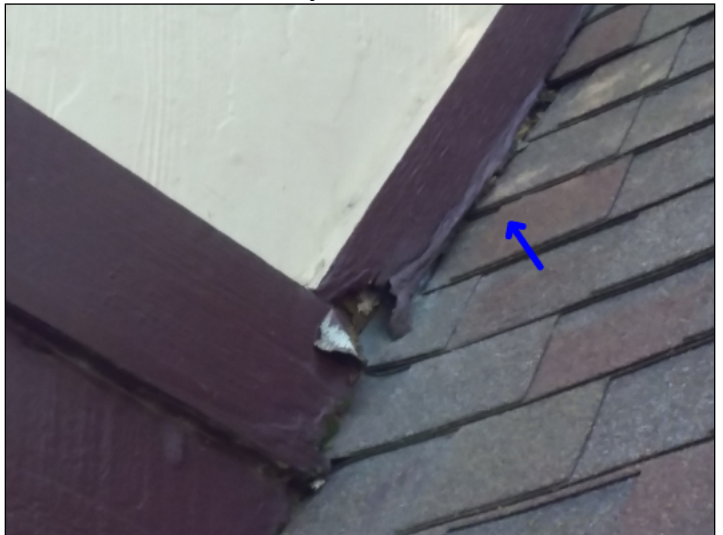
-Deterioration was noted at the trim, recommend replacing all deteriorated trim. Unable to determine the condition of the underlying materials. Mainly at -front

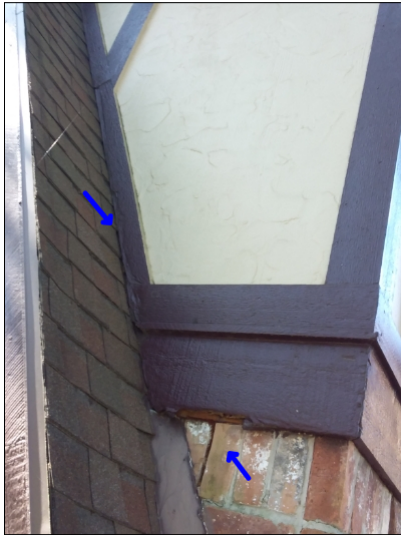
-Deterioration was noted at the trim, recommend replacing all deteriorated trim. Unable to determine the condition of the underlying materials. Mainly at -front

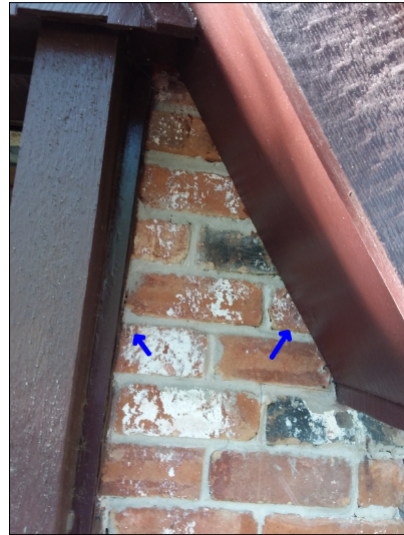
-Recommend sealing between the trim and brickwork to help prevent water penetration. Mainly at -front

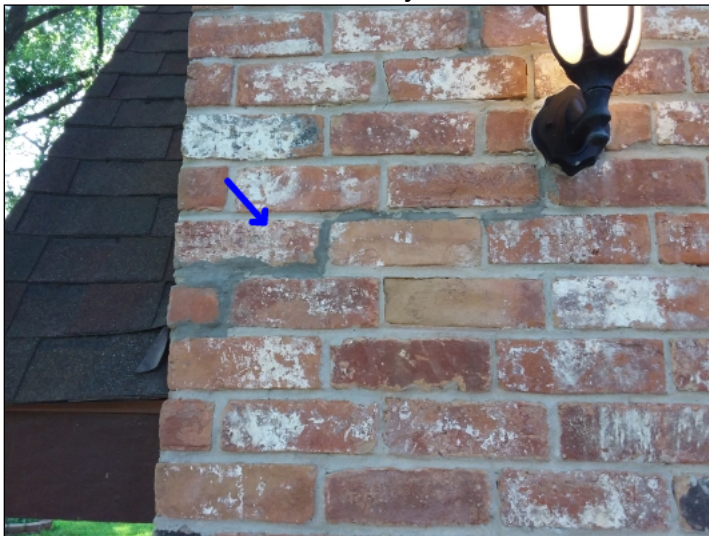
-There are signs of previous repairs in the brickwork. Mainly at -front

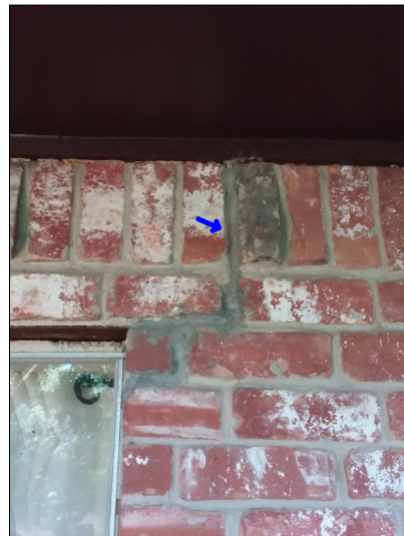
-There are signs of previous repairs in the brickwork. Mainly at -front

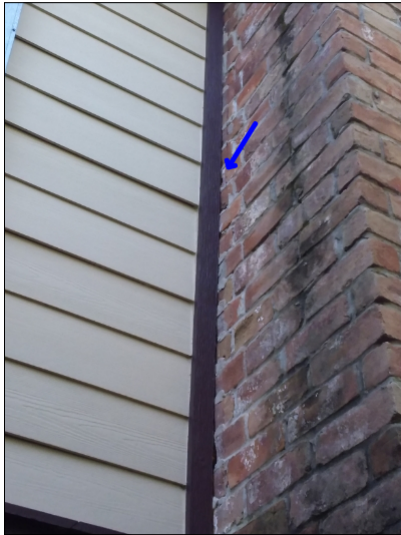
-Recommend sealing between the trim and brickwork to help prevent water penetration.
Mainly at -chimney

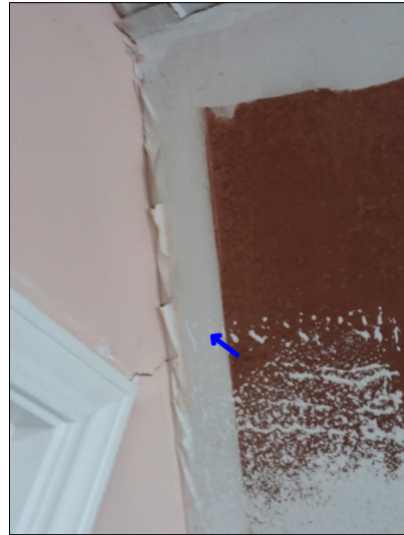
E.8. -Tape is twisting due to movement in the corners of the drywall, this is normally a sign of foundation movement or structural settlement, other movement noted may give signs of the cause. Mainly at -garage, game room

-Tape is twisting due to movement in the corners of the drywall, this is normally a sign of foundation movement or structural settlement, other movement noted may give signs of the cause.
Mainly at - garage

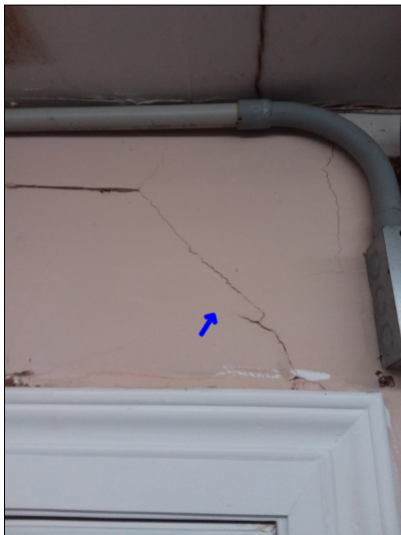
-Settlement cracks were noted in the drywall.
Mainly at -garage

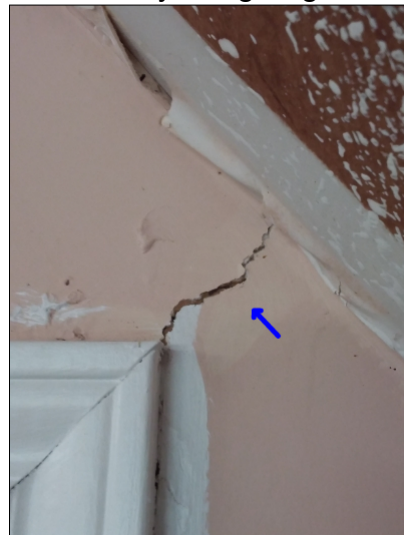
-Settlement cracks were noted in the drywall.
Mainly at -garage

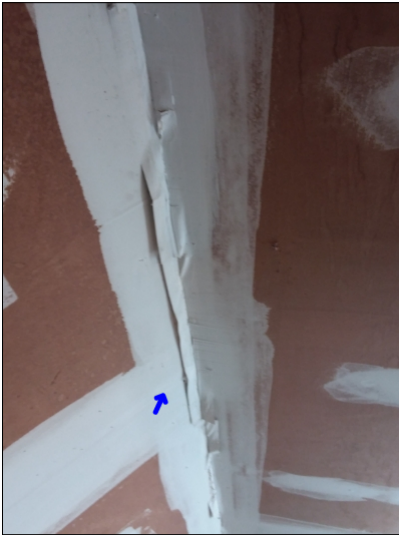
E.9. -The drywall tape is loose. This is often due to higher humidity or improper installation. Mainly at -garage

-The drywall tape is loose. This is often due to higher humidity or improper installation. Mainly at -garage

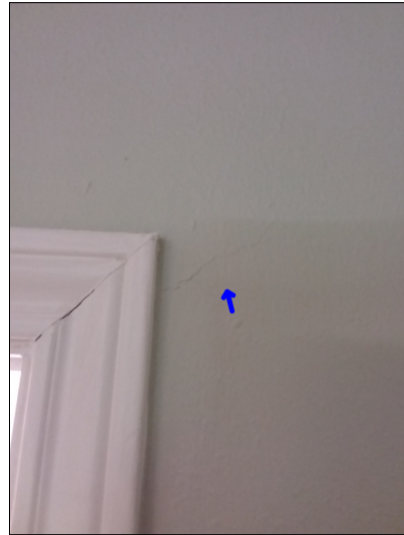
-Settlement cracks were noted in the drywall. Mainly at -game room

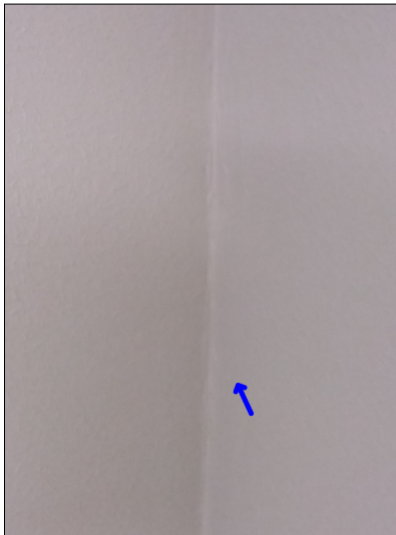
-Tape is twisting due to movement in the corners of the drywall, this is normally a sign of foundation movement or structural settlement, other movement noted may give signs of the cause. Mainly at -game room

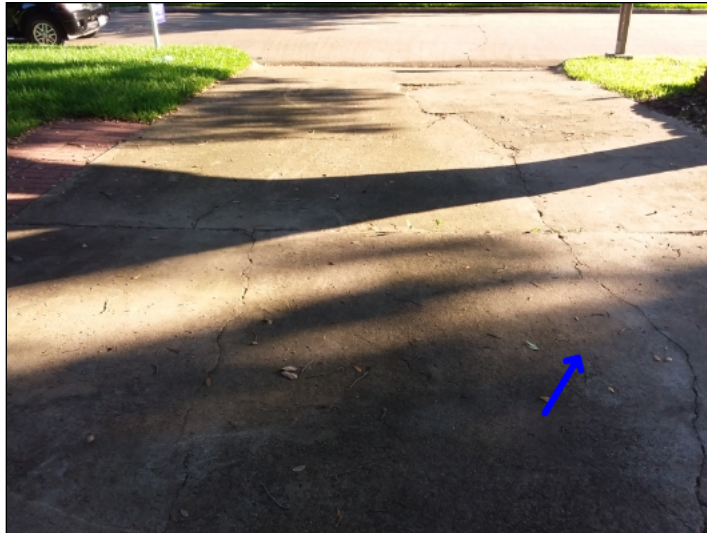
-Cracks were noted in the pavement. The pavement is unlevel and can be a tripping hazard if not corrected, recommend repairs. Mainly at -driveway

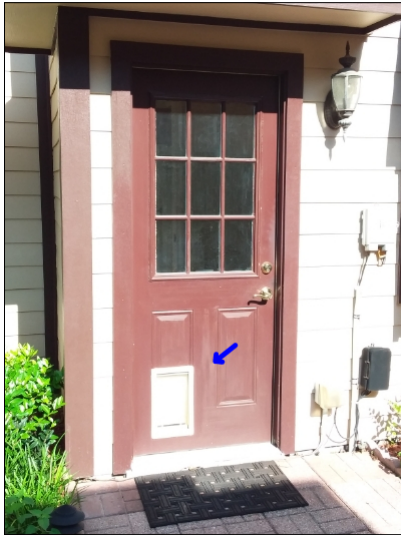
-Doggie door is a security hazard If it can't be locked.

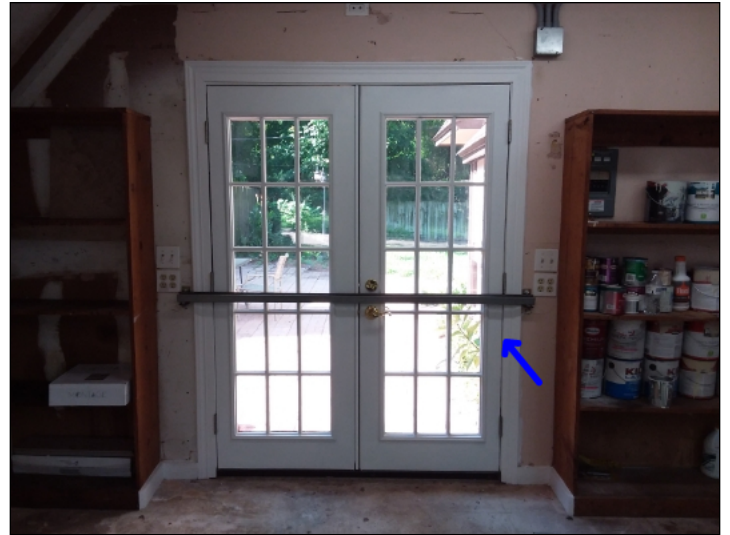
-The double doors door has been sealed off. Mainly at -garage

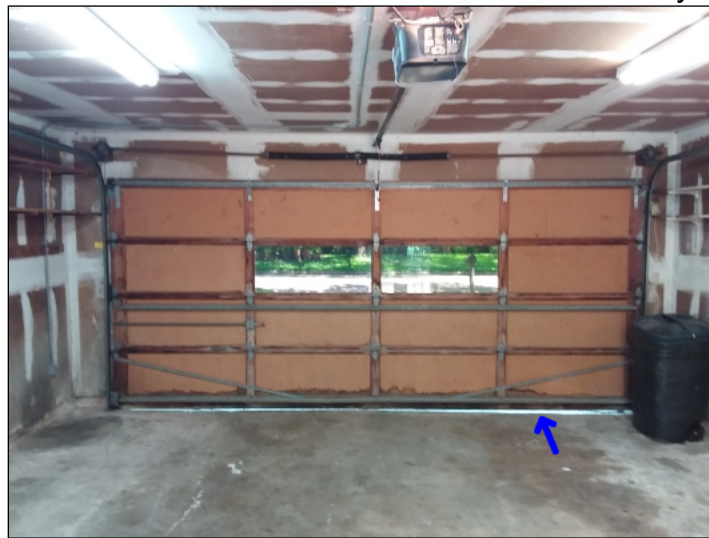
-Garage door is deteriorating.

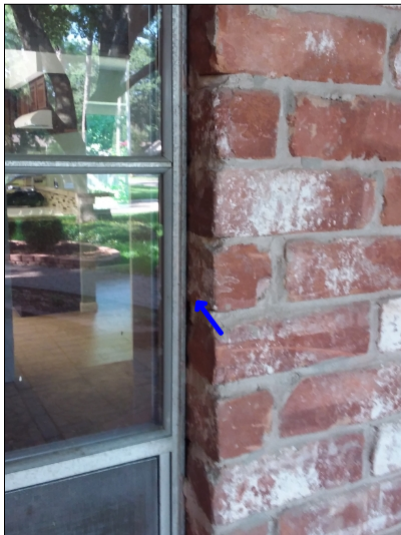
-Sealant is needed around various windows between the window framing and exterior brickwork to help prevent water penetration, recommend checking all windows for proper sealant.

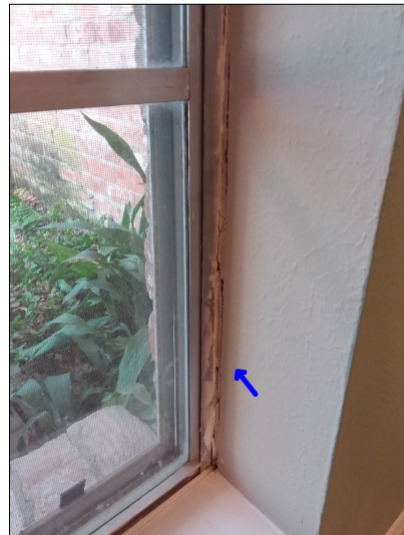
H.5. -Sealant is needed around the interior of the windows between the window framing and the drywall to help prevent water penetration. Mainly at -dining room

-Sealant is needed around the interior of the windows between the window framing and the drywall to help prevent water penetration. Mainly at -dining room

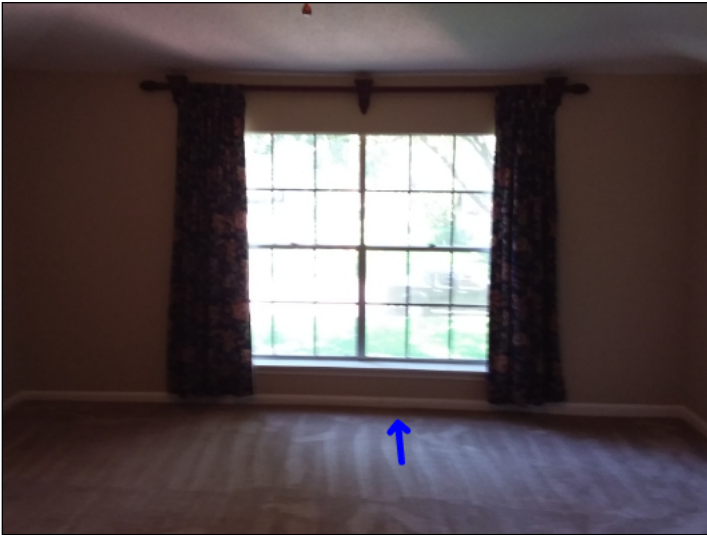
H.4. -Windows lower than 24" in upstairs applications should have a manually operated lock to keep windows from opening more than 4" with out unlatching manual lock. This is designed to help keep children from falling out the window. Mainly at -master bedroom

-Windows lower than 24" in upstairs applications should have a manually operated lock to keep windows from opening more than 4" with out unlatching manual lock. This is designed to help keep children from falling out the window. Mainly at -master bedroom

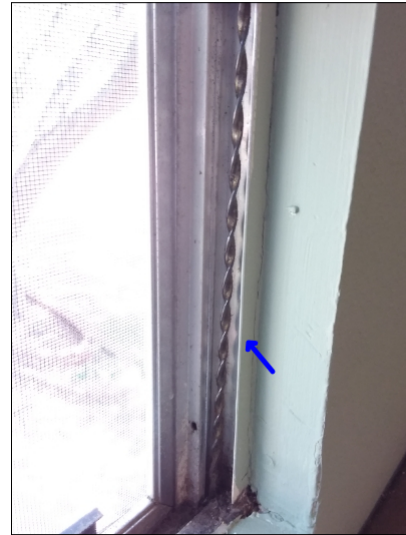
-Springs were not attached or broken on window(s). Mainly at - game room

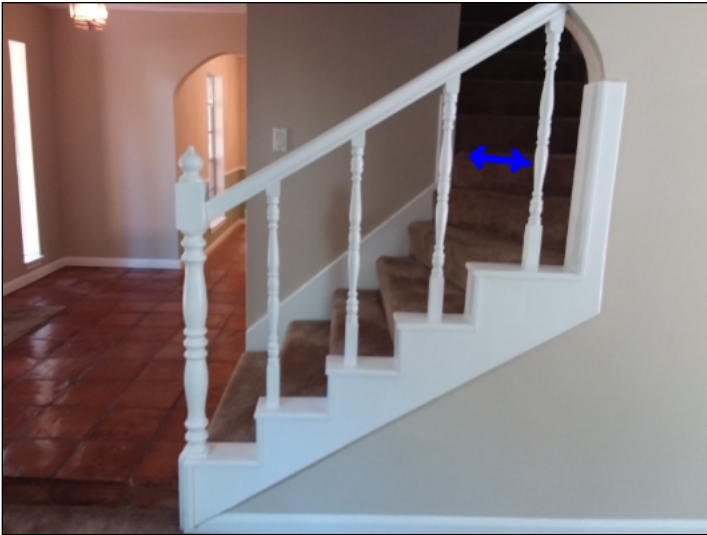
-The baluster spacing of the stairs and or balcony is greater than the currently recommended four inches. This is a safety hazard as children or pets can get caught between or slip through the balusters. This may have been to code during construction, but may want to upgrade for additional safety.

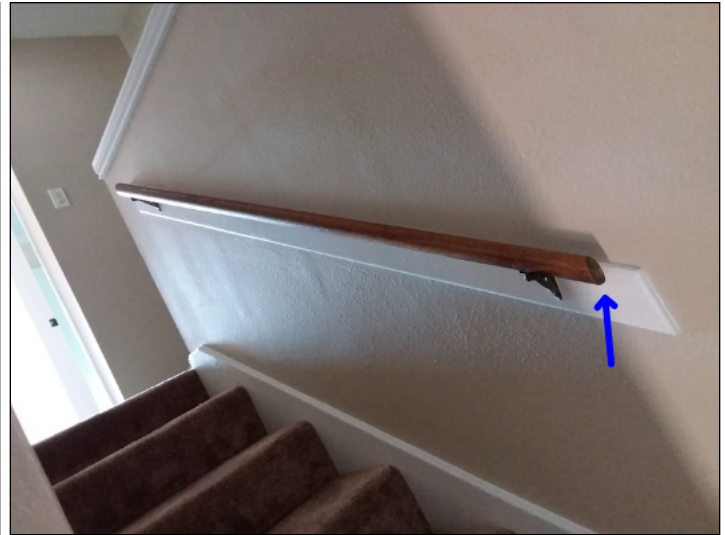
-Rail not extended to wall at the ends. This is a safety concern as clothes or other objects can get caught in this area causing someone to trip and fall.

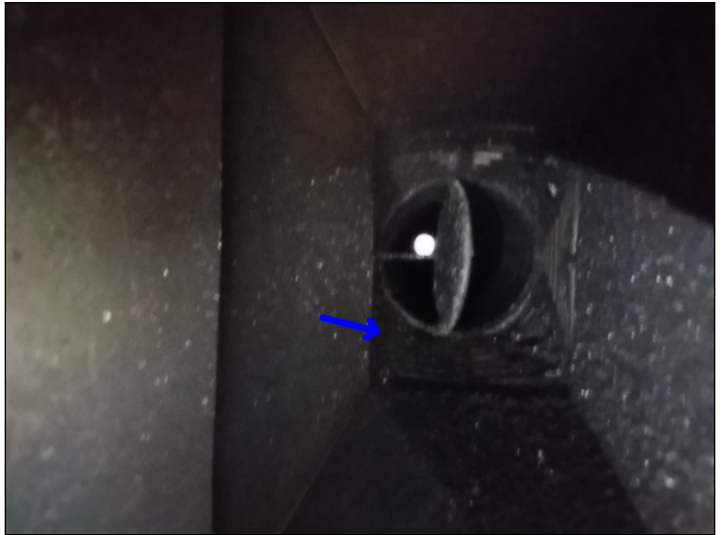
-The fireplace firebox and flue are dirty, recommend cleaning.

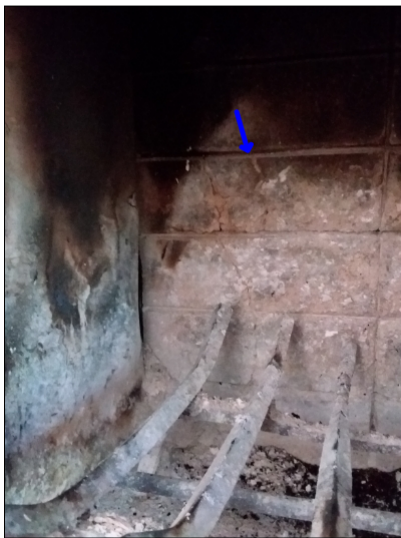
-The mortar in the fire box is deteriorating, recommend repairs.

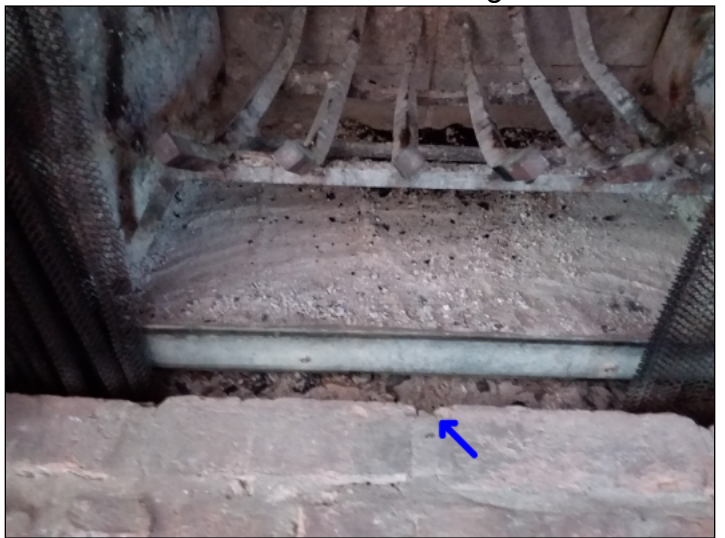
-There is a gap between the fireplace and the firebox. Recommend sealing the gap for safety.

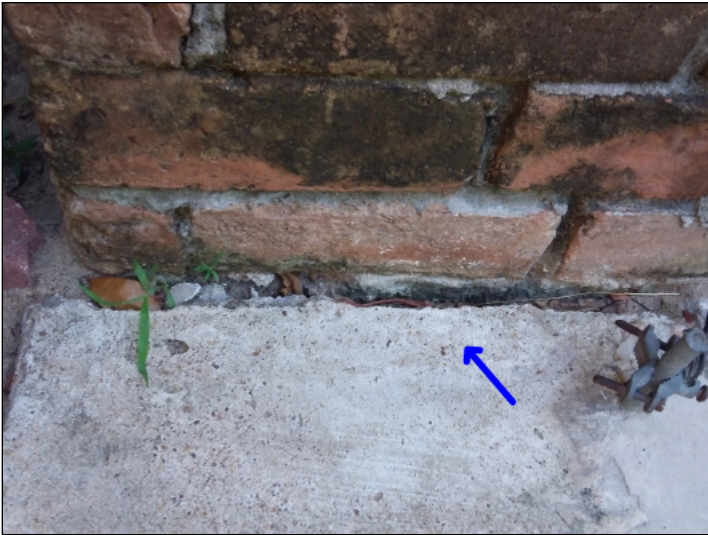
-There is a gap between the patio and foundation of the home recommend sealing to help prevent water penetration at foundation.

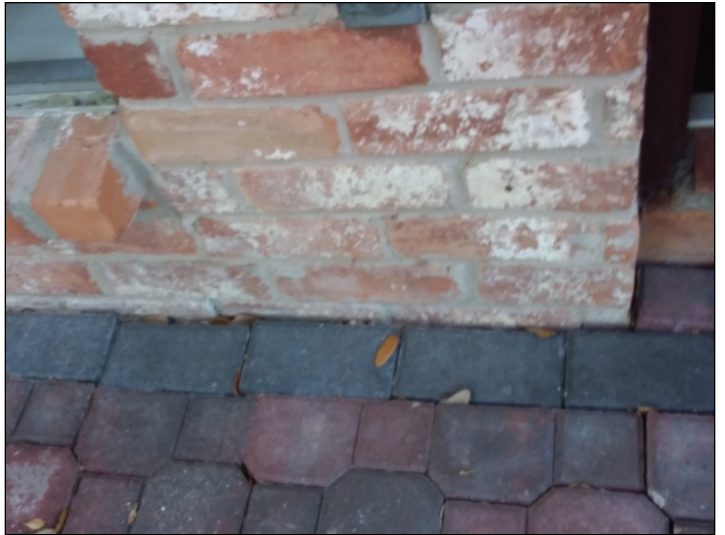
-There is a gap between the porch and foundation of the home recommend sealing to help prevent water penetration at foundation.

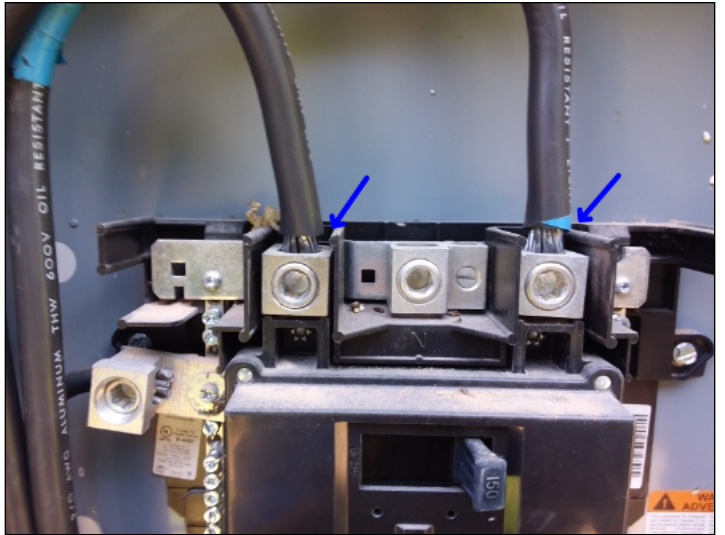
-There is no antioxidant on main aluminum feeds to the panel box. This should be used to help prevent overheating.

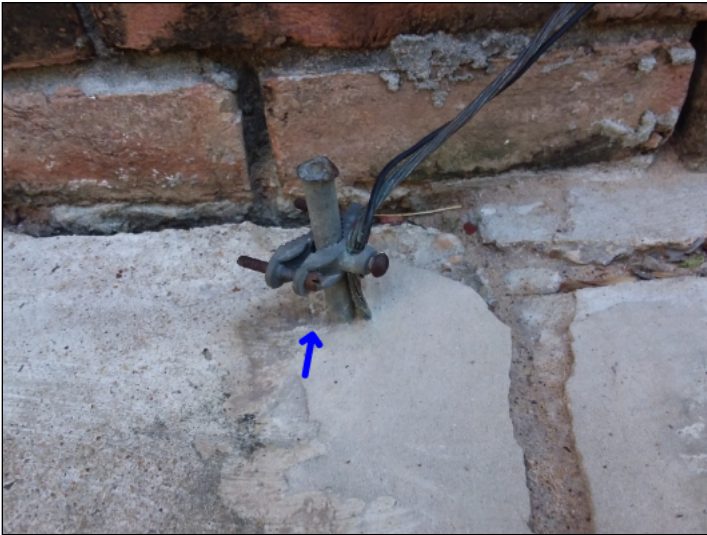
-The ground connection is loose at the ground rod, this could be hazardous, it is recommended that ground wires be secured with the proper acorn style clamp for proper protection.

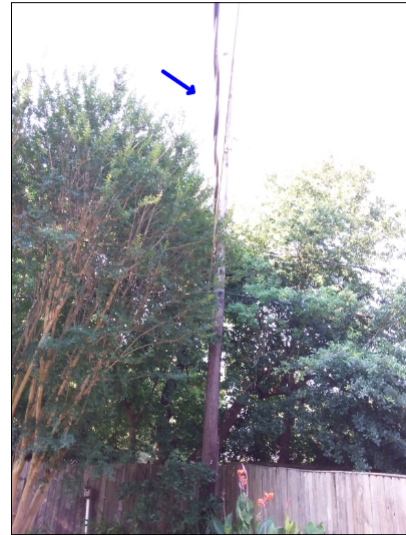
-Electrical feeds were running through the trees, recommend trimming limbs from wires.

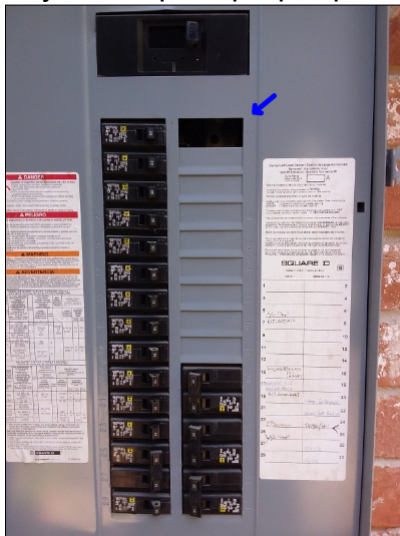
-There is at least one filler plate missing on the main electrical panel cover. Recommend adding missing filler plates to help prevent electrical shock.

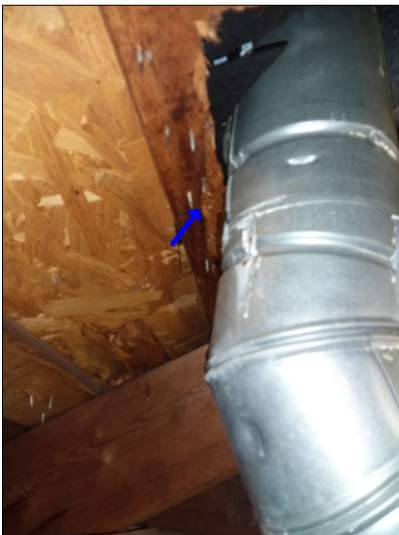
A.1. -There is improper clearance around the flue pipe, the furnace vent should have at least 1" clearance to combustibles.

-There is improper clearance around the flue pipe, the furnace vent should have at least 1" clearance to combustibles.

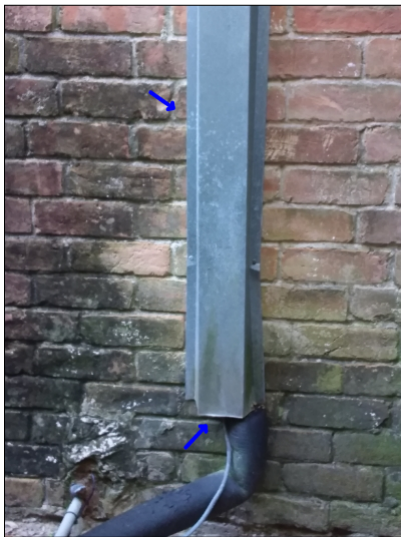
-Seal A/C line entry cover at wall connection to help prevent water penetration.

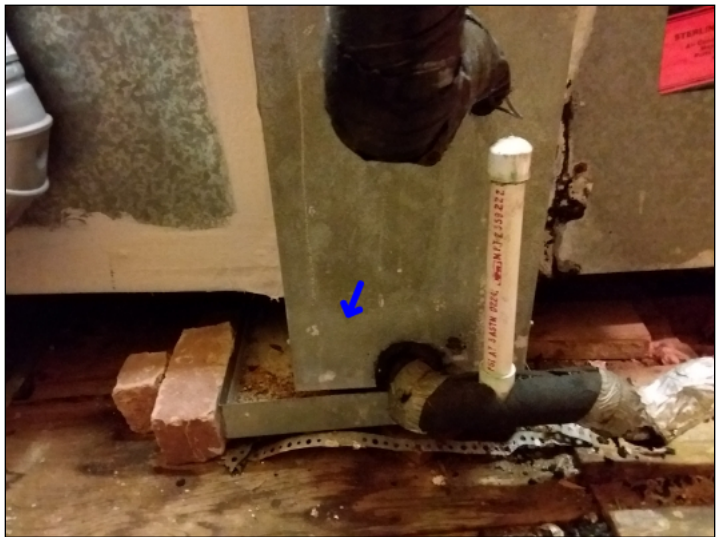
B.3. -The evaporator unit was not manufactured with a secondary drain to release condensation to pan or exterior incase the primary drain line is clogged, recommend adding a high water shutoff to primary condensation line if not present for additional protection.

-The evaporator unit was not manufactured with a secondary drain to release condensation to pan or exterior incase the primary drain line is clogged, recommend adding a high water shutoff to primary condensation line if not present for additional protection.

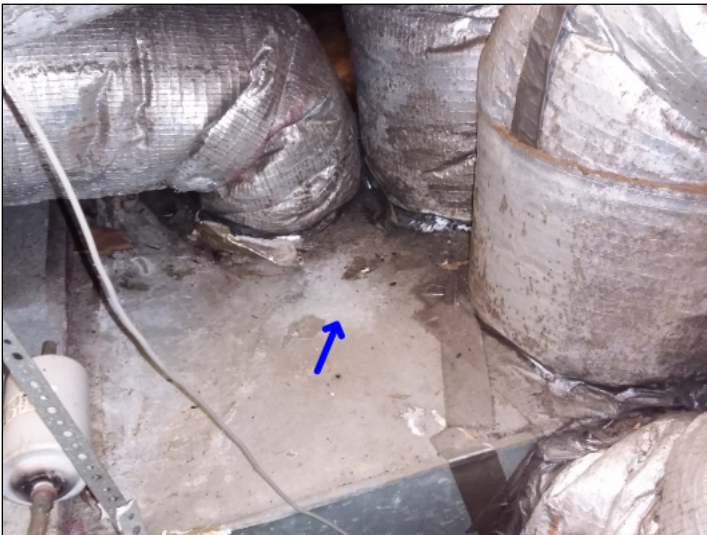
-There is a microbial growth noted at the plenum and/or evaporator. This is often caused by a conditioned air leak causing condensation and microbial growth, recommend sealing all air leaks and cleaning all surfaces.

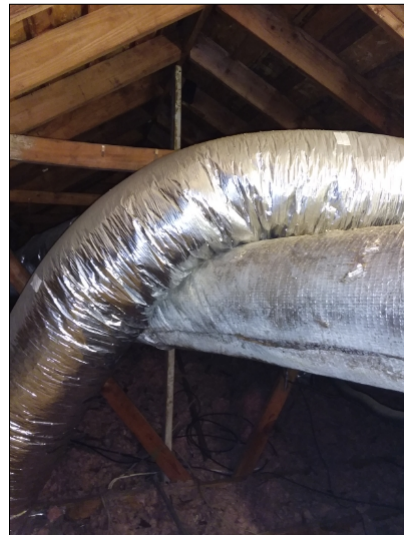
-The ducts do not have the proper separation. It is recommended that an air gap or insulation be used to separate ducts that are in contact with each other to help prevent condensation.

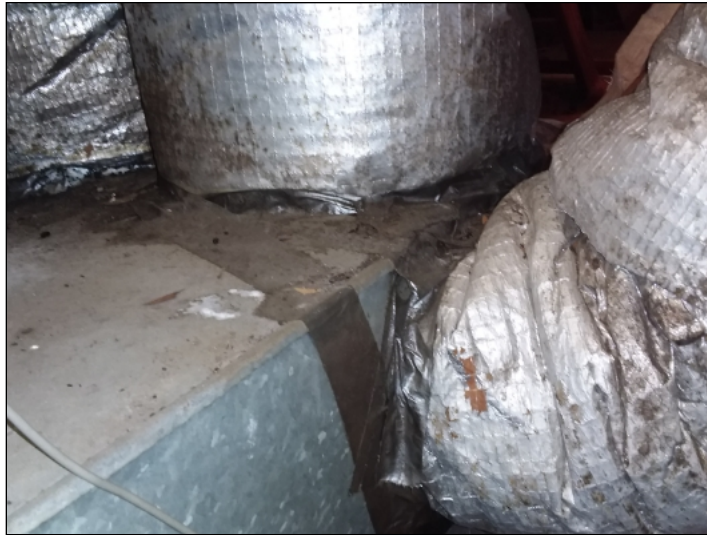
-Duct tape is present on air conditioning & heating system, recommend using approved duct tape (Marked UL181) or aluminum tape for A/C & heating units and ducts.

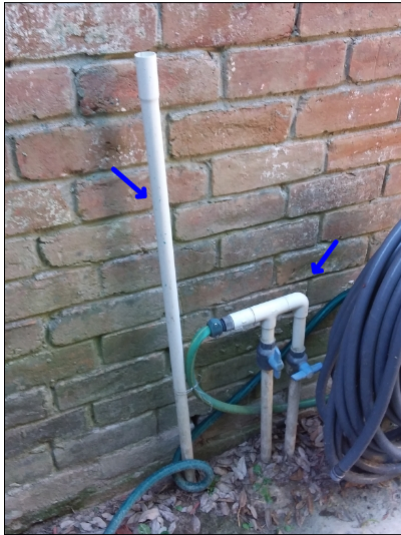
-Recommend painting all exposed plastic pipe to prevent premature deterioration from UV rays.

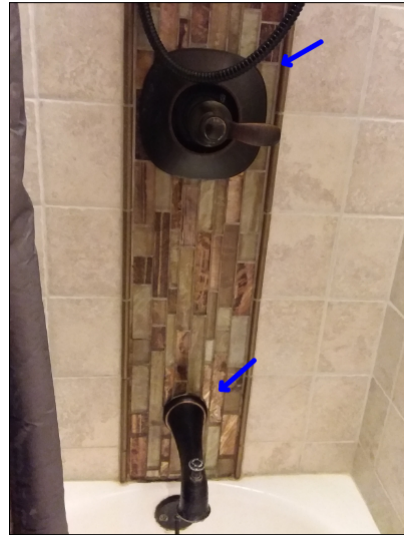
-All tub shower faucets and spouts should be sealed to help prevent water penetration behind the fixture.

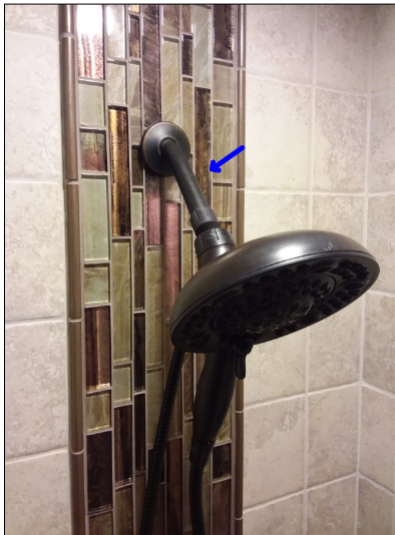
-The shower head loose. Mainly at -master bath

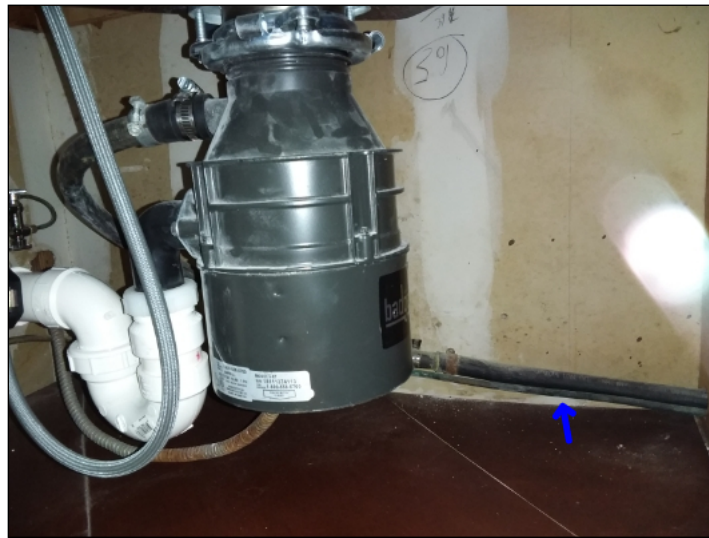
A.1. -Dishwasher drain line missing high loop or air gap in drain line. This helps prevent water from siphoning back into dishwasher from disposal or drain line.

-Dishwasher drain line missing high loop or air gap in drain line. This helps prevent water from siphoning back into dishwasher from disposal or drain line.

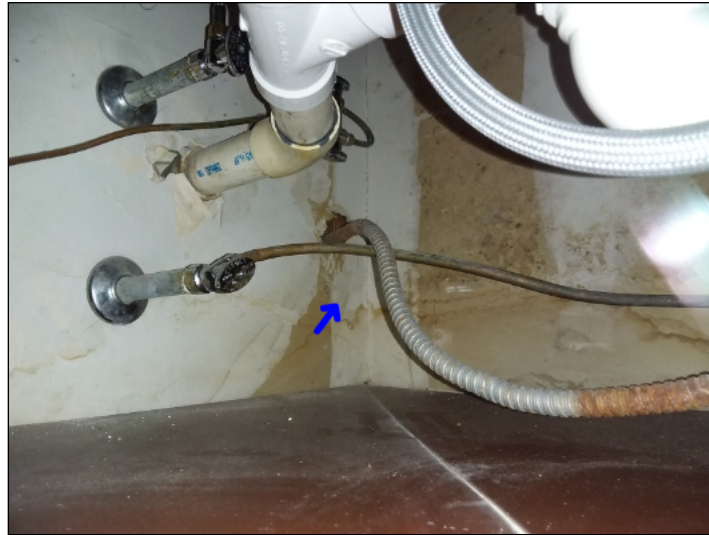
-Disposal was hard wired, has no disconnect. Disposal should have a cord and plug connection.
