Property Inspection Report

Concerning:
11633 Grandview Dr,
Montgomery, TX 77356

By:
Cory Alan Haddox, P.E.
Professional Real Estate Inspector
License No.: 20464
2635 North Spring
Spring, TX 77373

Issued: 15 May 2021
Revision: 0

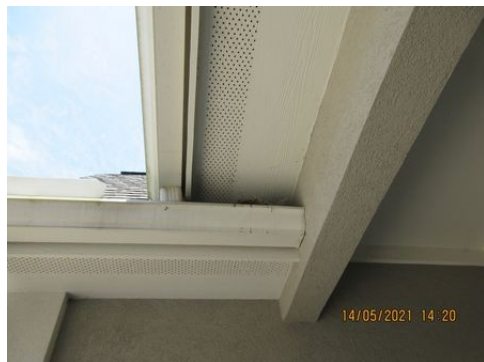
Photo 1

1. A bird's nest was observed in the gutter on the left side of the front entry. See Photo 1.
2. One of the gutter downspouts on the left side of the house was found to be dented. See Photo 2.
3. Some of the gutters were noted to have signs of leaking.

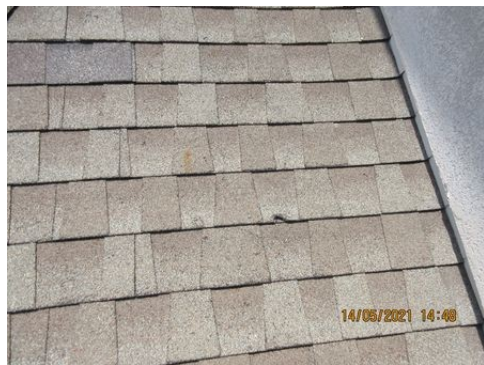
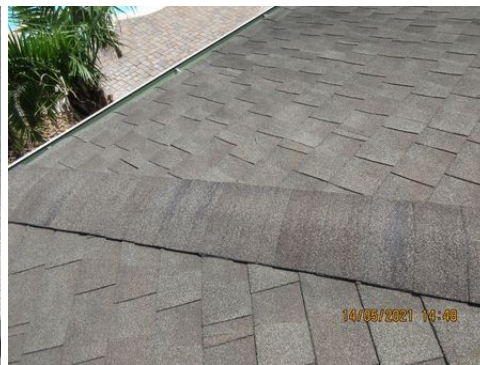
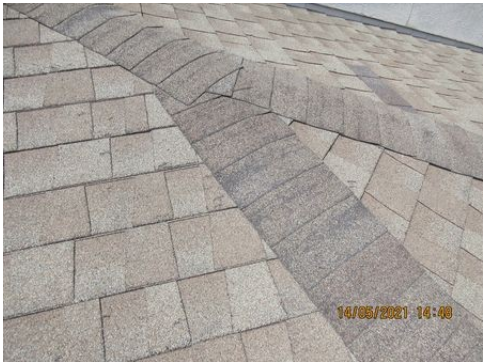
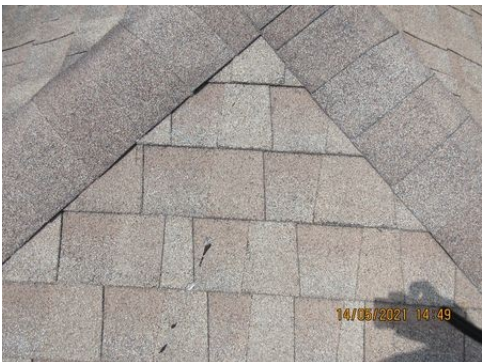
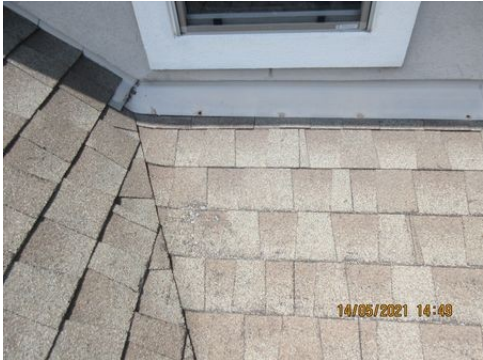
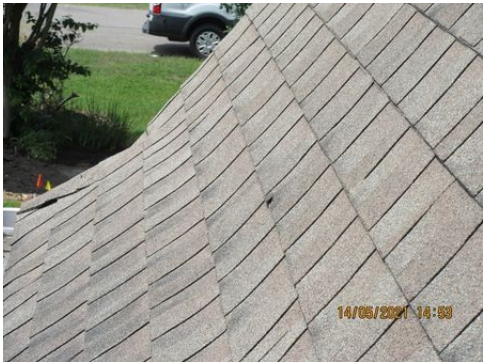
1. Damaged and deteriorated shingles were noted in a number of places on the roof. See Photos 3 through 17.
2. Several areas of patched shingles were observed on the roof. See Photos 18 through 20.

8. A hole was observed in the roof at the peak. See Photo 40.
9. It is recommended to have the roof further evaluated by a qualified roofing contractor.

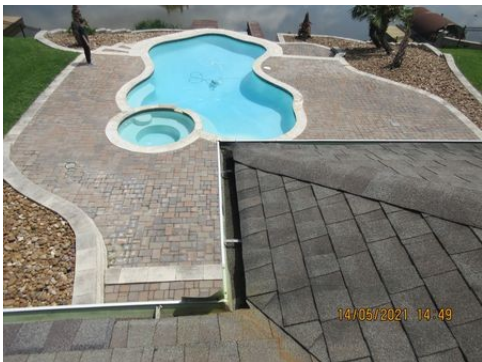
Photo 22

3. A significant amount of the ultra-violet protection (gravel) was found in some of the gutters. See Photos 21 and 22. This could be a sign of shingle deterioration.

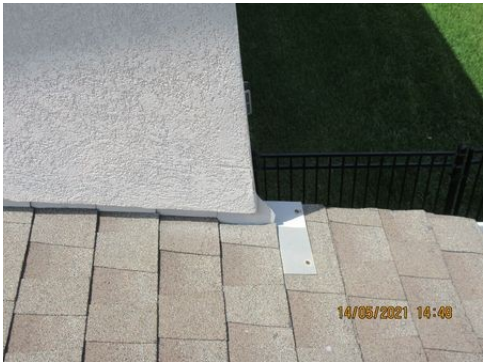
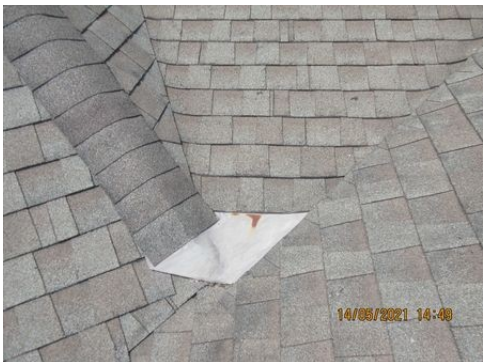
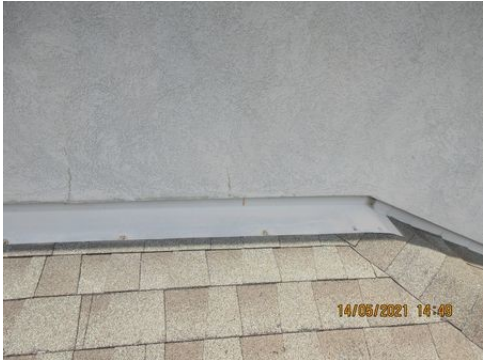
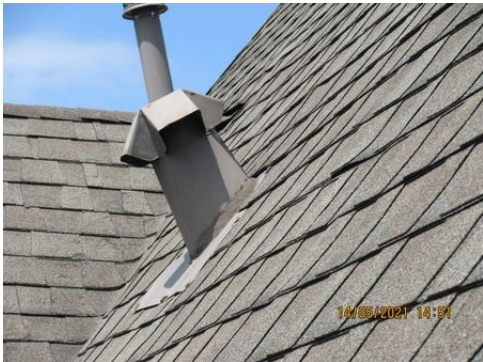
4. Deteriorated, lifted and rusted flashing was noted at the back of the house, with several exposed and rusted nails. See Photos 23 through 31.
5. The vent covers were observed to be deteriorated and lifted with exposed and rusted nails. See Photos 32 through 38.

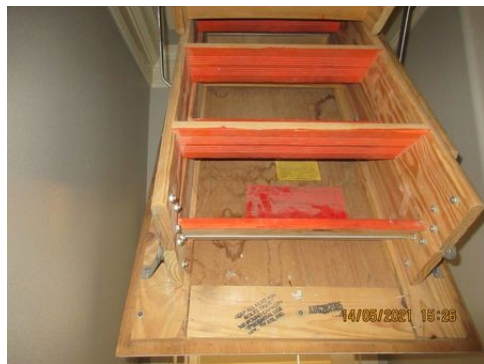
Photo 41

1. The attic access ladder was observed to be without insulation or an air seal. See Photo 41.
2. As well, water stains were noted on the attic access ladder. See Photo 41.
3. The attic access ladder was found to not be secured in place with the appropriate fasteners. See Photo 42.
4. The upper section of the attic was observed to be without collar ties. See Photo 43 and Illustration 1.

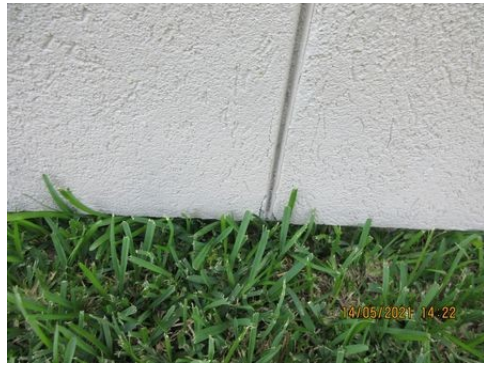
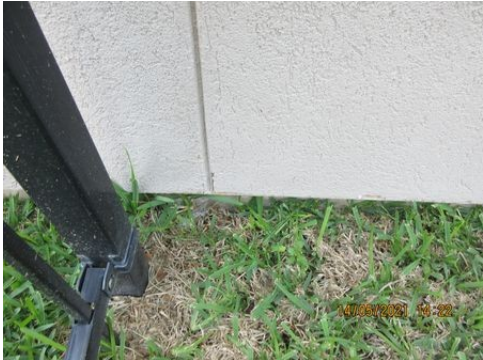
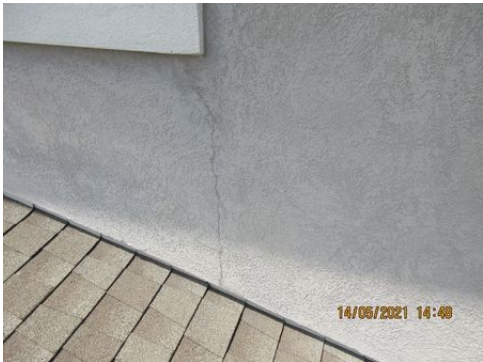
1. The stucco finish was found to be cracked in a number of places. See Photos 45 through 58.
2. Drywall separations were noted in the dining room and in the under stair closet. See Photos 59 and 60.
3. The master bathroom shower was observed to have several tile grout separations and missing tile grout. See Photos 61 through 70.
4. As well, the tile grout around the master bathroom bathtub was found to be separated. See Photos 71 through 74.
5. Some grout separations were also noted in the upstairs guest bathroom bathtubs. See Photos 75 through 77.
6. The tile grout was observed to be separated on the end of the kitchen bar. See Photo 78.

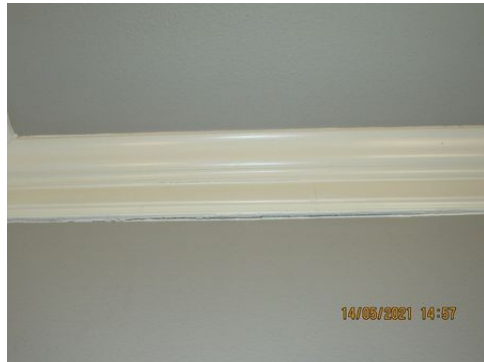
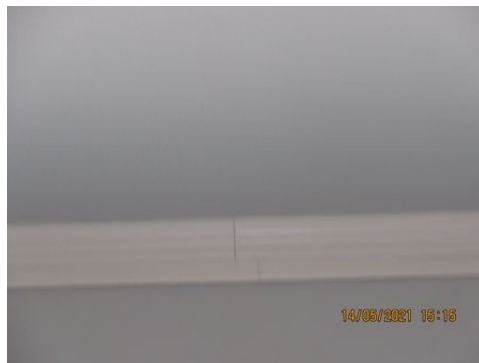
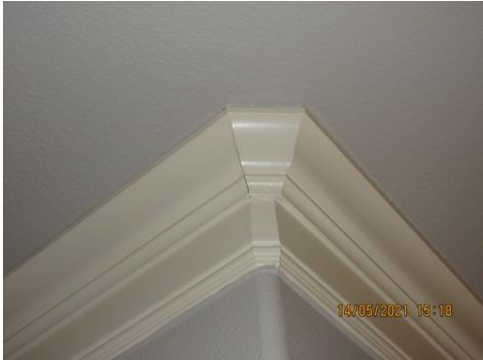
1. The ceiling trim was found to be separated in a number of places throughout the house. See Photos 79 through 83.
2. Several drywall separations and uncovered ceiling drywall nails were noted. See Photos 84 through 95.
3. A drywall patch and water stains were observed on the ceiling at the front of the garage room. See Photos 96 and 97.
4. Water stains and deterioration were found on the ceiling in the upstairs hall closet and on the living room ceiling. See Photos 98 and 99.
5. The upstairs floor was noted to make a noise when walked upon.
6. The floor trim was observed to be deteriorated and separated in a number of places throughout the house. See Photos 100 through 105.

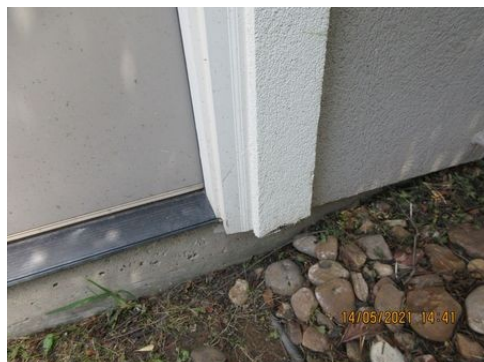
Photo 106

1. The garage back door trim and door were noted to be deteriorated and damaged at the bottom. See Photos 106 and 107.
2. Some of the doors throughout the house were found to be without or to have damaged door stops. See Photos 108 and 109.
3. A garage entry door is expected to be 1-3/8 inches thick and to be self-closing. This garage entry door was noted to be less than the expected thickness at the insets and to not be self-closing. See Photo 110.
4. One of the master bathroom closet doors was found to have been removed. See Photo 111.
5. Some of the door knobs were observed to not be secured in place properly. See Photos 112 through 114.
6. The upstairs front middle bedroom door was noted to not latch.
7. The stationary side of the office double doors was found to not shut completely. See Photo 115.

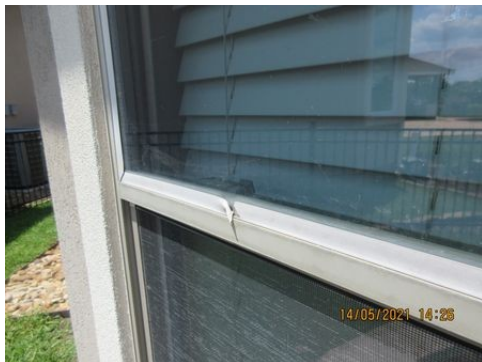
Photo 116

1. Some of the window seals were noted to be damaged or separated. See Photos 116 and 117.
2. Windows that are larger than nine square feet are expected to be made of safety glass. A number of the windows throughout the house were found to be more than nine square feet, but to not be made of safety glass or labeled as such.
3. One of the windows on the right side of the house was observed to be without a window screen. See Photo 118.
4. Some of the screens were noted to be damaged. See Photos 119 through 121.
5. The window sill was found to be significantly separated from the wall in the upstairs front middle bedroom. See Photos 122 and 123.
6. The window sill was observed to be damaged in the upstairs back right bedroom. See Photo 124.

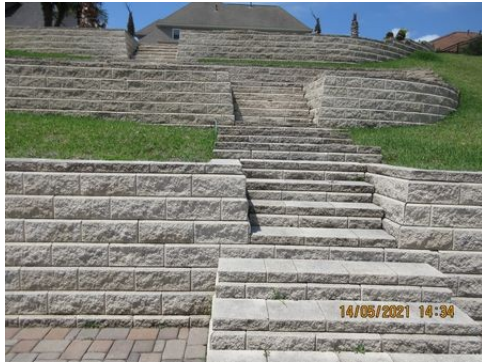
Photo 125

1. The back yard stairs were noted to be without a handrail. See Photo 125. This could be a safety hazard.
2. The handrail for the stairway in the house was found to be loose at the top. See Photo 126.

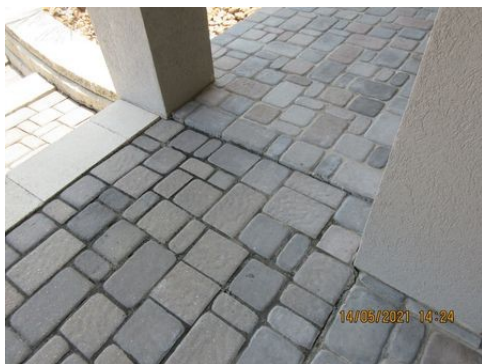
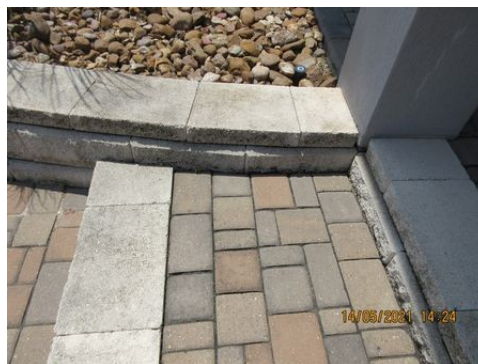
1. The stone walkways at the back patio was noted to have settled slightly. See Photos 127 and 128.

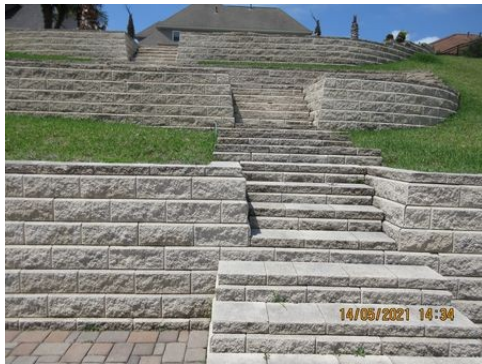
Photo 129

1. The back retaining walls were noted to be without handrails. See Photo 129. This could be a safety hazard.
2. The boat launch pier was found to have several deteriorated and lifted boards. See Photos 130 through 135. These lifted boards could be tripping hazards.
3. The boat launch piers were observed to move when walked upon.
4. The boat launch was noted to be deteriorated. The boat launch motor was found to be intact, but was not operated due to the electrical issues that were found at the boat launch pier.

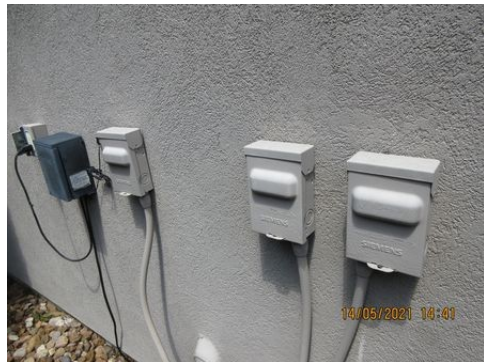
Photo 137

1. The exterior AC unit electrical disconnect boxes and light control panel box on the right side of the house were observed to not be sealed to the wall properly. See Photo 137.
2. The 200 amp panel was noted to be Brand Square D and was found to be located on the back wall of garage, which is the right wall of the house. See Photo 138.
3. The larger panel was noted to not be labeled completely. See Photo 139.

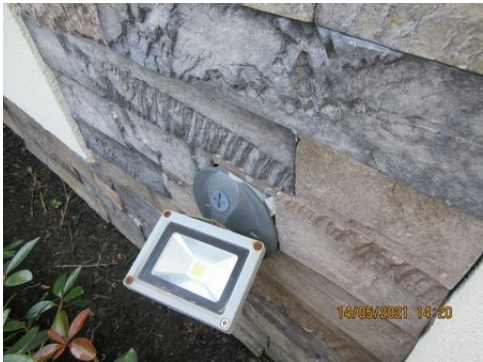
Photo 140

1. Some of the exterior light fixtures and the exterior receptacles were noted to not be sealed to the wall properly. See Photos 140 through 143.
2. A damaged conduit and junction box were found on the right side of the house. See Photo 144.

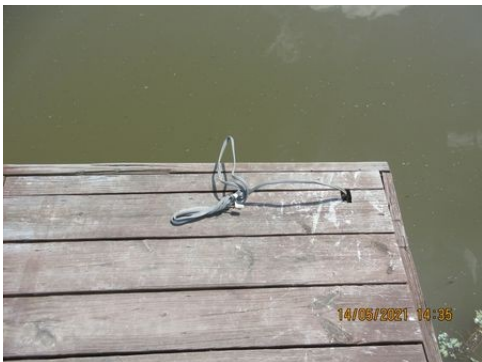
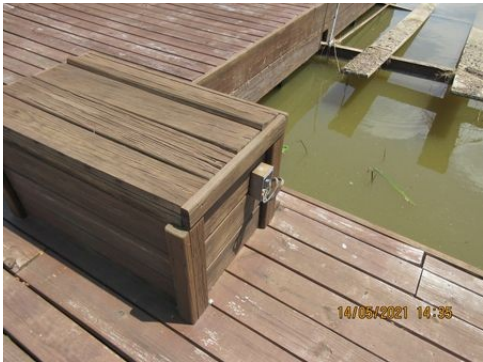
3. Exposed and unsecured wires were noted on the boat launch pier. See Photos 145 through 147.
4. As well, the receptacle in the boat launch motor box was found to be without a cover. See Photo 148.

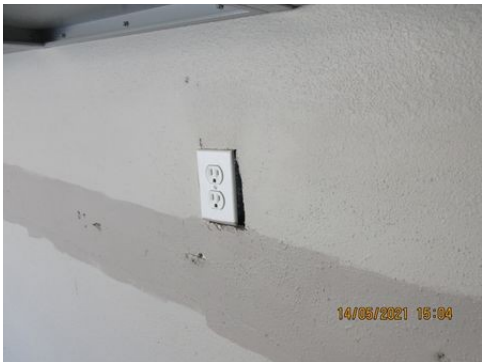
Photo 149

6. The receptacle below the electrical panels in the garage was observed to have the hot and neutral reversed.
7. As well, one of the receptacles on the back wall of the garage was noted to have a cover that did not cover the hole in the wall completely. See Photo 149.

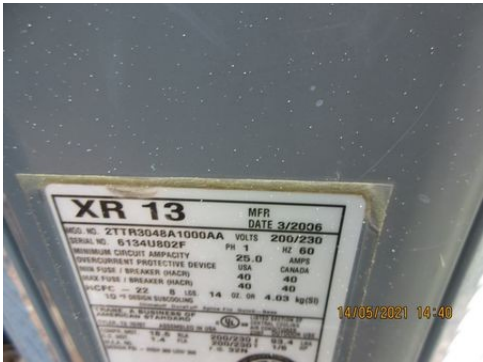
Photo 150

1. Two of the exterior AC units were noted to have been manufactured in 2006 and one was found to have been manufactured in 2004. See Photos 150 through 152.
2. Some of the exterior AC unit refrigerant line insulation was found to be missing. See Photo 153.
3. Rust was observed in all three of the overflow pans under the AC units in the attic. See Photos 154 through 156.
4. The temperature of the air coming from the downstairs unit was noted to be significantly higher than expected when the unit was operated in the cooling mode.
5. The temperature of the air coming from the upstairs units was found to be higher than expected when the units were operated in the cooling mode.
6. It is recommended that both the heating and cooling systems be serviced before use and annually thereafter.

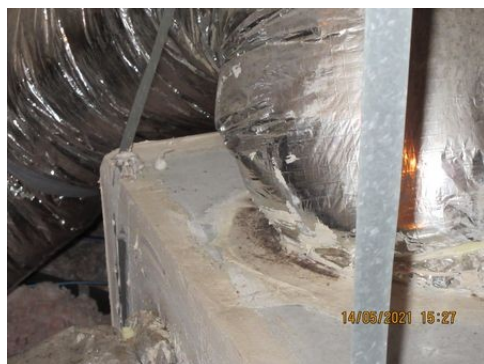
Photo 157

1. Discoloration from condensation was noted on some of the duct boxes in the attic. See Photo 157.
2. Air ducts in an attic are expected to be separated. A few of the air ducts in the attic were found to not be separated. See Photos 158 and 159.

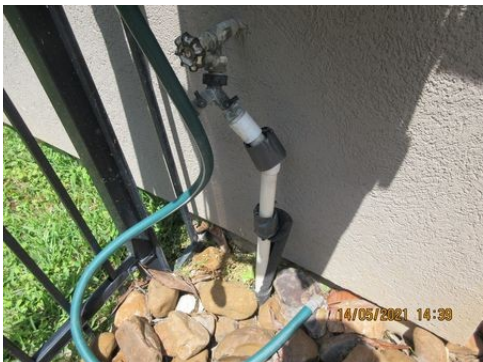
Photo 165

6. A PVC pipe connected to the exterior hose spigot at the back right of the house was noted to have damaged and missing insulation. See Photo 165.
7. One of the washing machine water supply valves was observed to be corroded. See Photo 166.

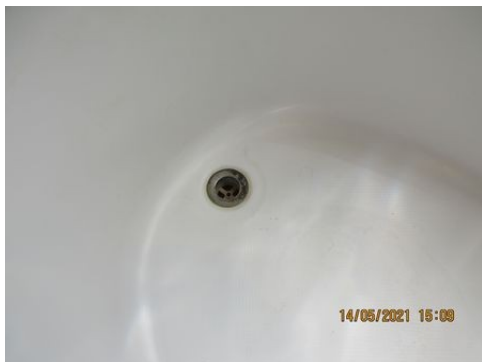
Photo 168

1. The master bathroom bathtub was noted to be without an installed drain plug. See Photo 168.
2. Some of the bathroom sink drain plugs were found to not open completely, causing the sinks to drain slowly at the time of the inspection.

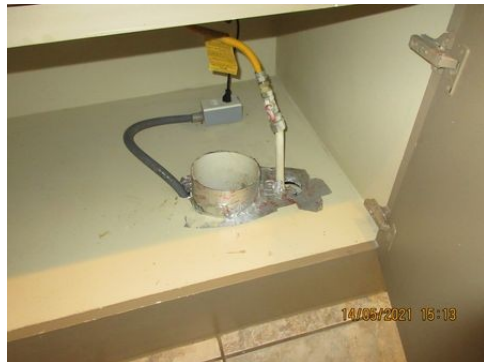
Photo 171

1. A range hood was noted to not be installed in the kitchen island. See Photo 171.

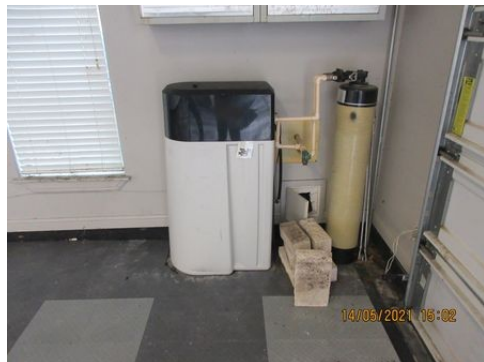
Photo 174

1. An out of use water softener was noted in the garage. See Photo 174.
2. The medium container was found to not be filled with medium. See Photo 175.
