15603 Stone Gables Lane

PROPERTY INSPECTION REPORT

Concerning: 15603 Stone Gables Lane, Houston TX 77044
(Address or Other Identification of Inspected Property)

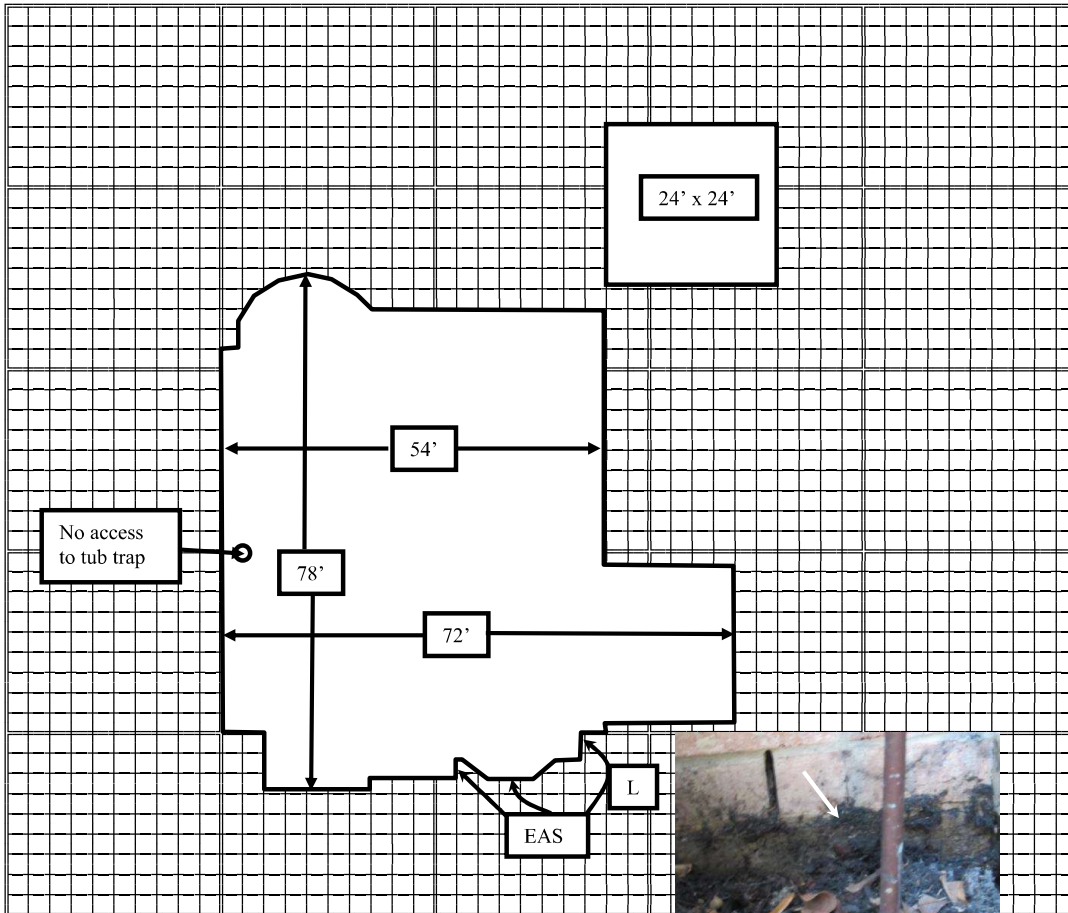
Diagram of Structure(s) Inspected

8G. Visible evidence of: Subterranean termites has been observed in the following areas: at the front of the house in three areas, see diagram below for exact locations.

9A. Corrective treatment recommended for active infestation or evidence of previous infestation with no prior treatment as identified in Section 8. (Refer to Part G, H, and I, Scope of Inspection) Yes [X] No []

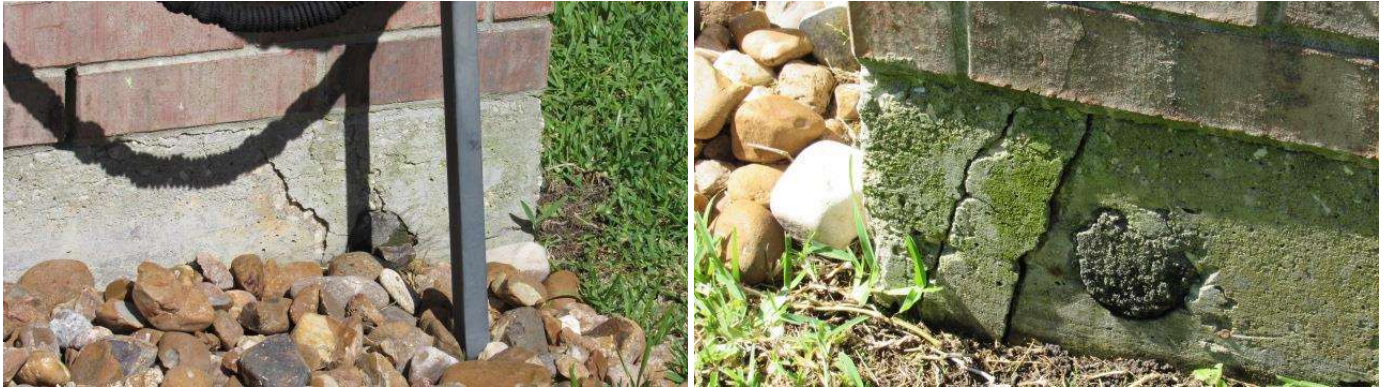
- Unable to inspect portions of the slab perimeter due to elevated soil, concrete flatwork.
- Slab could have experienced signs of settlement as evidenced by measurements on the diagram below.
- This could imply that structural settlement of the building has occurred. The rate of movement cannot be predicted during a one-time inspection. This condition should be monitored in the future.
- **Corner cracks were observed and should be repaired.**

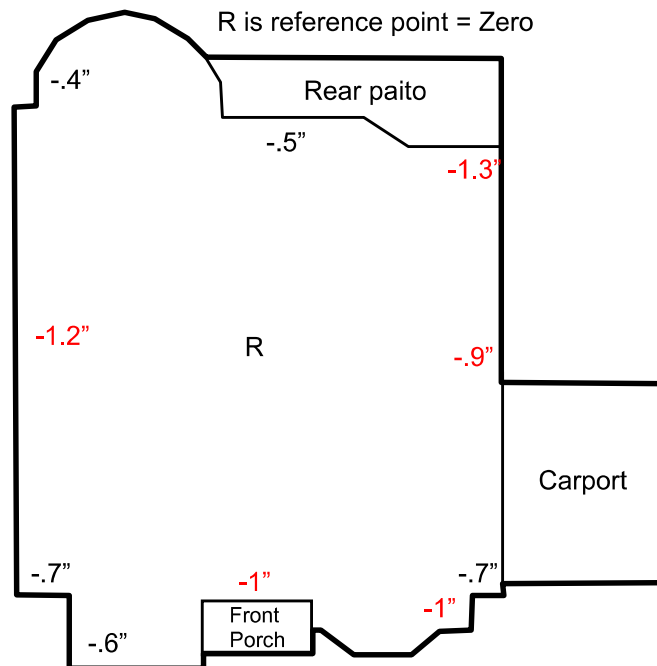
- See measurements below of the slab at the time of the inspection.

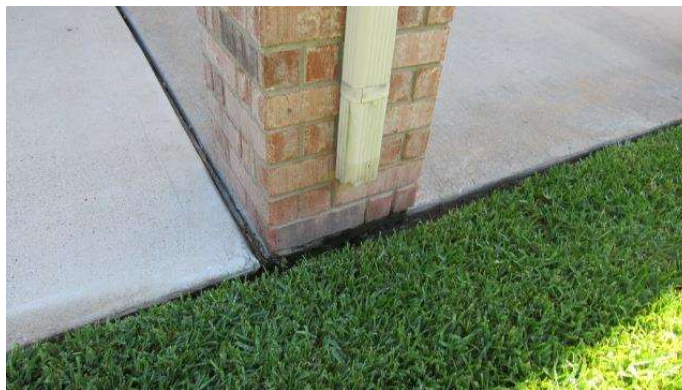
- Missing diverter noted at the right front corner, recommend repair.

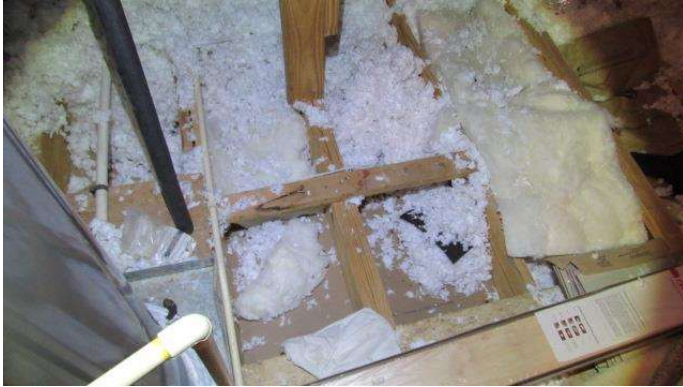
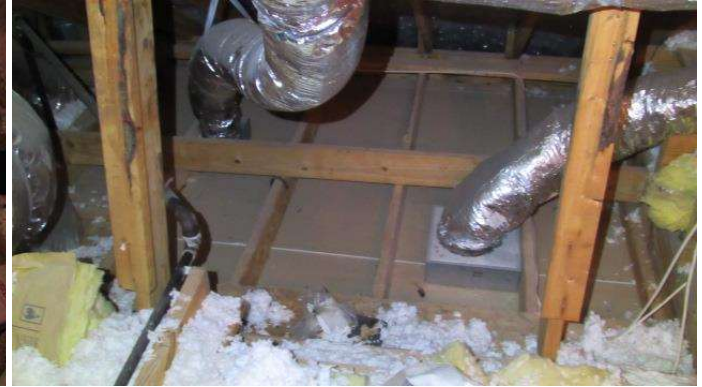
- Adequate attic ventilation at house noted.
- Missing and / or displaced attic insulation noted (exposed sheetrock) around the water heater & directly over the rear storage area near the game room, this condition is a recommended repair.

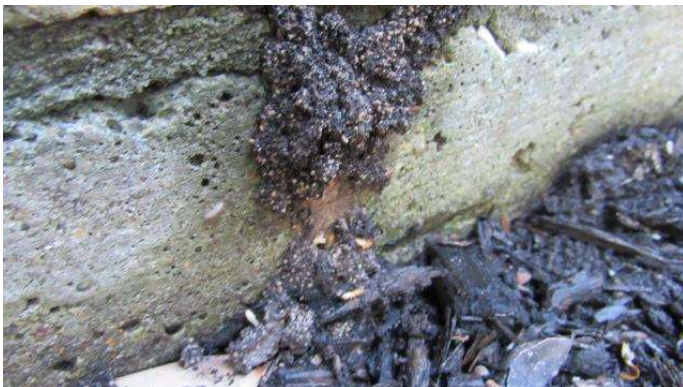
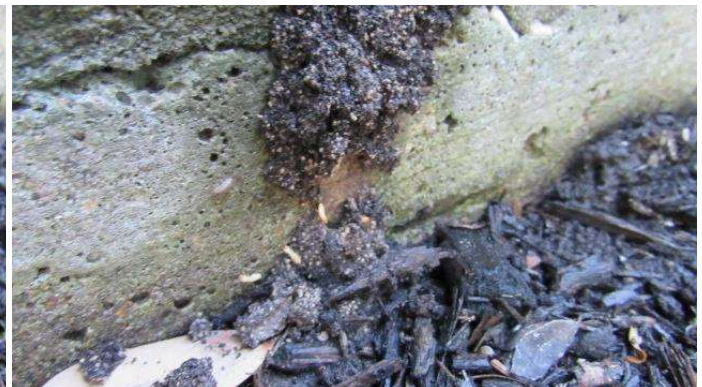
- Active Wood Destroying Inspects noted on the front side of the house in three areas, see the Wood Destroying Inspection Report for more details.

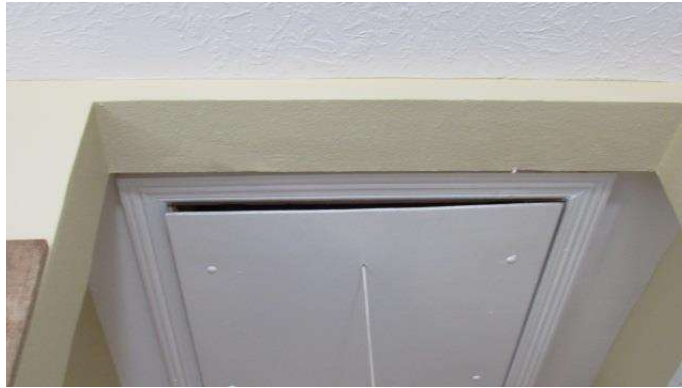
- Attic pulldown door is not completely sealing when shut, recommend adjusting the door.

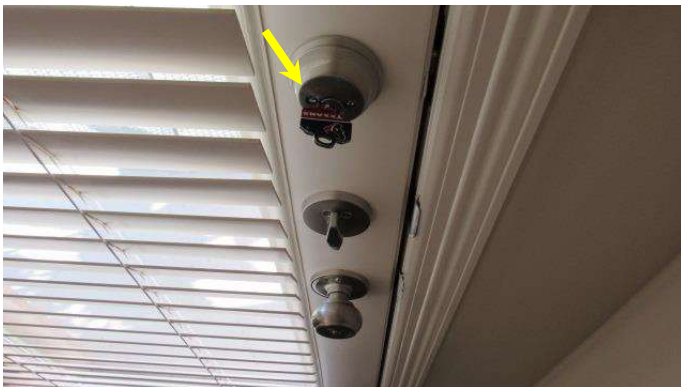
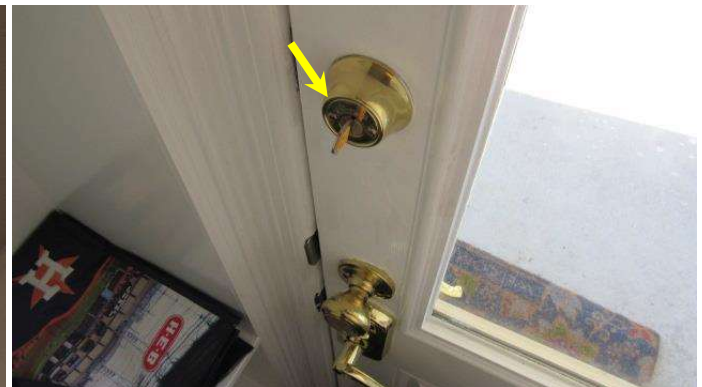
- All dead bolt locks on exterior doors should not be keyed from the inside, should have flip locking mechanism.

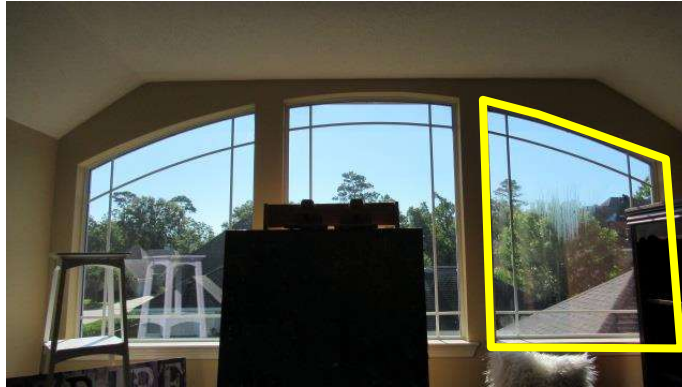
- Recommend having all windows professionally cleaned, if any internal hazing exist at the cleaning process, recommend replacing the defective windows.
- Defective window noted in the upstairs game room on the rear wall right window with internal hazing / condensation, recommend replacing all defective windows.

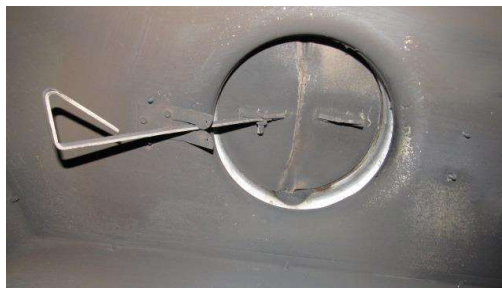
- Improper type of burner noted in the fire box, recommend replacing the burner with an artificial log burner.
- Observed no / damper stopper installed, recommend installing damper stopper when artificial logs are present in firebox.

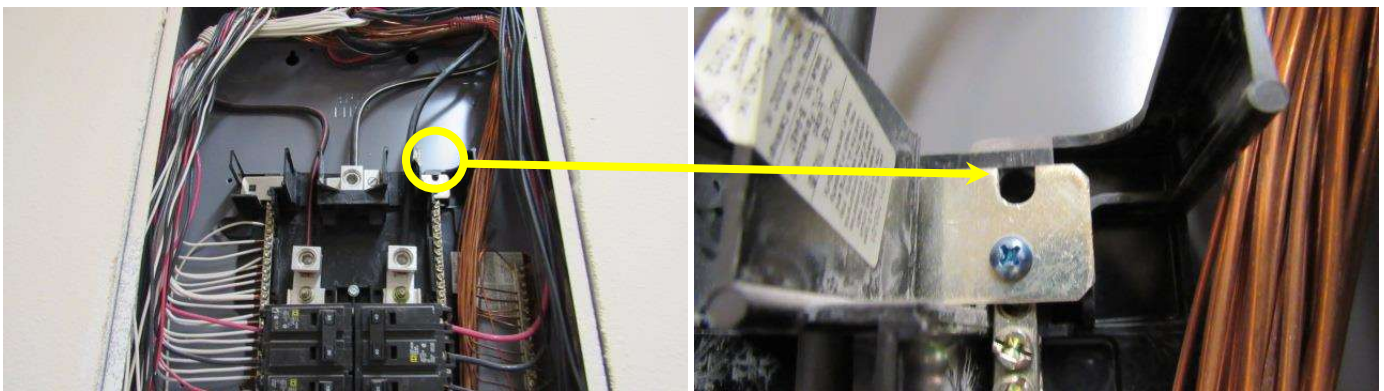
- Grounding screw for the sub panel in the laundry room is missing, recommend installing a grounding screw so the sub panel housing can be properly grounded to the neutral bar & grounding bar.

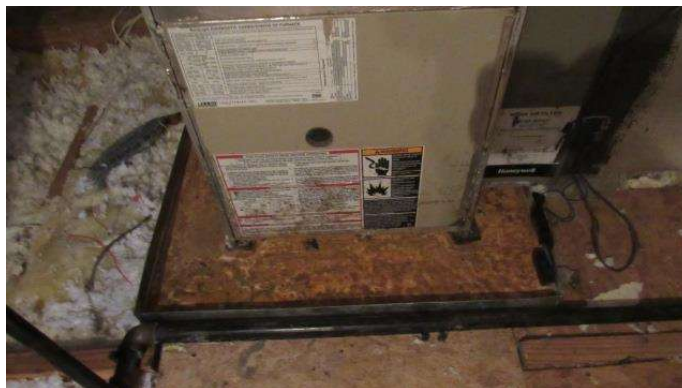
- Rust & corrosion noted in emergency drain pan.

- Recommend service and a complete inspection of the cooling system by a licensed Cooling & Heating service.

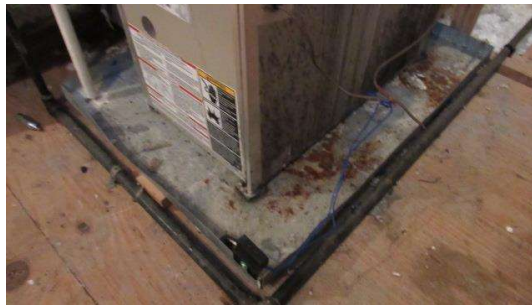
- Standing water, debris & corrosion noted in emergency drain pan.

- Recommend service / repairs, and a complete inspection of the cooling system by a licensed Cooling & Heating service.
- A/C is working efficiently as evidence by an 18 degree drop between return air and supply register.
- Observed 67 degrees at return air chase and 49 degrees at supply register.

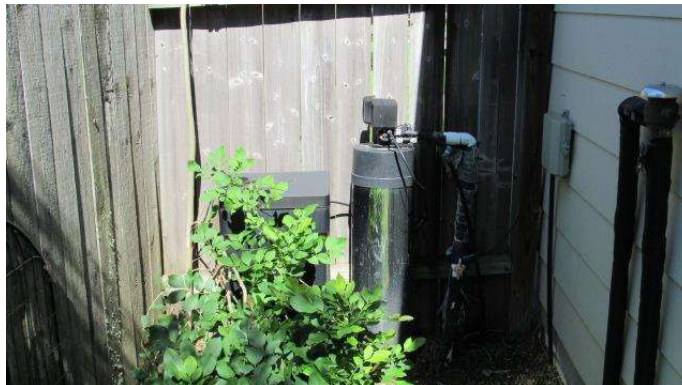
- Softener system noted on the right side of the garage, recommend consulting with the manufacturer to verify that the system functions as intended.
