Property Inspection Report

9307 Reston Grove Ln, Houston, TX 77095

Date of Inspection: 6/29/2021 Time: 12:30

Inspector: B. Ashley Granger

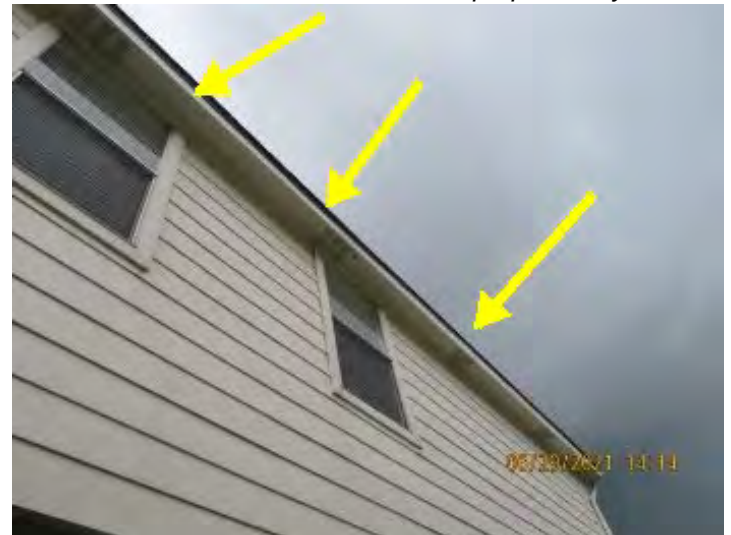
Missing gutters noted on sides of structure noted. Recommend adding gutters for optimal efficiency.

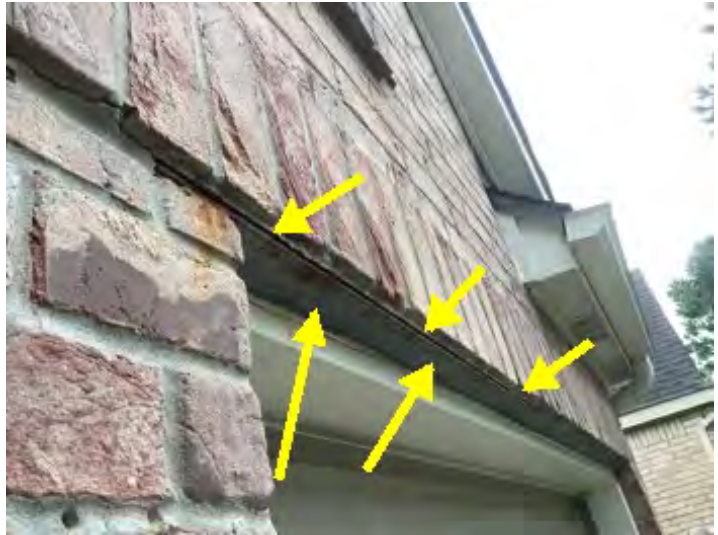
All metal lintils above garage and windows should be sanded caulked sealed and painted properly. Conducive to moisture intrusion, damage and potential WDO. Recommend having a professional inspect and correct

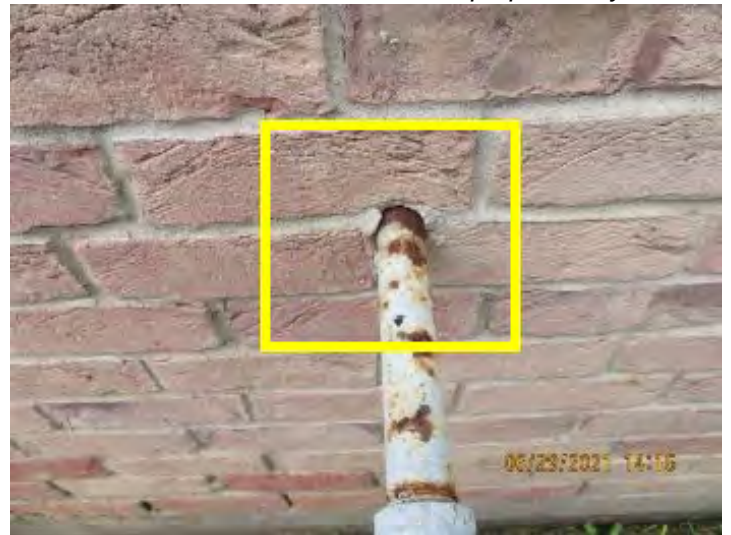
Galvanized plumbing at gas meter penetration into wall systems should be sealed properly. Conductive to moisture intrusion, damage and potential WDO.

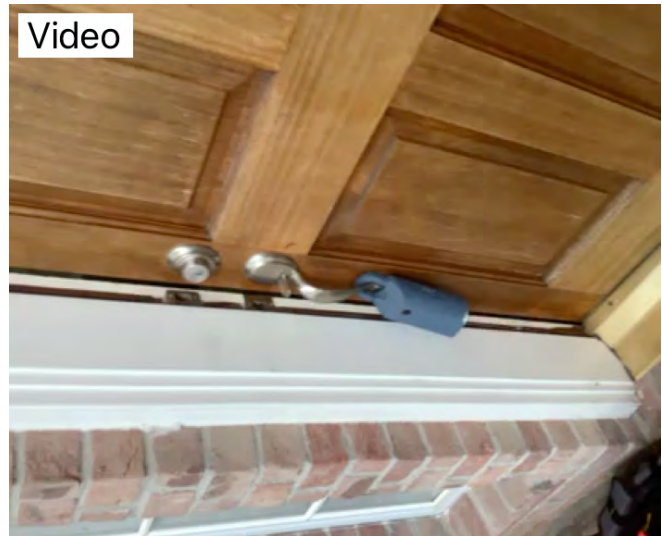
Front door not closing properly at time of inspection noted. Observational an informational purpose only.

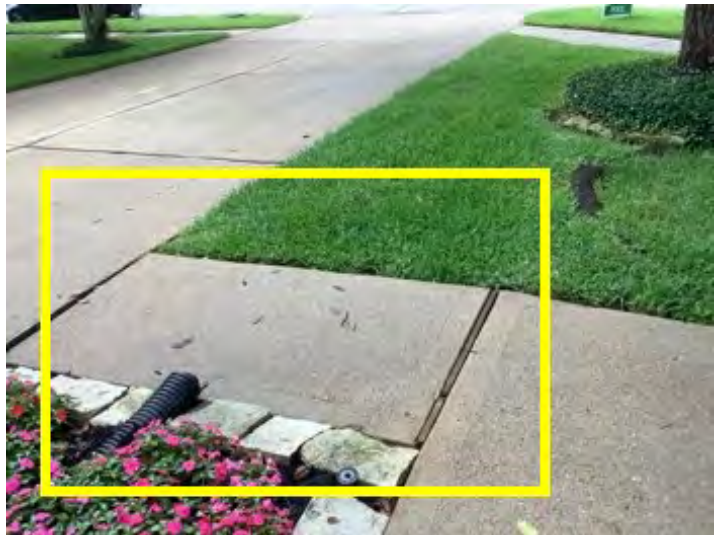
Slight bulging and heaving noted in concrete sidewalk due to expose root system from tree in front yard. Recommend having all three routes corrected by a professional.

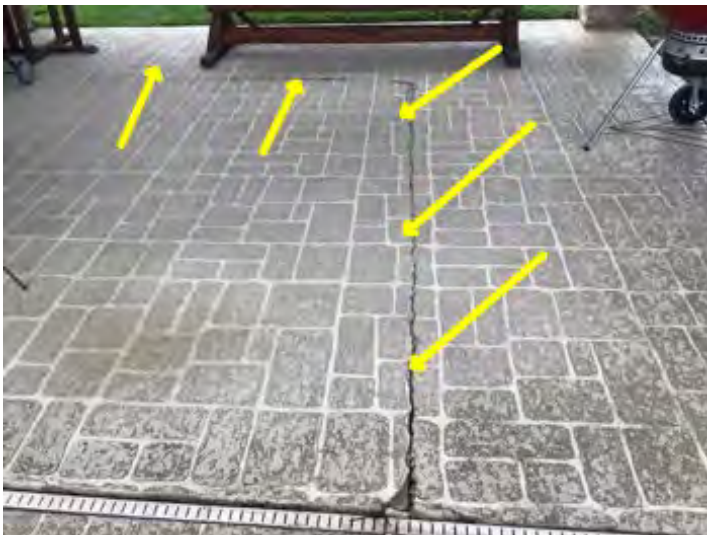
Cracking noted on back patio at time of inspection. Recommend having a professional inspected correct potential trip hazard conducive a moisture intrusion, shifting expansion and contraction potential.

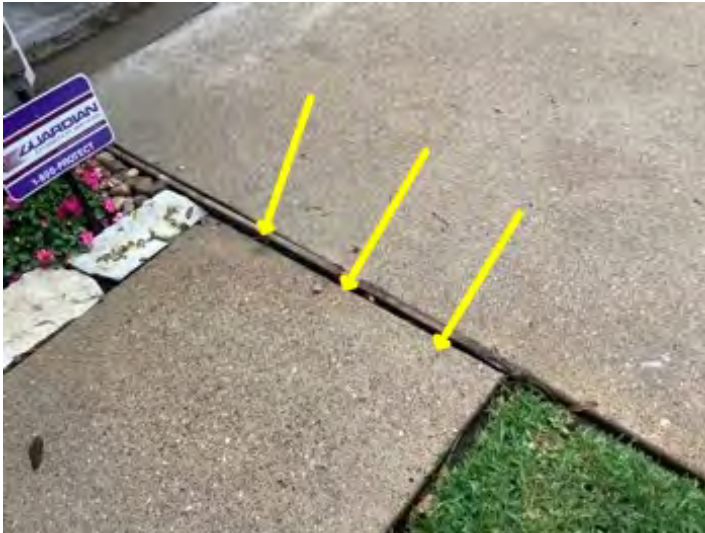
Slight deflection noted by sidewalk into front door at time of inspection. Inspectors opinion is exposed route from tree is shifting the concrete sidewalk in this area noted.

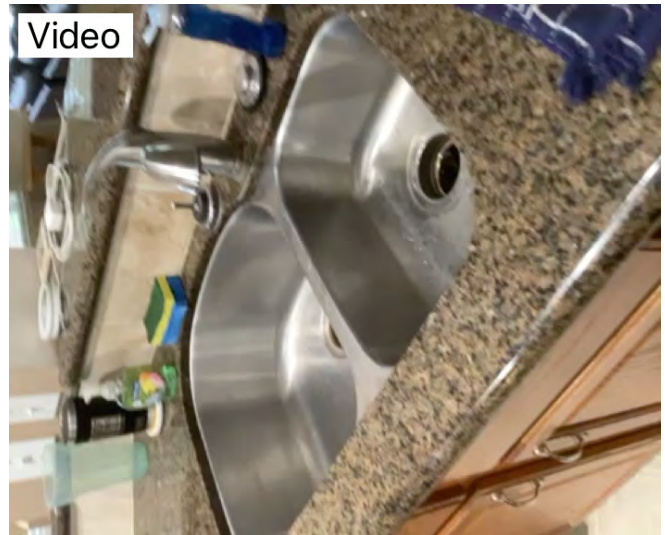
GFCI outlet located by kitchen sink while working properly recommend labeling has recommended

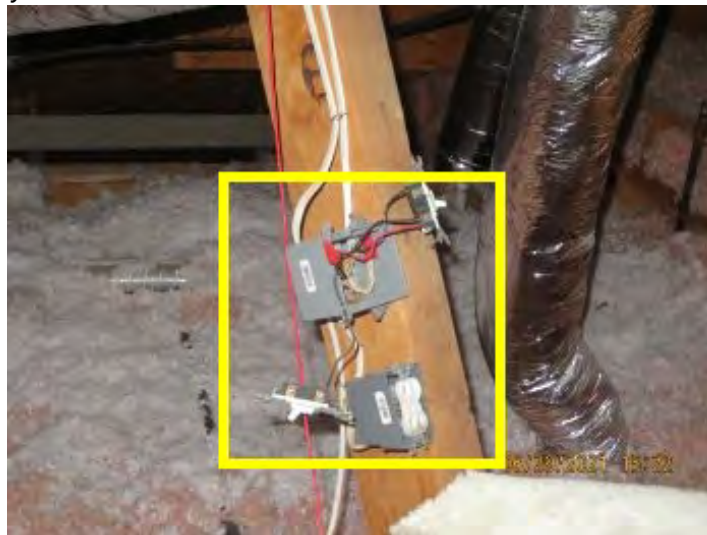
Exposed wiring in attic and outlets / receptacles missing cover plates noted. Potential hazard and recommend having a professional inspect and correct.

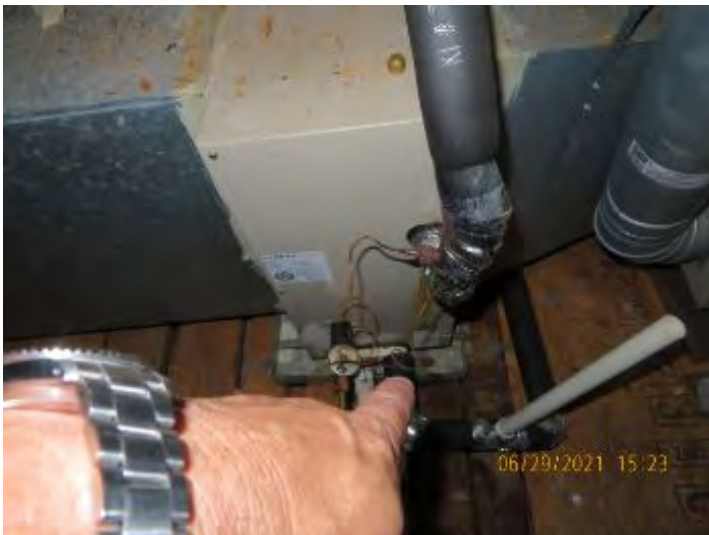
Missing float switch noted. Recommend having one added for proactive protection in case drain pan gets full of water "Float Switch" Will shut off system for protection from moisture damage and intrusion from drain pan potentially overflowing.

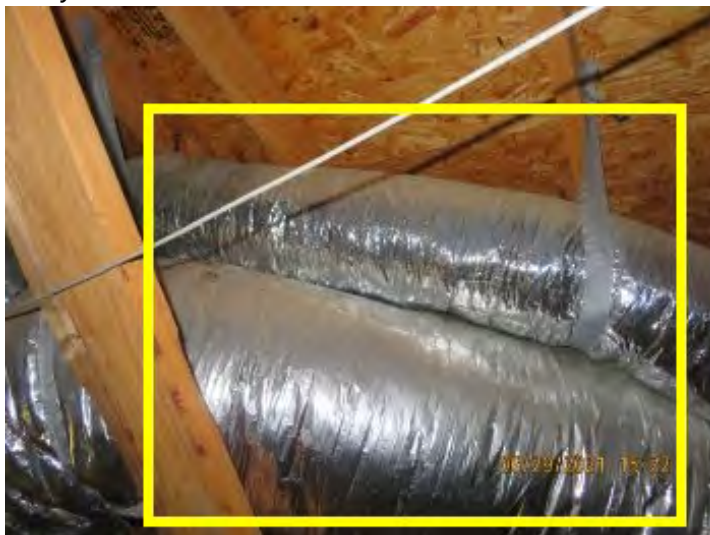
All HVAC ducts should not touch one another and be properly hung. Conducive to moisture intrusion, damage and potential WDO

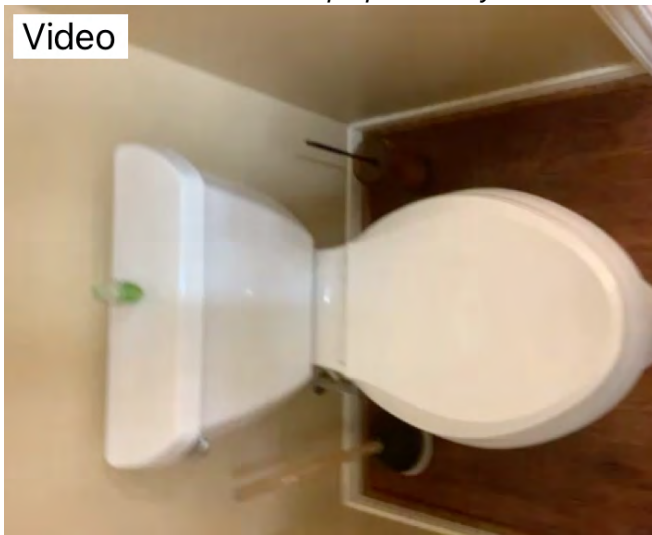
First floor Half bathroom toilet tank is slightly loose recommend taking the very least almost intrusion with damage.

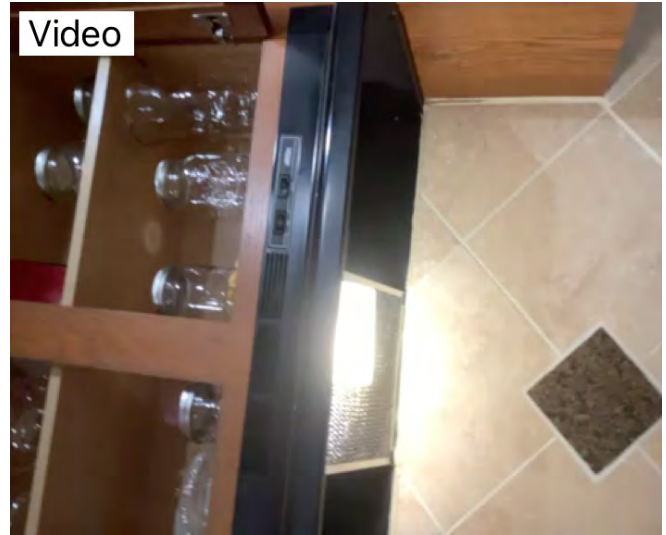
Range hood was noisy at time of inspection recommend having a professional inspect fan motor.

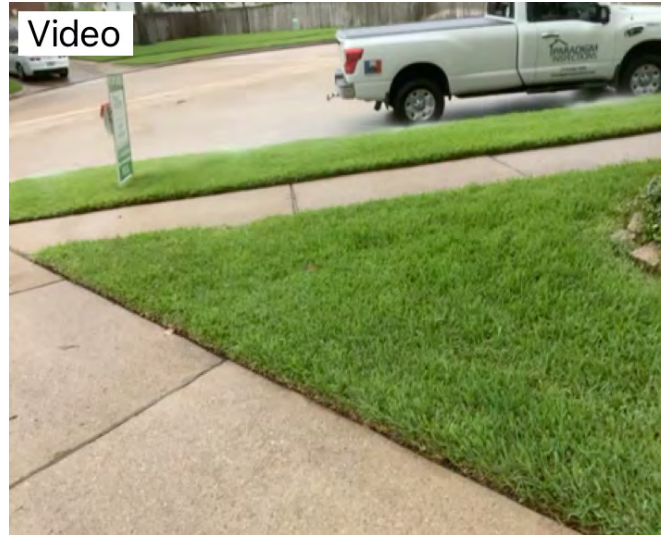
Rainbird control panel for automatic sprinkler system noted at time of inspection. Unit was not working properly.

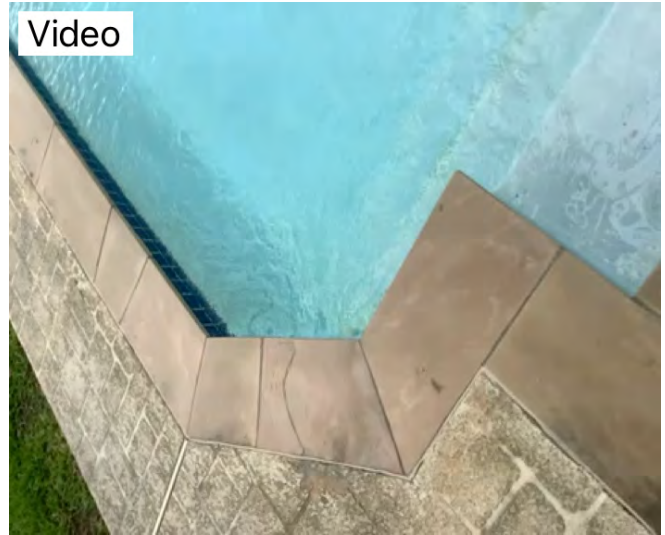
All caulking around pool between decking and coping should be sealed properly conducive to moisture intrusion, damage, expansion and contraction. Recommend having a professional inspecting correct.

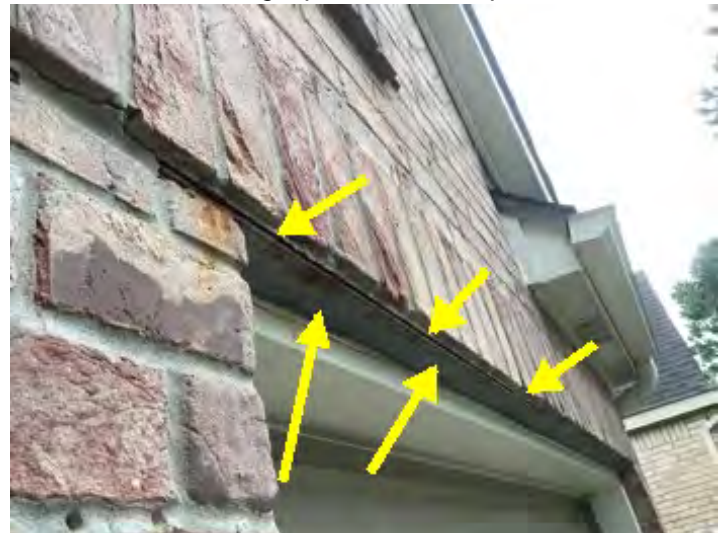
All metal lintels above garage and windows should be sanded caulked sealed and painted properly. Conducive to moisture intrusion, damage and potential WDO. Recommend having a professional inspect and correct

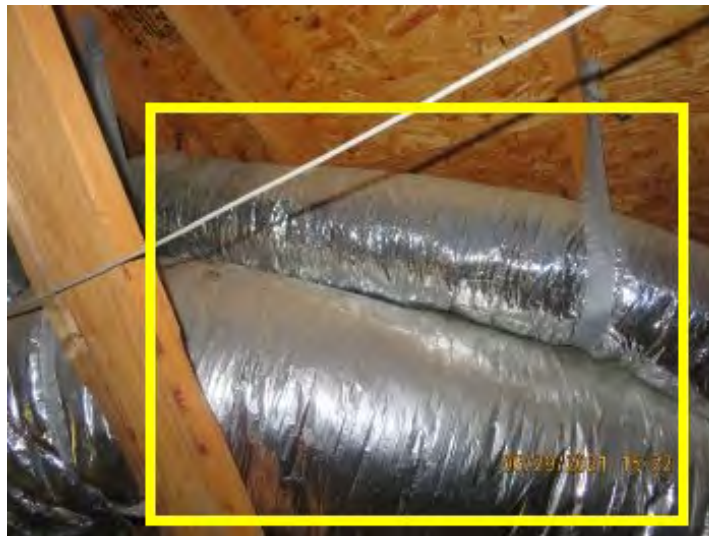
All HVAC ducts should not touch one another and be properly hung. Conducive to moisture intrusion, damage and potential WDO
