# American Dream Home Inspections, LLC

9307 Reston Grove Ln, Houston, TX

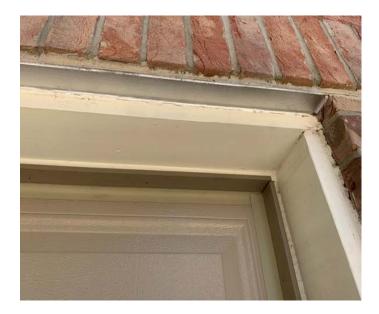
All metal lentils above garage and windows should be sanded cauliked sealed and painted properly. Conducive to moisture intrusion, damage and potential WDO. Recommend having a professional inspect and correct

• Repairs completed on metal lentils above garage and doors

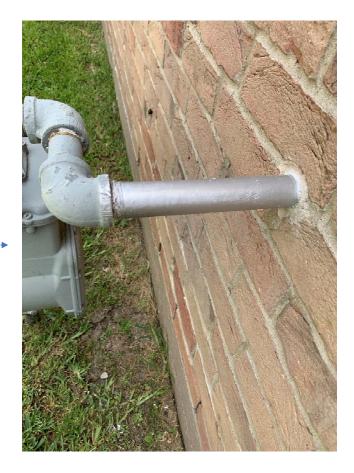
Galvanized plumbing at gas meter penetration into wall systems should be sealed properly. Conducive to moisture intrusion, damage and potential WDO. Observational an informational purpose only.

• Repairs completed on gas meter penetration
